## COLORADO DIVISION OF RECLAMATION, MINING AND SAFETY COAL PROGRAM INSPECTION REPORT

<b>Permit Number:</b> C-1981-012 <b>Mine Name:</b> New Elk Mine <b>Operator:</b> New Elk Coal Company, LLC <b>Operator Address:</b> Mr Mark Haywood 12250 Highway 12 Weston, CO 81091	<b>County:</b> Las Animas <b>Operation Type:</b> Underground <b>Permit Status:</b> Temporary Cessation <b>Ownership:</b> Private
	<b>Operator Representative Present:</b>  Ron Thompson
<b>Operator Representative Signature:</b> (Field Issuance Only)

<b>Inspection Start Date:</b> July 23, 2013 <b>Inspection Start Time:</b> 12:48 <b>Inspection End Date:</b> July 26, 2013 <b>Inspection End Time:</b> 11:30	<b>Inspection Type:</b> Coal Complete Inspection <b>Inspection Reason:</b> Normal I&E Program <b>Weather:</b> Cloudy	
<b>Joint Inspection Agency:</b>  None	<b>Joint Inspection Contacts:</b>	
<b>Post Inspection Agency:</b>  None	<b>Post Inspection Contacts:</b>	
<b>Inspector(s):</b>  Leigh D. Simmons  Daniel I. Hernandez	<b>Inspector's Signature:</b>

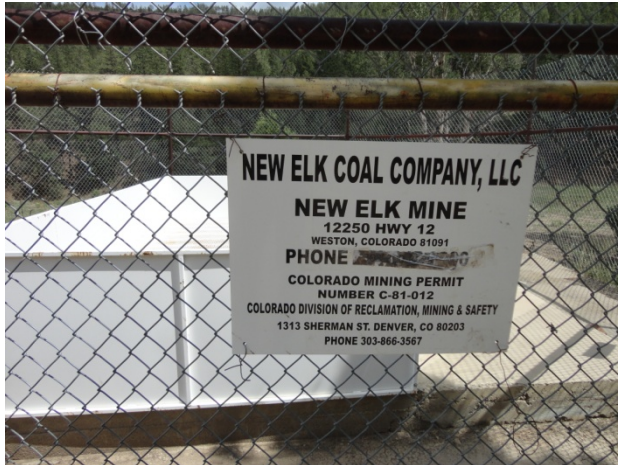
Mine ID signs are in varied states. Some of the old signs have been replaced, however the new signs do not show the phone number for the Division.

Photo 1: Example of old Mine ID signs, showing temporary nature

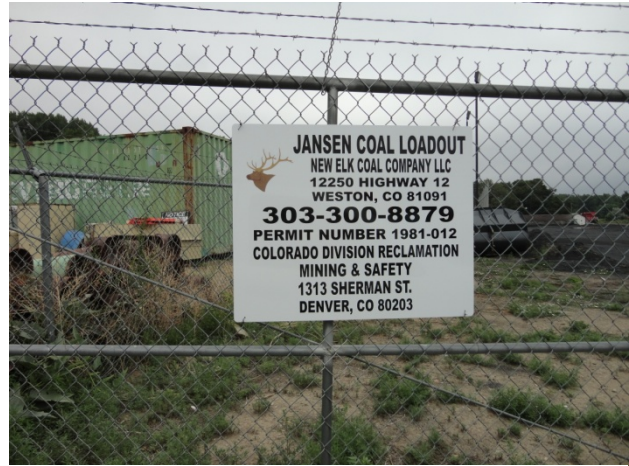
Photo 2: Example of new Mine ID signs, missing DRMS phone number

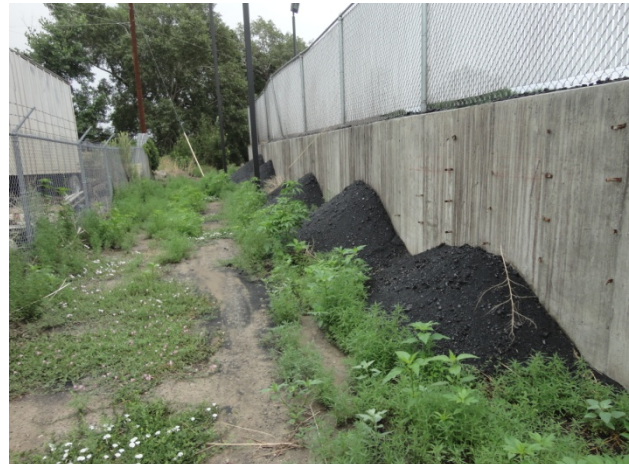
The Jansen Load-out was inspected on Wednesday, July 24, 2013. Virtually all the coal had been shipped from the site. No weeds or non-coal waste were observed. The berm was intact. Boundary markers were in place. Both sumps were clear and well defined. Some dead thistles were observed - the weed spraying program has been effective and should be continued. A little coal had spilled over the concrete retaining wall. The gate had been damaged. **The coal should be cleared up and the gate should be repaired.**

Photo 4: Spilled coal at Jansen Load-out

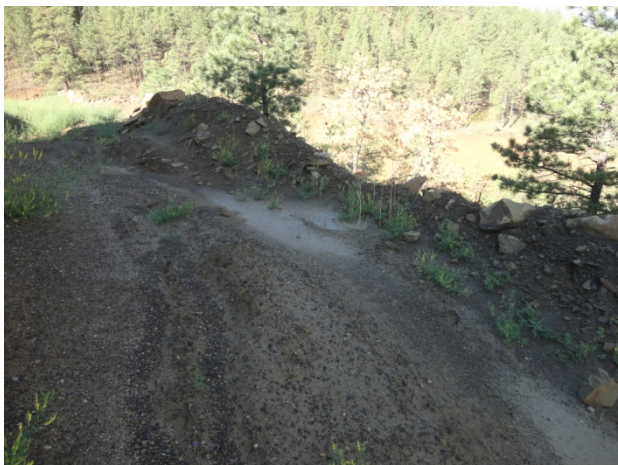
- Ditches and culverts surrounding DWDA 1 were clear and in good order.
- The “new water tank” SAE appeared to be fairly well drained and stable. The berm had not been breached, however ponded water shows where low spots should be built up. **Some non-coal waste should be cleared and a low spot in the berm should be built up; since this was an item that was identified in the inspection report of April 29, 2013, and is not the subject of a permitting action, the Division finds that this is a violation for failure to maintain a Small Area Exemption site in accordance with the approved design. This is discussed further in the ENFORCEMENT ACTIONS section of this report.**

Photo 5: Low spot in water tank SAE berm

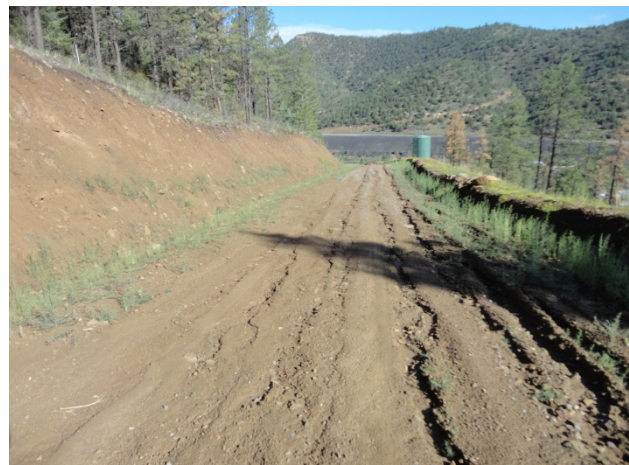
Photo 6: Road to water tanks

Roads on the mine site were generally in a good state of repair, however **the road up to the water tanks will need to be regraded when conditions allow.**

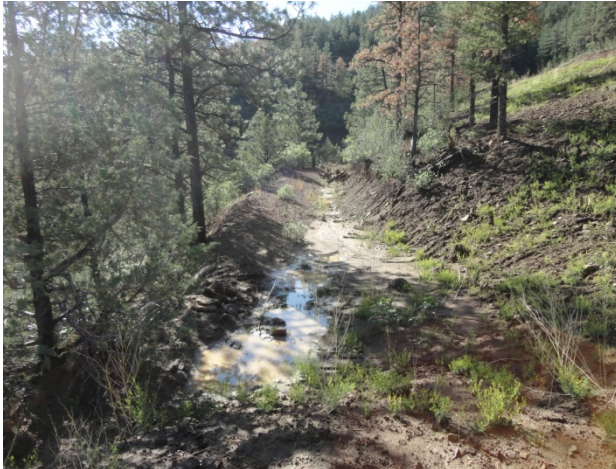
Photo 7: Old diversion, to be reclaimed

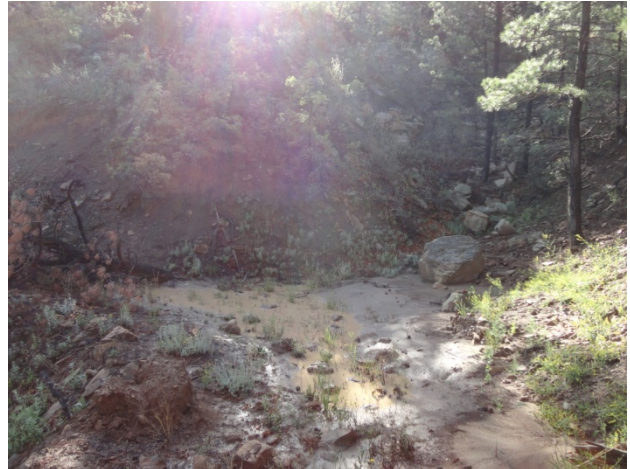
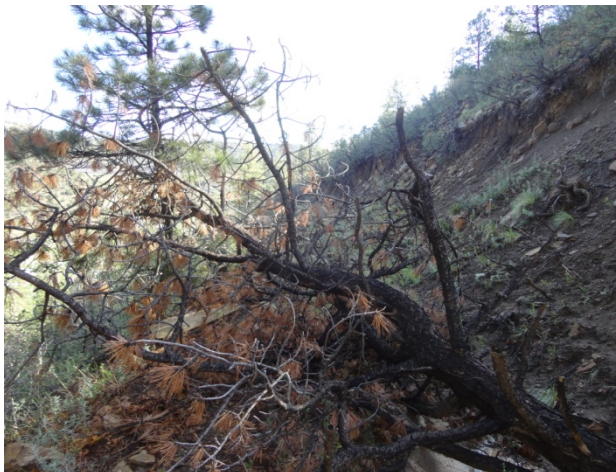
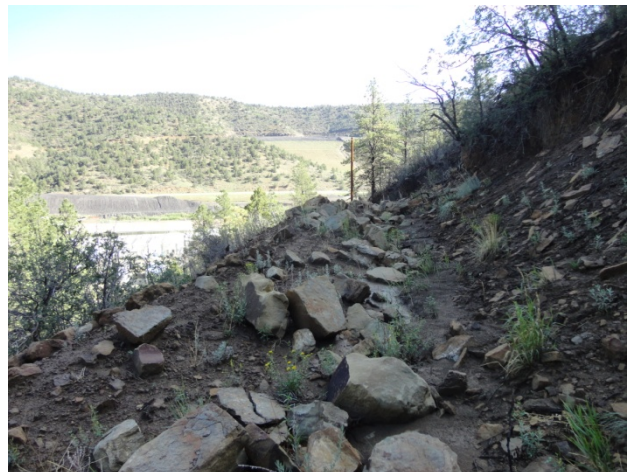
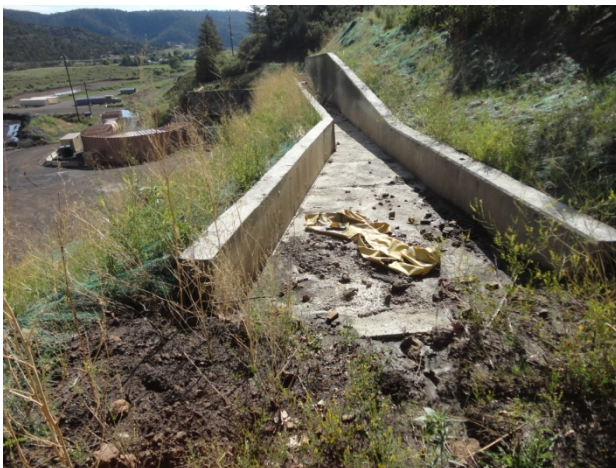
- Ditch D18 was in good shape to the junction with D9
- Clean water diversion ditch D26 does not exist as shown on map 13, and may be impossible to construct without compromising the road above. The short leg of the ditch west of the natural drainage has a very small watershed and is not necessary. **East of the drainage, the ditch needs to be cleaned of rocks, non-coal waste and vegetation, and should be shaped and graded to ensure it functions as designed. The old section of ditch, running south east from the lower water tank pad, should be reclaimed. Since these were items that were identified in the inspection report of April 29, 2013, and are not the subject of a permitting action, the Division finds that this is a violation for failure to maintain ditches in accordance with the approved design. This is discussed further in the ENFORCEMENT ACTIONS section of this report.**

Photo 8: D26, to be re-graded

Photo 9: D26 to be cleared

Photo 40: D26 to be cleared (2)

Photo 31: D26 to be cleared (3)

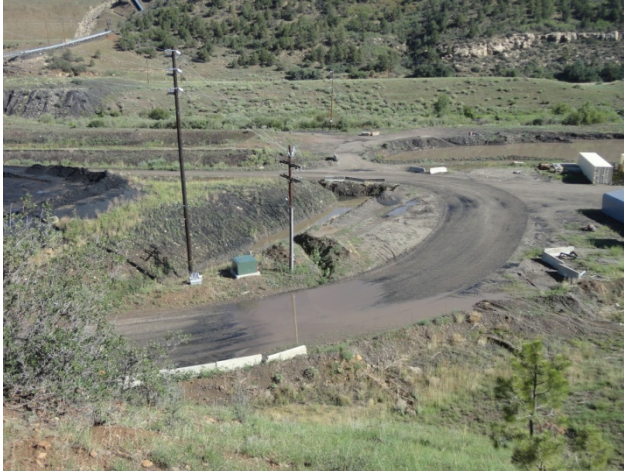
Photo 83: Water in Pond 7 backed up through C20, into D24A

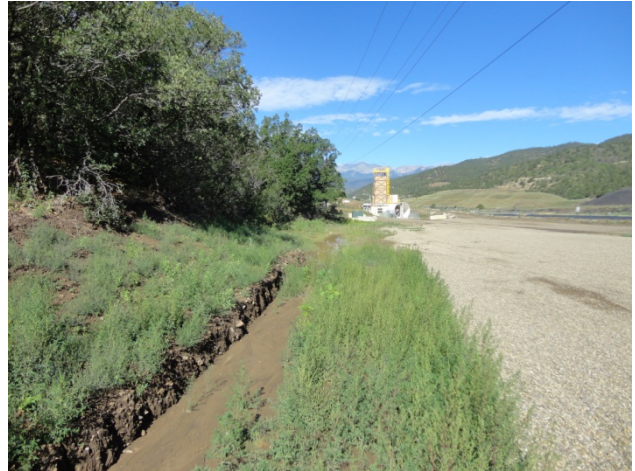
Photo 74: D39A puddle – ditch to be extended

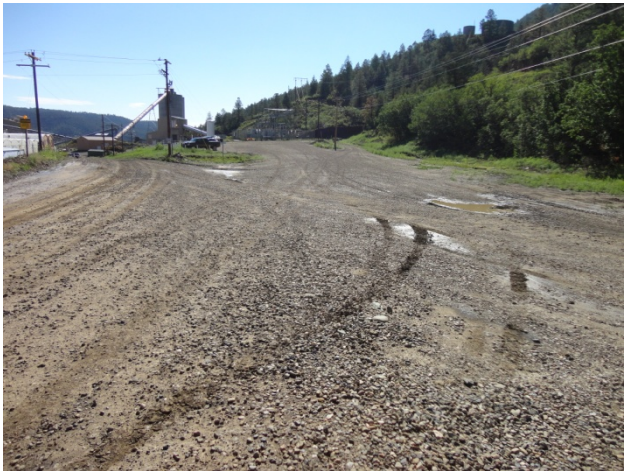
Photo 65: New drainage scheme needed around East Portal fan

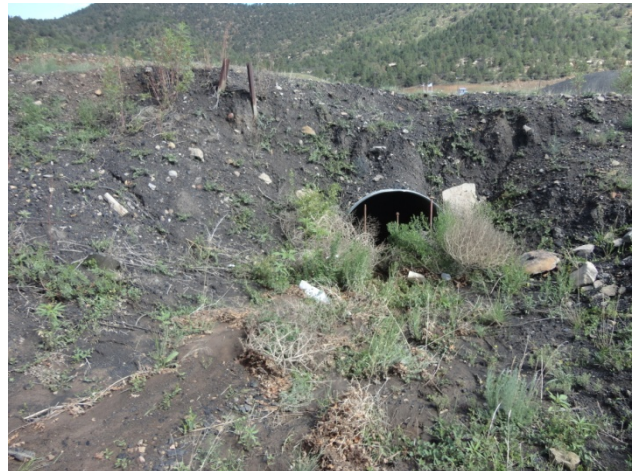
Photo 56: Inlet of C5

- Culvert C3 had been shortened and about 20' had been replaced with a new culvert. **Some material from the work needs to be cleared up.**
- **Some non-coal waste and vegetation should be cleared from ditch D9 and the inlet to culvert C5.** Since these were items that were identified in the inspection report of April 29, 2013, and are not the subject of a permitting action, the Division finds that this is a violation for failure to maintain ditches in accordance with the approved design. This is discussed further in the ENFORCEMENT

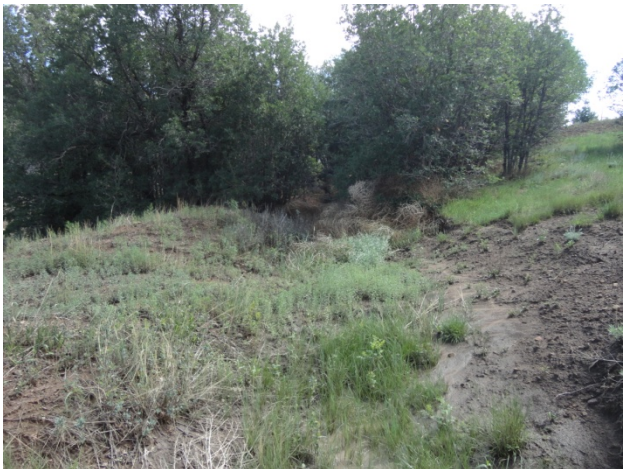
Photo 17: D9 vegetation to be cleared

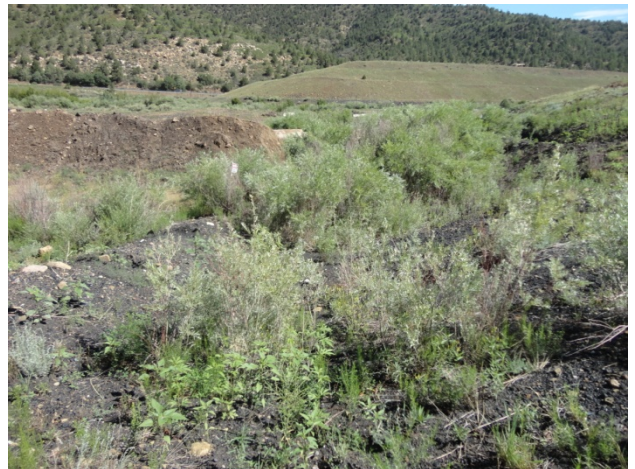
Photo 18: D7 full of willows

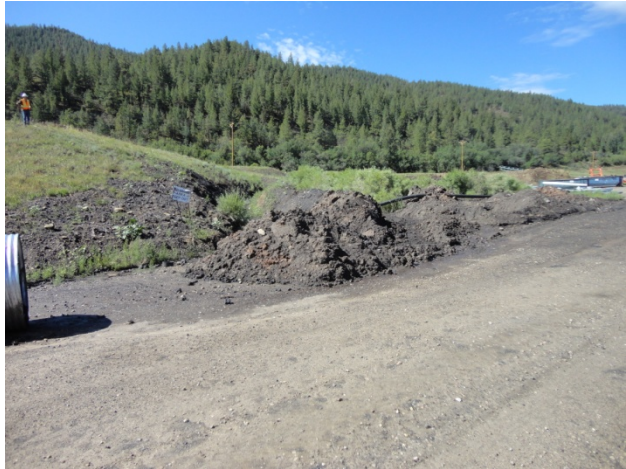
Photo 19: Material to be cleaned up from C3 project

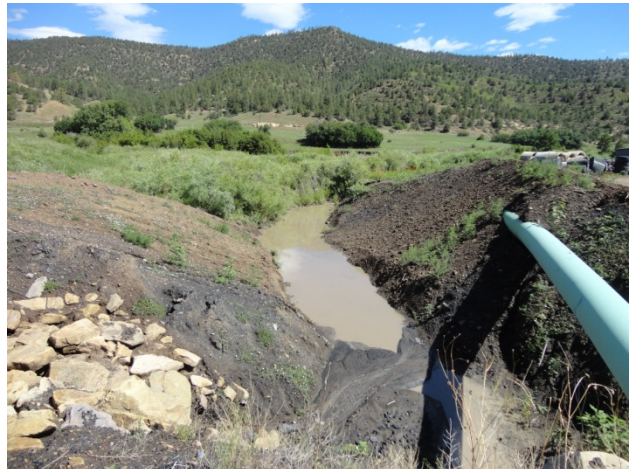
- Above C2, Ditch D34BBB was good. Below C2, the ditch runs into a wetland. At the time of the inspection water had ponded in a low section of the ditch before the willows, which acted as an impoundment. It's not clear how best to manage the flow in this location, since it would be preferable to avoid disrupting the existing wetlands by cutting a ditch to the river.

Photo 20: Downstream of C2 – how to drain and maintain?

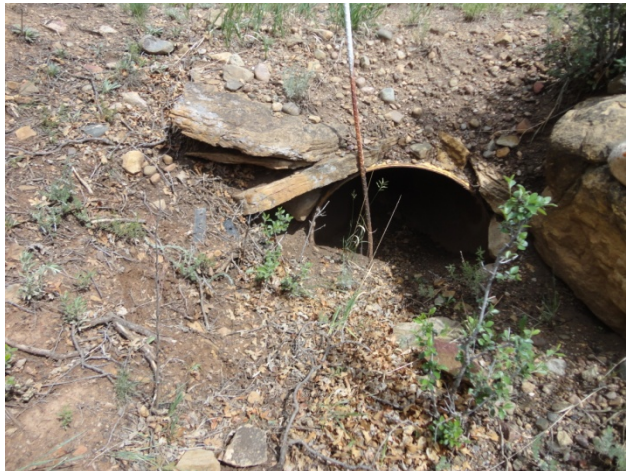
Photo 21: Inlet of C21 to be cleared

- **Culvert C21 should be cleaned at the inlet** (this is a job for a shovel rather than heavy machinery)
- The "old water tank" and "old substation" SAEs showed no recent disturbance. Each could be a candidate for bond release.

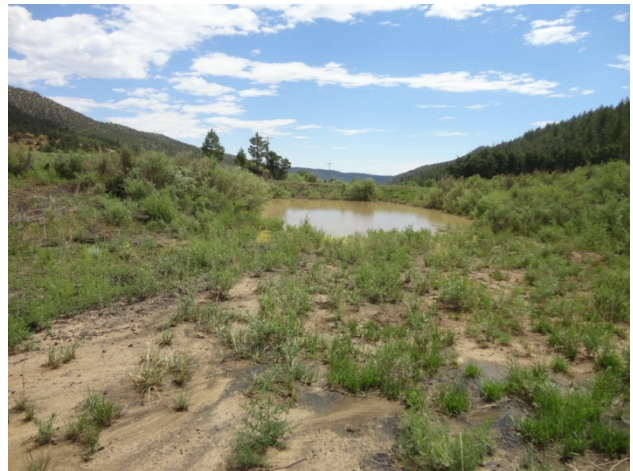
- Containment 2 was fine, but is not shown on map 14. **It should be included on the redrawn map. Non-coal waste should be cleared from the adjacent ditch.**

Photo 22: Containment to be shown on map

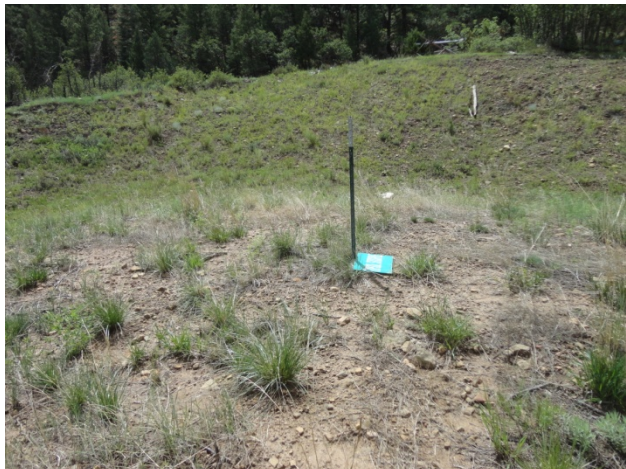
As noted in the inspection report of April 29, 2013, the topsoil stockpile shown on the 7/25/2012 version of map 14 does not exist and may not be constructed. Also, a second topsoil stockpile, in the area of containments 1 and 2 is not shown on map 14. **The map should be updated accordingly. Also, the sign on the second pile should be replaced.**

Photo 23: Topsoil stockpile to be sign-posted and shown on map

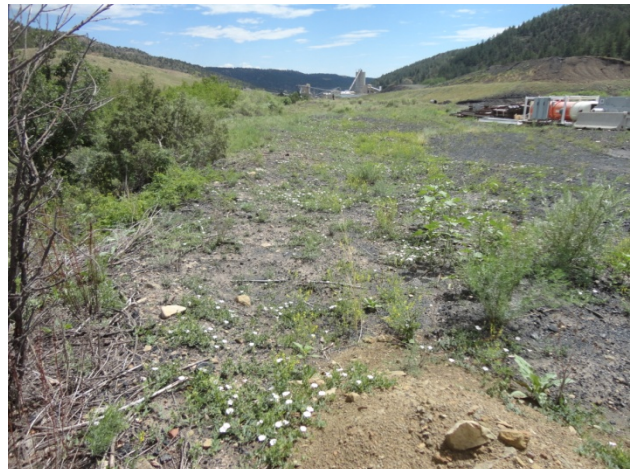
Photo 24: D5 to be re-cut

- Ditch D5 had become ill-defined. **D5 should be re-cut, north of the shop area.**
- Culvert C9A was clear. C9 was not blocked, but sediment had accumulated at the outlet. C8 was more than half full with sediment, and the inlet was damaged. **Culverts C8 and C9 should be cleaned and repaired as necessary to allow maintenance.**

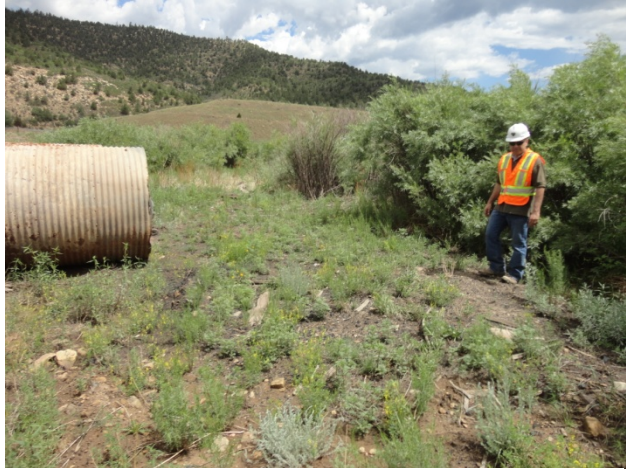
- The new armoring at the outlet of ditch D10 had held up well to the recent heavy rain and looked very good.
- The explosives area was clean and in good shape, but **the ditch/berm around it needs to be re-shaped to ensure that disturbed area runoff does not flow into the clean water ditch.** There was a clean water diversion ditch to the south that is not marked on map 13, which joins ditch D7. **The ditch should be added to the redrawn map. Some timber should be cleared from it, and the ditch re-shaped in places.**

Photo 25: Ditch/berm around explosives area to be established

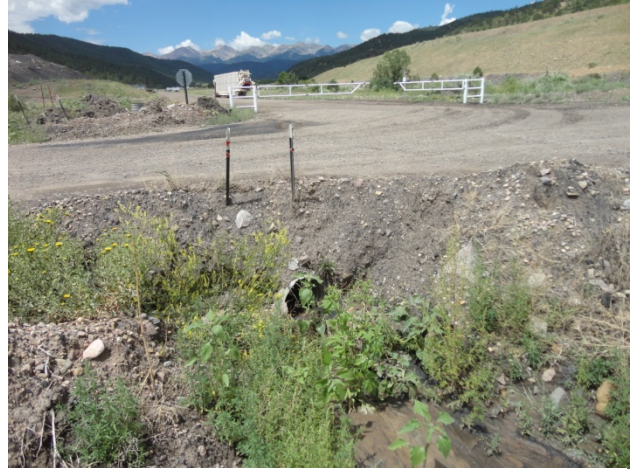
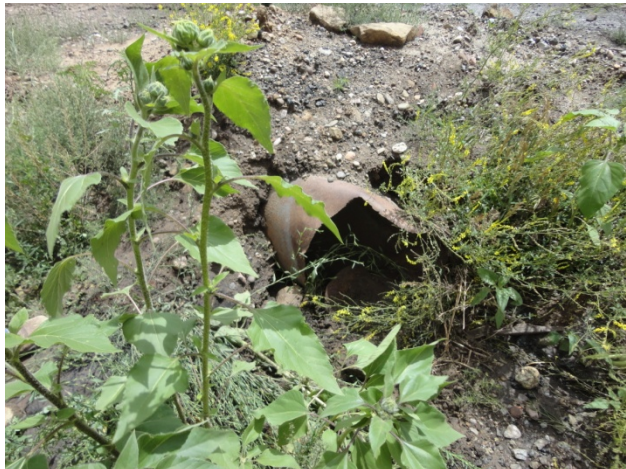
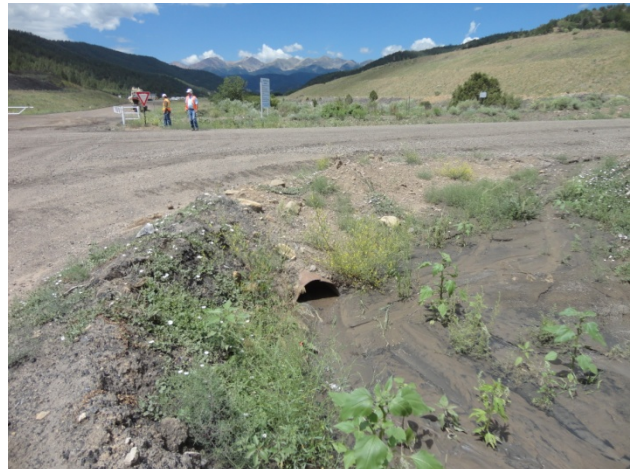
Photo 26: C9 to be cleared at outlet

Photo 27: C8 inlet damaged

Photo 28: C8 to be cleaned

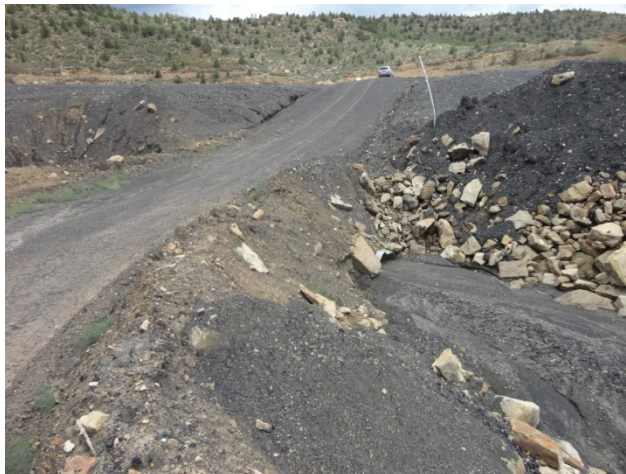
- **Along the conveyor line, spilled refuse should be shoveled back onto the belt and sent up to the RDA.**
- Culverts under the haul road up the west side of the RDA were as follows: C40, good; C-B, good; C39, a little erosion at the outlet to monitor; C45, good; C-A is mis-located on map 13, and has some erosion at the outlet. **The position of C-A should be corrected when the map is redrawn and the erosion should be repaired.**

Photo 29: Culvert under road on west side of RDA to be cleaned

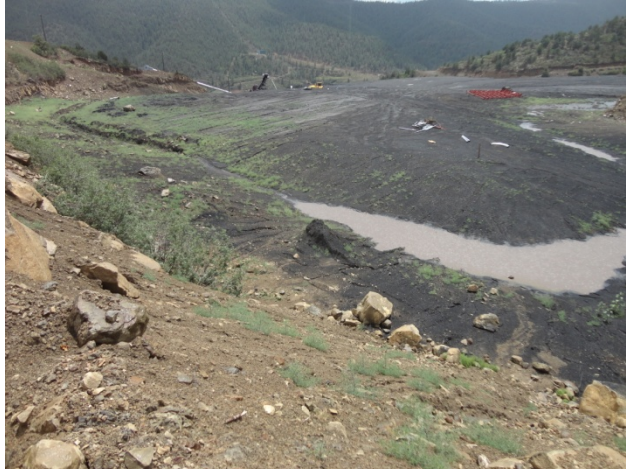
- There were some large puddles on the top of the RDA. **The swales in the refuse should be extended when conditions allow, to ensure that no water is allowed to collect on the RDA.**

Photo 31: East side of RDA – needs to be drained

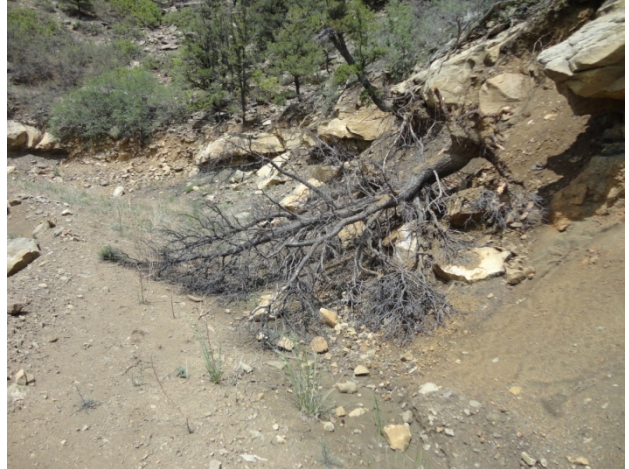
Photo 32: RDA diversion ditch to be cleared

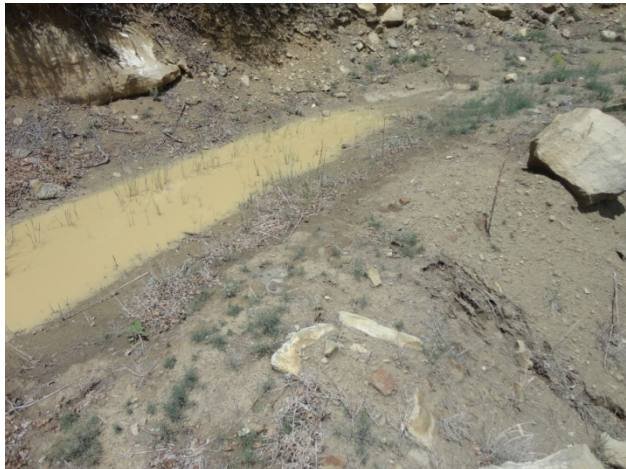
Photo 33: Low spot and breach in RDA diversion ditch, to be surveyed

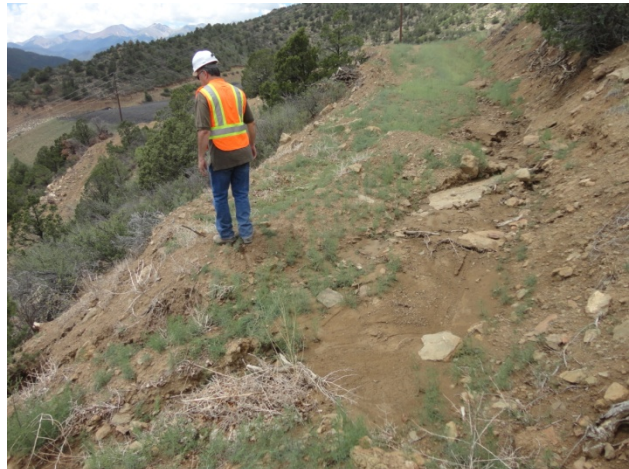
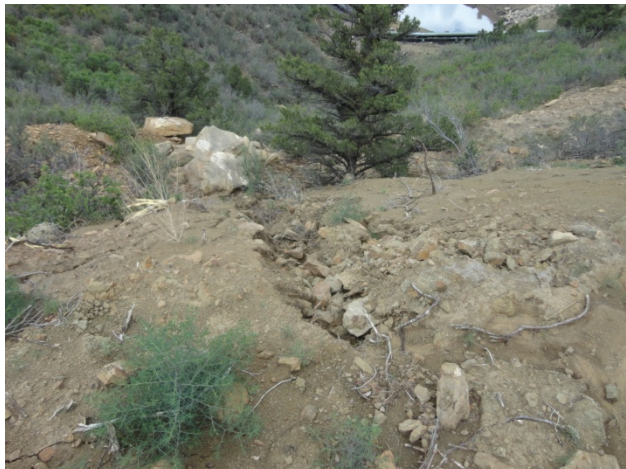
Photo 34: Erosion below cell phone pad (1)

Photo 35: Erosion below cell phone pad (2)

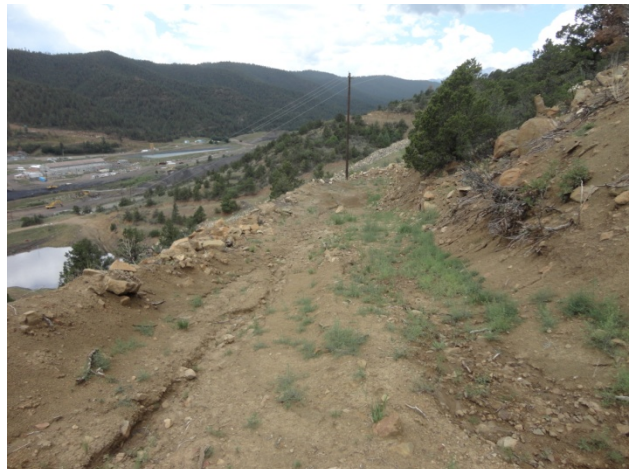
Photo 36: Road to power poles needing flow control

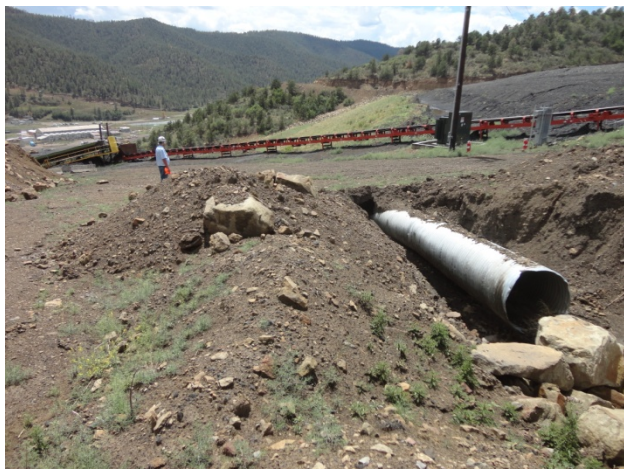
- A culvert on the RDA, level with the highest reclaimed bench, is not shown on map 13. **It was partially crushed, so needs repair. It also needs to be permitted; this should be addressed in TR68.**

Photo 37: Unidentified and damaged culvert on east side of RDA

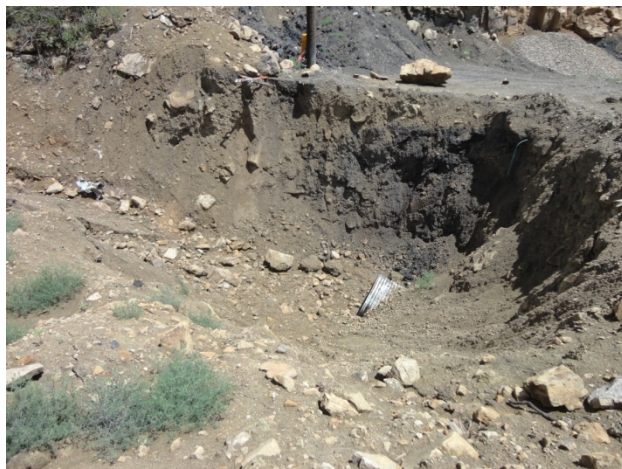
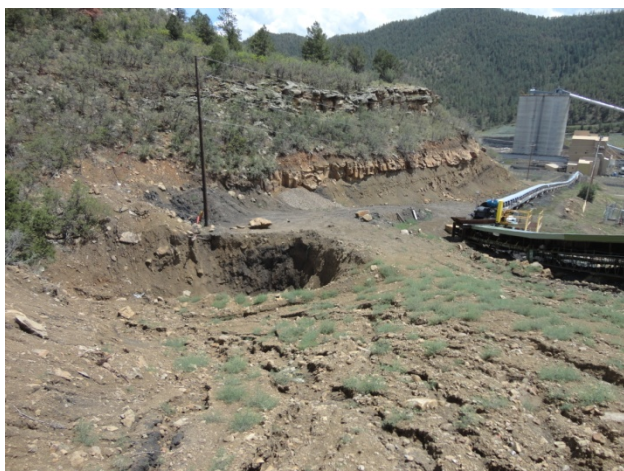
- The damaged section of the culvert under the conveyor, C41, had been replaced and the area around it filled and restored. Delivery of a final 30' section of culvert is holding up the completion of this project. **The final section should be placed and the surrounding area backfilled around it; since this item was first identified in the inspection report of October 16, 2012, and is not the subject of a permitting action, the Division finds that this is a violation for failure to maintain culverts in accordance with the approved design. This is discussed further in the ENFORCEMENT ACTIONS section of this report.**

Photo 38: C41 (1)

Photo 39: C41 (2)

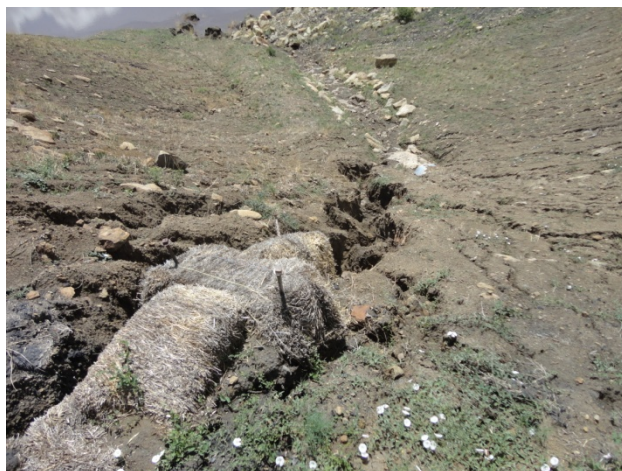
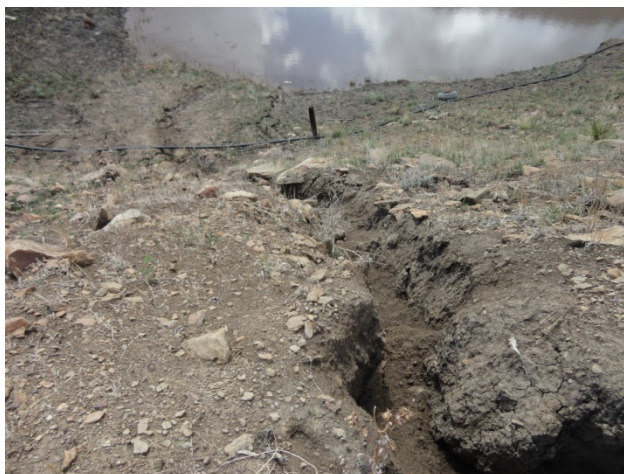
- The gully by the junction of the conveyors was huge and had grown significantly since the April inspection. A long term solution might be to create a concrete structure, with a sump, to collect conveyor runoff and pump it up to the RDA. **In the short term, spilled refuse should be cleared, the gully should be repaired, and a berm should be built up to protect it. A couple of other gullies lower down the conveyor line should be addressed in the same way.**

Photo 40: Large gully below conveyor, above pond 8

Photo 41: Second gully above pond 8

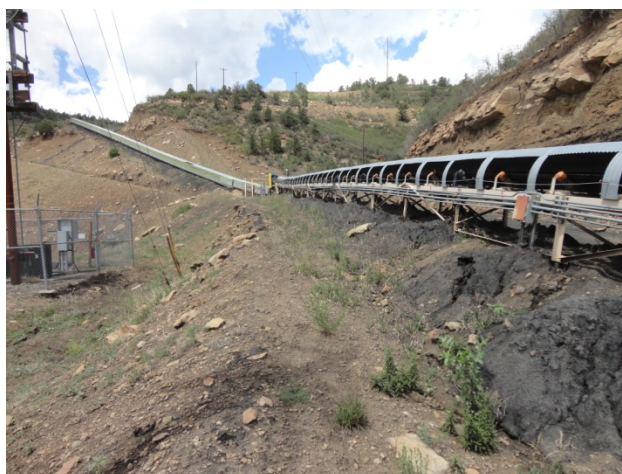
Photo 42: Spilled refuse to be cleaned up

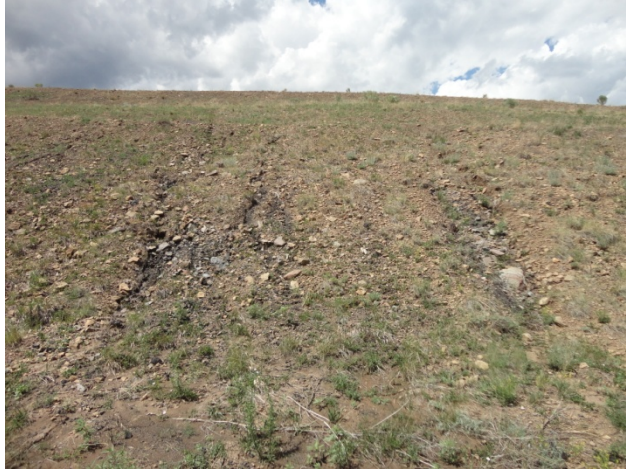
The reclaimed Development Waste Pile (DWDA 1) was stable and well vegetated. Some erosion was evident on the south side of the pile. **The erosion should be repaired and reseeded.** DWDA 1 is a potential candidate for a phase II bond release application, this would then allow pond 4 to be reclaimed, upon approval of a pond removal demonstration.

Photo 43: Erosion on DWDA 1 to be repaired

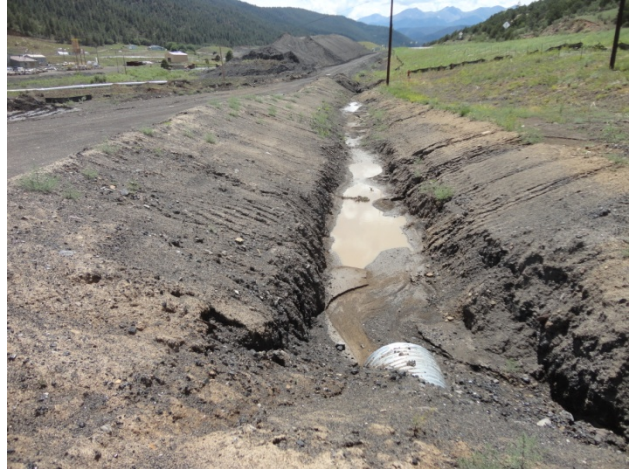
- The new culvert across the gateway to the highway (C14?) was partially blocked. **The culvert should be cleaned out.**
- Clean water culvert C30 was in good condition. **The need for straw bales at the outlet should be evaluated. If they are deemed necessary, they should be replaced.**

Photo 44: New culvert (C14?) to be cleaned

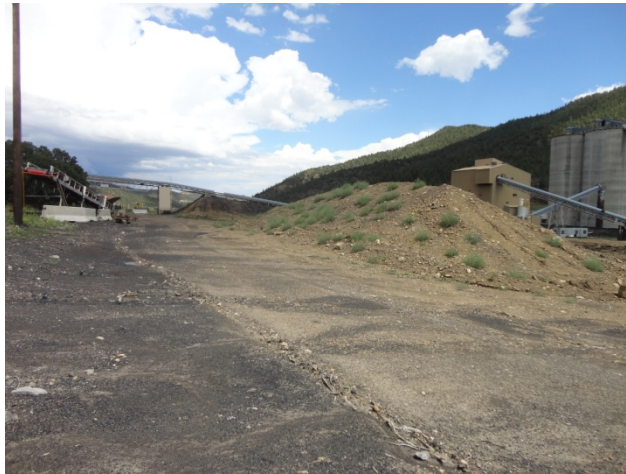
Photo 45: Topsoil pile to be marked or moved

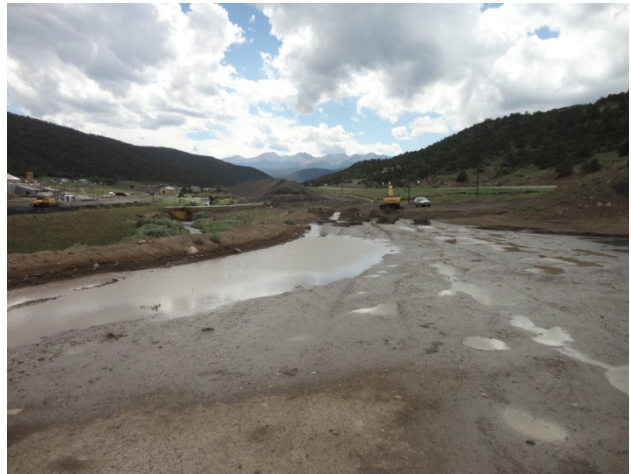
Photo 46: SAE showing berm and high spot to be graded out

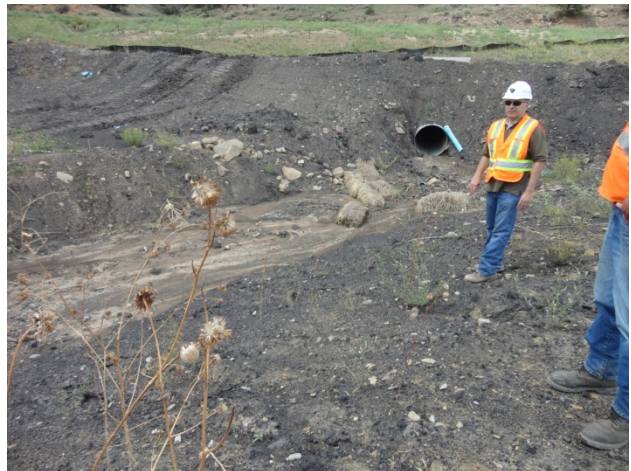
- The open channel where culvert C26 used to be showed signs of erosion. This is a clean water diversion. **The new ditch should be armored to ensure that the clean water does not collect sediment before discharging to the Purgatoire River, which would be a violation of Rule 4.05.3(4).**

Photo 48: New section of D11 to be armored

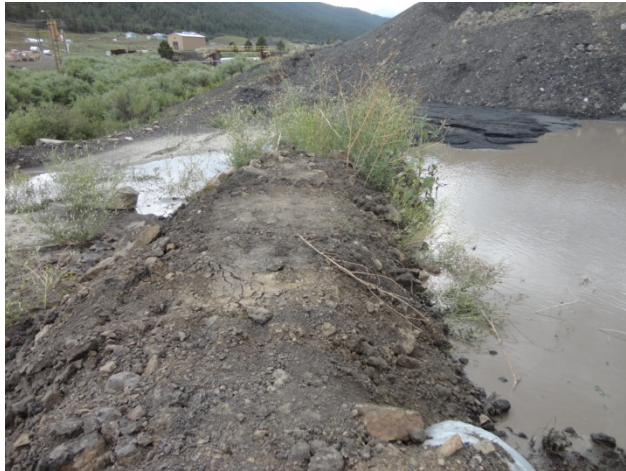
need to be cleaned frequently. Culvert C13 was clear, which shows the effective design of the sump at the inlet (which was holding water). **The sump should be cleaned, and the ditches should be cleaned and re-shaped, as conditions allow.** Additionally, Ditch D14 had breached, near the footbridge, allowing disturbed area runoff (sediment from DWDA 2) to flow into the Purgatoire River without first passing through a treatment pond. This ditch was functional during the inspection of April, and no problems were noted in May or June; it seems likely that the breach was a result of recent heavy rain. **The Division finds that this is a violation for failure to treat disturbed area runoff before leaving the permit area. This is discussed further in the ENFORCEMENT ACTIONS section of this report.**

Photo 49: Inlet to C13

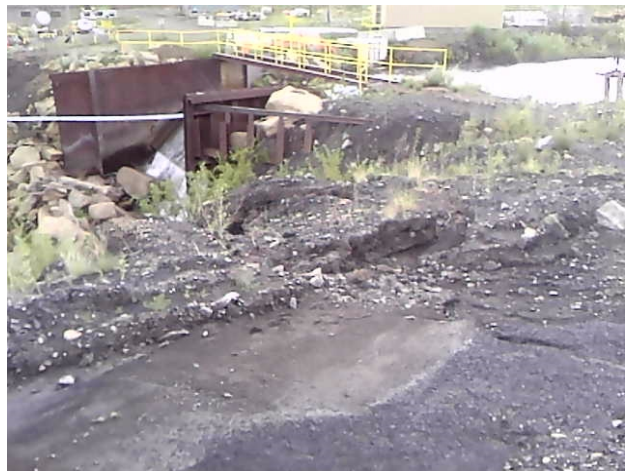
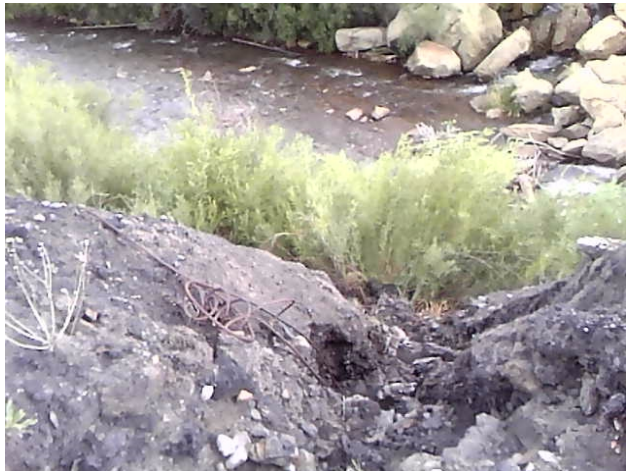
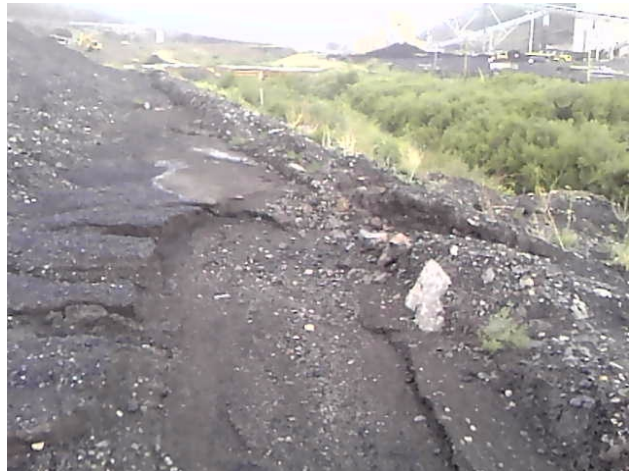
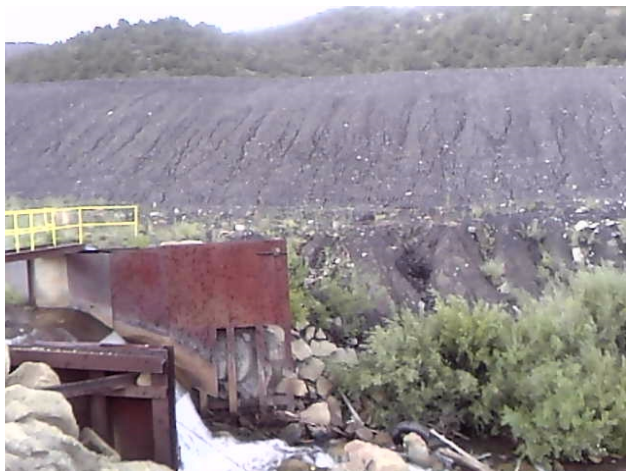
Photo 50: Breach in D14 (1)

Photo 51: Breach in D14 (2)

Photo 52: Breach in D14 (3)

Photo 53: Breach in D14 (4)

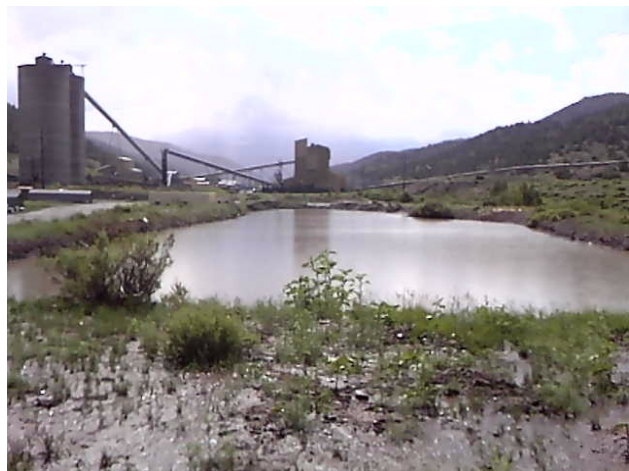
Photo 54: Pond 7

- Pond 6 had not yet been lined. No problems were observed and there was plenty of freeboard.
- Pond 7 was holding water, but not discharging, since the primary spillway gate valve was shut. The embankments and spillways were in good order. Although the level of the pond was above the height of the inlet to the primary spillway, Mr Thompson had found that water samples exceeded the Total Suspended Solids standard for the NPDES permit. Mr Thompson was waiting for the delivery of a flocculent that had been ordered; he planned to re-circulate the water in the pond, treating it with the flocculent, before testing again, and hopefully discharging. He expected to be able to discharge the pond before August 2, 2013.

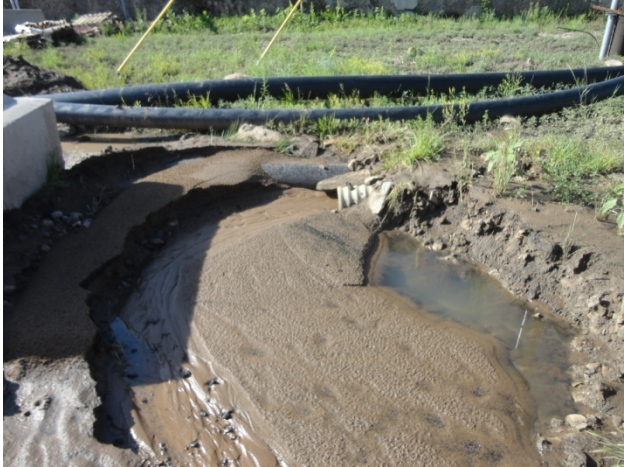
Photo 55: C16B to be cleared

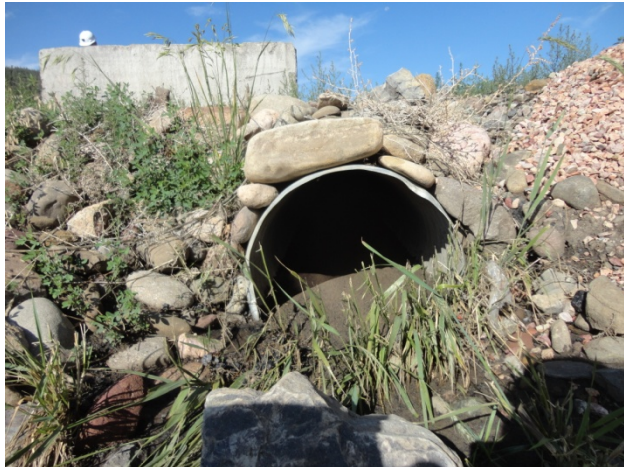
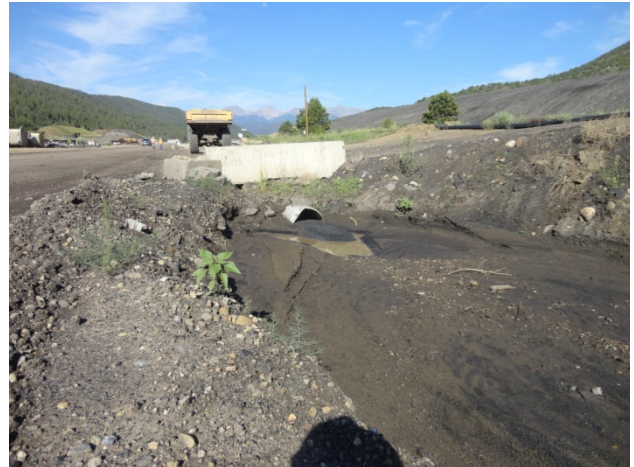
- Culvert C72 was partially blocked at the outlet; C73 was the same; C74 does not exist; ditch D15 was being excavated upstream of the outlet of culvert C13; D32 was in good shape. **Culverts C72 and C73 should be cleaned. Since the cleaning of C73 was an item that was identified in the inspection report of April 29, 2013, and is not the subject of a permitting action, the Division finds that this is a violation for failure to maintain culverts in accordance with the approved design. This is discussed further in the ENFORCEMENT ACTIONS section of this report.**

Photo 57: Outlet to C72

Photo 58: Outlet to C73

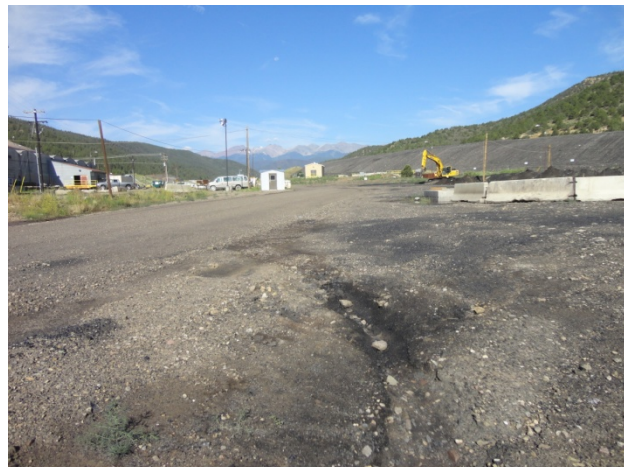
Photo 59: Ditch south of Raw Coal Stockpile to be cut

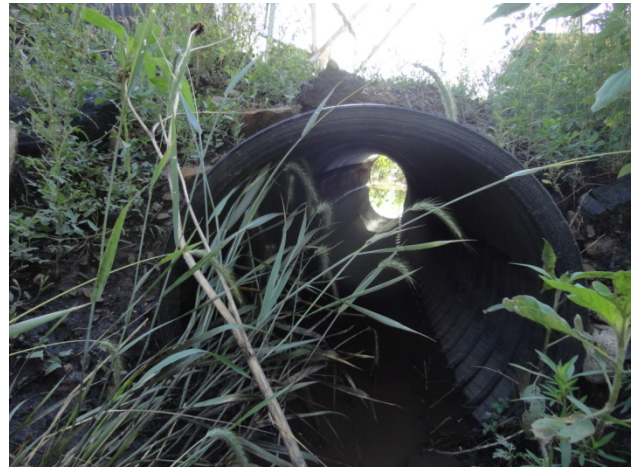
Photo 60: C17A partially backed up

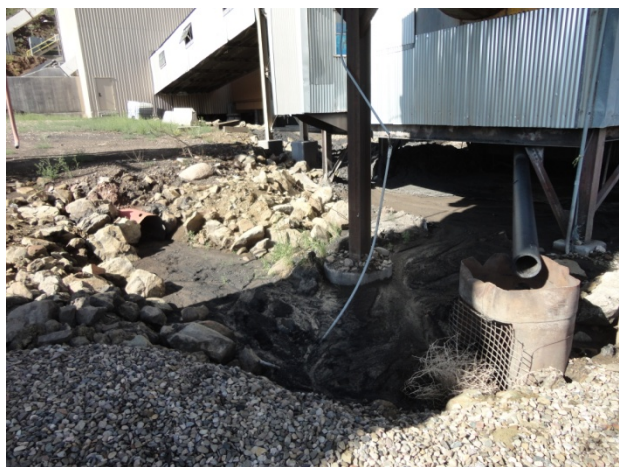
- As previously noted in the inspection report of April 29, 2013, an unidentified culvert outlets into drop inlet 3. **The culvert should be identified or removed.**

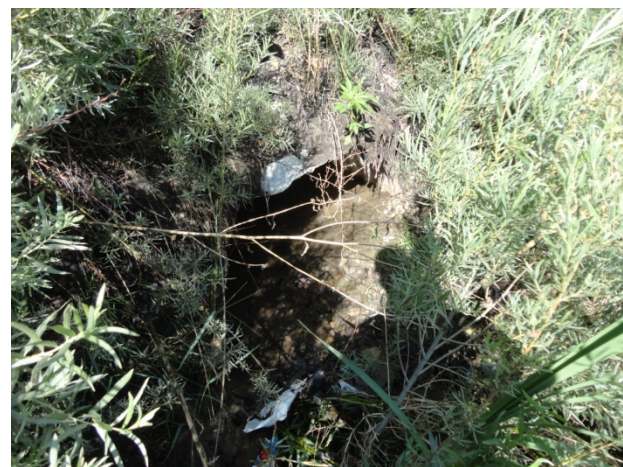
Photo 64: C61 outlet to be cleared

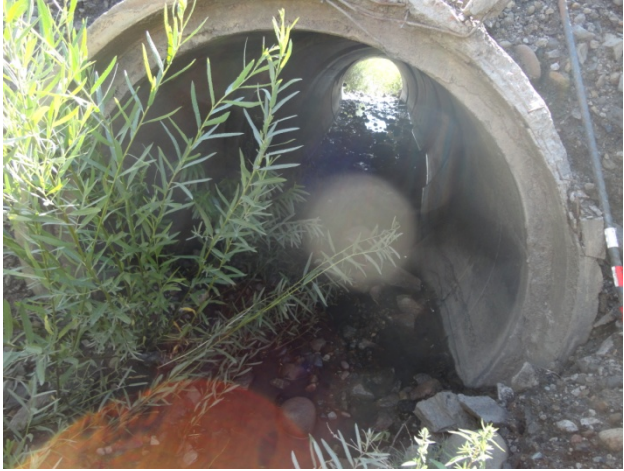
Photo 67: C19 to be cleaned

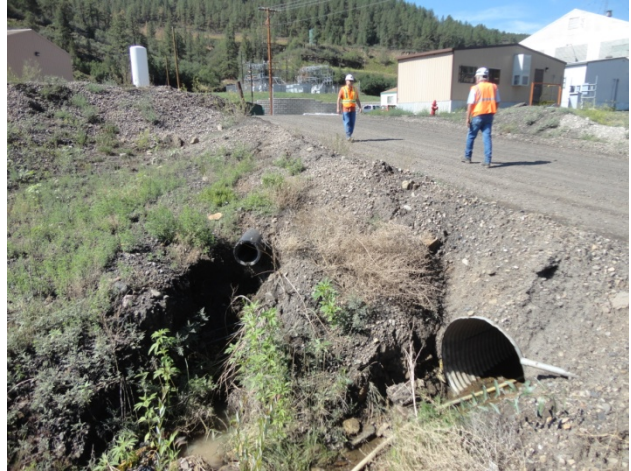
Photo 68: Unidentified culvert at outlet of C16

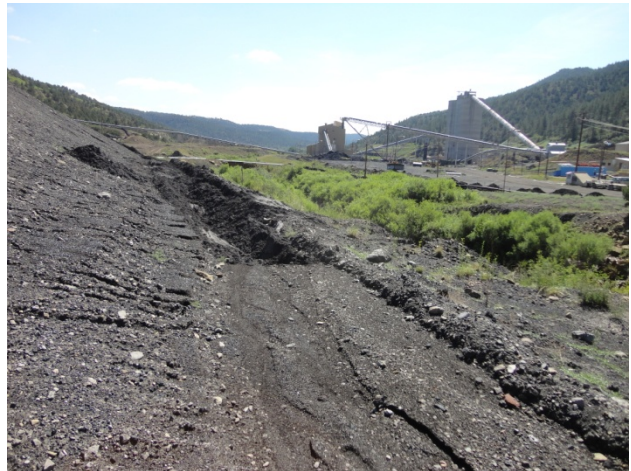
Photo 70: Temporary repair to D14
