# COLORADO DIVISION OF RECLAMATION, MINING AND SAFETY COAL PROGRAM INSPECTION REPORT

<b>Permit Number:</b> C-1981-014 <b>Mine Name:</b> Southfield Mine <b>Operator:</b> Energy Fuels Coal, Inc. <b>Operator Address:</b> Mr George Patterson P.O. Box 459 Florence, CO 81226	<b>County:</b> Fremont <b>Operation Type:</b> Underground <b>Permit Status:</b> Permanent Cessation <b>Ownership:</b> Private
<b>Operator Representative Present:</b>  George Patterson	
<b>Operator Representative Signature:</b> (Field Issuance Only)

<b>Inspection Start Date:</b> August 20, 2013 <b>Inspection Start Time:</b> 11:50 <b>Inspection End Date:</b> August 20, 2013 <b>Inspection End Time:</b> 18:00	<b>Inspection Type:</b> Coal Complete Inspection <b>Inspection Reason:</b> Normal I&E Program <b>Weather:</b> Cloudy
<b>Joint Inspection Agency:</b>  None	<b>Joint Inspection Contacts:</b>
<b>Post Inspection Agency:</b>  None	<b>Post Inspection Contacts:</b>
<b>Inspector(s):</b>  Janet H. Binns	<b>Inspector's Signature:</b>

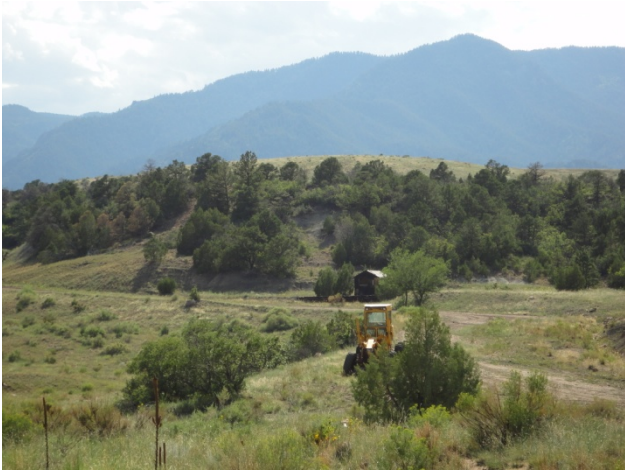
Photo 1: looking across truck tunnel area towards Proposed PJ reference area and Black hawk mine grassy feature.

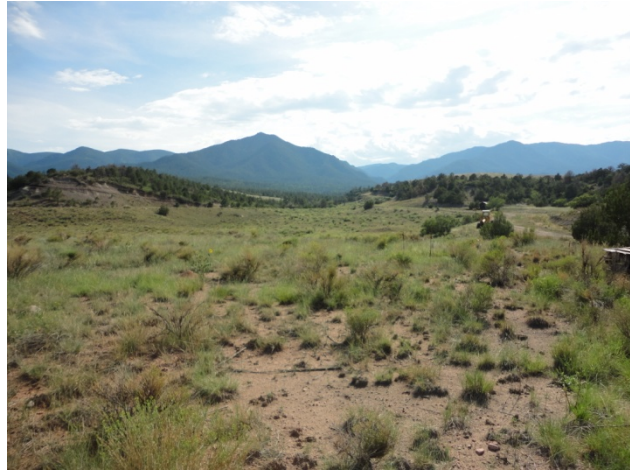
Photo 2: looking westward from south end of truck tunnel across reclaimed portal area.

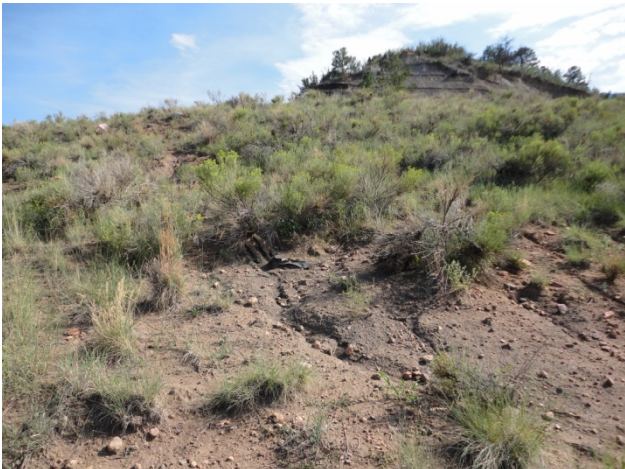
Some sediment movement appears to be occurring on the south side of the reclaimed portal area at the base of the slope adjacent to the Magpie Diversion. Some filter fabric has become exposed and should be removed or covered. This location is adjacent to a large (~1/2 cubic yard gray boulder). Limited rill prevention could be implemented on this short slope.

Photo 3: Thin cover area north of Magpie diversion EFCI needs to implement limited rill mitigation.

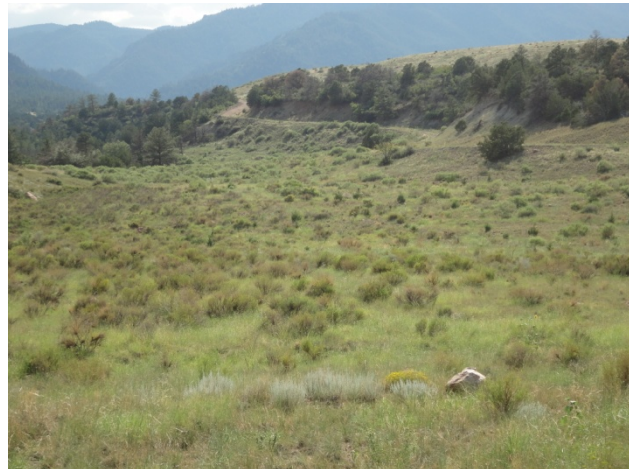
Photo 4: Reclaimed portal area

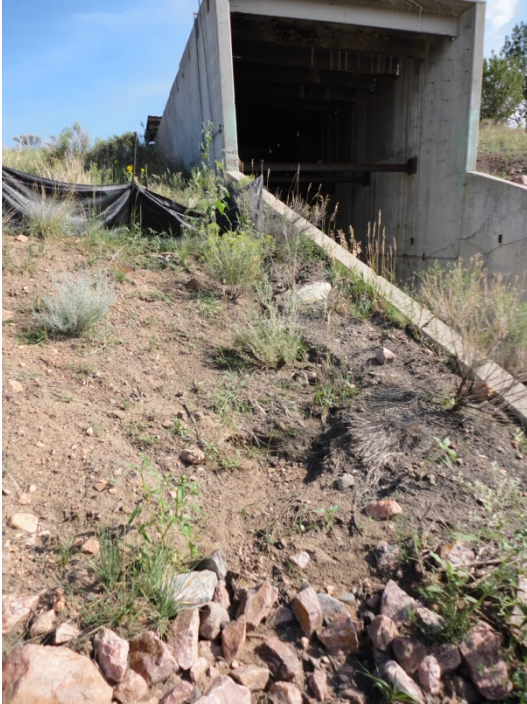
Silt fence at the north west corner of the permanent truck tunnel is holding up, as well as the rock armoring at the base of this slope. It appears some sediment is still being transported down the slope. Limited repair could be implemented to retard rill formation in this location. EFCI has removed the sediment that had accumulated at the base of this slope.

Photo 5: rill repairs adjacent to truck tunnel holding well but poor seedling emergence

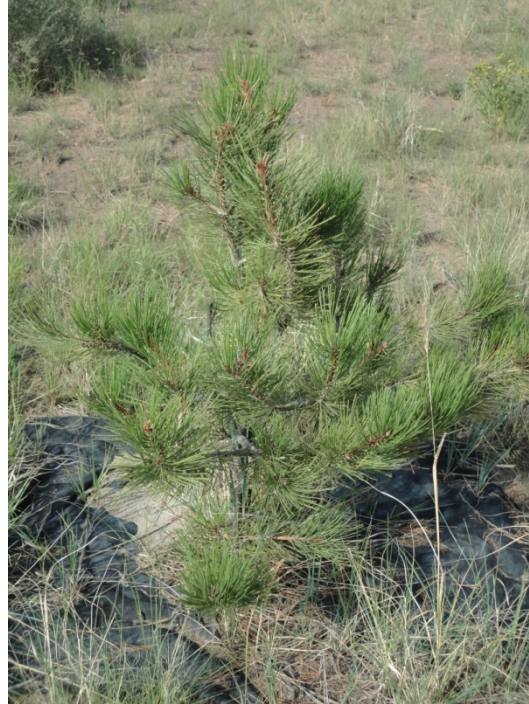
Photo 6: healthy tree transplant on Portal area.

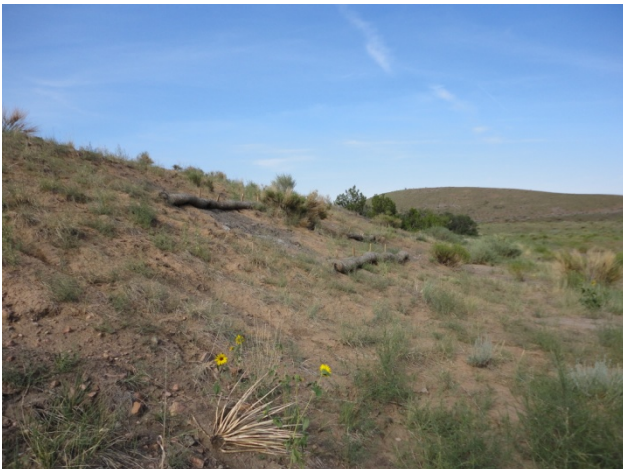
Wattles previously secured by EFCI on the north side of the permanent gravel parking area have held well and appear to be aiding in slope stabilization. Several localized spots on the wattles appear to be undercutting. Fill and additional staking would help keep these erosion control structures effective.

Photo 7: effective wattle placement on slope north of permanent parking area.

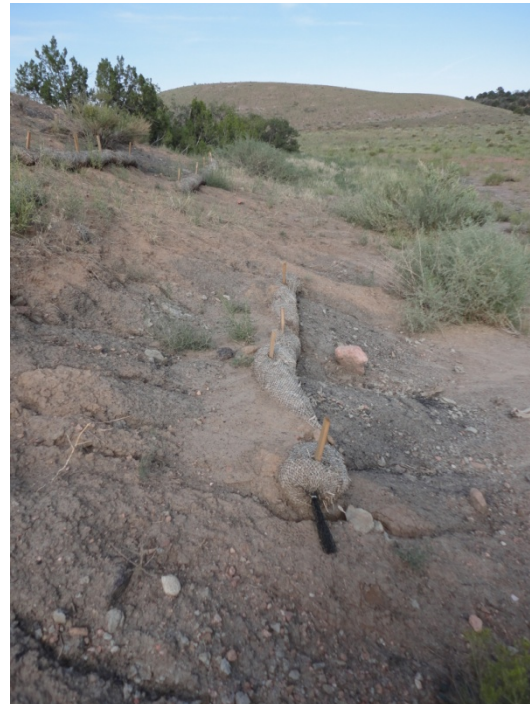
Photo 8: wattles stabilizing slope.

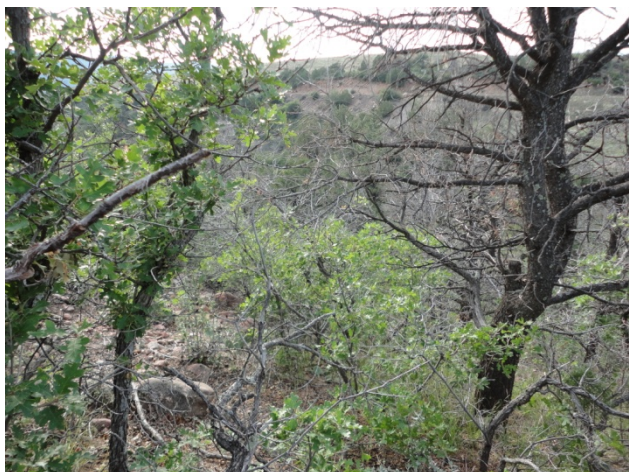
Plot B is located on a very steep rocky north facing slope. Dense decadent oak brush dominates Plot B. Juniper and Pinyon pine are prevalent as well. The dense overstory results in poor herbaceous ground cover. Litter in Plot B appears considerable consisting of a lot of oak leaves and duff.

Photo 9: SW corner of Plot B looking north.

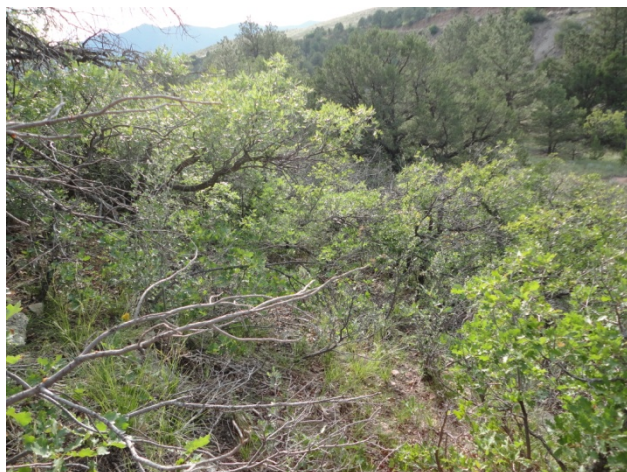
Photo 10: SE corner of Plot B looking northward.

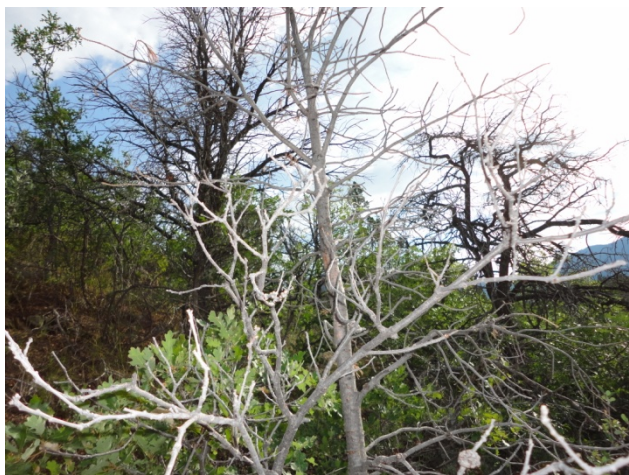
Photo 11: NE corner of Plot B looking SSW.

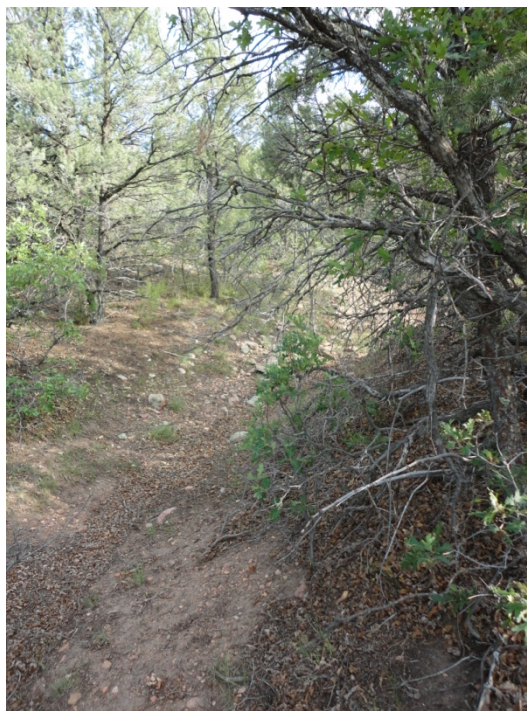
Photo 12: NW corner of Plot B looking S.  
Natural drainage runs through reference area.

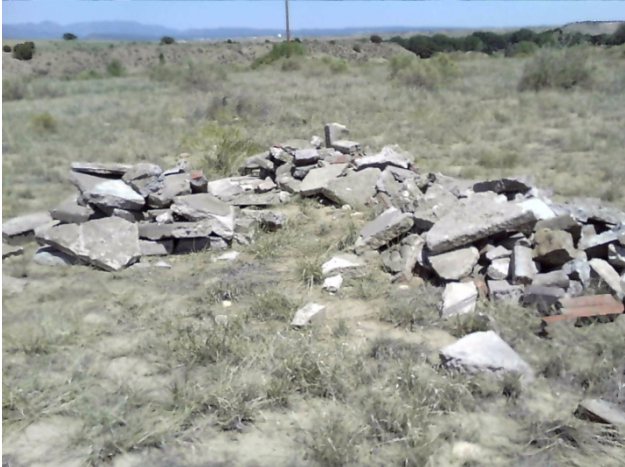
On the East side of the load out a pair of glasses and 4 vehicle tires have been dumped as well as approximately 2.5 cubic yards of broken concrete and bricks. Vehicle tracks could be seen leading to this recent deposit of trash. EFCI remains responsible for maintenance of the load out.

Photo 13: broken concrete & bricks dumped on east Side of load out (west of Pond 1)

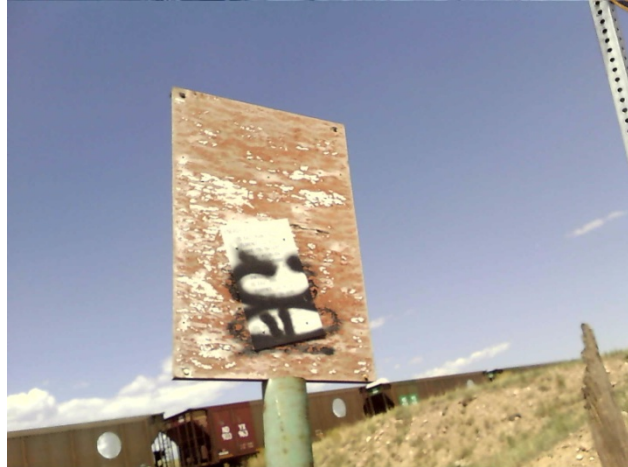
Photo 14: Graffiti on Load Out ID sign.

The mine ID sign at the loadout has been covered with graffiti. Please repaint the sign to maintain its legibility.

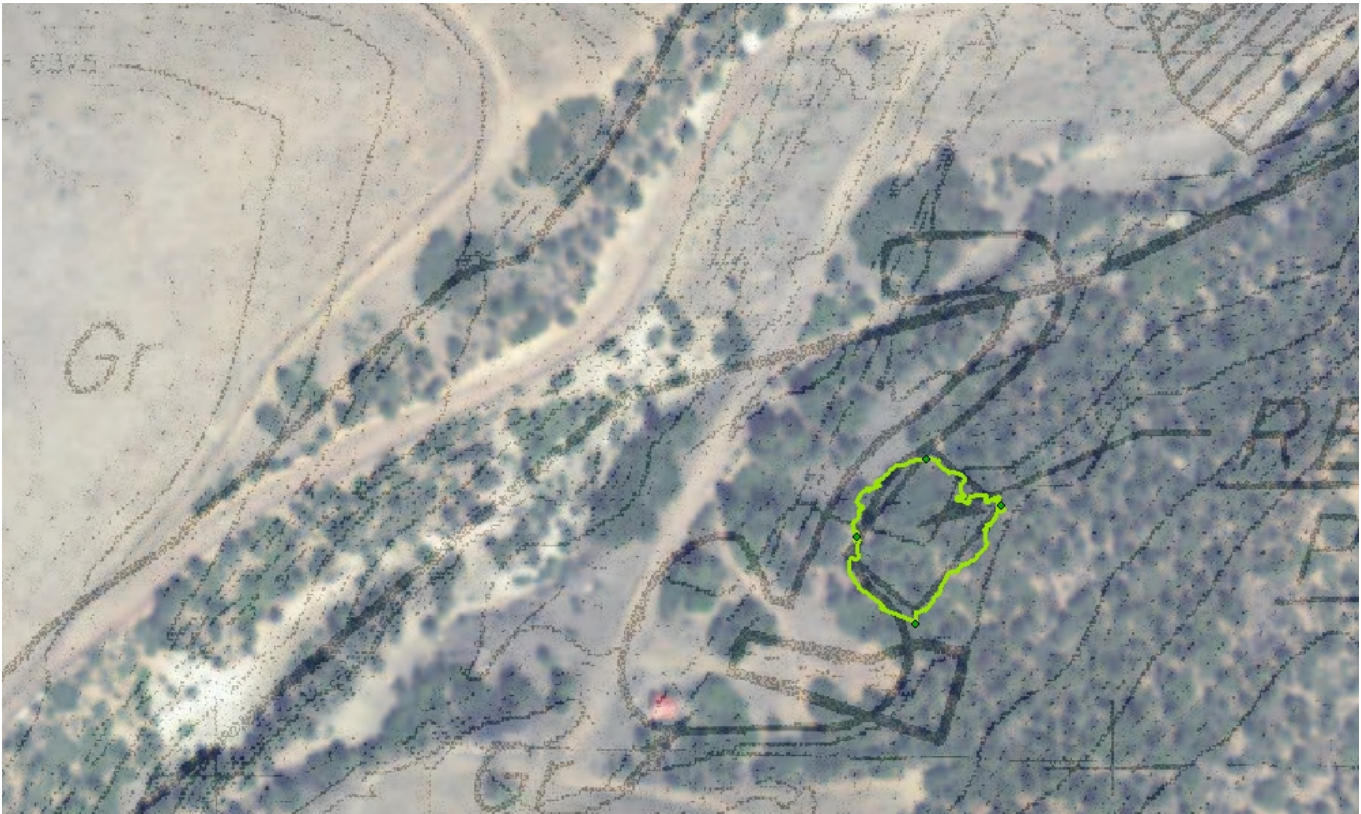
The inspector located Plot B reference area using a Yuma GPS tablet and Map 16 loaded into the GPS. Map 16 had previously been geo-referenced, and landmark points on the map aligned with on the ground features.

Map 1: GPS track of Plot B overlaid on 2011 NAIP and Map 16. GPS trail not straight lines due to thick Oak Brush and steep rocky slope.
