**COLORADO DIVISION OF RECLAMATION, MINING AND SAFETY
COAL PROGRAM INSPECTION REPORT**

Permit Number: C-1994-082 Mine Name: Yoast Mine Operator: Seneca Coal Company, LLC Operator Address: Mr. Roy Karo 37796 Routt County Road 53 P.O. Box 670 Hayden, CO 81639	County: Routt Operation Type: Surface Permit Status: Permanent Cessation Ownership: Federal
	Operator Representative Present: Roy Karo
Operator Representative Signature: (Field Issuance Only)

Inspection Start Date: August 12, 2013 Inspection Start Time: 11:00 Inspection End Date: August 16, 2013 Inspection End Time: 09:15	Inspection Type: Coal Complete Inspection Inspection Reason: Normal I&E Program Weather: Clear
Joint Inspection Agency: None	Joint Inspection Contacts:
Post Inspection Agency: None	Post Inspection Contacts:
Inspector(s): Jared L. Ebert	Inspector's Signature:

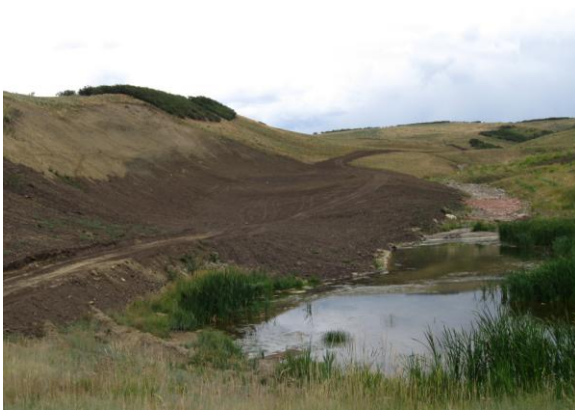
The Pond 012 slide was observed. Overall the area appears stable. Minor rilling was observed on the steep portion of the slope. SCC has recently applied topsoil to base of the slide area.

Pond 012 slide

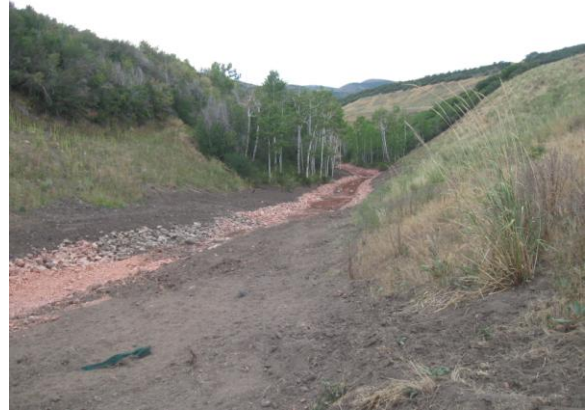
SCC was conducting repairs in the following drainage channels during the inspection; YPM-6-1, 6-2, 7, and 5-1. A new channel has been constructed in YPM-6-2 and 6-1 and has been lined with rock. The operator was actively working on YPM-5-1. A shovel was excavating and shaping the channel with the assistance of a small dozer. A haul truck was transporting rock and staging it along the channel and transporting soil up the drainage excavated by the shovel. Gabion baskets have been staged along the drainage.

YPM-6-1 drainage repair

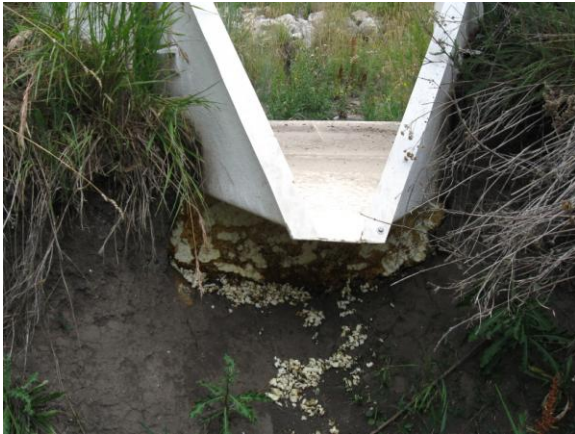
Pond 014 was holding water but was not discharging. The leak that was observed under the flume of Pond 014 has been repaired. The outlet of the pond is rip-rapped and stable. The embankment was stable and vegetated. The primary and emergency spillway was clear and functional.

Pond 014 flume repair

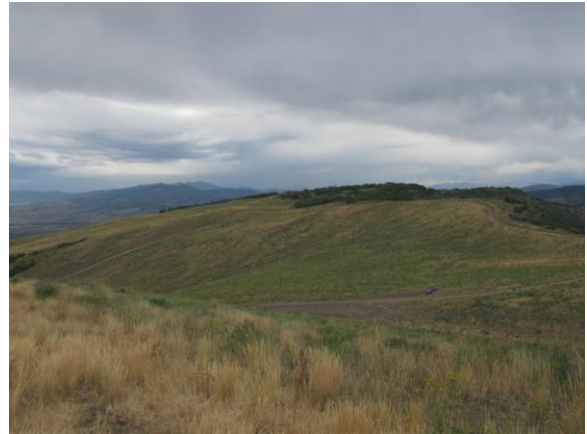
The YPM-1-1 drainage basin was walked. Shrub Plot SP-06-1 was observed. Woods Rose, Serviceberry, Silver Sage and Buffalo Berry shrubs were observed. Perennial Grasses such as Sheep Fescue, Western Wheatgrass, Timothy, Basin Wildrye and an introduced forb; Alfalfa seems to be the dominant vegetation in this drainage basin.

YPM-1-1 drainage basin

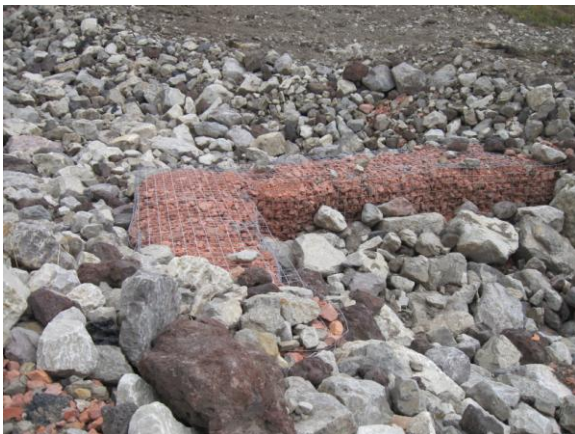
Gabion installed

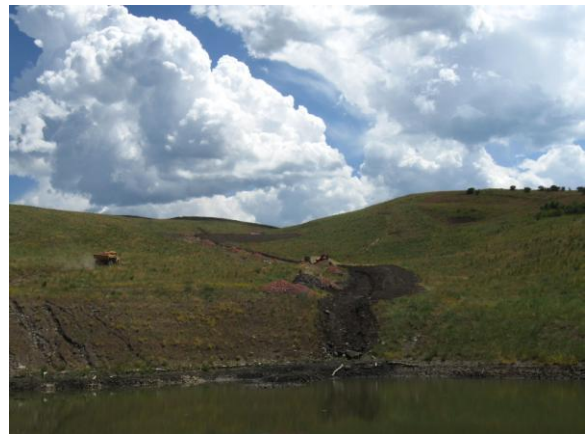
YPM-5-1 drainage repair above Pond 012a

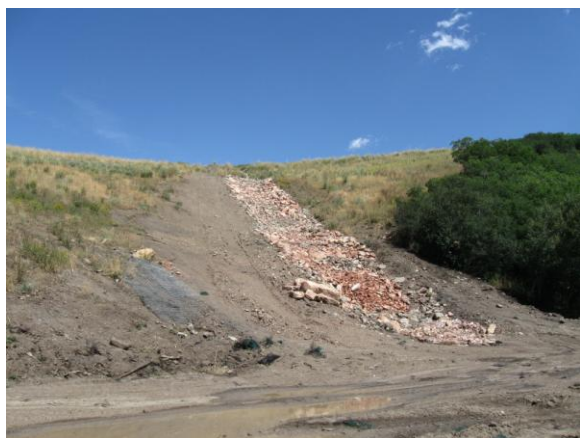
An access road has been constructed along YPM-7 from light use road LU3B. This road is being used to conduct repairs in the drainage channels in the Pond 012 basin. It appears topsoil has been stripped from the road and stockpiled adjacent to the road.

YPM-7 drainage repair

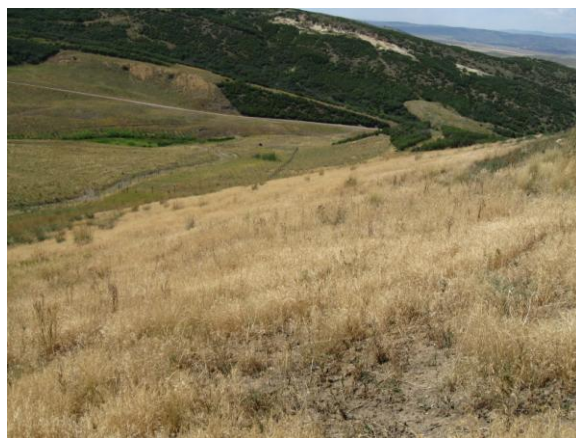
The head pit area was observed. Large portions of the revegetated slope above YPM-10 have large patches of cheatgrass and tumble mustard established.

Cheatgrass and tumble mustard patch above YPM-10

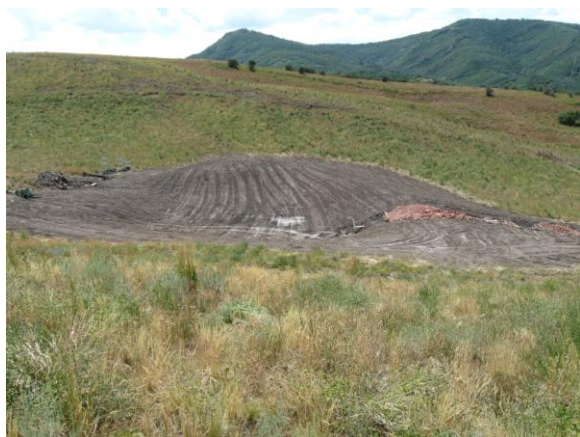
Pond 012a was observed. This pond was holding water and discharging. The embankment was stable and the primary and emergency spillway was clear and functional. A new surge tank has been installed in the YPM-5-1 channel

New surge tank in YPM-5-1 drainage.

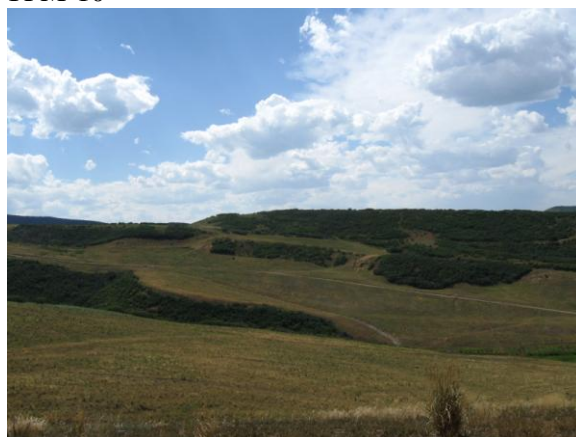
The Pond 013 slide and Neck Pit slide areas were observed. It does not appear these areas have changed since the last inspection.

Neck pit area

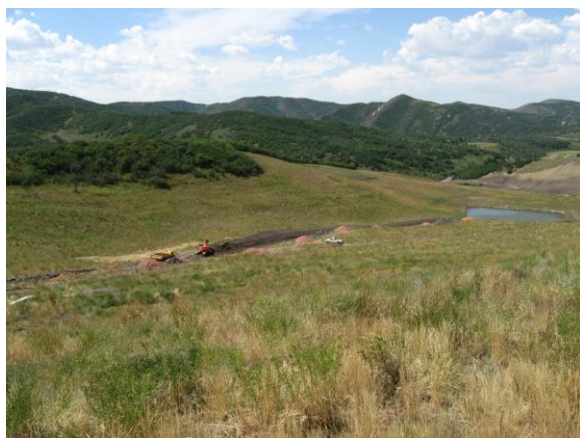
YPM-5-1 drainage repair

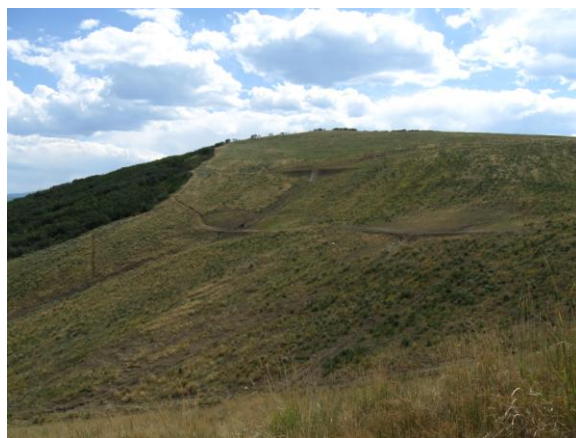
The lowest surge tank in the YPM-13 drainage southwest of Pond 011a is damaged and needs repair. The embankment has eroded away under the spillway.

YPM-13 drainage

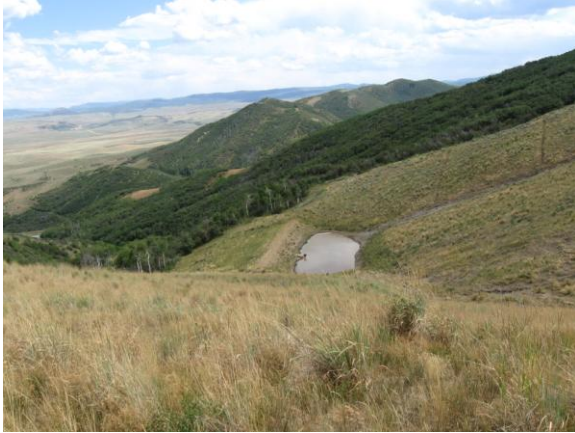
Pond 011a was holding water but was not discharging. The embankment appears stable and the primary and emergency spillway was clear and functional.

Pond 011a
