**COLORADO DIVISION OF RECLAMATION, MINING AND SAFETY
COAL PROGRAM INSPECTION REPORT**

Permit Number: C-1981-018 Mine Name: Deserado Mine Operator: Blue Mountain Energy, Inc Operator Address: Mr Scott Wanstedt 3607 County Road 65 Rangely, CO 81648	County: Rio Blanco Operation Type: Underground Permit Status: Active Ownership: Federal
	Operator Representative Present: Jeff Dubbert
Operator Representative Signature: (Field Issuance Only)

Inspection Start Date: August 22, 2013 Inspection Start Time: 11:00 Inspection End Date: August 22, 2013 Inspection End Time: 14:00	Inspection Type: Coal Partial Inspection Inspection Reason: Normal I&E Program Weather: Cloudy
Joint Inspection Agency: None	Joint Inspection Contacts: None
Post Inspection Agency: None	Post Inspection Contacts: None
Inspector(s): Zach T. Trujillo	Inspector's Signature:

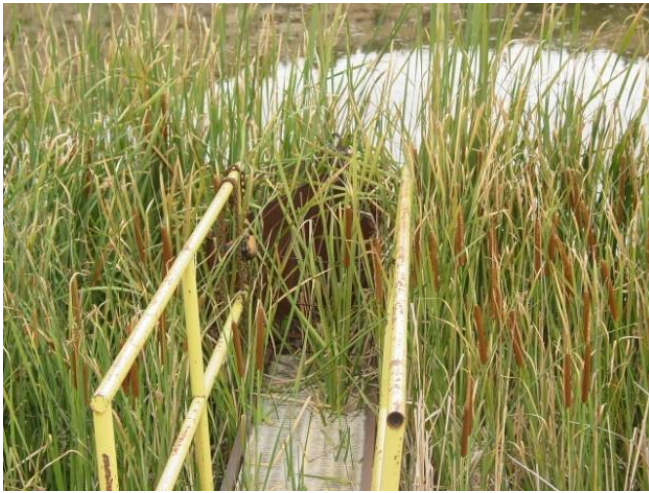
Pond DP-1 held water with no discharge at the time of the inspection. Embankment and the repair work on the sink hole remains stable. Bulks of cat tails have formed within the pond and around the primary spillway possibly impeding any flow that would occur. Cat tails should be removed from the inlet of DP-1's primary spillway. Rip rap channel from the facility benches into the pond remain stable and well armored. Secondary ditch into DP-1 by the rotary breaker also remains stable. No cutting in the channel was observed.

Primary spillway for DP-1.

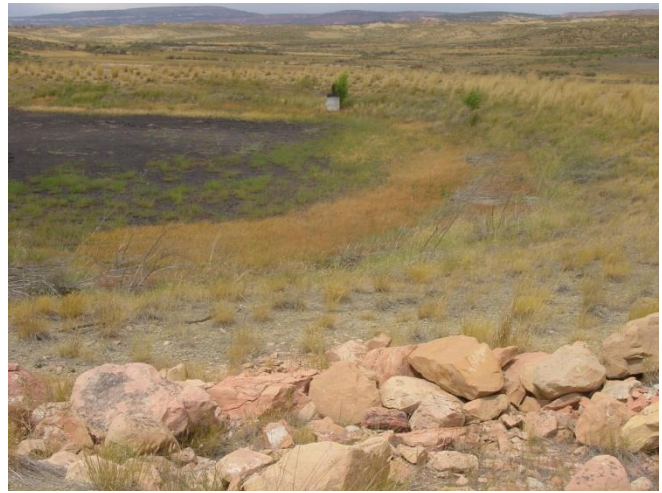
Ponds RP-2/3, RP-4 and RP-5 were dry during the time of the inspection. All embankments were vegetated and stable. Rip rap channels were well armored with no signs of erosion or cutting. Pond RP-4 has differential settlement north of its embankments. The settlement crack has no affect on the pond.

Pond RP-4.
