**COLORADO DIVISION OF RECLAMATION, MINING AND SAFETY  
COAL PROGRAM INSPECTION REPORT**

<b>Permit Number:</b> C-1981-041 <b>Mine Name:</b> Roadside Portals <b>Operator:</b> Snowcap Coal Company, Inc <b>Operator Address:</b> Ms. Tonya Hammond P.O. Box 1430 Palisade, CO 81526	<b>County:</b> Mesa <b>Operation Type:</b> Underground <b>Permit Status:</b> Permanent Cessation <b>Ownership:</b> Federal
<b>Operator Representative Present:</b>  Tonya Hammond	
<b>Operator Representative Signature: (Field Issuance Only)</b>

<b>Inspection Start Date:</b> August 23, 2013 <b>Inspection Start Time:</b> 10:00 <b>Inspection End Date:</b> August 23, 2013 <b>Inspection End Time:</b> 12:30	<b>Inspection Type:</b> Coal Partial Inspection <b>Inspection Reason:</b> Normal I&E Program <b>Weather:</b> Clear
<b>Joint Inspection Agency:</b>  None	<b>Joint Inspection Contacts:</b>  
<b>Post Inspection Agency:</b>  None	<b>Post Inspection Contacts:</b>  
<b>Inspector(s):</b>  Michael P. Boulay	<b>Inspector's Signature:</b>  <i>Michael P. Boulay</i>  <b>Signature Date:</b>  August 27, 2013

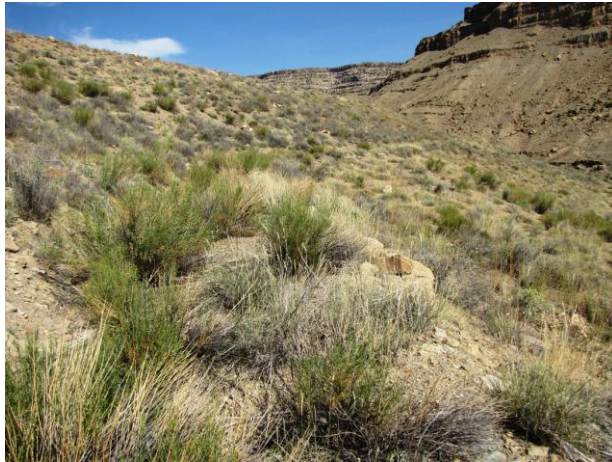
The CRDA-1, CRDA-2, and RSRDA waste piles were inspected. Terrace drains and perimeter ditches are well vegetated and functional. Several of the terrace drains have accumulated some sediment over time but they all remain functional with adequate freeboard.

CRDA-1 Terrace Drain Midway on Pile

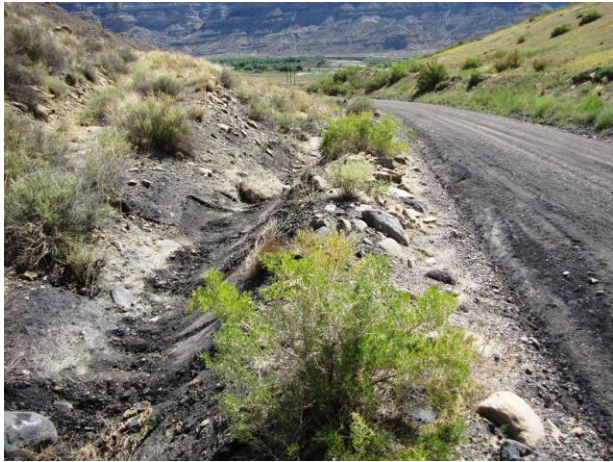
Ground conditions were dry throughout the site. Coal Creek was dry. There was a recent precipitation event a couple of weeks prior to this inspection that required SCC to bring in a trackhoe and do some routine maintenance on several refuse pile perimeter ditches to remove sediment accumulation. The work has been completed and the refuse piles remain stable.

CRDA-1 Lower Perimeter Ditch and Road Ditch Repair

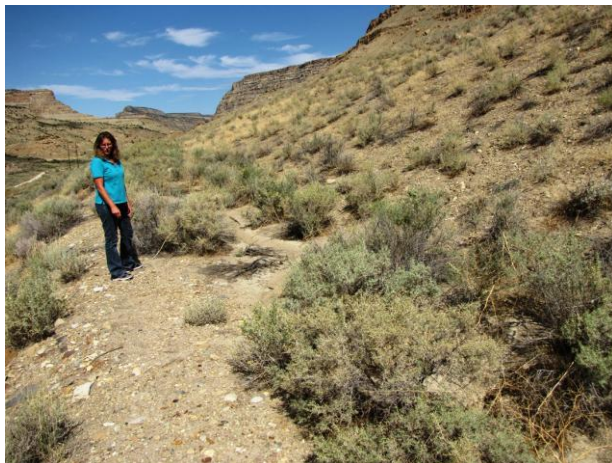
CRDA-2 Midpoint on Upper Terrace Drain

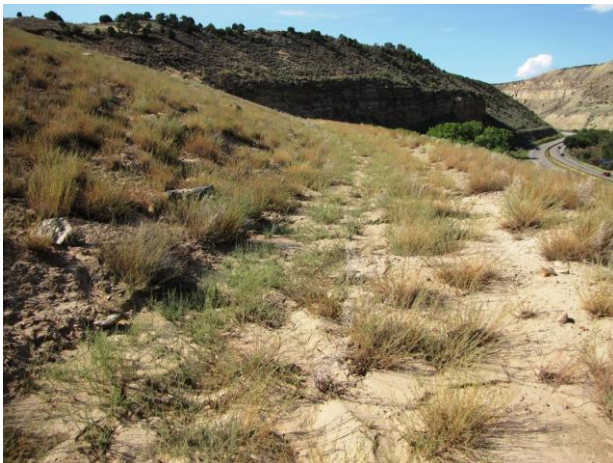
RSRDA Mid-level Terrace Drain
