**COLORADO DIVISION OF RECLAMATION, MINING AND SAFETY
COAL PROGRAM INSPECTION REPORT**

Permit Number: C-1981-020 Mine Name: Munger Canyon Mine Operator: CAM Mining, LLC Operator Address: Mr. Corey Heaps P.O. Box 98 Loma, CO 81524	County: Garfield, Mesa Operation Type: Underground Permit Status: Permanent Cessation Ownership: Federal
	Operator Representative Present: None
Operator Representative Signature: (Field Issuance Only)

Inspection Start Date: August 22, 2013 Inspection Start Time: 11:45 Inspection End Date: August 22, 2013 Inspection End Time: 14:10	Inspection Type: Coal Complete Inspection Inspection Reason: Normal I&E Program Weather: Cloudy
Joint Inspection Agency: None	Joint Inspection Contacts:
Post Inspection Agency: None	Post Inspection Contacts:
Inspector(s): Michael P. Boulay	Inspector's Signature: <i>Michael P. Boulay</i> Signature Date: 8/27/13

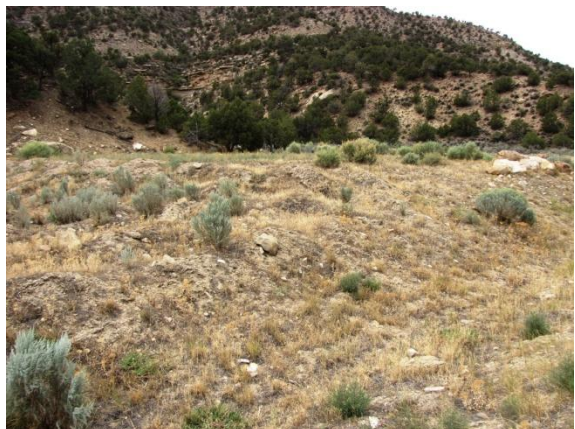
Coverfill Stockpile

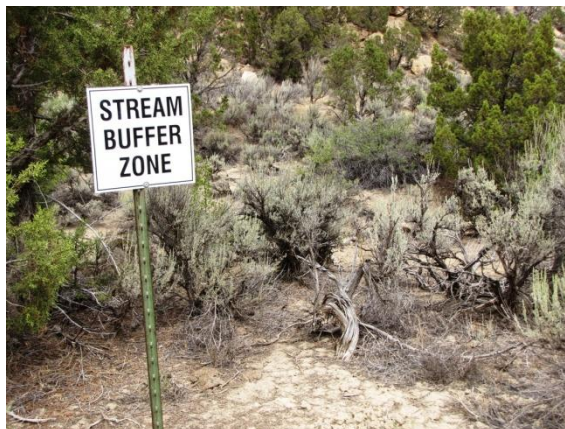
East Salt Creek was not flowing but had some damp areas and some standing water. Munger Creek appeared to be entirely dry. The culvert at the Munger Creek road crossing was clear and well maintained. Ditches and culverts associated with the reclaimed waste disposal site, the coverfill stockpile, and the topsoil stockpile locations were in good condition and well maintained. The waste disposal area sediment pond was not retaining water. The inlet and discharge structures were stable and no problems were noted. The pond embankment showed no signs of erosion or other problems. Stream Buffer Zones signs were properly displayed along the length of Munger Creek adjacent to the reclaimed haul road.

Signs along Munger Creek

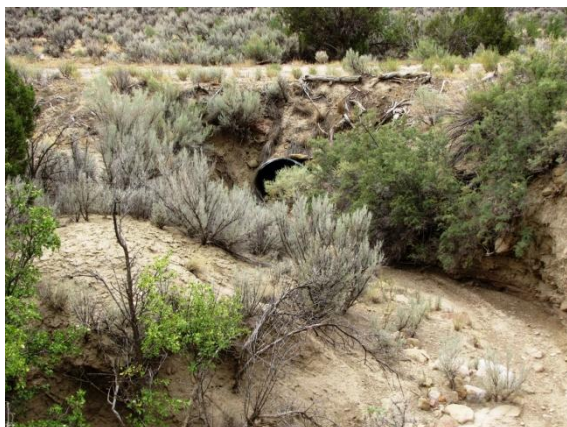
Munger Creek Road Crossing

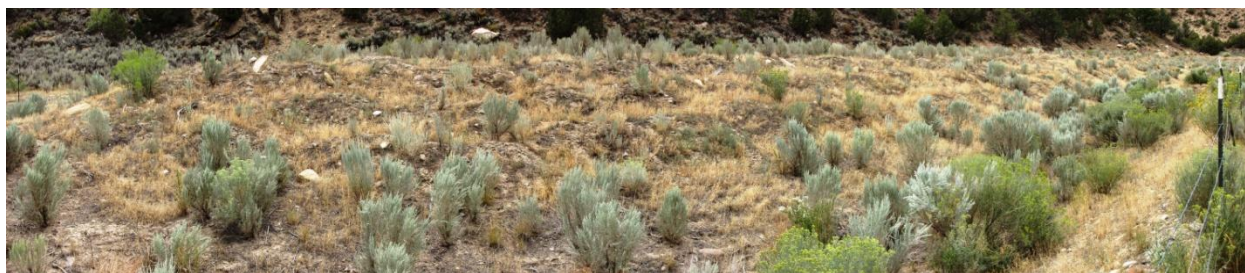
The fully reclaimed coal waste pile remains stable, with no signs of erosion or instability. In 2008 a final waste pile certification was completed and the waste pile site remains in good condition.

Panoramic view of Reclaimed Refuse Pile
