## COLORADO DIVISION OF RECLAMATION, MINING AND SAFETY COAL PROGRAM INSPECTION REPORT

<b>Permit Number:</b> C-1981-019 <b>Mine Name:</b> Colowyo Coal Mine <b>Operator:</b> Colowyo Coal Company L.P. <b>Operator Address:</b> Mr. Tony Tennyson 5731 State Highway 13 Meeker, CO 81641	<b>County:</b> Moffat, Rio Blanco <b>Operation Type:</b> Surface <b>Permit Status:</b> Active <b>Ownership:</b> Federal
	<b>Operator Representative Present:</b>  Kurt Blunt, Elliott Russell
<b>Operator Representative Signature: (Field Issuance Only)</b>

<b>Inspection Start Date:</b> August 21, 2013 <b>Inspection Start Time:</b> 14:00 <b>Inspection End Date:</b> August 22, 2013 <b>Inspection End Time:</b> 16:00	<b>Inspection Type:</b> Coal Partial Inspection <b>Inspection Reason:</b> Normal I&E Program <b>Weather:</b> Clear	
<b>Joint Inspection Agency:</b>  None	<b>Joint Inspection Contacts:</b>  	
<b>Post Inspection Agency:</b>  None	<b>Post Inspection Contacts:</b>  	
<b>Inspector(s):</b>  Robert D. Zuber, P.E.	<b>Inspector's Signature:</b>

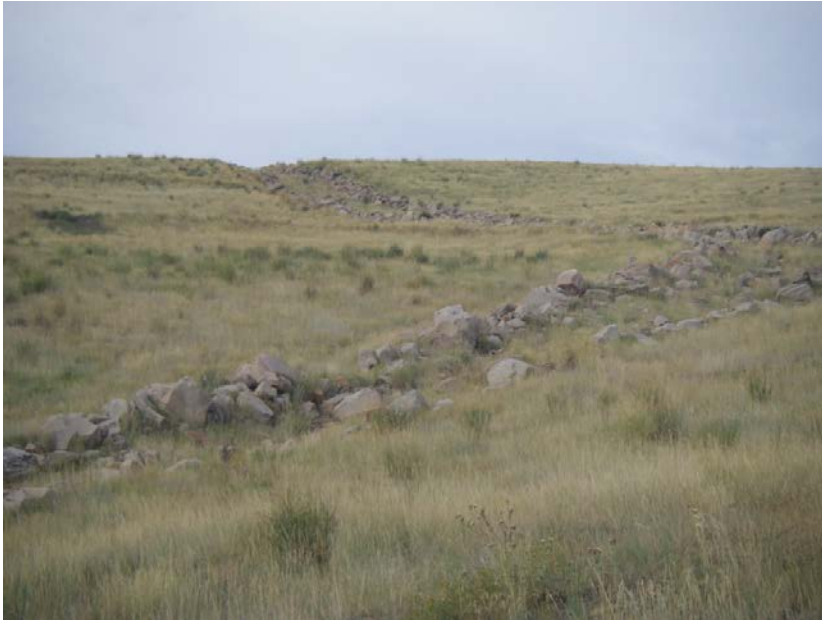
**Gulch A Ditch**

- Gulch A Ditch and the East Side Collection Ditch were observed nearly in their entirety, and no erosion or other problems were observed in the ditches.
- A gully was seen along Gulch A, approximately 300 feet west of the power line.
- The ditch (and culvert) below the Gossard Pond outlet has been cleaned.

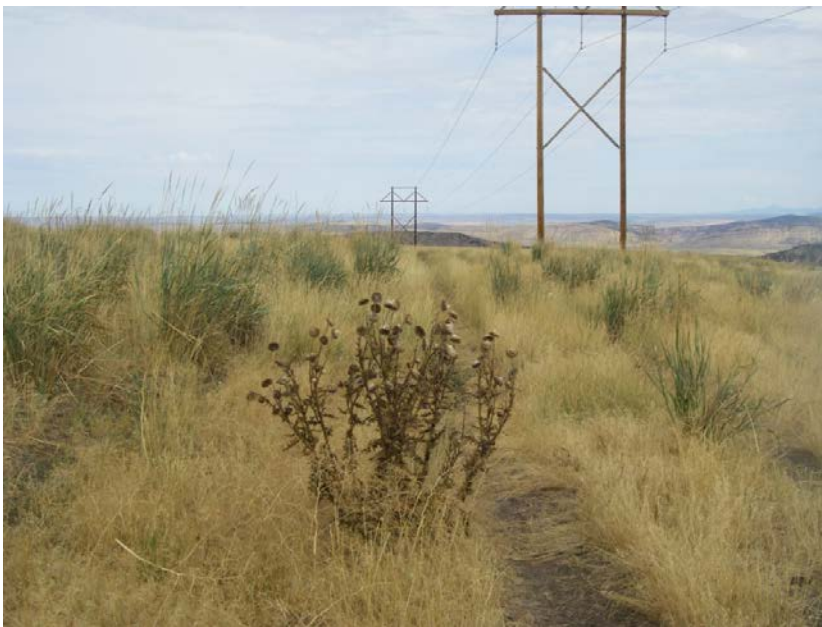
In several locations, there was evidence of weed spraying: Gulch A Pond, East Pit area, near the West Taylor Pond, near the East Taylor Pond,

**Signs of weed management in East Pit area**

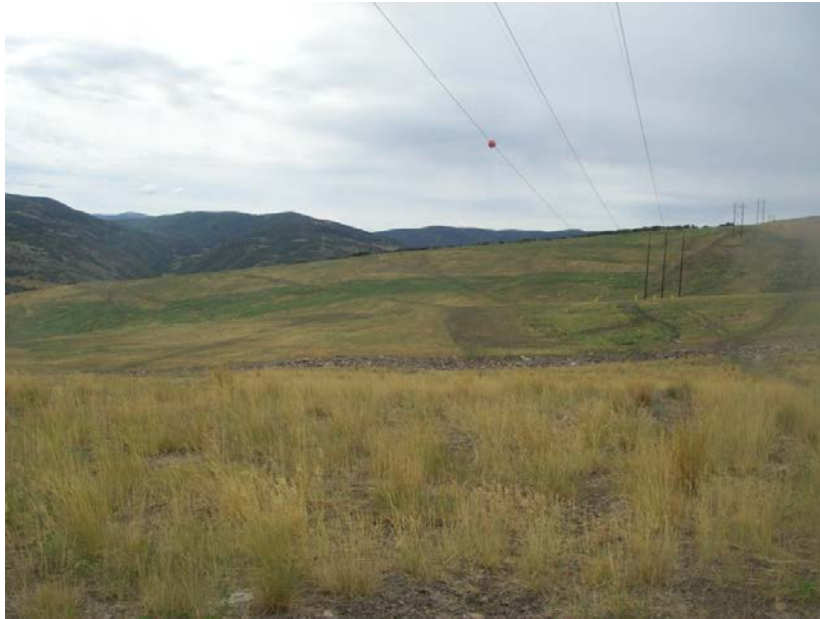
Revegetation generally looked good. South of the Final East Pit Ditch the emerging vegetation was very green, as seen from across the ditch.

**East Pit reclamation**

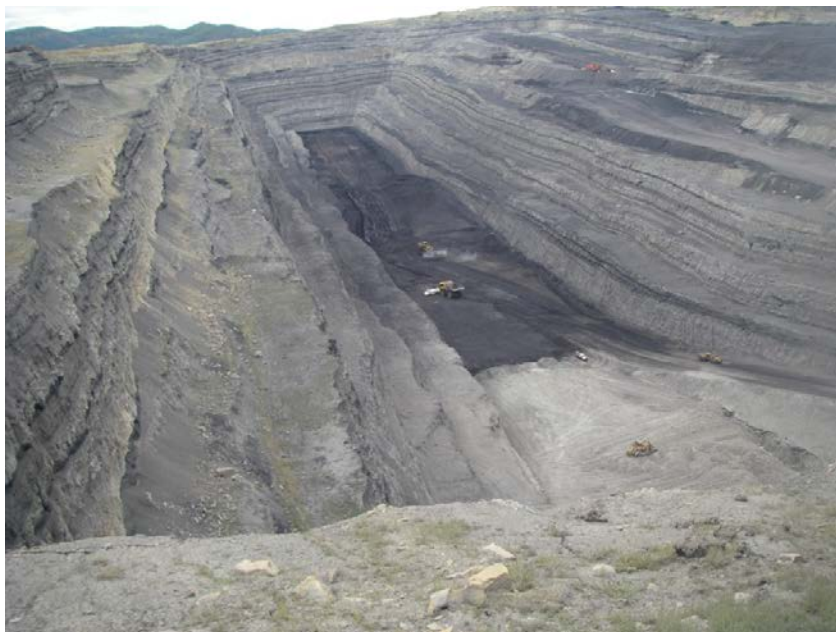
**South Taylor Pit, looking south**

The depth of South Taylor Pit was estimated with a TruPulse laser rangefinder, and the vertical distance from the northeast edge to the bottom of the pit was approximately 420 feet.

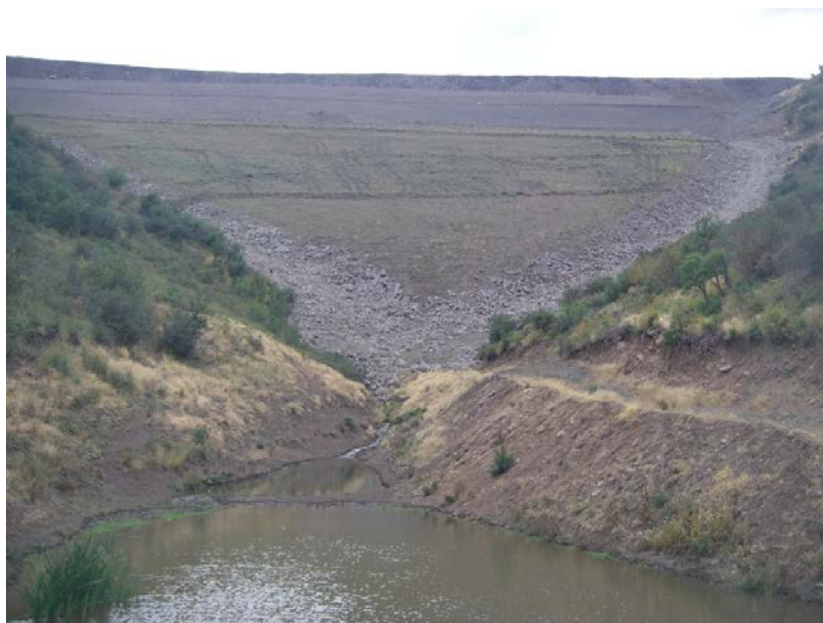
**West Taylor Pond and West Taylor Fill**

Rills have been repaired on the surface of the West Taylor Fill and have not opened up again (as seen from the West Taylor Pond). The side drains of this fill remain stable.

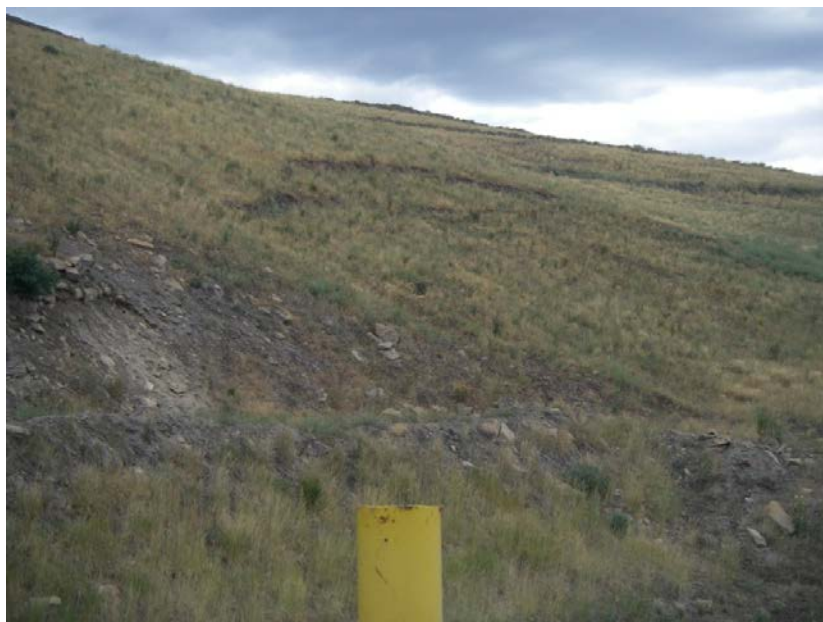
The slump above East Taylor Pond (east side of drainage) appears to be healing well; it is filling in with vegetation.

**Slump above East Taylor Pond**
