**COLORADO DIVISION OF RECLAMATION, MINING AND SAFETY
MINERALS PROGRAM INSPECTION REPORT
PHONE: (303) 866-3567**

MINE NAME: ZMK Gravel Pit	MINE/PROSPECTING ID#: M-1991-146	MINERAL: Gravel	COUNTY: Ouray
INSPECTION TYPE: Multi Person Inspection	INSPECTOR(S): Wallace H. Erickson, G. Russell Means	INSP. DATE: June 4, 2013	INSP. TIME: 13:30
OPERATOR: Sako Excavation, LLC	OPERATOR REPRESENTATIVE: Travis Sackman, Bob & Pam Larson, Tim Pasic	TYPE OF OPERATION: 110c, In-Stream, Construction Materials

ZMK Gravel Pit
M-1991-146
June 4, 2013

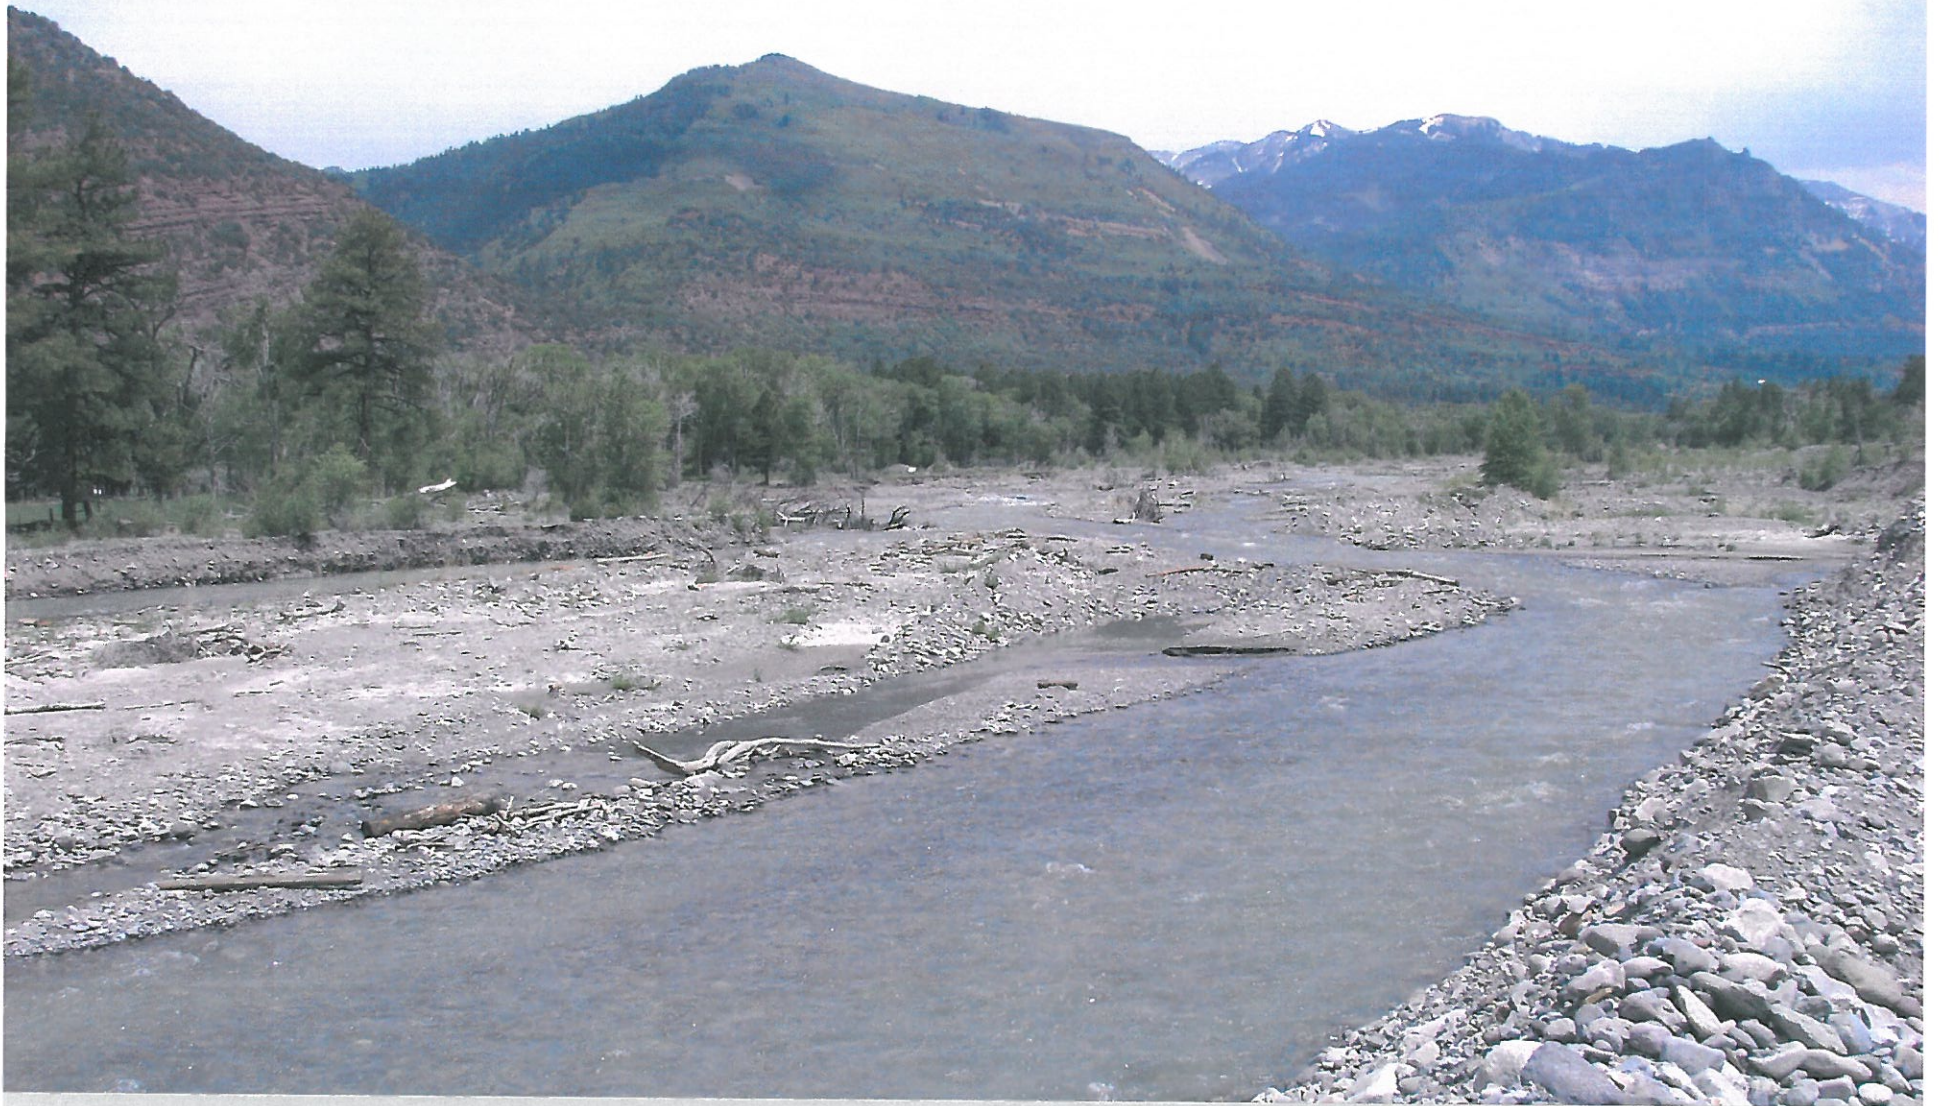
View south, taken from the flood protection levee and nearby the southern permit boundary, showing the Uncompahgre River channel upstream of the permit area. The braided channel is wide, with an abundance of flow debris. Near vertical cut banks, estimated at four feet high and indicating active erosion of the channel banks, were observed upstream of the permit area. The Uncompahgre River flows north, from background through the foreground of this photo.

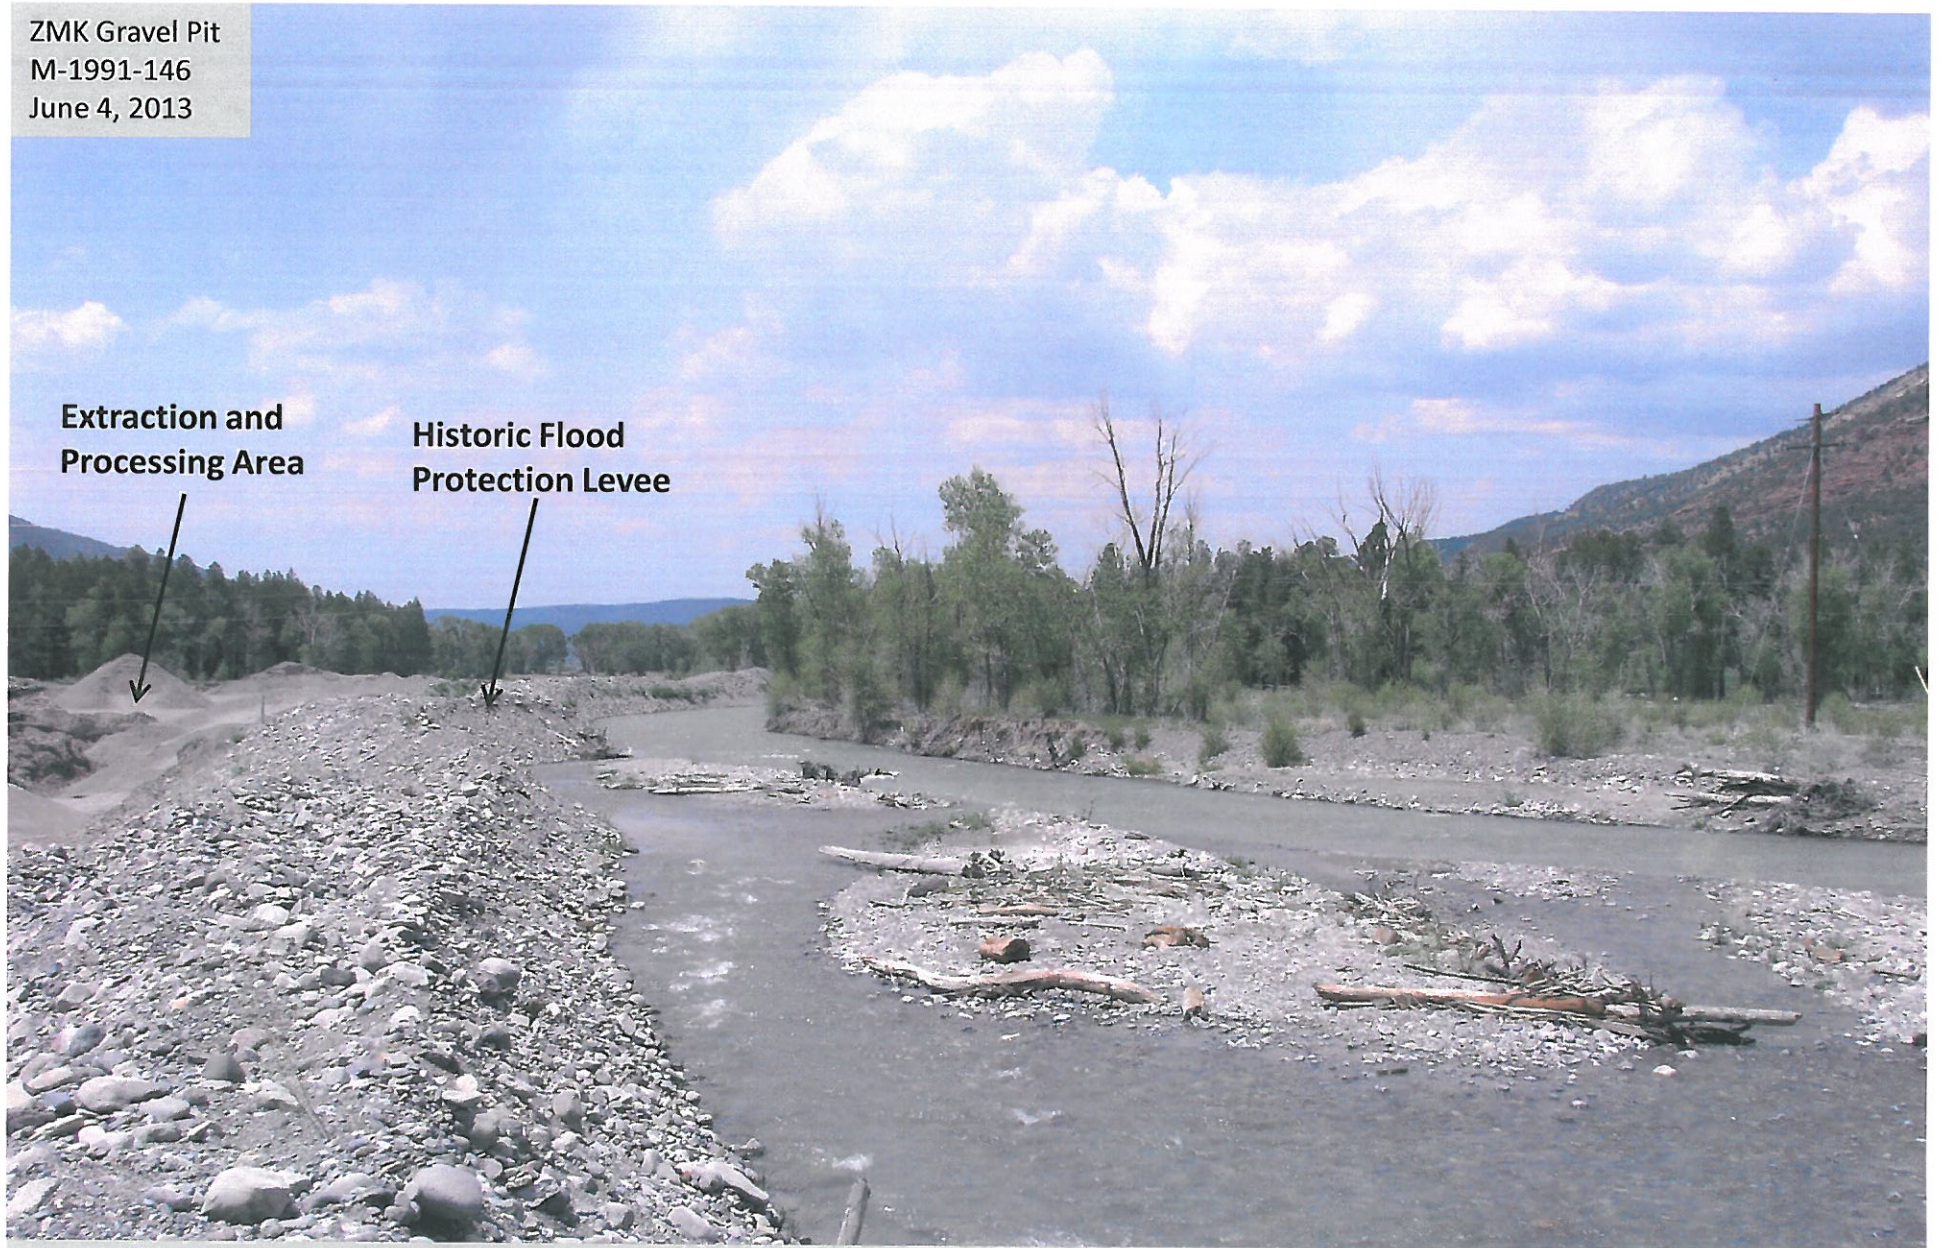
View north, taken from the flood protection levee and nearby the southern permit boundary, showing the Uncompahgre River channel through the permit area. The low-flow channel is constricted by the levee. Evidence of erosion of the east bank through the permit area was observed only where mid-channel gravel bars were present, as shown in this photo. The Uncompahgre River flows north, from foreground to background through this photo.

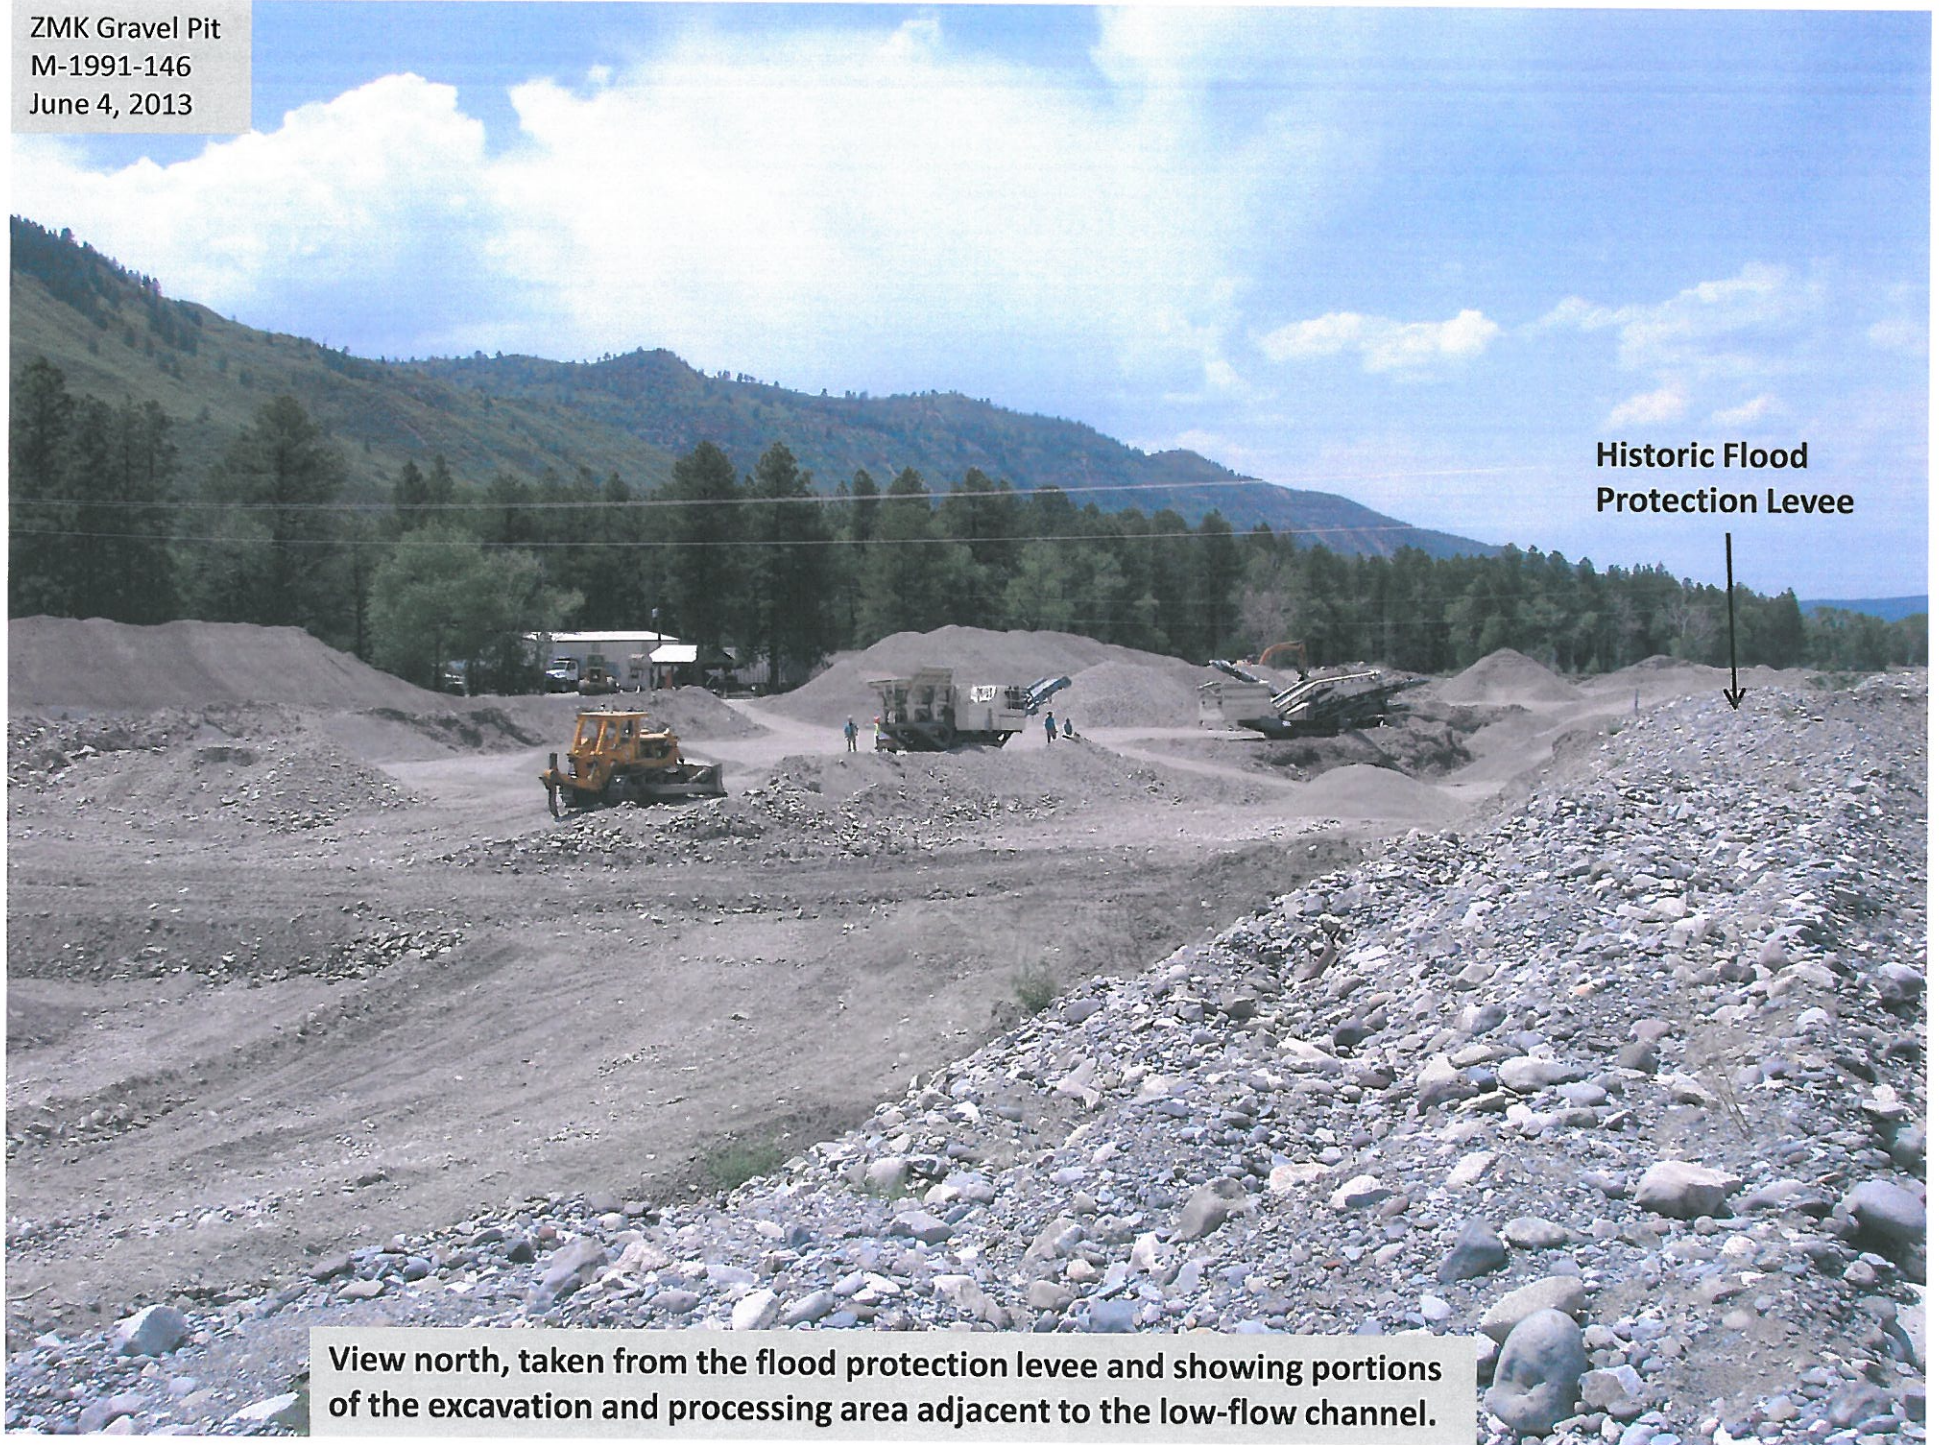
View north, taken from the flood protection levee and showing portions of the excavation and processing area adjacent to the low-flow channel.

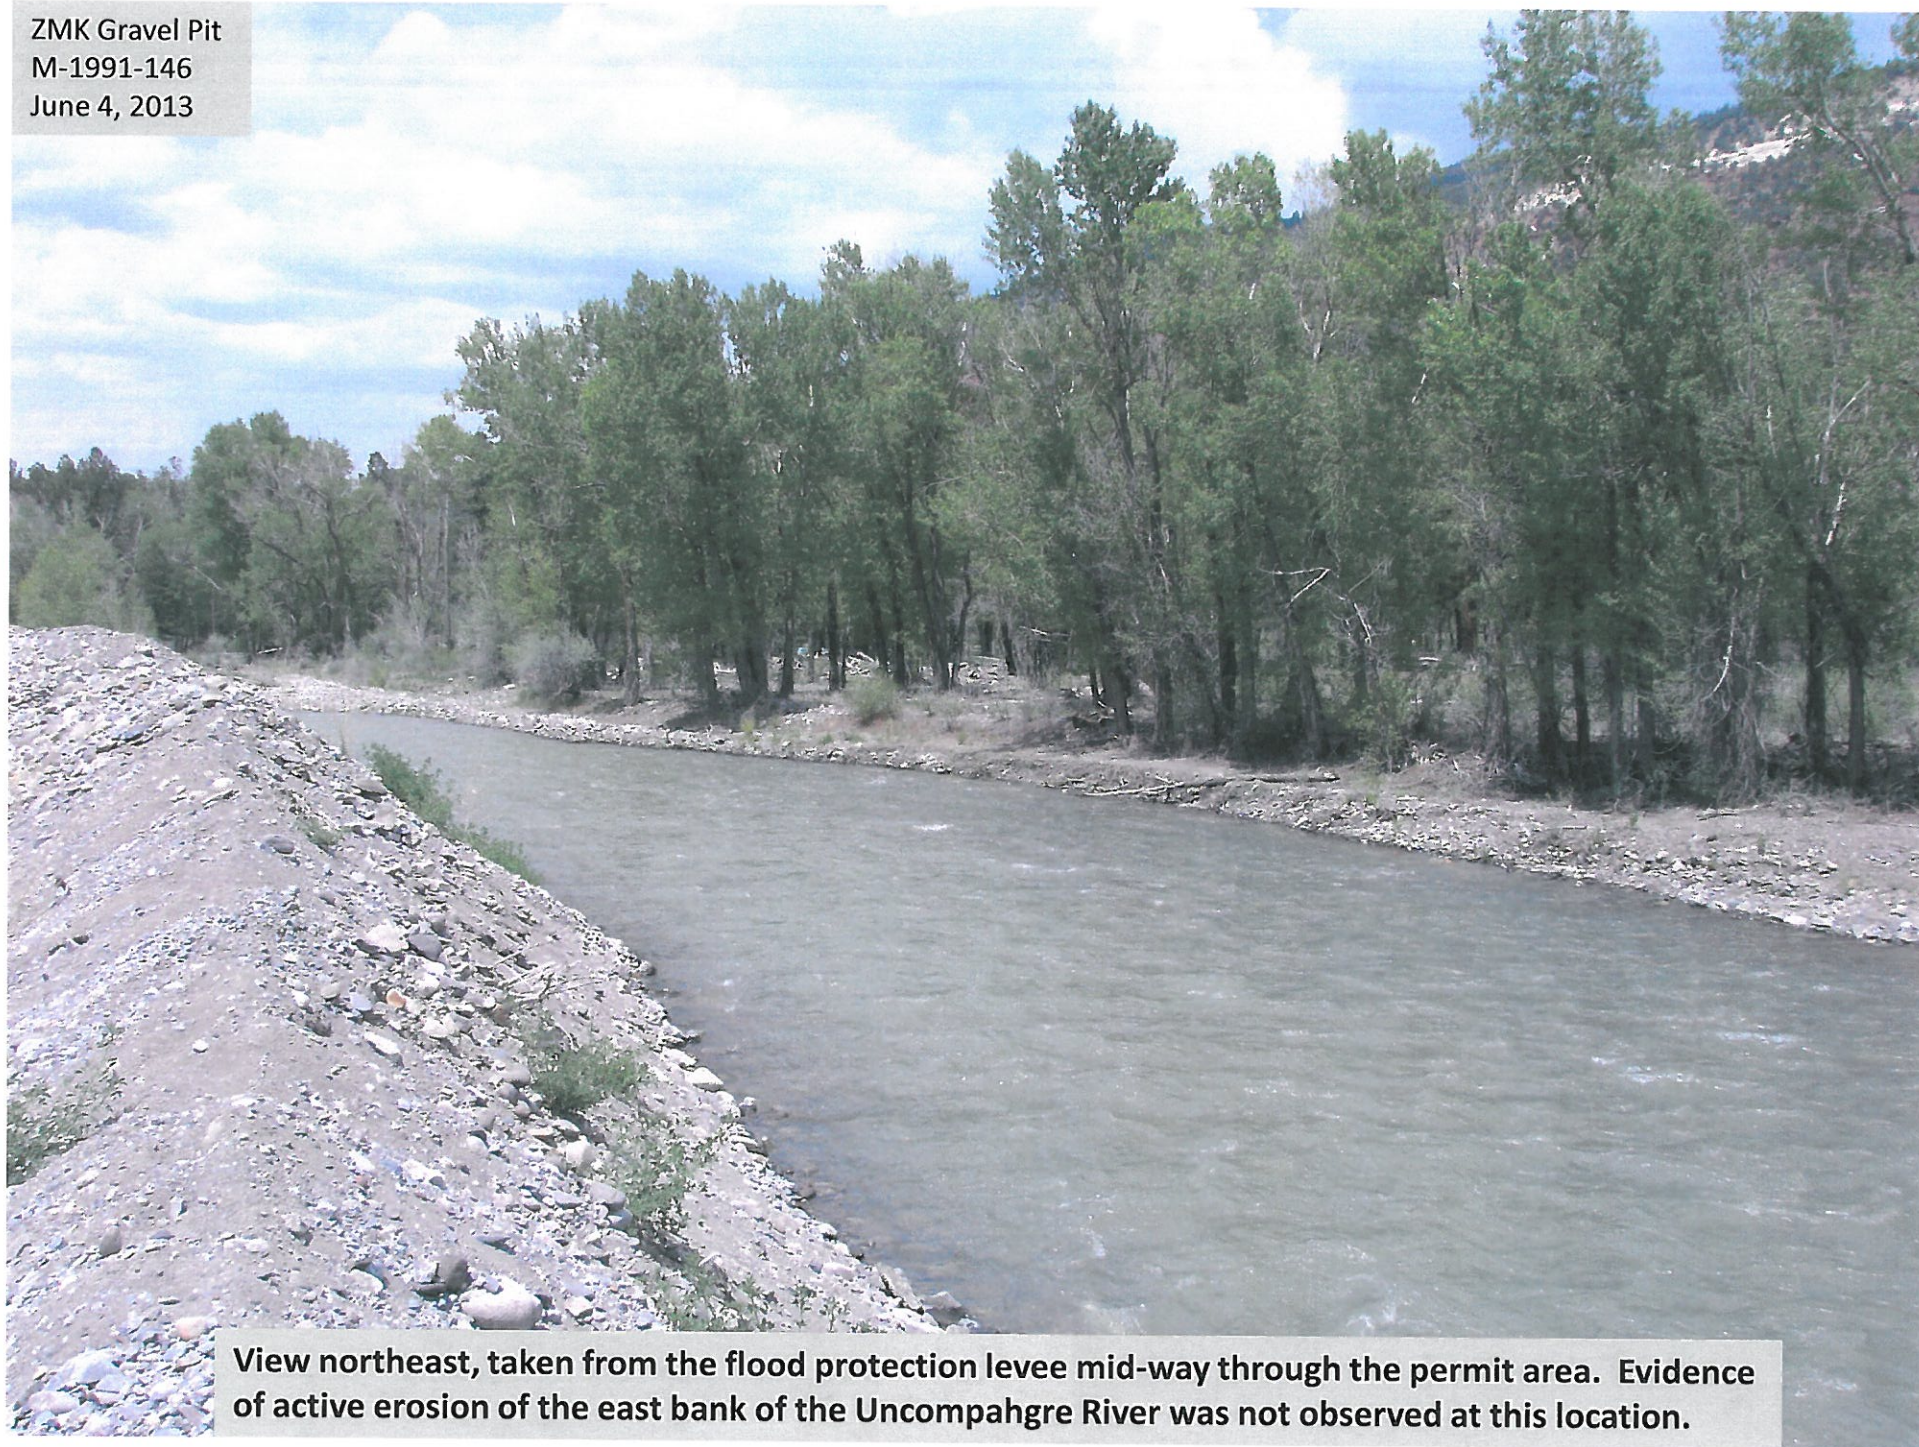
View northeast, taken from the flood protection levee mid-way through the permit area. Evidence of active erosion of the east bank of the Uncompahgre River was not observed at this location.
