# COLORADO DIVISION OF RECLAMATION, MINING AND SAFETY COAL PROGRAM INSPECTION REPORT

<b>Permit Number:</b> C-1996-084 <b>Mine Name:</b> Lorencito Canyon Mine <b>Operator:</b> New Elk Coal Company, LLC <b>Operator Address:</b> Mr Mark Haywood 12250 Highway 12 Weston, CO 81091	<b>County:</b> Las Animas <b>Operation Type:</b> Surface <b>Permit Status:</b> Permanent Cessation <b>Ownership:</b> Private
<b>Operator Representative Present:</b>	
<b>Operator Representative Signature:</b> (Field Issuance Only)

<b>Inspection Start Date:</b> August 27, 2013 <b>Inspection Start Time:</b> 15:30 <b>Inspection End Date:</b> August 27, 2013 <b>Inspection End Time:</b> 18:30	<b>Inspection Type:</b> Coal Partial Inspection <b>Inspection Reason:</b> Normal I&E Program <b>Weather:</b> Clear
<b>Joint Inspection Agency:</b>  None	<b>Joint Inspection Contacts:</b>
<b>Post Inspection Agency:</b>  None	<b>Post Inspection Contacts:</b>
<b>Inspector(s):</b>  Leigh D. Simmons	<b>Inspector's Signature:</b>

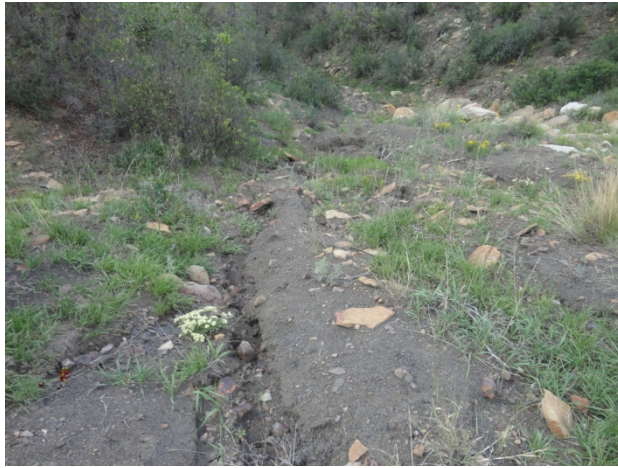
Pond 9 was discharging at a trickle. The embankment and spillways appeared to be in good order. The water level was too high to allow for any pond maintenance. The erosive gullies around the pond noted in the inspection report of July 23 had grown noticeably and new gullies had formed. Additionally, a gully to the west of the emergency spillway was noted. An old silt fence was visible; **this should be replaced to prevent further erosion.**

Photo 1: Erosion below pond 9/9B

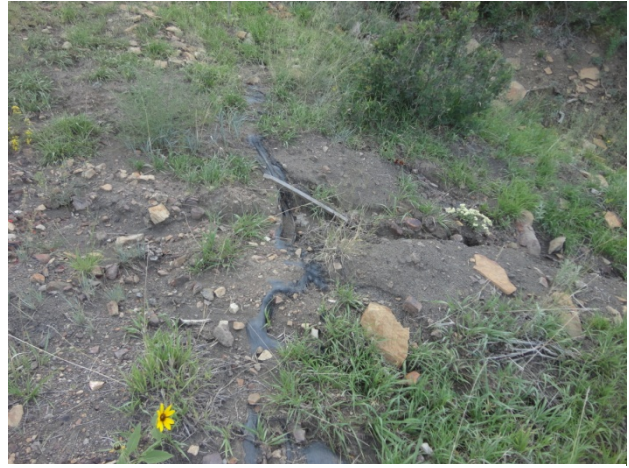
Photo 2: Old silt fence

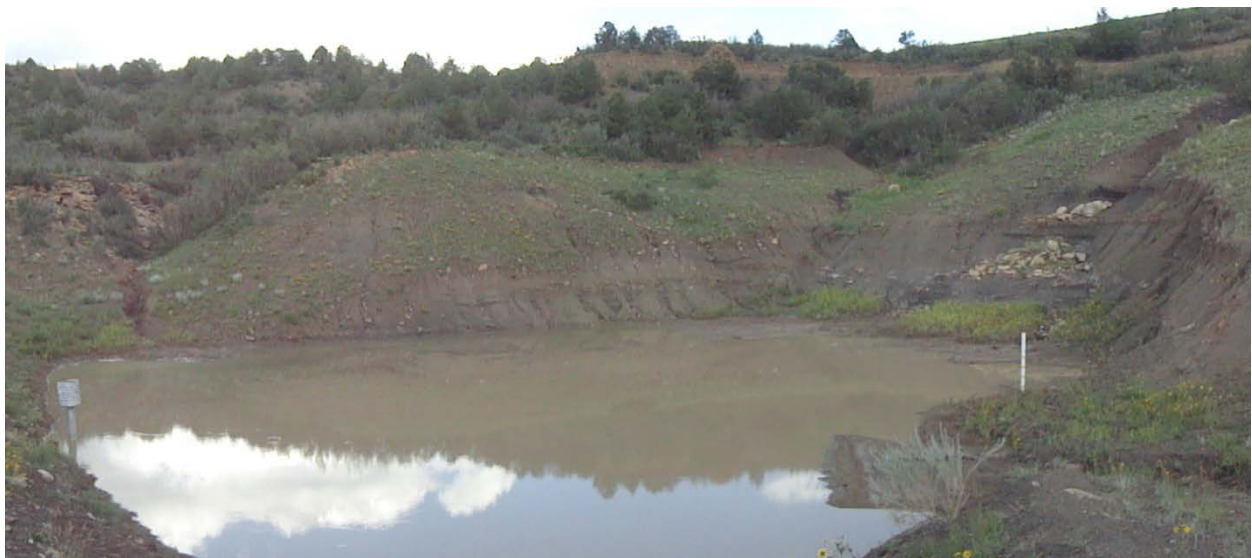
Photo 3: Pond 9/9B – several erosion problems

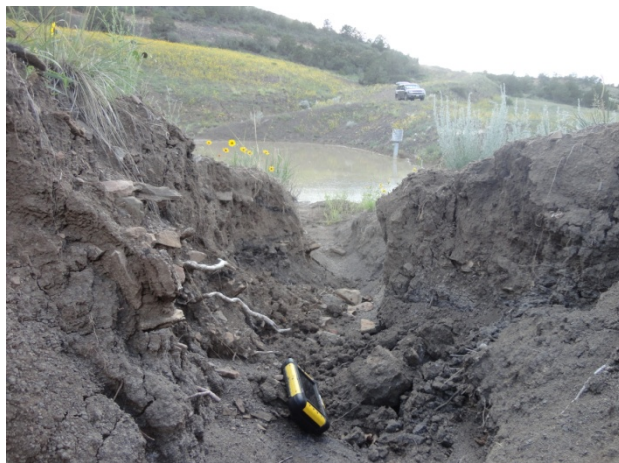
Photo 4: One of several growing gullies at pond 9/9B

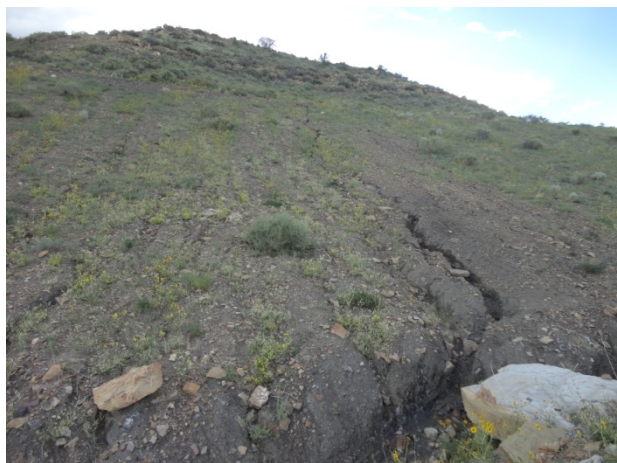
Culvert C3 was clear, but a gully had formed in the slope above where water had piped through the side of

ditch D3 and “cut the corner”. The gully was in a bare patch of an otherwise well vegetated slope. **Repair of this erosion should be prioritized to prevent the problem growing more severe.**

Photo 5: New gully above C3

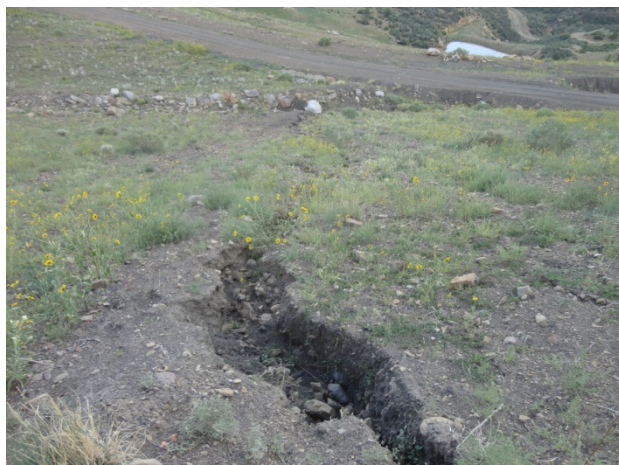
Photo 6: New gully above C3 from above
