## COLORADO DIVISION OF RECLAMATION, MINING AND SAFETY COAL PROGRAM INSPECTION REPORT

<b>Permit Number:</b> C-1981-012 <b>Mine Name:</b> New Elk Mine <b>Operator:</b> New Elk Coal Company, LLC <b>Operator Address:</b> Mr Ron Thompson 12250 Highway 12 Weston, CO 81091	<b>County:</b> Las Animas <b>Operation Type:</b> Underground <b>Permit Status:</b> Temporary Cessation <b>Ownership:</b> Private
	<b>Operator Representative Present:</b>  Greg Smith
<b>Operator Representative Signature:</b> (Field Issuance Only)

<b>Inspection Start Date:</b> August 28, 2013 <b>Inspection Start Time:</b> 08:00 <b>Inspection End Date:</b> August 29, 2013 <b>Inspection End Time:</b> 11:30		<b>Inspection Type:</b> Coal Partial Inspection <b>Inspection Reason:</b> Normal I&E Program <b>Weather:</b> Clear	
<b>Joint Inspection Agency:</b>  None		<b>Joint Inspection Contacts:</b>	
<b>Post Inspection Agency:</b>  None		<b>Post Inspection Contacts:</b>	
<b>Inspector(s):</b>  Leigh D. Simmons	<b>Inspector's Signature:</b>

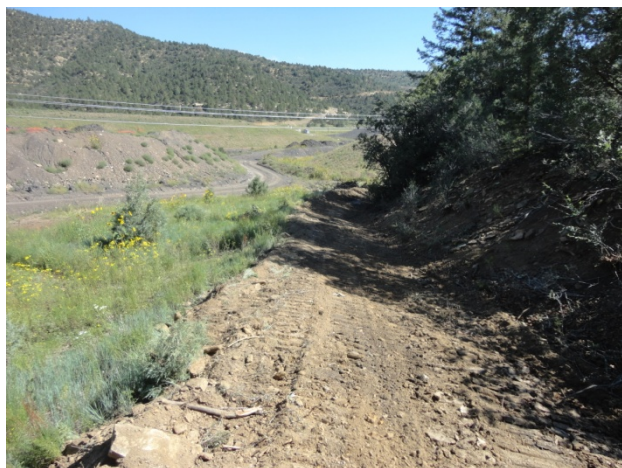
The diversion ditches along the southern boundary of the disturbed area (D26, D18, D9, D7, D29 and the ditches around the West Fan) had been cleared with a D5 bulldozer. The ditches were well defined and clear of obstructions, although a little trash remained in the concrete section of D26.

Photos 2-3: Southern diversion ditches

Abatement Description: Clear vegetation, rocks and non-coal waste, and reshape and grade the following ditches as necessary to restore them to the approved design: clean water diversion ditch above West Fan; D29; D29B; D7; D9; D26

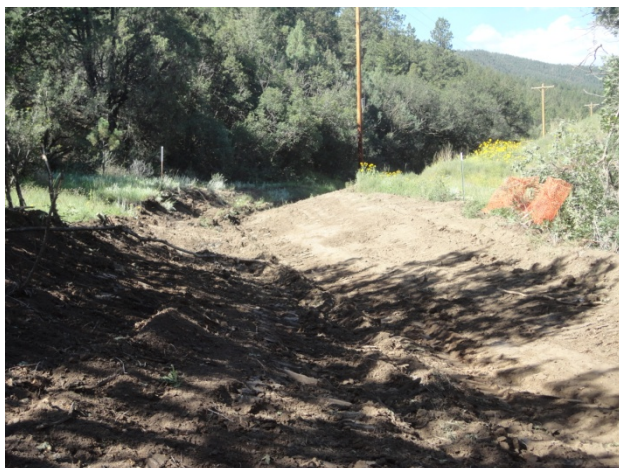
Photos 1-3: Southern diversion ditches

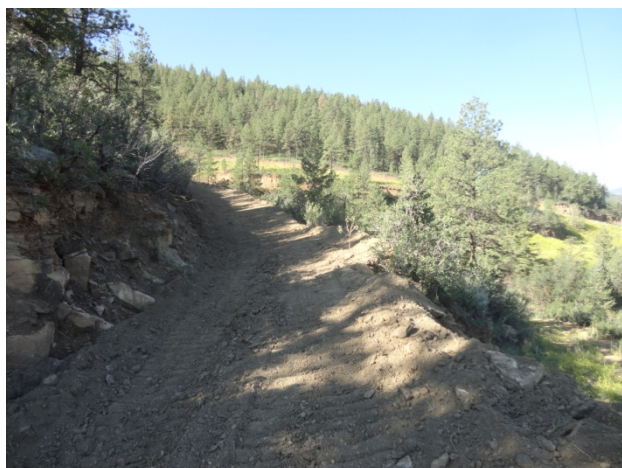
Photos 3-3: Southern diversion ditches

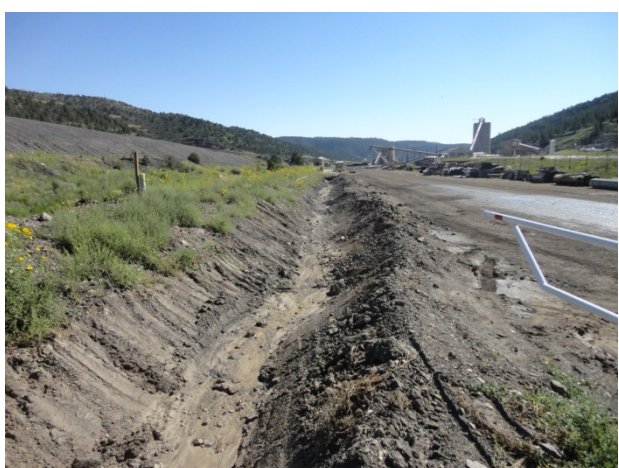
Culvert C73 still needs to be flushed, although ditch D15 had been excavated between the four-way and C72, and below C73.

Photo 4: D15

Abatement Description: Clear culverts C73 and C19 of accumulated sediment to restore them to the approved design

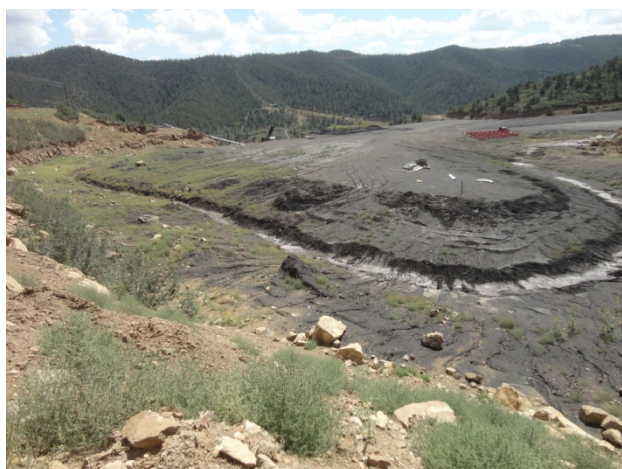
Drainage on the RDA had been taken care of.

Photo 5: Improved RDA drainage

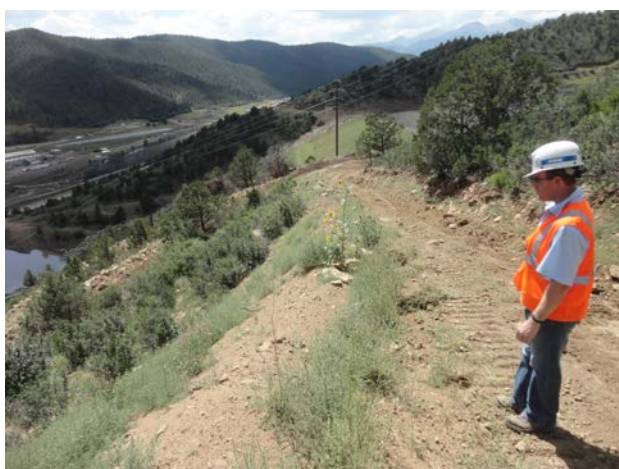
Improvements had been made to the power pole light use road.

Photo 6: Improvements to power pole road

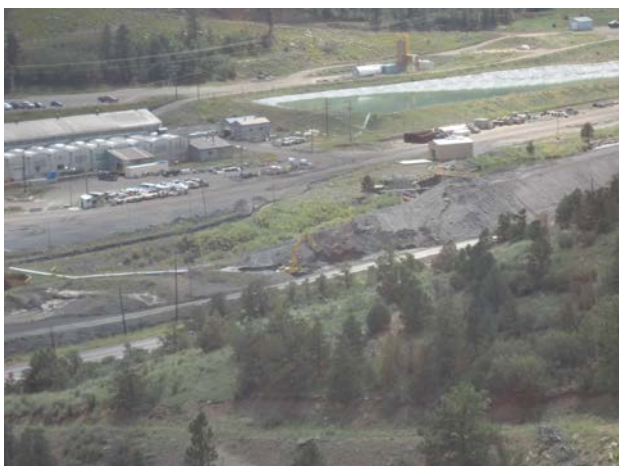
The sump at the inlet to C13 had been cleaned out, however the soft ground made access to ditch D14 impossible.

Photo 7: Cleaning sump at inlet to C13

Abatement Description: Ditch D14 should be restored to the approved design.

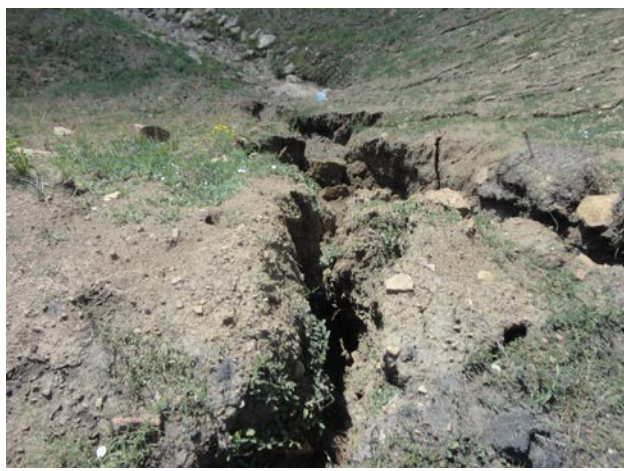
Photo 8: Erosion above pond 8

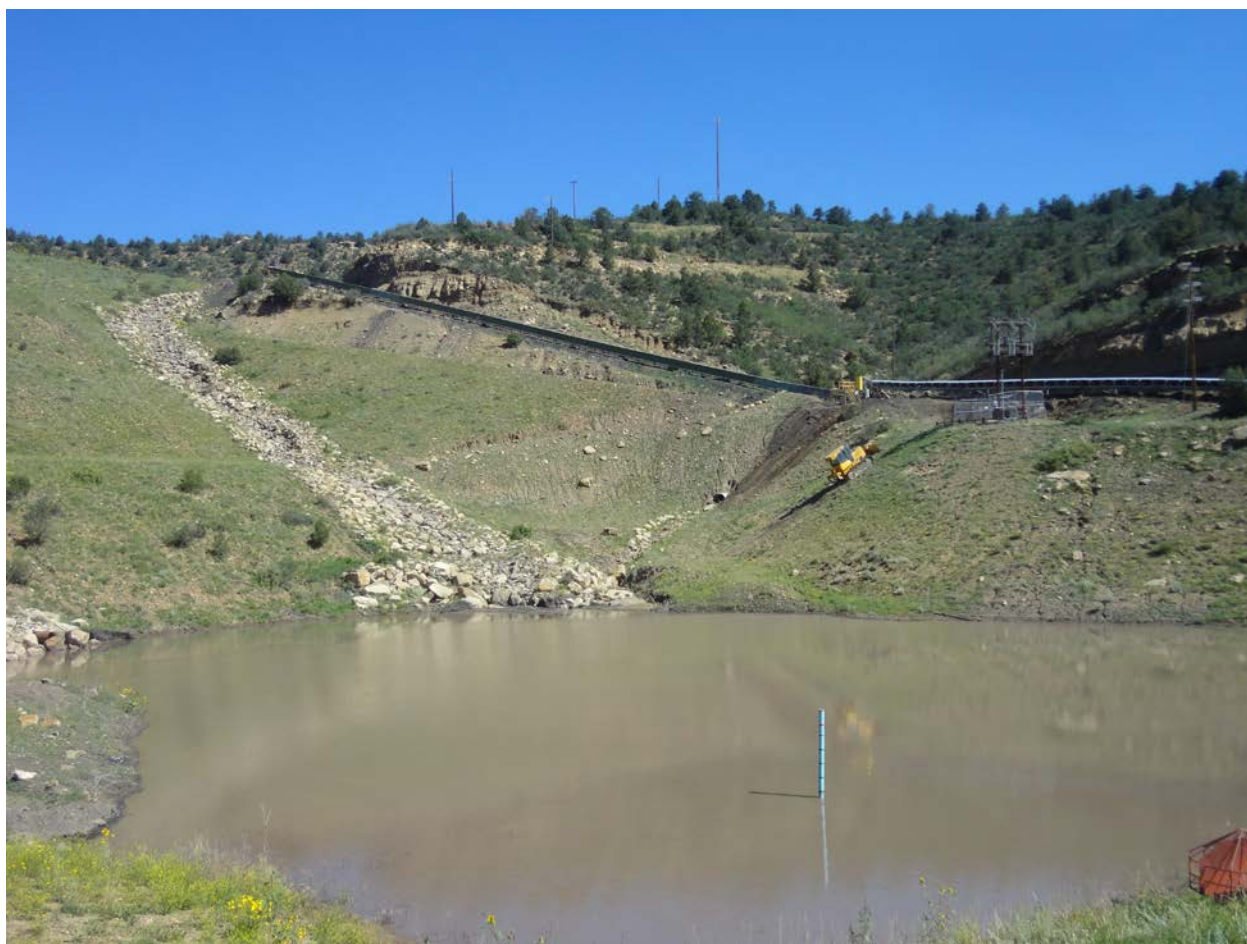
During the inspection, work was taking place to repair the erosion below the conveyor junction.

Photo 9: Erosion repair in progress
