COLORADO DIVISION OF RECLAMATION, MINING AND SAFETY COAL PROGRAM INSPECTION REPORT

Permit Number: C-2010-089 Mine Name: New Horizon North Mine Operator: Western Fuels-Colorado, LLC Operator Address: Mr. David G Anderson 12050 N. Pecos St., Suite 100 Westminster, CO 80234	County: Montrose Operation Type: Surface Permit Status: Active Ownership: Private Operator Representative Present: Ross Gubka
Operator Representative Signature: (Field Issuance Only) This report was issued electronically from the Division's Durango Field Office.

Inspection Start Date: August 22, 2013 Inspection Start Time: 08:30 Inspection End Date: August 22, 2013 Inspection End Time: 15:00		Inspection Type: Coal Partial Inspection Inspection Reason: Normal I&E Program Weather: Clear	
Joint Inspection Agency: None		Joint Inspection Contacts:	
Post Inspection Agency: None		Post Inspection Contacts:	
Inspector(s): Marcia L. Talvitie, P.E.	Inspector's Signature:

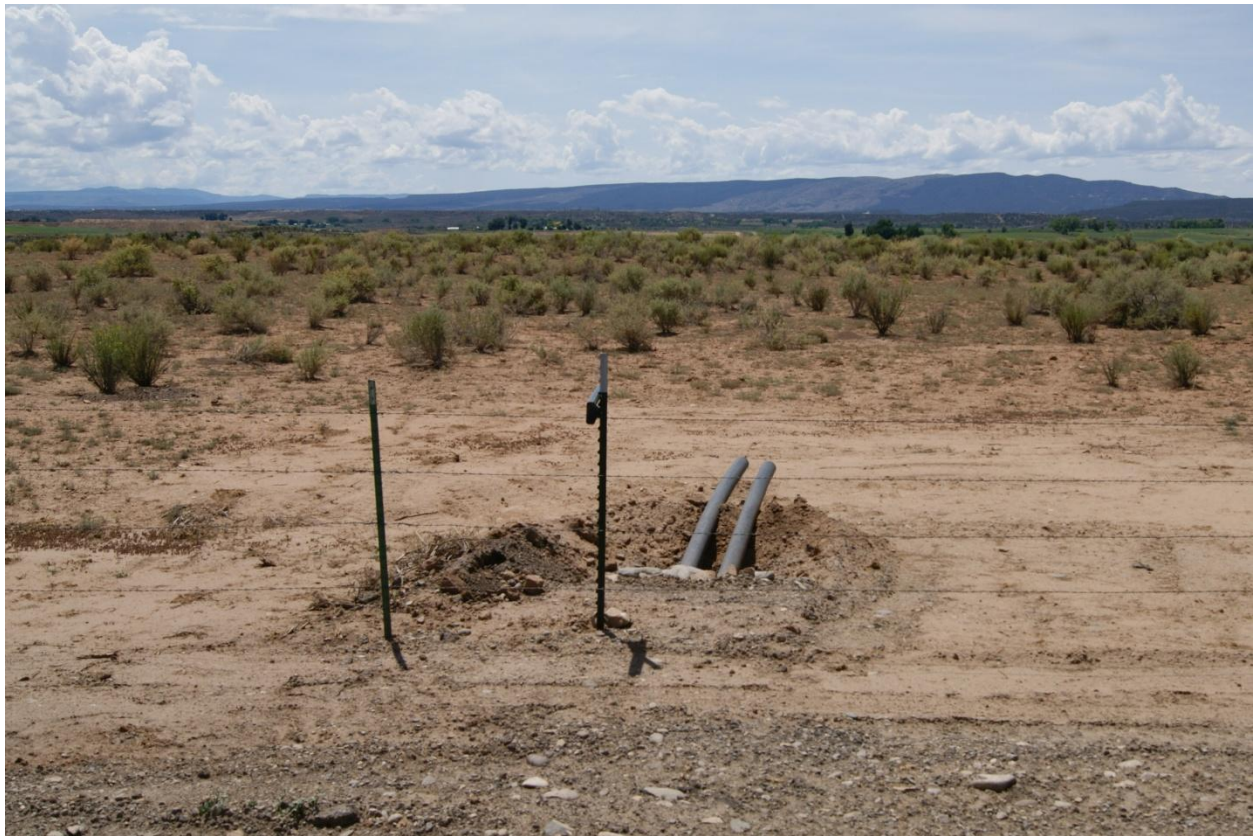
- Conduit has been installed beneath AA Road, just west of the mine entrance (Photo 1), in order to connect the water line (originating at NH1 Pond 001) to the overhead water tank, from which the water will be used for dust control.

Photo 1 - Conduit

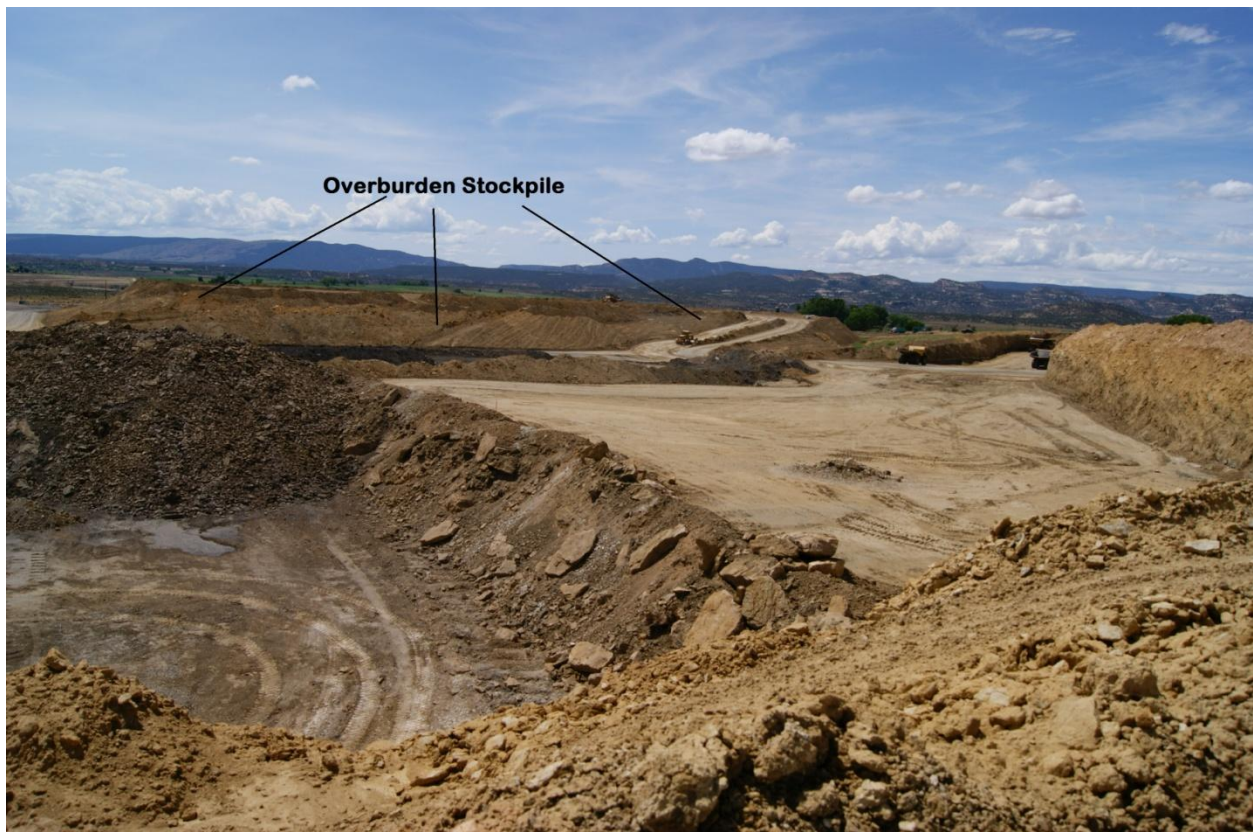
- Significant progress has been made in the construction of the boxcut overburden stockpile, immediately north of Pond NHN-001 (Photo 2).
- Free-dig overburden material excavated from the area to be blasted is being placed in the lower portion of the pile. The lower overburden, once it has been shattered by blasting, will then be trucked and dumped in the upper portions of the pile.

Photo 2 – Looking WSW at Boxcut Overburden Sockpile

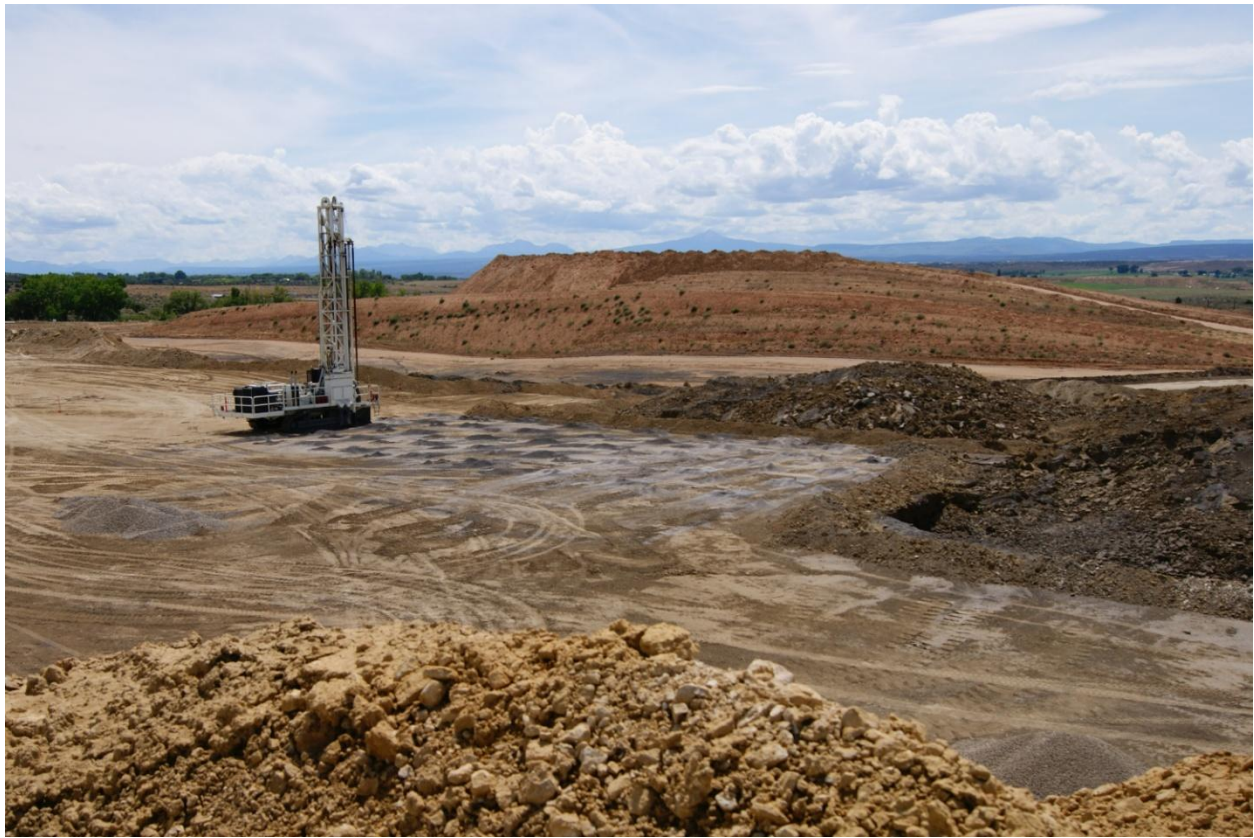
- Drilling and blasting has commenced this week at the mine. A pattern of holes had been recently drilled, and appeared to be ready for loading with explosives (Photo 3).

Photo 3 – Drill rig and pattern of holes

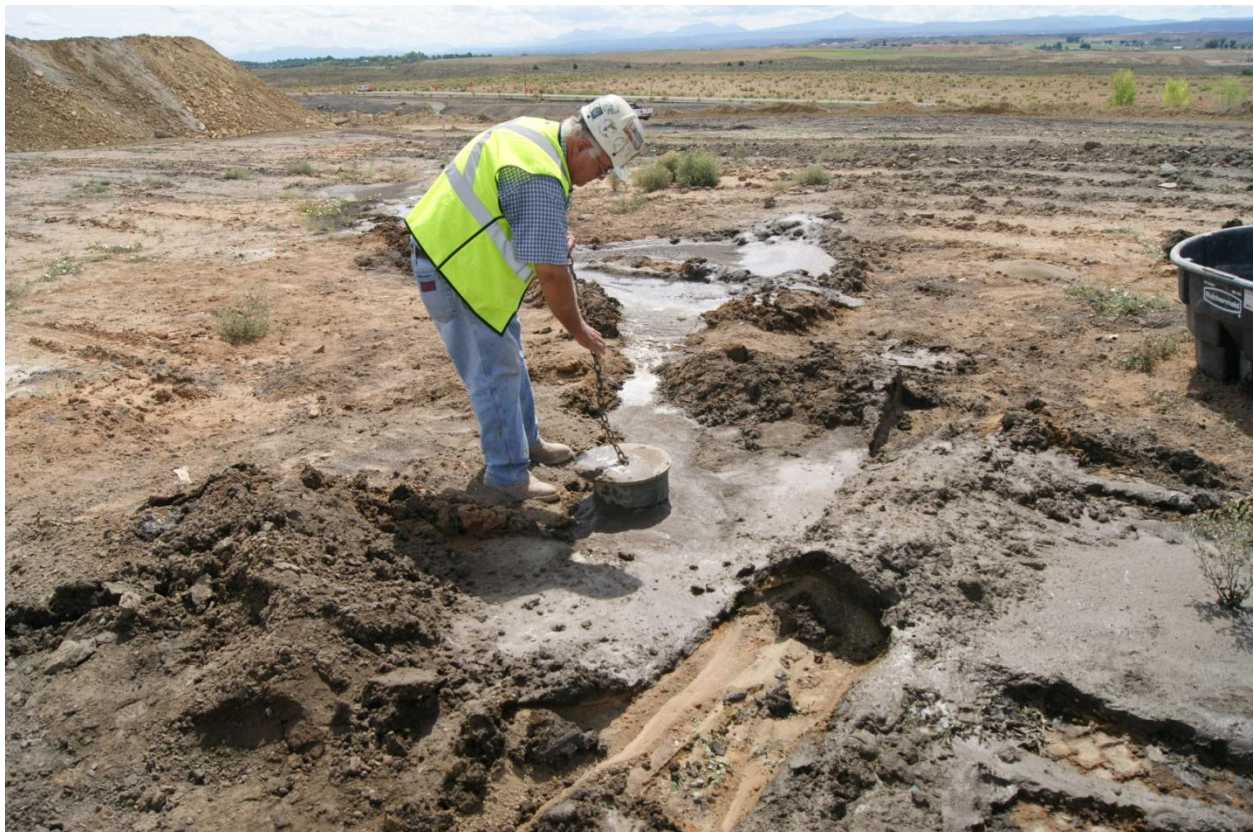
- Mr. Gubka and I arrived at the site shortly after drilling of a Dewatering Well (DW12-1) had been completed (Photo 4). This well was one of three permitted by the Division of Water Resources for the purpose of dewatering the spoil used to backfill the former highwall of the Nucla/NH1 Mine.

- George O'Hara, consulting geologist, oversaw the drilling operation. Himes drilling was contracted to do the work. A 20' 10-inch surface casing was used. Mr. O'Hara said no groundwater was encountered, and that the drill rig hit a hard sandstone layer at a depth of 70.5 feet, which was the estimated depth of backfill. Because the hole was dry, no dewatering of the spoil will be necessary, and the operator will not drill the other two dewatering wells, which were to have been located up-gradient of this well.

Photo 4 – DW12-1 casing

- Mr. O'Hara said this well would not be mined through; rather, the overburden stockpile will cover this area. Reclamation of the well will be accomplished by filling the bottom of the hole with bentonite pellets (using whatever amount was available at the local Co-Op), and then filling the remainder of the well and casing with Portland cement. The casing would be cut off at three feet below the surface.

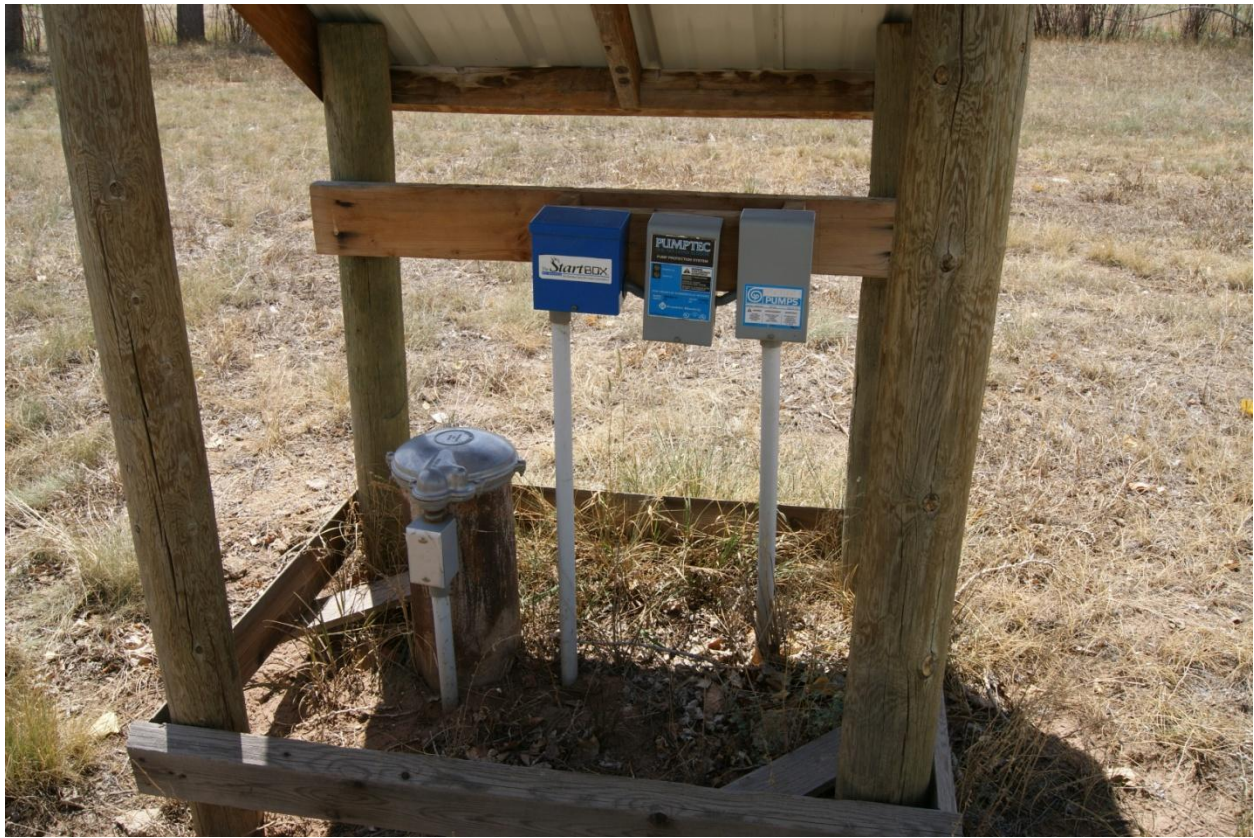
- There is a permitted domestic well at the Meehan homesite (Photo 5). The well was transferred to Western Fuels with the purchase of the former Meehan property. Because the well will be mined through, permission to abandon the well must be obtained from the Division of Water Resources.

Photo 5 – Well house – Meehan property

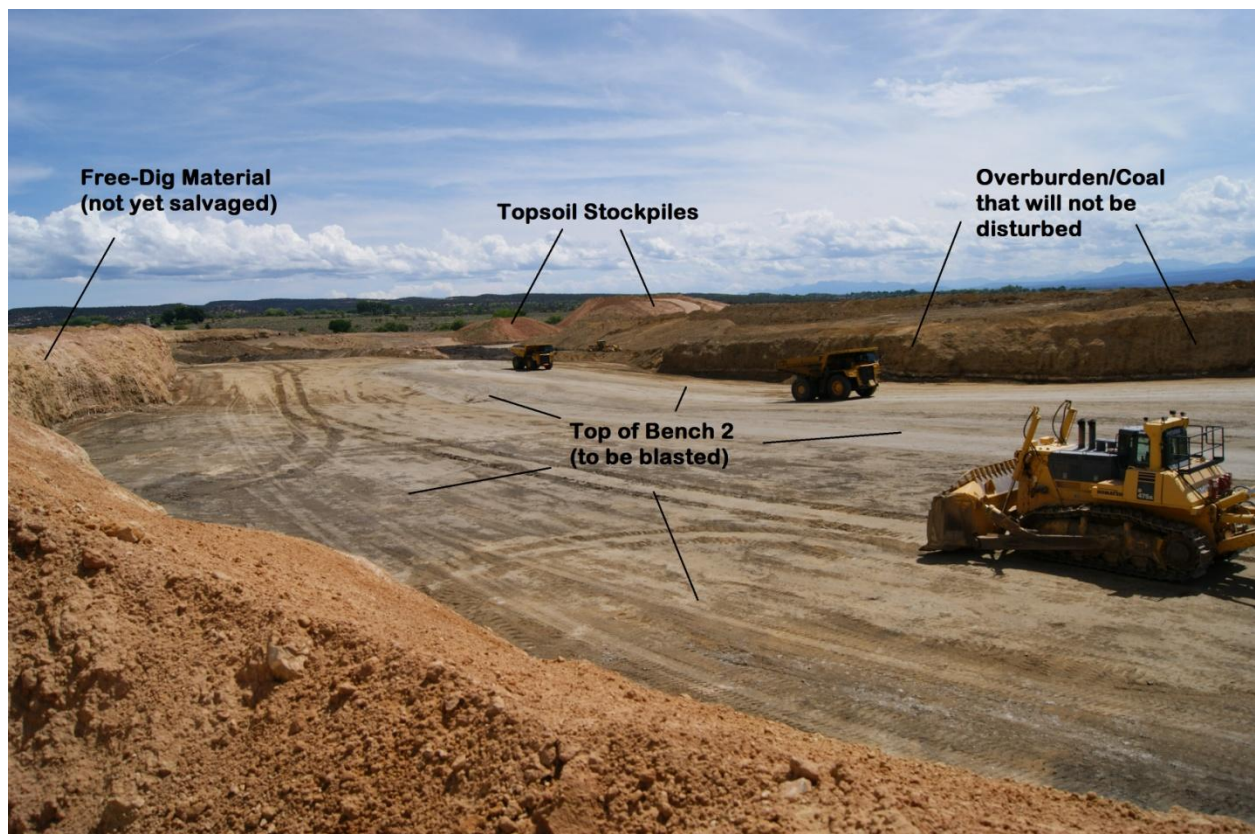
Photo 6 – Surface ready for blasting, looking SE

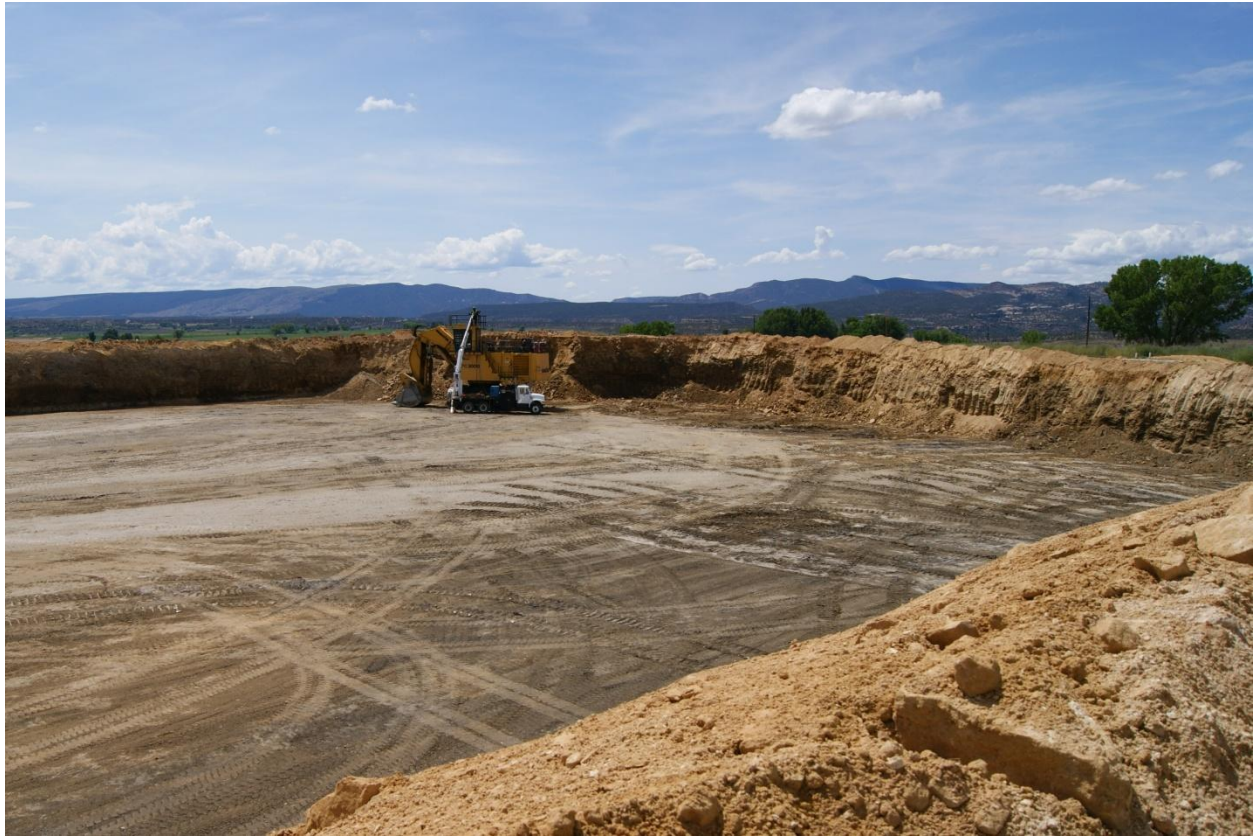
- The mine plan, as illustrated on permit Map 2.05.2-1, consists of a series of cuts oriented in an East-West direction. Mining will begin at the south, and move northward. Each cut is designed to be 115 feet in width.
- For the western side of the current mining area, Western Fuels has determined that the old Peabody highwall will not be exposed for commencement of mining. Instead, a quantity of coal, together with the overburden, will be left in place (Photo 6).
- Free-dig, or “Bench 1”, overburden has been removed from an area 230 feet (two cuts) in width on the western side of the mining area. Drilling and blasting will follow. The Bench 1 highwall surrounding the area on three sides appears to be approximately 20 feet in height (Photo 7).

Photo 7 – West end of cuts, shovel for scale
