COLORADO DIVISION OF RECLAMATION, MINING AND SAFETY COAL PROGRAM INSPECTION REPORT

Permit Number: C-1996-083 Mine Name: Bowie No. 2 Mine Operator: Bowie Resources, LLC Operator Address: Mr William A Bear P.O. Box 483 Paonia, CO 81428	County: Delta Operation Type: Underground Permit Status: Active Ownership: Federal and Forest
	Operator Representative Present: None Present - Aerial Inspection
Operator Representative Signature: (Field Issuance Only)

Inspection Start Date: August 27, 2013 Inspection Start Time: 10:29 Inspection End Date: August 27, 2013 Inspection End Time: 10:29	Inspection Type: Aerial Inspection Inspection Reason: Normal I&E Program Weather: Clear
Joint Inspection Agency: None	Joint Inspection Contacts:
Post Inspection Agency: None	Post Inspection Contacts:
Inspector(s): Susan L. Burgmaier Harry B. Ranney	Inspector's Signature:

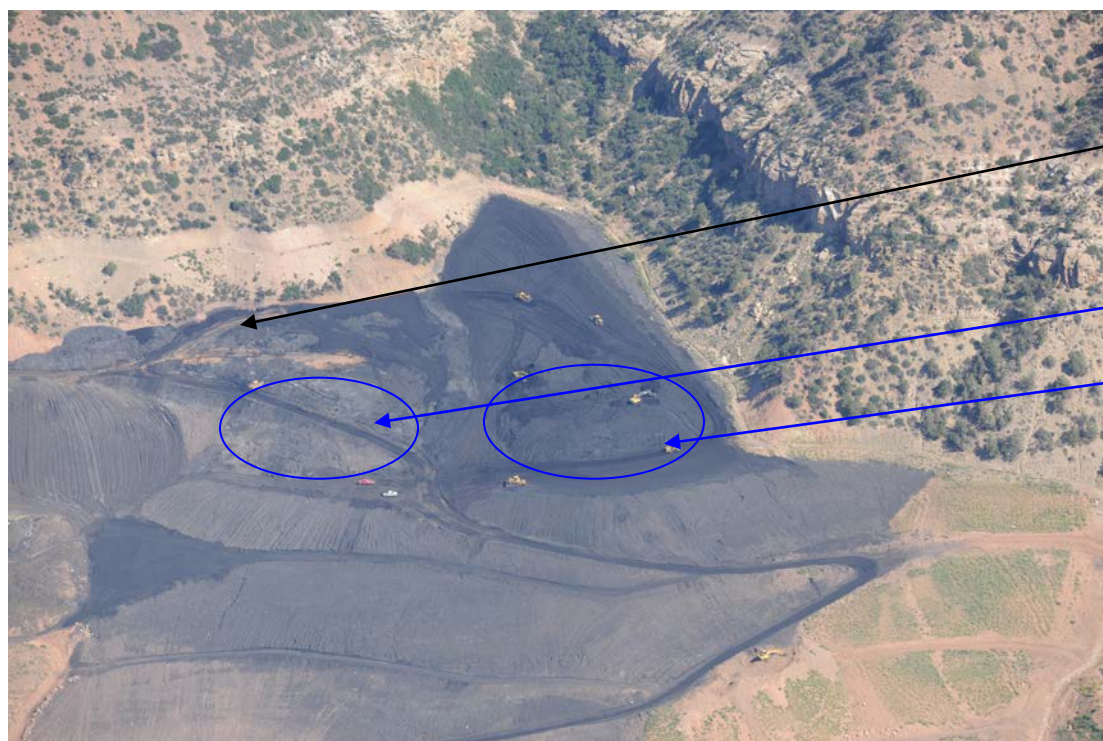
The operator has made significant progress grading and compacting the upper bench of the east end of Gob Pile #2, where material was end dumped over the winter (cited in Notice of Violation CV2013004.) There is approximately one acre of end dumped material remaining to be graded in this area. End dumped material

remaining in the expansion area between the two piles, also the subject of CV2013004 and remaining to be graded, covers approximately 0.75 acres. The areas requiring grading are indicated on the photos accompanying this report.

Active disposal is underway in the upper bench of the expansion area of Gob Pile #2. Material that has been placed in this area for spreading and compaction covers approximately 1.5 acres.

Active disposal
area

Remaining
end-dumped
material to be
graded

Abatement Description: Place and compact all existing end-dumped material on Gob Pile #2 in accordance with the Rules and approved permit application package.

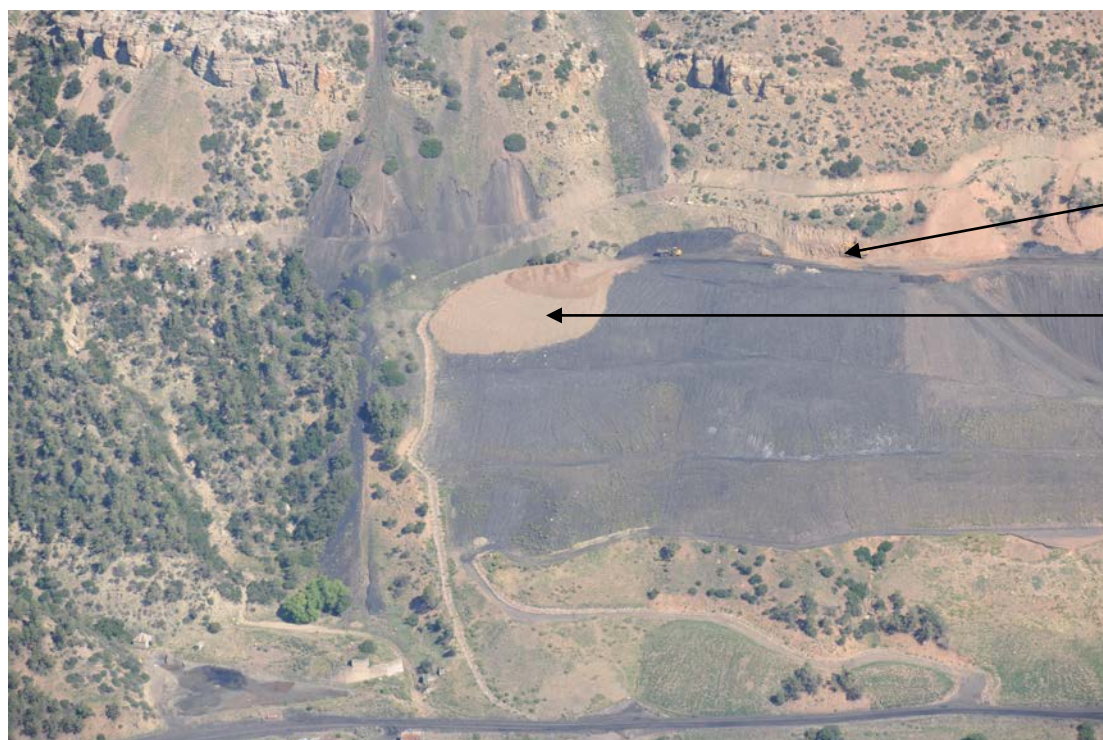
Refuse material was being compacted on the third bench of the east end of Gob Pile #2. Material from the upper bench of Gob Pile #2 was being excavated for placement on the third bench. An excavator was working above Gob Pile #4, excavating cover material below the diversion ditch. The excavated material was being placed on Gob Pile #4 where final grade of the refuse was previously verified.

Excavation
area

Cover material
placement
