COLORADO DIVISION OF RECLAMATION, MINING AND SAFETY
MINERALS PROGRAM INSPECTION REPORT
PHONE: (303) 866-3567

MINE NAME: Malouff Pit	MINE/PROSPECTING ID#: M-1982-033	MINERAL: Sand & Gravel	COUNTY: Conejos
INSPECTION TYPE: Monitoring	INSPECTOR(S): Wallace H. Erickson	INSP. DATE: May 14, 2013	INSP. TIME: 11:35
OPERATOR: Absmeier Landscaping & Construction, LL	OPERATOR REPRESENTATIVE: Adrian Absmeier	TYPE OF OPERATION: 112c - Construction Regular Operation	
REASON FOR INSPECTION: Normal I&E Program	BOND CALCULATION TYPE: Complete Bond	BOND AMOUNT: \$4,035.00	
DATE OF COMPLAINT: NA	POST INSP. CONTACTS: None	JOINT INSP. AGENCY: None	
WEATHER: Cloudy	INSPECTOR'S SIGNATURE: <i>Wallace H. Erickson</i>	SIGNATURE DATE: August 29, 2013

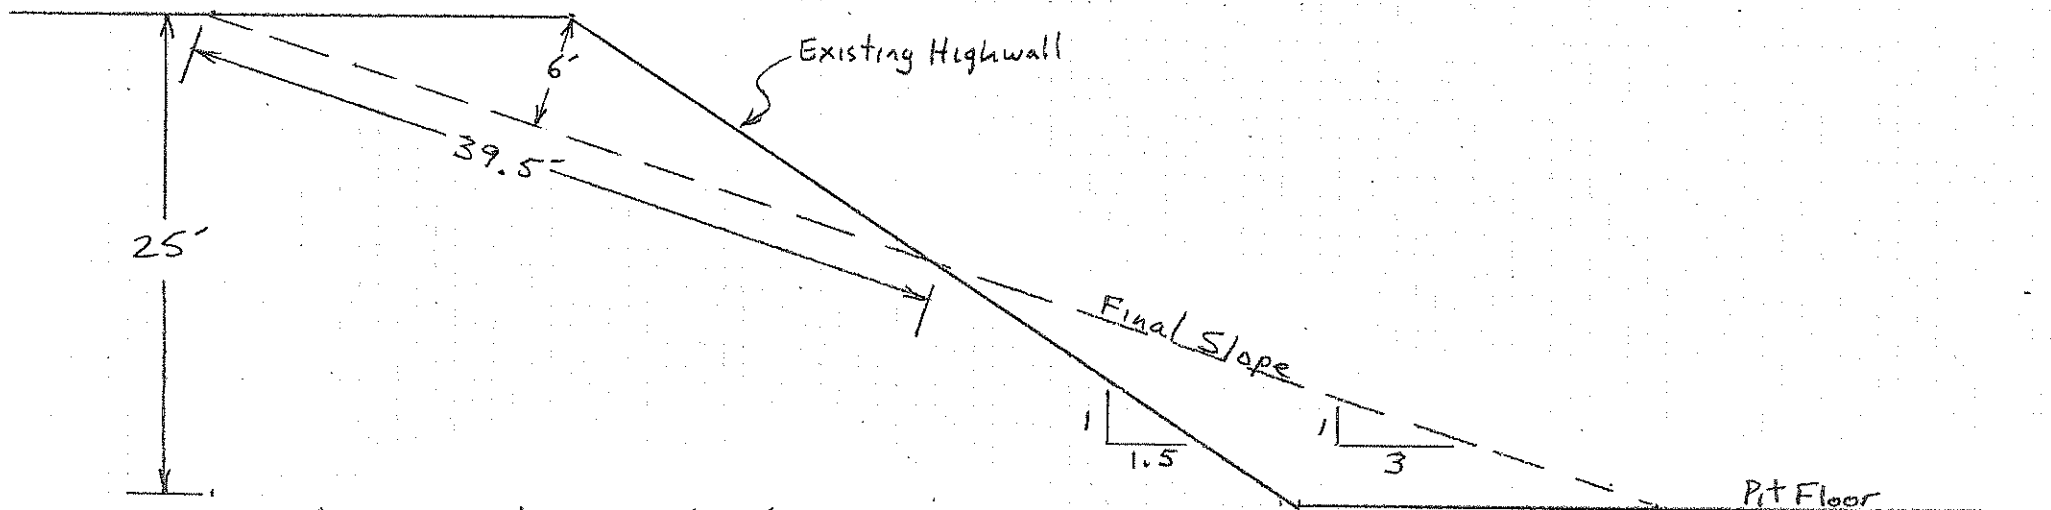
Highwall Reduction from 1.5H:1V to 3H:1V

$$\text{Area } \Delta = \frac{b \times h}{2} = \frac{39.5' \times 6'}{2} = 118.5 \text{ sq ft}$$

Length of highwall to be reduced $\approx 1,000'$

$$\begin{aligned} \text{Material Quantity} &= 118.5 \text{ sq ft} \times 1000' = 118,500 \text{ cu ft} \\ &= 4388.9 \text{ cy} \end{aligned}$$

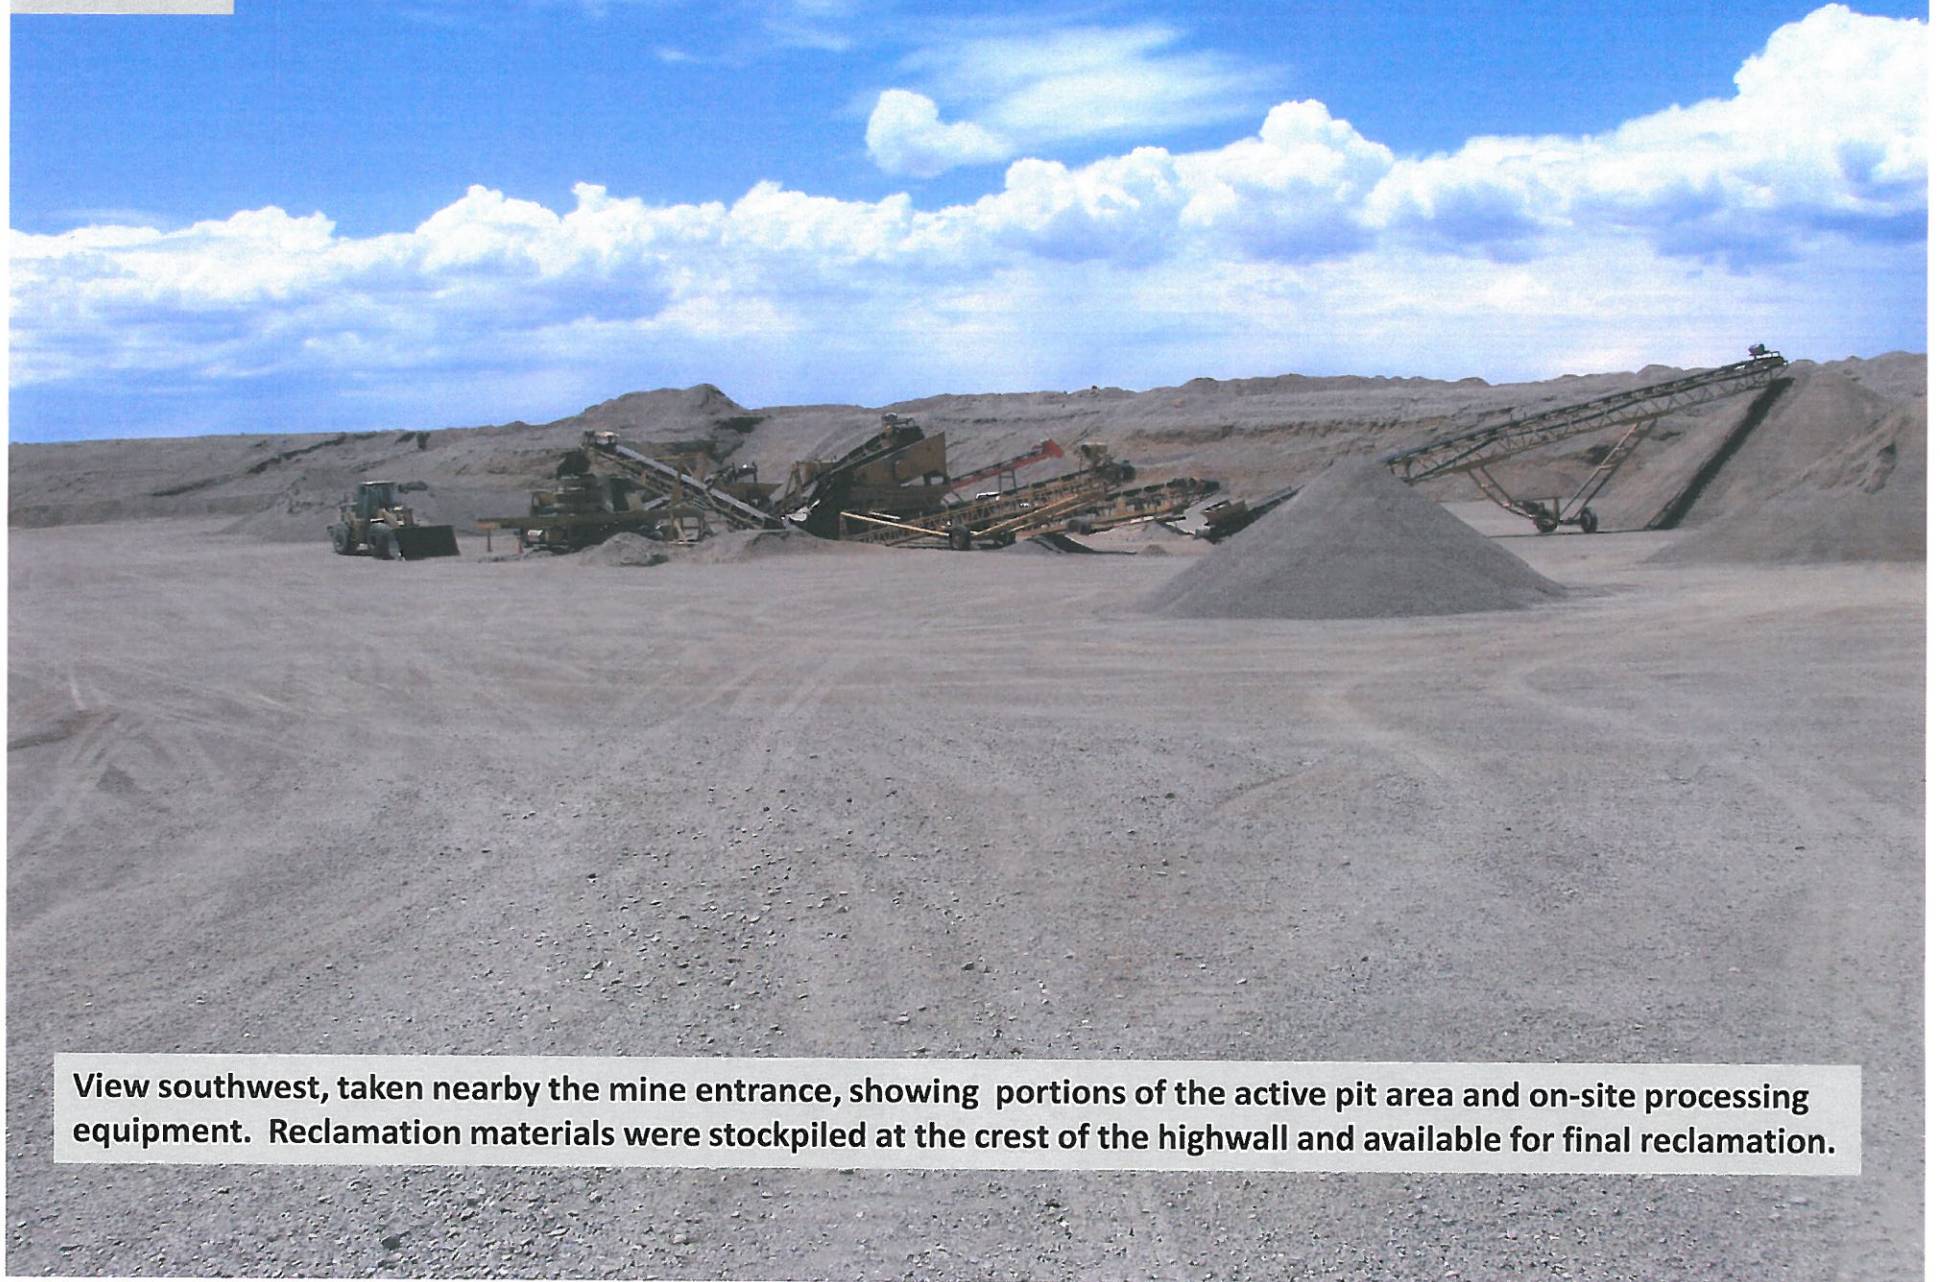
Malouff Pit
M-1982-033
May 14, 2013
Photo 1

View southwest, taken nearby the mine entrance, showing portions of the active pit area and on-site processing equipment. Reclamation materials were stockpiled at the crest of the highwall and available for final reclamation.

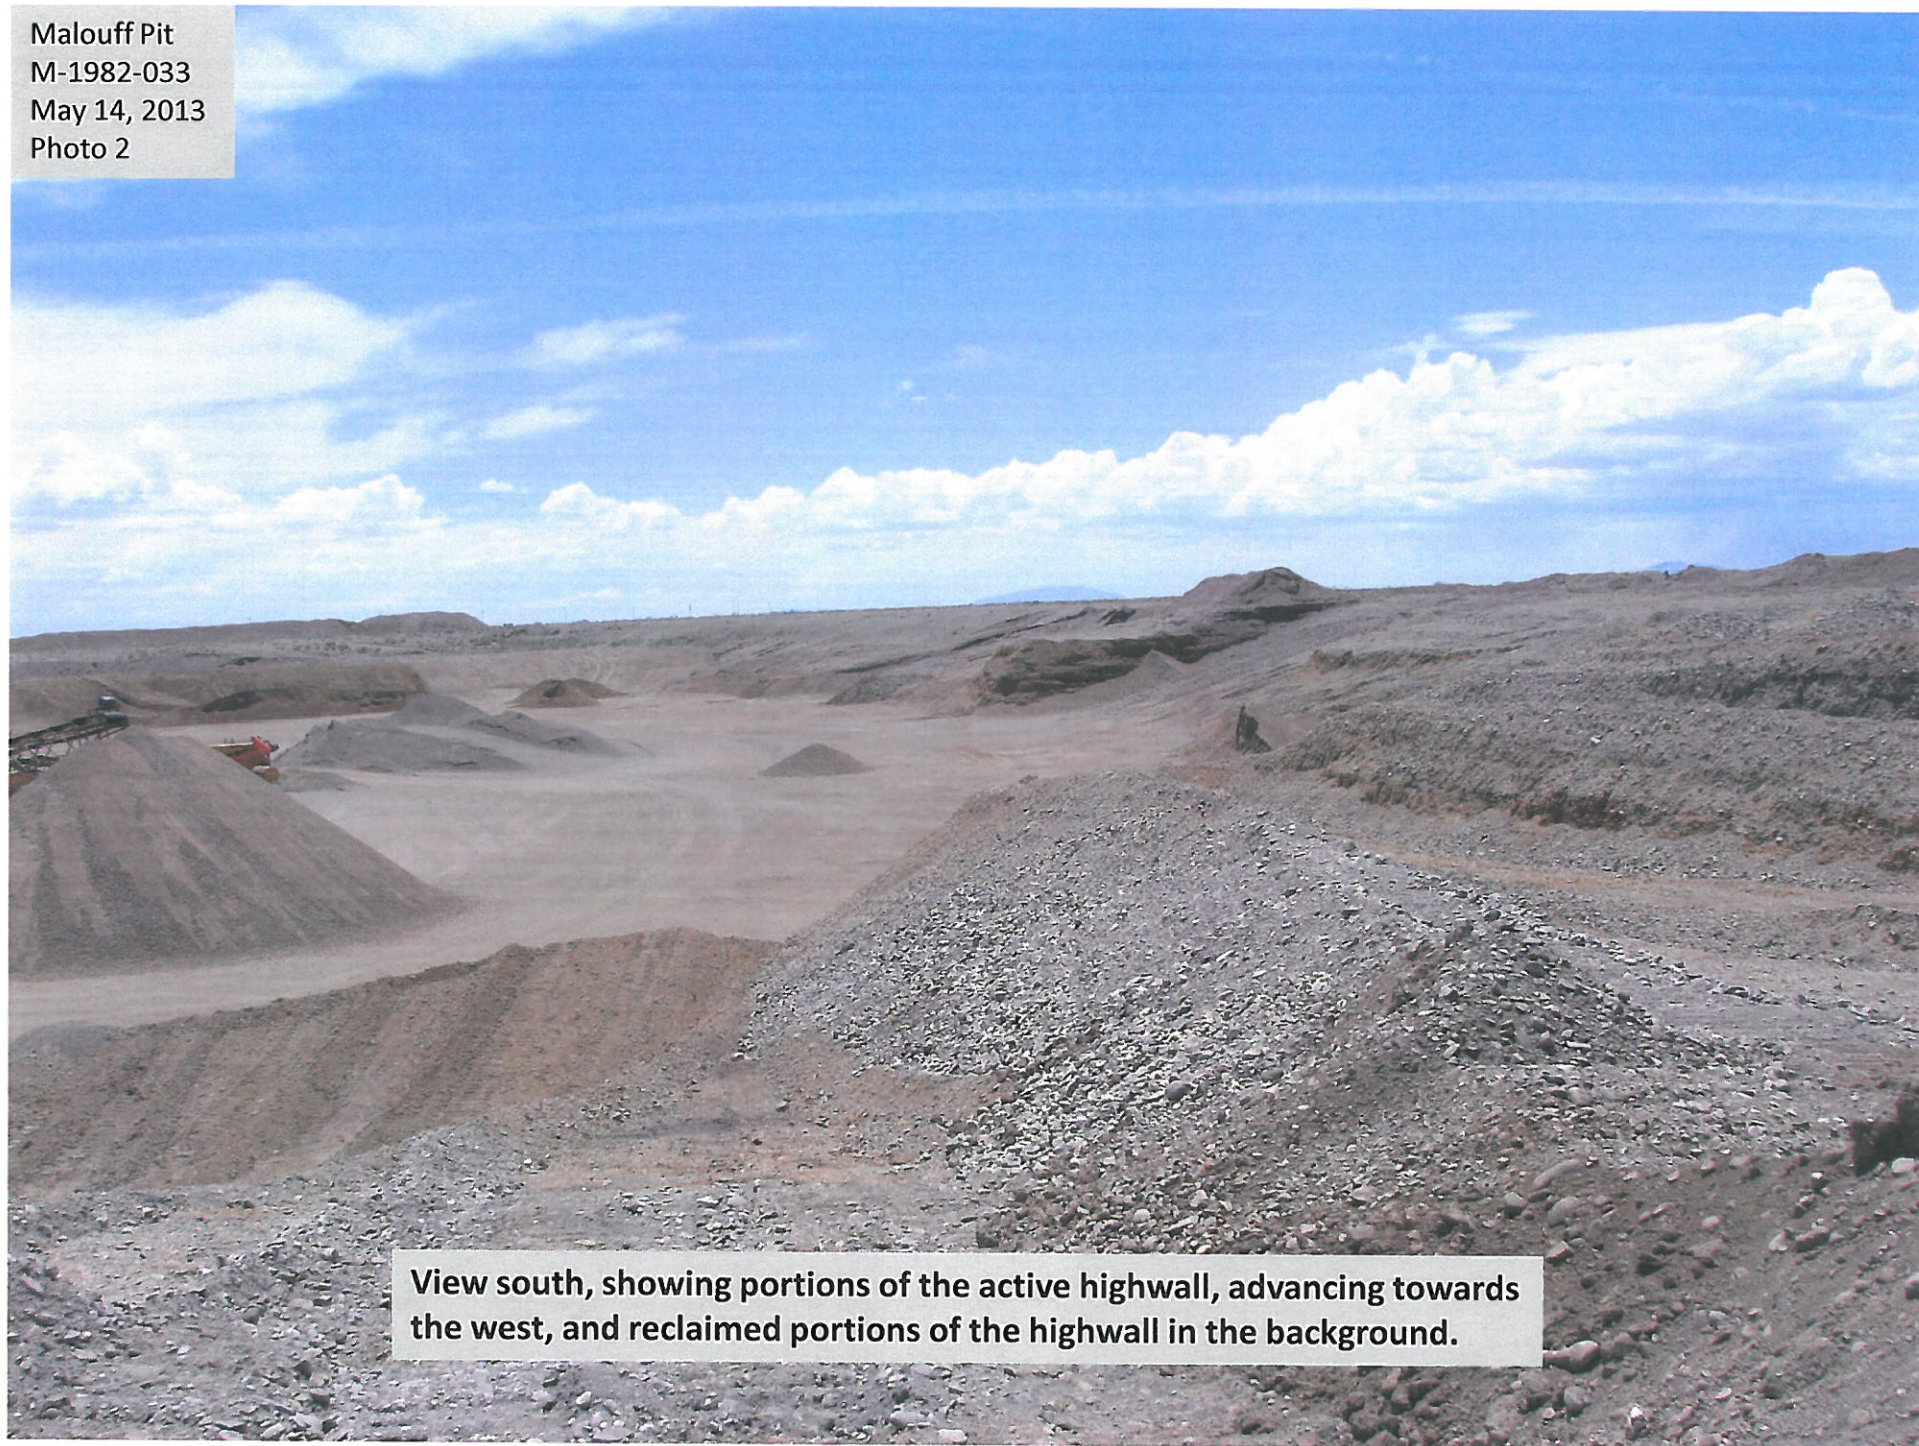
Malouff Pit
M-1982-033
May 14, 2013
Photo 2

View south, showing portions of the active highwall, advancing towards the west, and reclaimed portions of the highwall in the background.

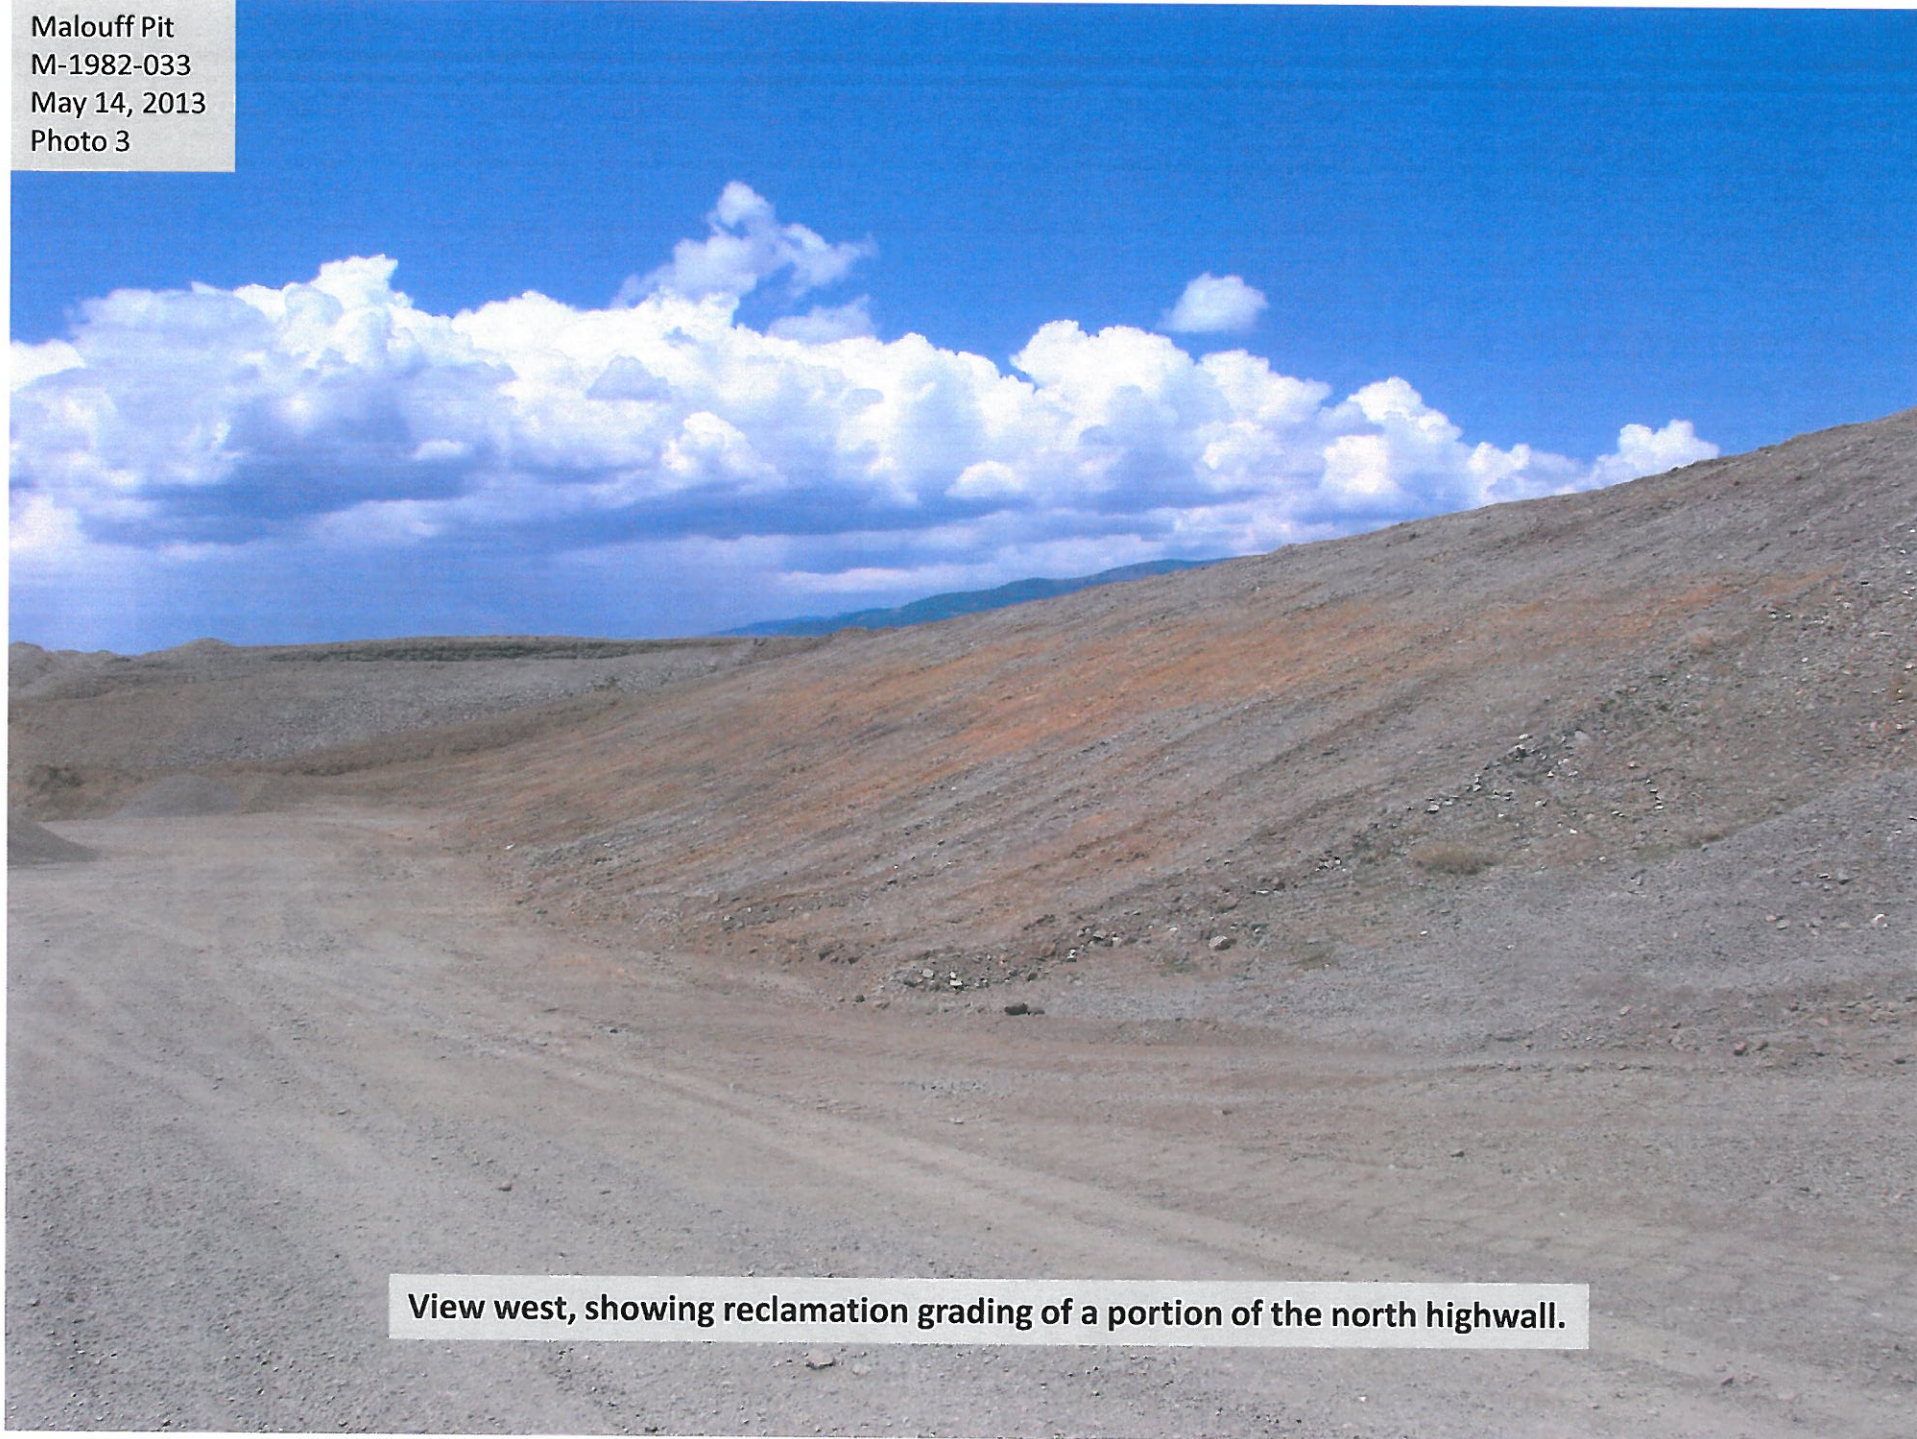
Malouff Pit
M-1982-033
May 14, 2013
Photo 3

View west, showing reclamation grading of a portion of the north highwall.

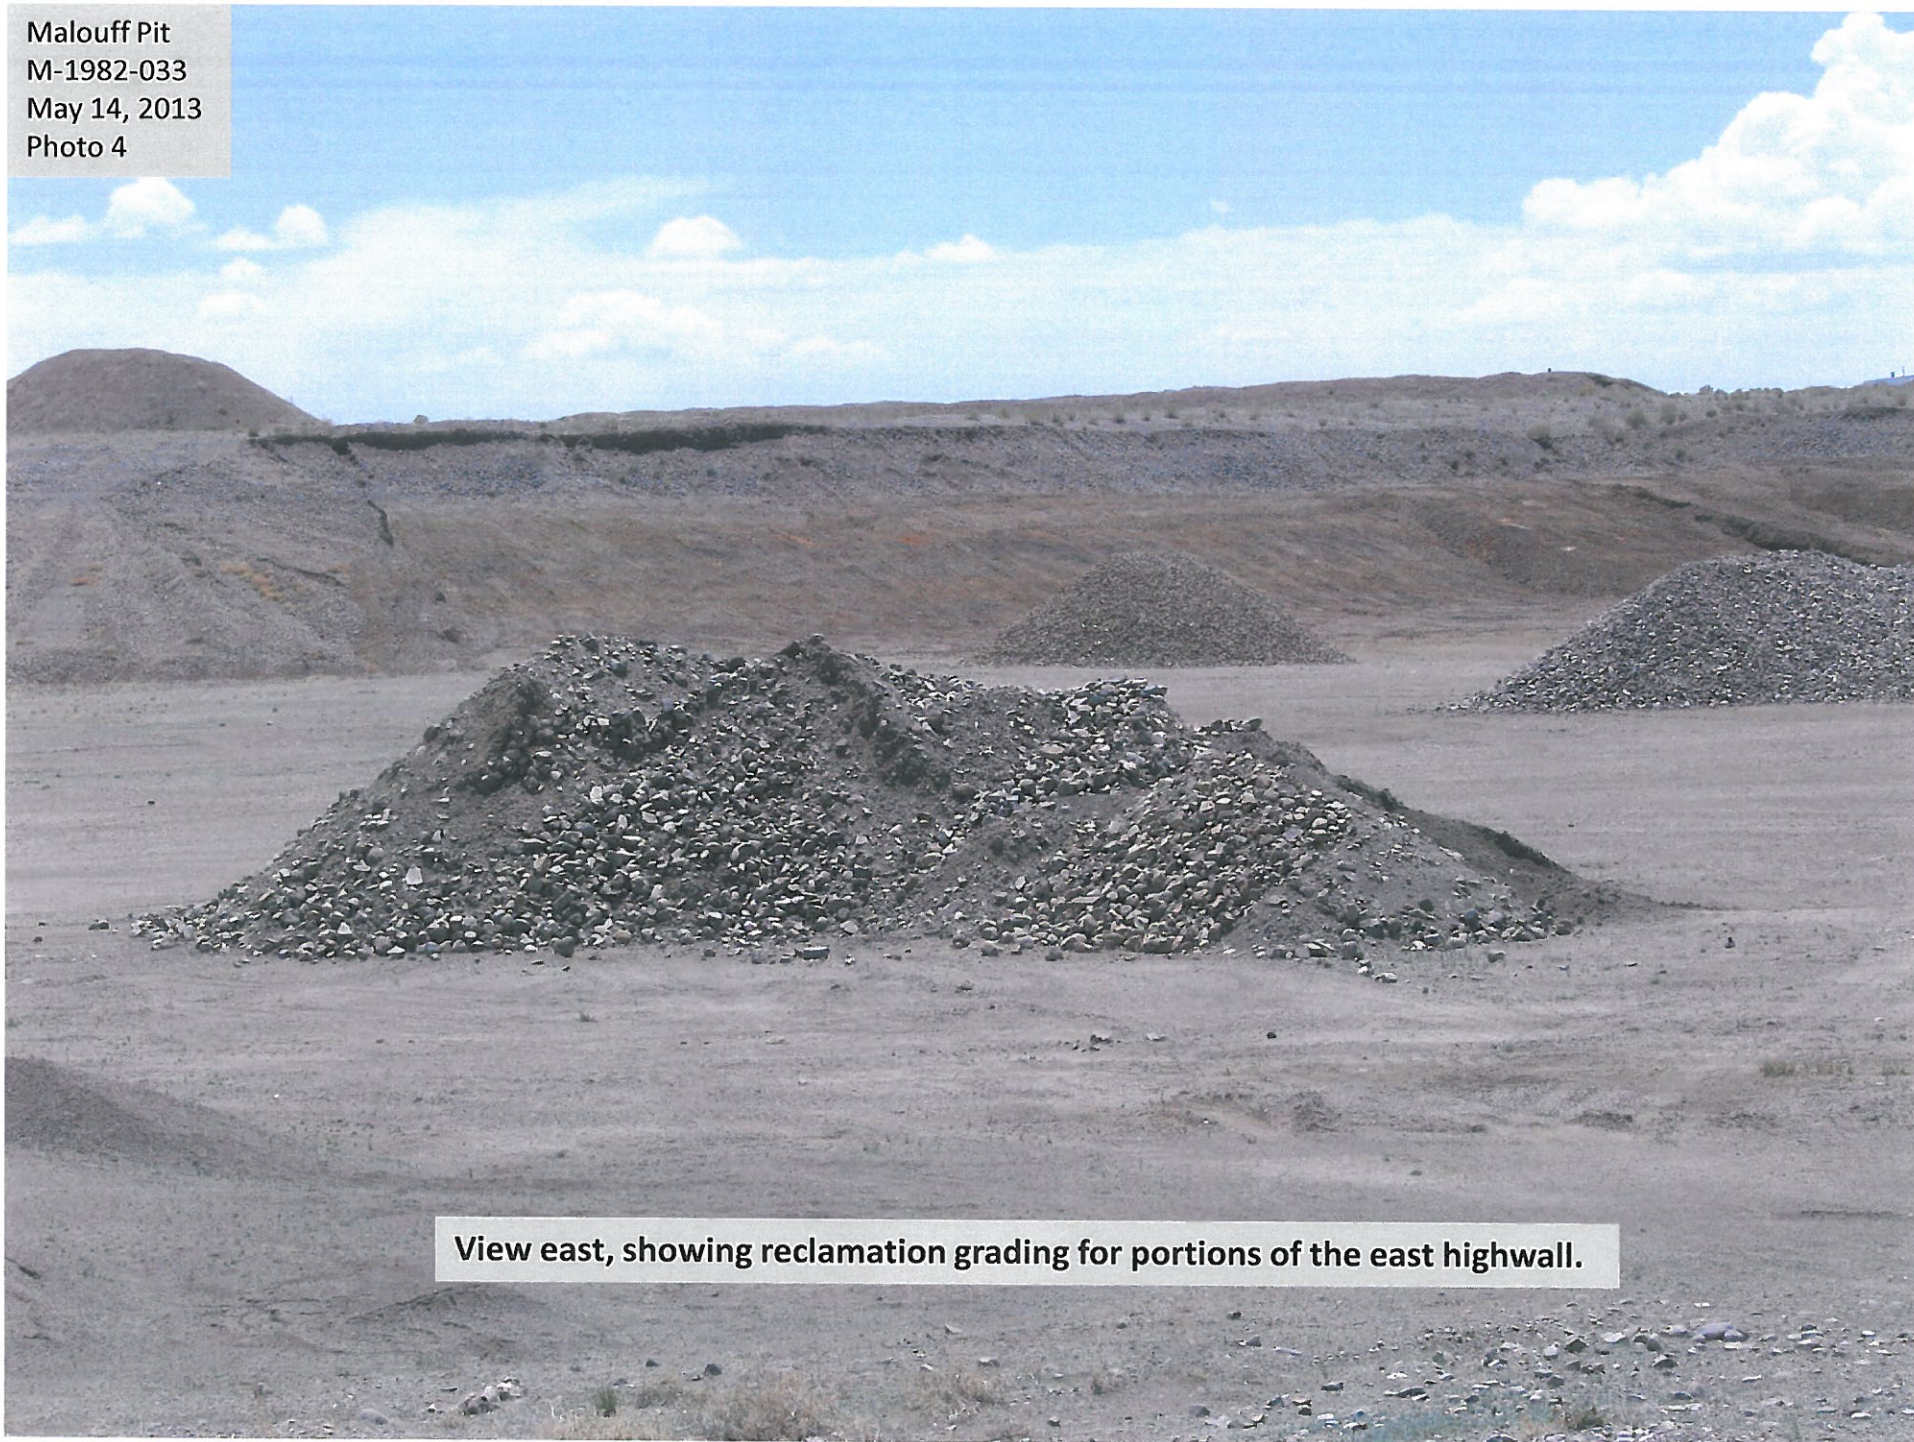
Malouff Pit
M-1982-033
May 14, 2013
Photo 4

View east, showing reclamation grading for portions of the east highwall.

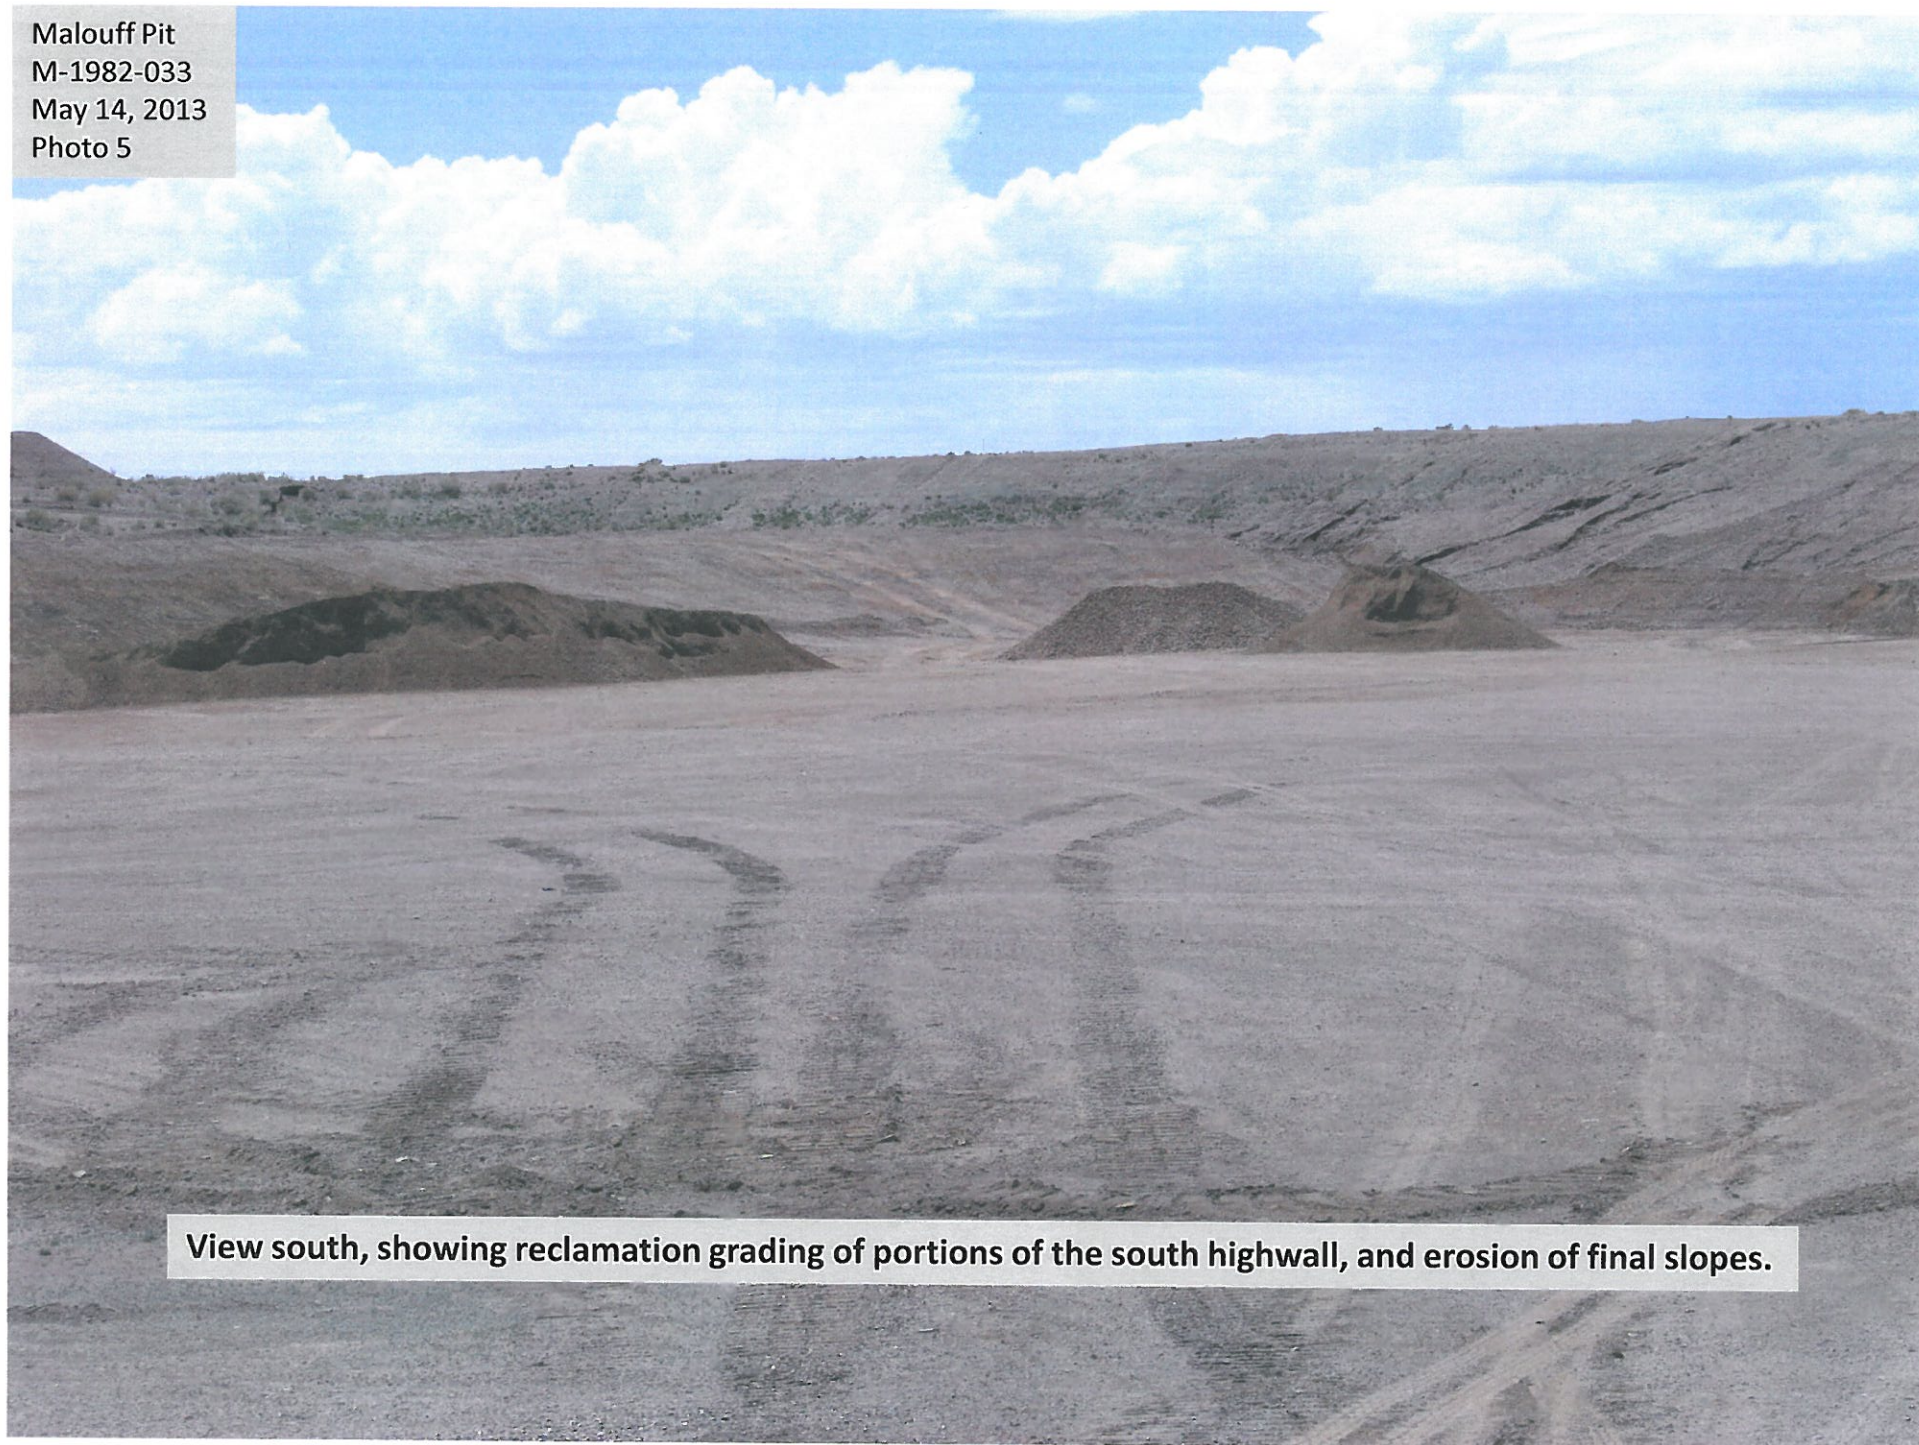
Malouff Pit
M-1982-033
May 14, 2013
Photo 5

According to the approved reclamation plan, the pit floor will be graded flat and stabilized with a gravel surface, and the pit slopes will be reduced to 3H:1V. The approved reclamation plan does not address topsoil replacement and/or the establishment of a protective vegetative cover for any portion of the reclaimed areas. As shown in the photos, the reclaimed slopes exhibit evidence of erosion, partly due to the absence of a stabilizing vegetative cover. The bare slopes are vulnerable to invasion by undesirable weed species, including regulated noxious weeds.

View south, showing reclamation grading of portions of the south highwall, and erosion of final slopes.

Pursuant to Rules 3.1.5(3) and 3.1.6(3), the Operator is obligated to control erosion and siltation of the affected lands. Pursuant to Rule 3.1.10(8), stabilization of surfaces is required. Pursuant to Rule 6.4.5(2)(c), the reclamation plan must demonstrate how the operation will comply with the performance standards of Rule 3.1. However, the approved reclamation plan does not clarify how the 3H:1V slopes will be stabilized against erosion or protected against invasion by weeds. The approved reclamation plan appears to not address the specific requirements of Rules 3.1.5(3), 3.1.6(3), and 3.1.10(8). Therefore, the Division strongly encourages the Operator to revise the reclamation plan, through either the Technical Revision process described under Rule 1.9, or the Amendment process described under Rule 1.10, to address the long-term stabilization of the 3H:1V slopes. This request for a revision to the permit to address reclamation of the 3H:1V slopes is repeated from the inspection report generated from the site-inspection occurring March 31, 2009, signed June 13, 2009.

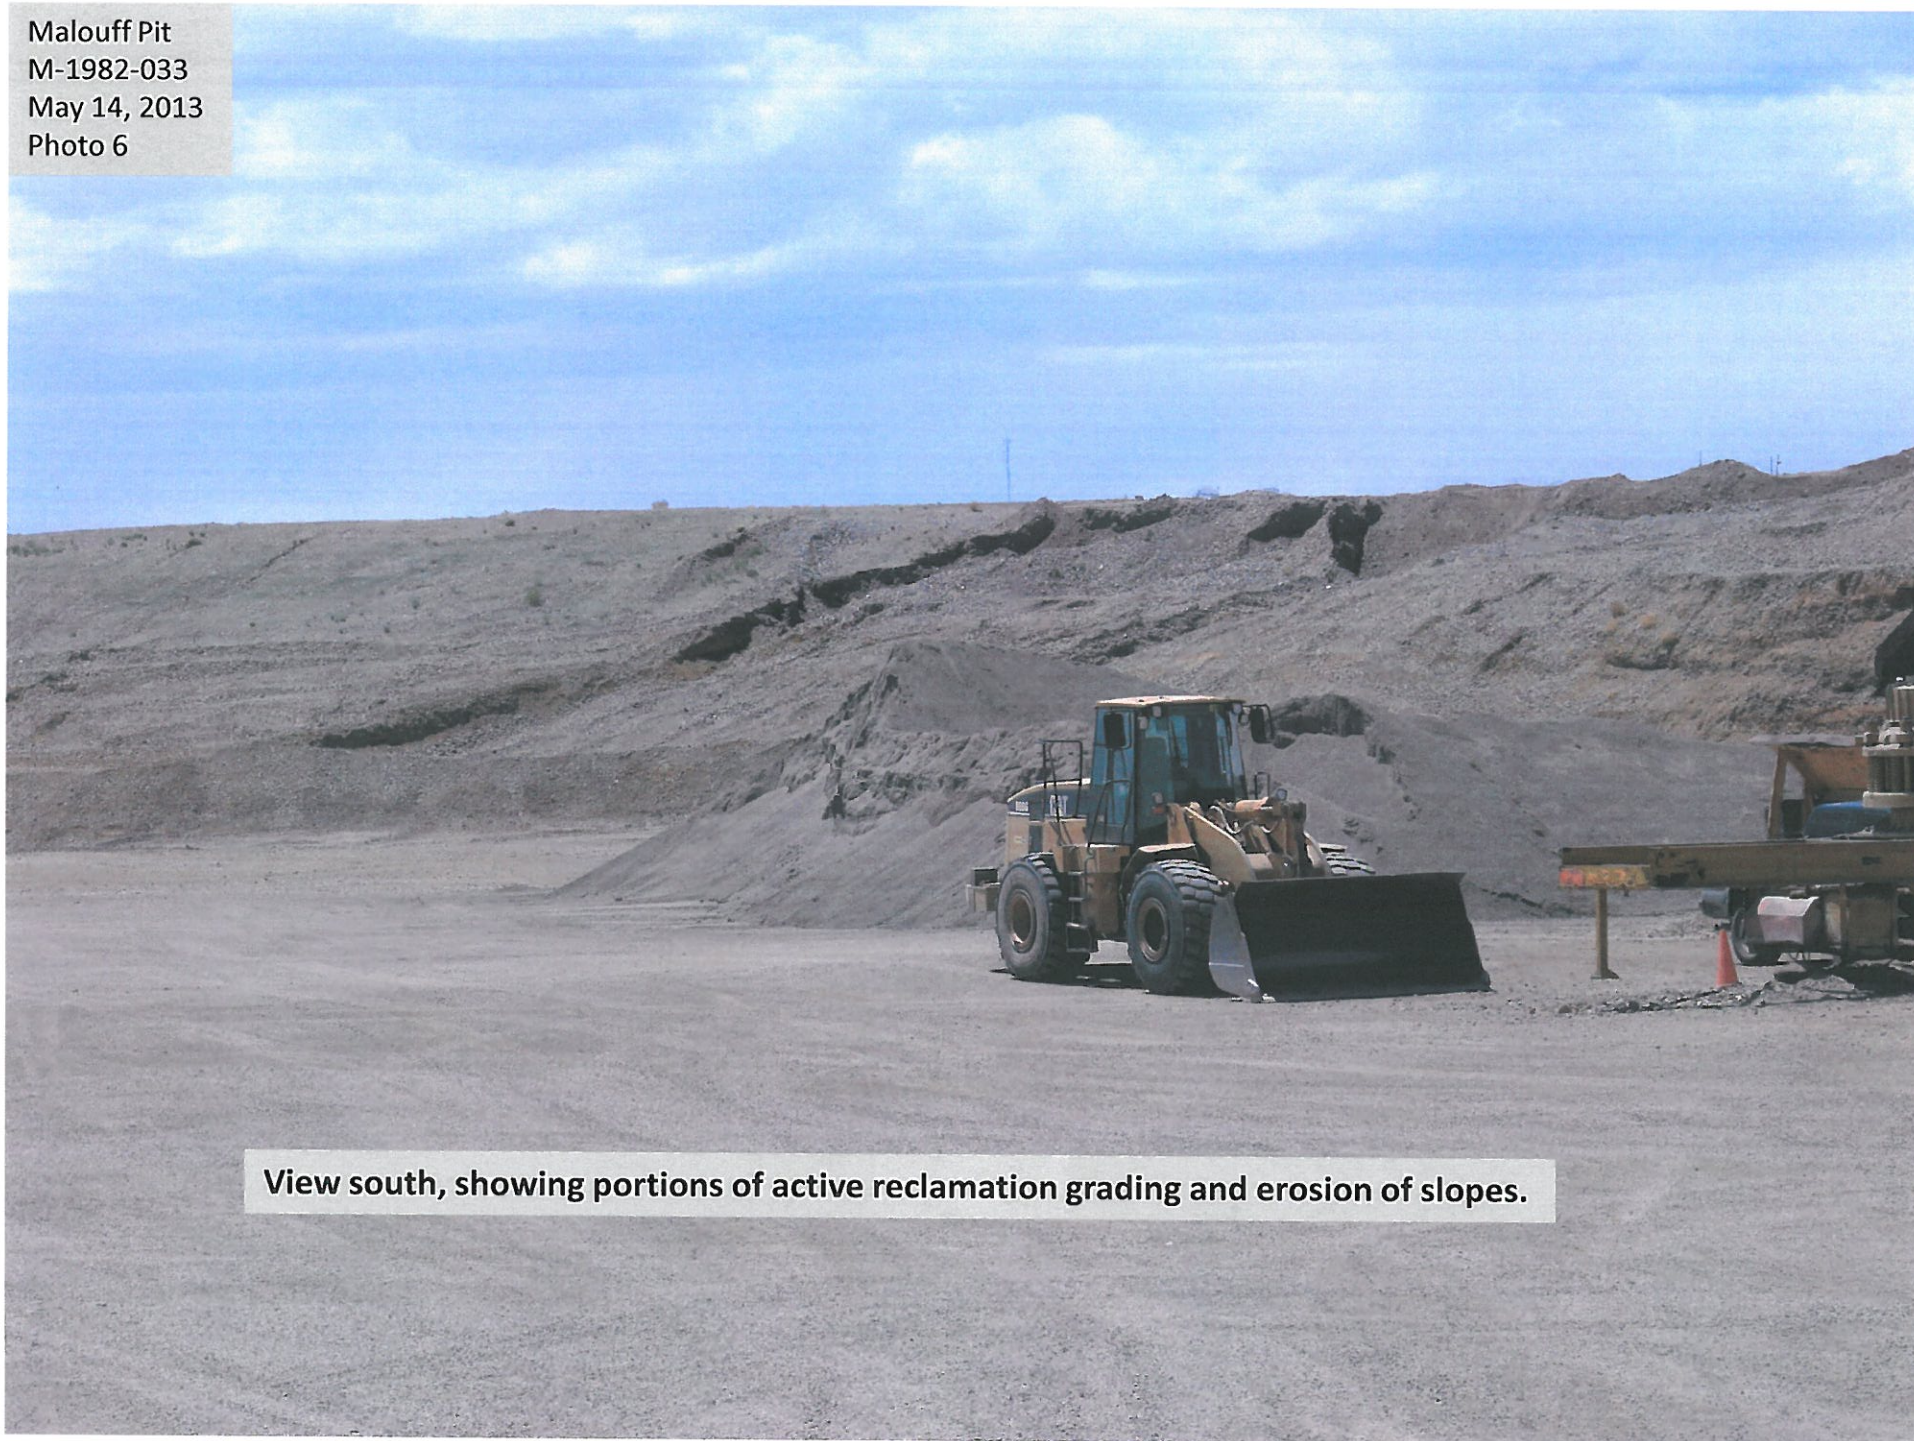
Malouff Pit
M-1982-033
May 14, 2013
Photo 6

View south, showing portions of active reclamation grading and erosion of slopes.
