COLORADO DIVISION OF RECLAMATION, MINING AND SAFETY COAL PROGRAM INSPECTION REPORT

Permit Number: C-1981-008 Mine Name: New Horizon Mine Operator: Western Fuels-Colorado, LLC Operator Address: Mr. Ross L Gubka, P.E. P.O. Box 628 Nucla, CO 81424	County: Montrose Operation Type: Surface Permit Status: Active Ownership: Private Operator Representative Present: Ross Gubka
Operator Representative Signature: (Field Issuance Only) This report was issued electronically from the Division's Durango Field Office.

Inspection Start Date: August 22, 2013 Inspection Start Time: 08:30 Inspection End Date: August 22, 2013 Inspection End Time: 15:00		Inspection Type: Coal Partial Inspection Inspection Reason: Normal I&E Program Weather: Clear	
Joint Inspection Agency: None		Joint Inspection Contacts:	
Post Inspection Agency: None		Post Inspection Contacts:	
Inspector(s): Marcia L. Talvitie, P.E.	Inspector's Signature:

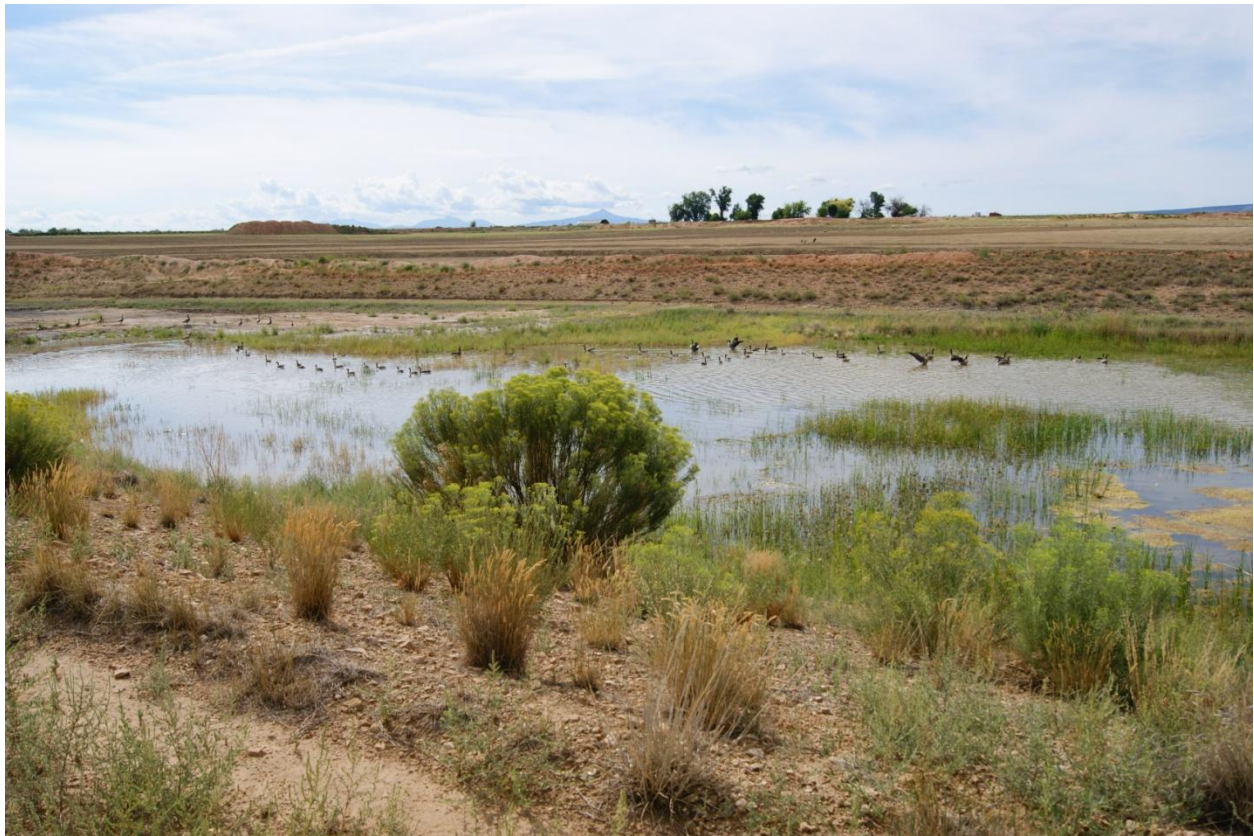
- A few ducks and grebes were spotted on Pond 007, and a number of Canada geese were enjoying the puddle that covered much of the bottom of Pond 011 (Photo 1).

Photo 1 – Canada geese at Pond 011, looking SE

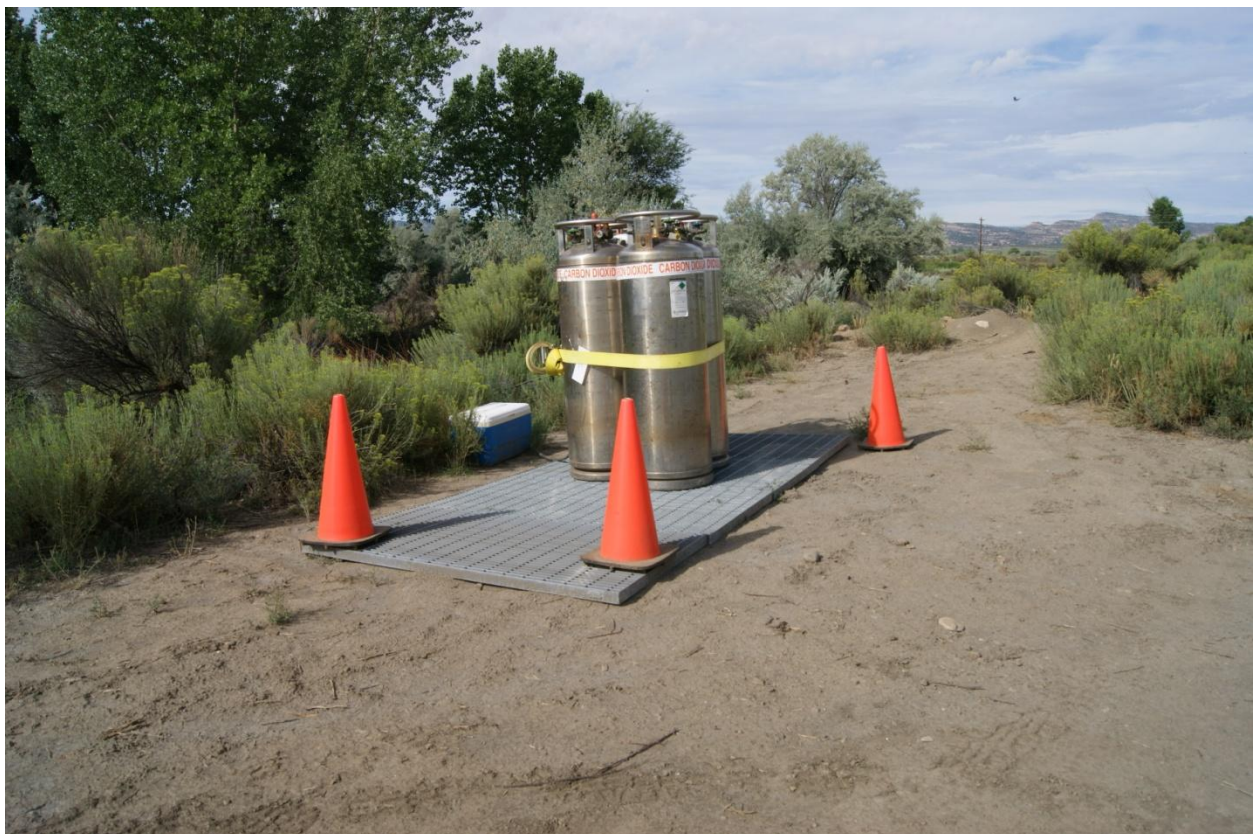
- Pond 007 was full and discharging. This summer, the operator has begun aerating the pond with Carbon Dioxide (CO₂) just upstream of the discharge, to mitigate any potential issues with elevated pH levels. A cluster of four large canisters were stationed above the discharge pool (Photo 2), and a slender nylon tube carried the gas down to the pool, where it could be seen bubbling (Photo 3). Mr. Gubka said the canisters are supplied from a firm in Grand Junction, and are typically replaced every week.

Photo 2 – CO2 canisters at Pond 007

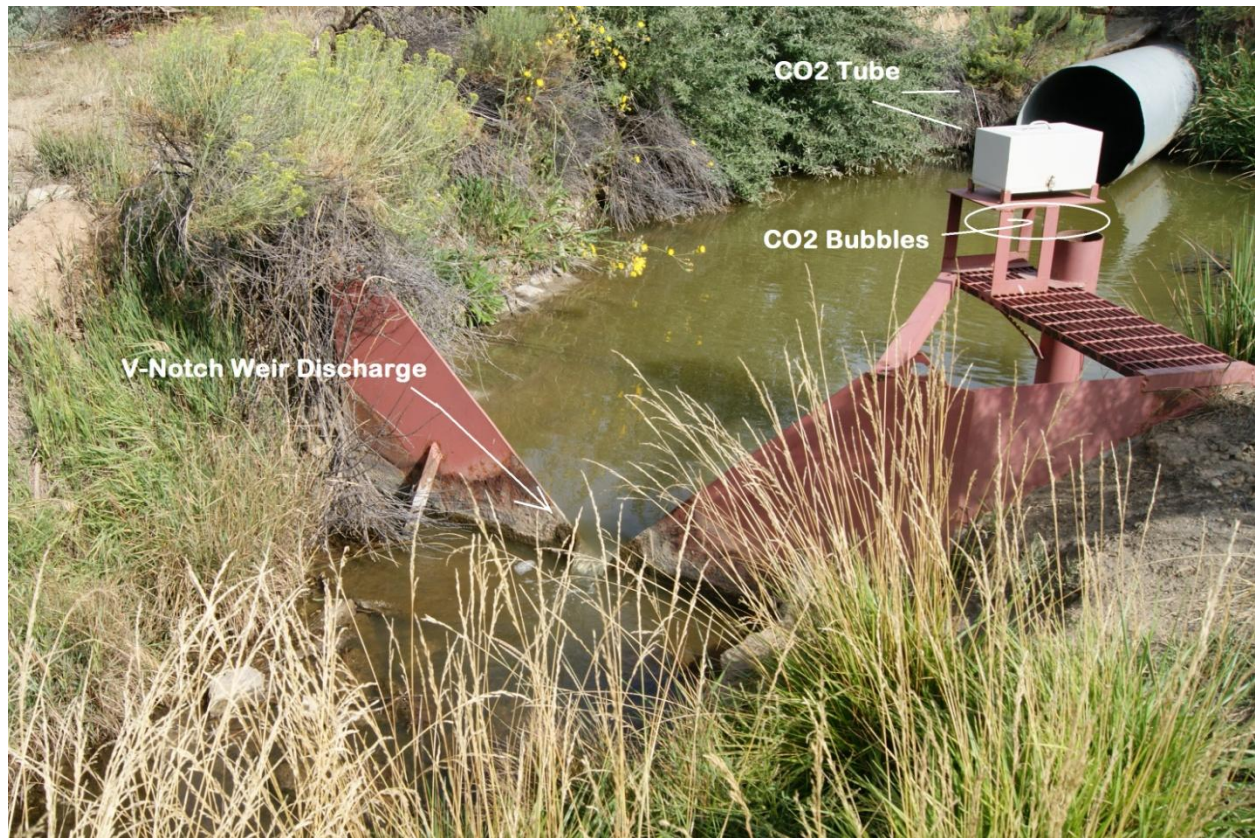
Photo 3 – Pond 007 discharge pool

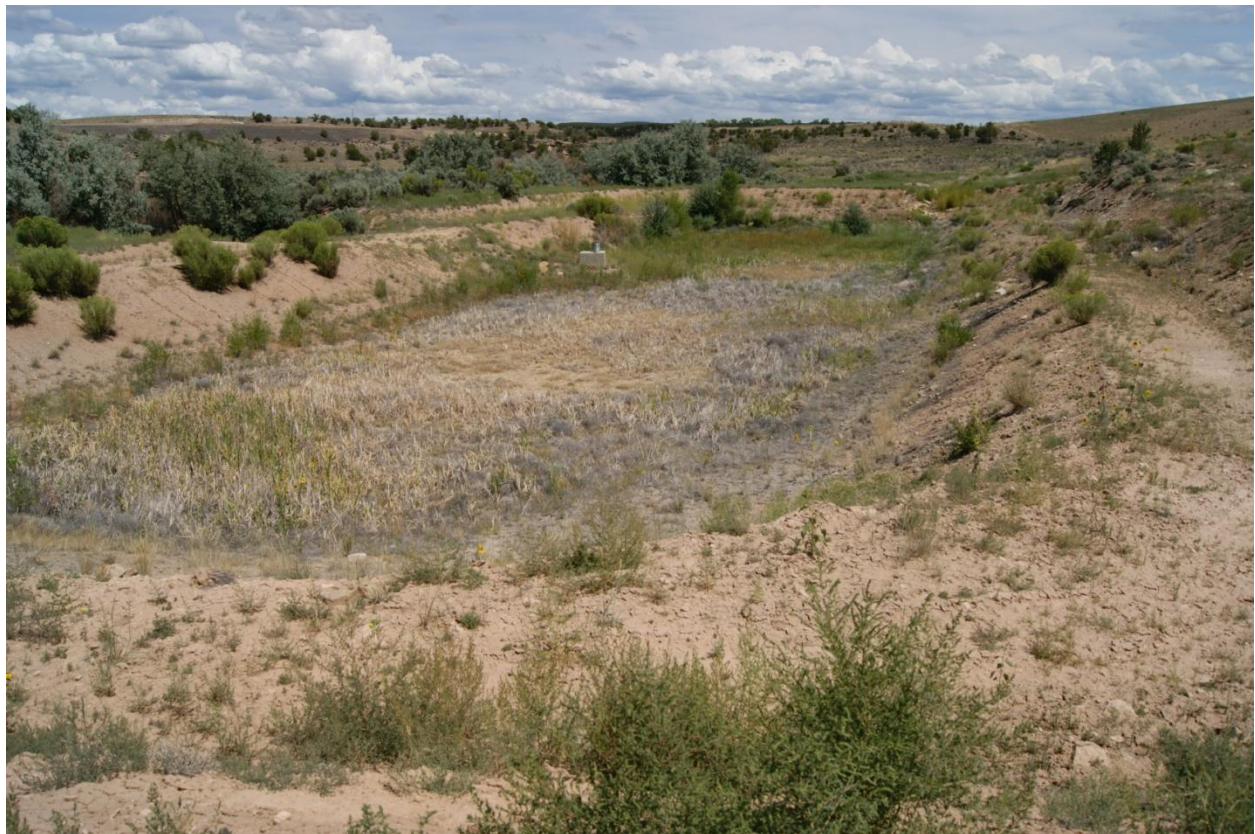
- Pond 009 was completely dry, as was Pond 015. Pond 012, which historically has had a shallow puddle at its western end, fed by seepage from Tuttle Draw, was bone dry (Photo 4). Cattails and other water-loving plants were no longer thriving.

Photo 4 – Pond 012, looking ENE

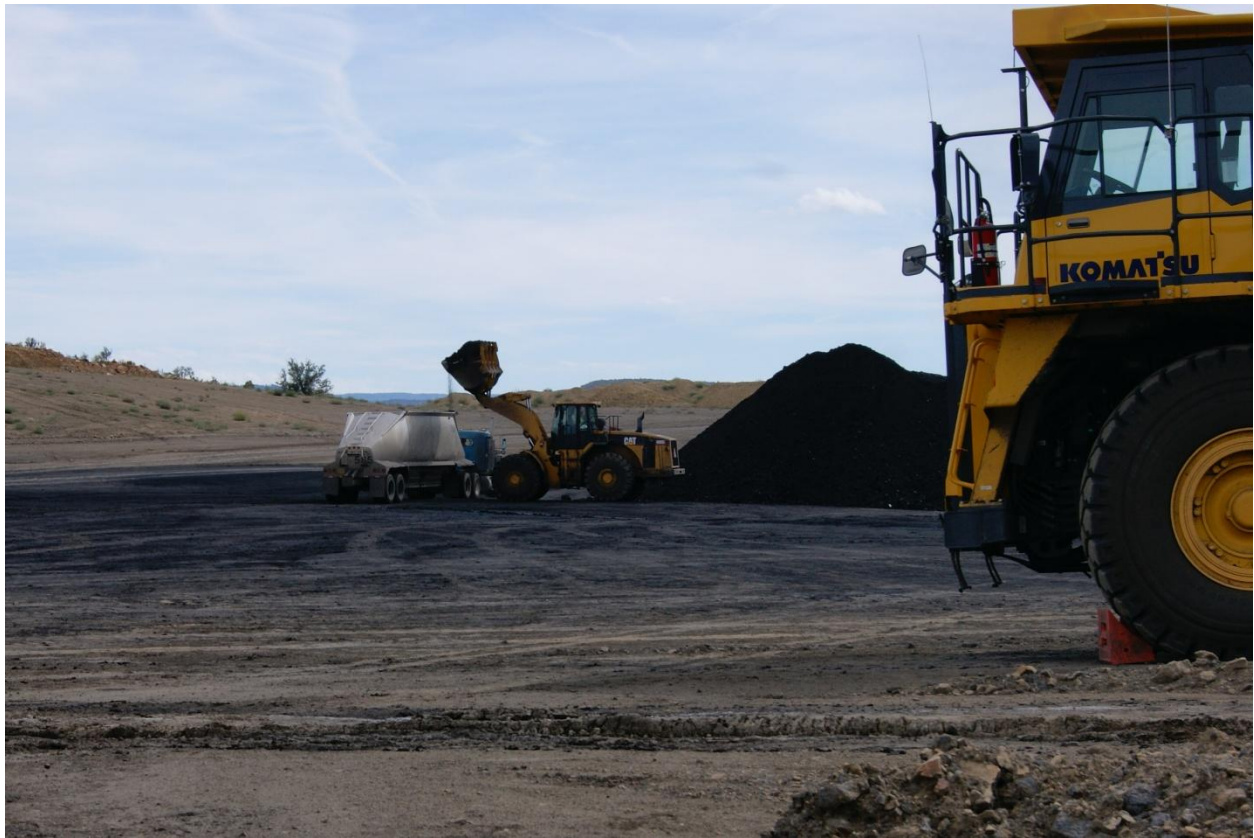
- On the WFC parcel in the NW corner of the permit area, a bulldozer and front-end loader were working to load highway haul trucks with the remaining coal for transport to Tri-State's Nucla Generating Station (Photo 5). Mr. Gubka said the coal hauling operation would be completed by the end of August.
- A pump was in operation, dewatering what remains of the "pit" and preventing the coal stockpile area from being flooded. The flow meter on the pump's line read 500 gpm. The water was being directed to Pond 013.

Photo 5 – Loading coal into highway haul truck

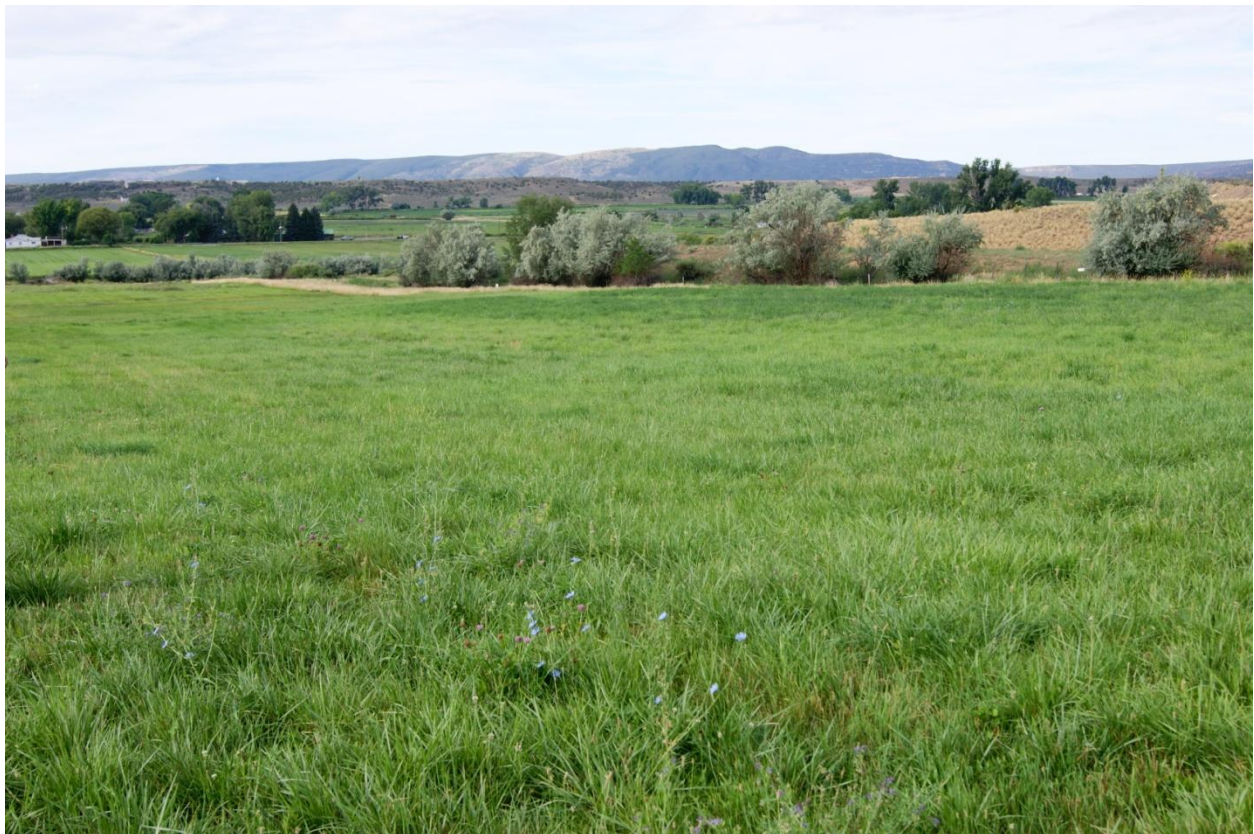
- Overall, the IP Reference Area was in beautiful condition (Photo 6). Mr. Gubka said the area had been receiving regular afternoon thundershowers in recent weeks, which were having a positive effect on vegetation growth.

Photo 6 – IP Reference Area, looking SW

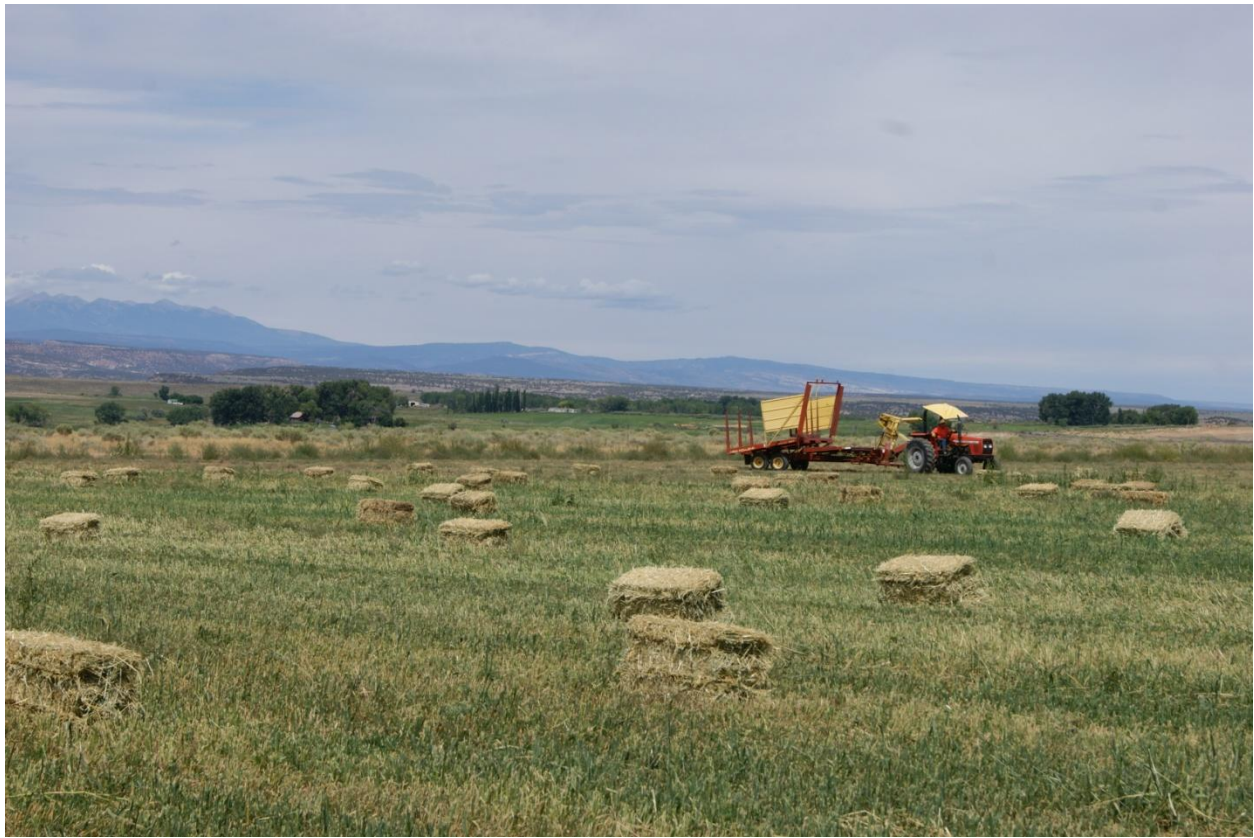
- West of 2700 Road, two separate IP areas have been established. Irrigation is accomplished using a system of gated pipe and furrows.
- For Benson-West, bales from the first (ever) cutting were on the ground and in the process of being collected by the contract farmer (Photo 7).

Photo 7 – Collecting bales on Benson-West, looking NW

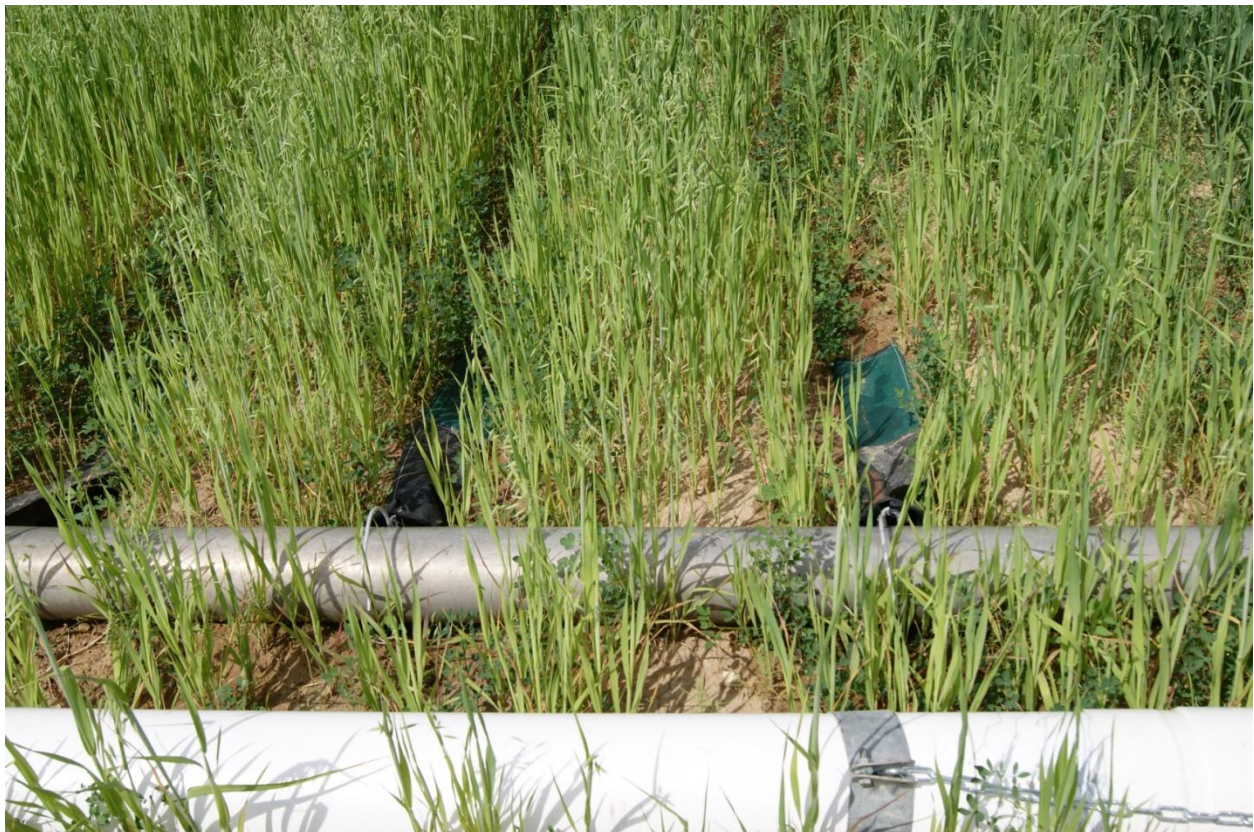
- On the former Lloyd property, irrigation was occurring for the first time. A flow meter installed on the pipe supplying the field gave a rate of 250 gpm being supplied to the field. Protective sleeves were installed at each one of the pipe gates to protect the soil from erosion (Photo 8). The field was lush in appearance (Photo 9), with oats and some alfalfa.

Photo 8 – Gated pipe, with protective sleeves in furrows

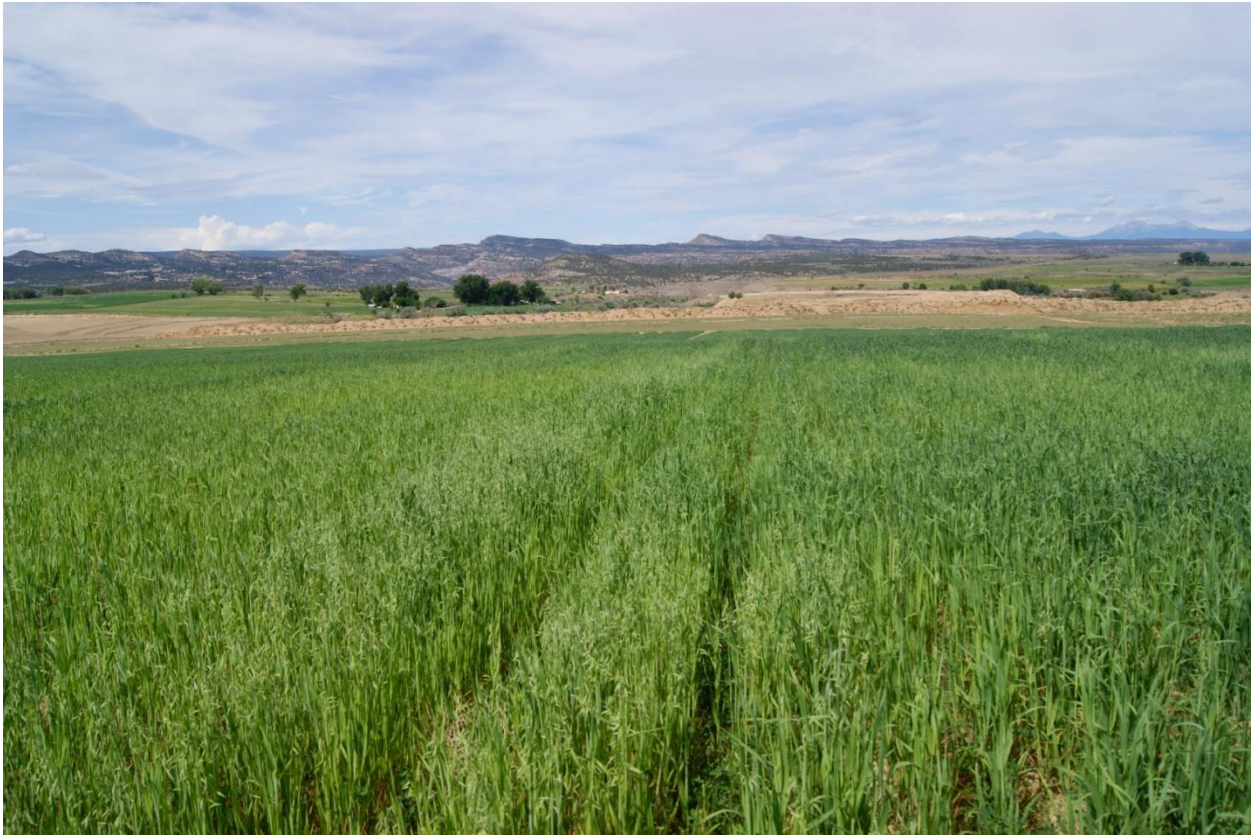
Photo 9 – IP on former Lloyd parcel – first season of irrigation, looking West

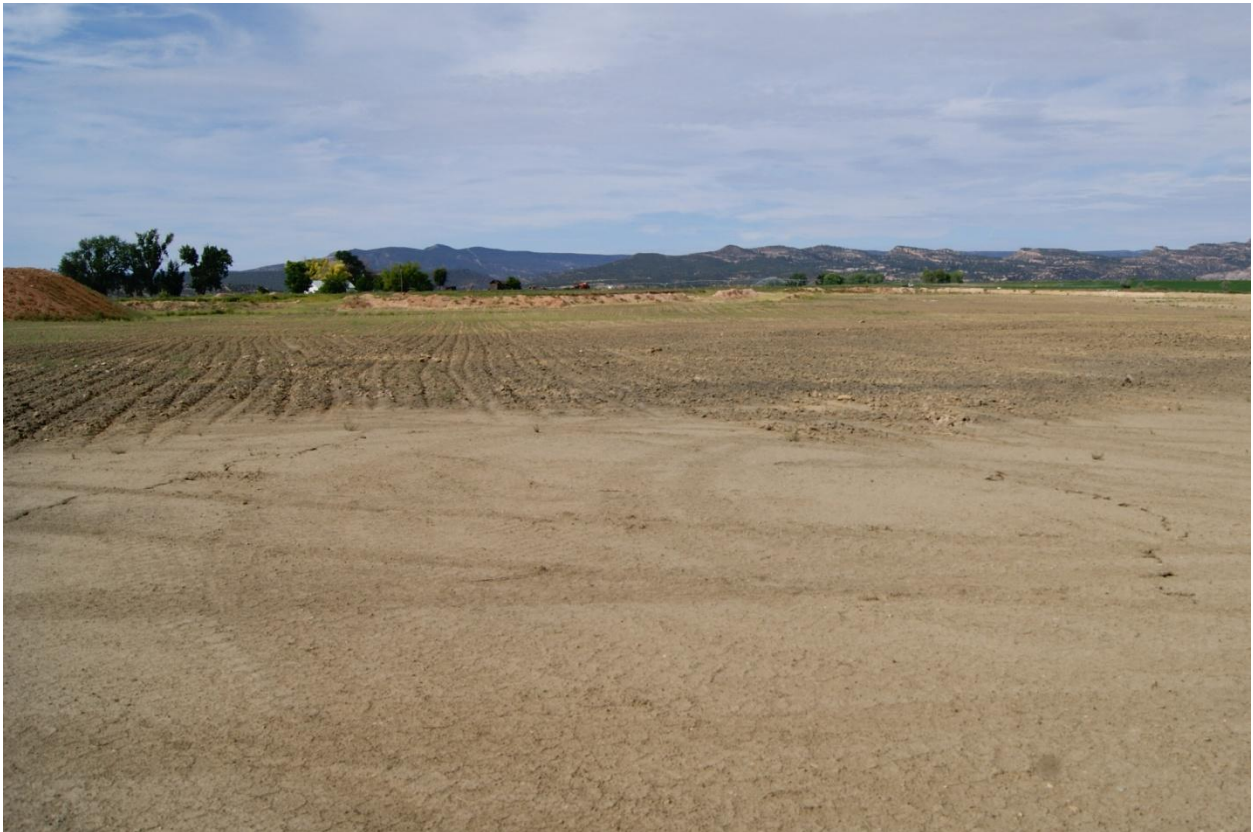
- Much of the area covered with Bench 1 Surface Spoil has been surface-roughened (Photo 10) using a motor grader. Mr. Gubka said this aided greatly in controlling runoff from this area during the recent rain events. This roughening should also serve to increase infiltration of water into the surface spoil.
- The Lift A, Lift B, and Mixed topsoil stockpiles have not been disturbed. It is anticipated that no further reclamation of the Morgan property be initiated until PR-08 is approved.

Photo 10 – Surface roughening on Morgan spoil, looking SW
