# Tarryall Creek Ranch 2009 Riparian Restoration Project

*Project summary and initial monitoring results*

*Mark Beardsley, M.S. EcoMetrics LLC October 16, 2009*

# Tarryall Creek Ranch Riparian Restoration Project 2009 Phase 1

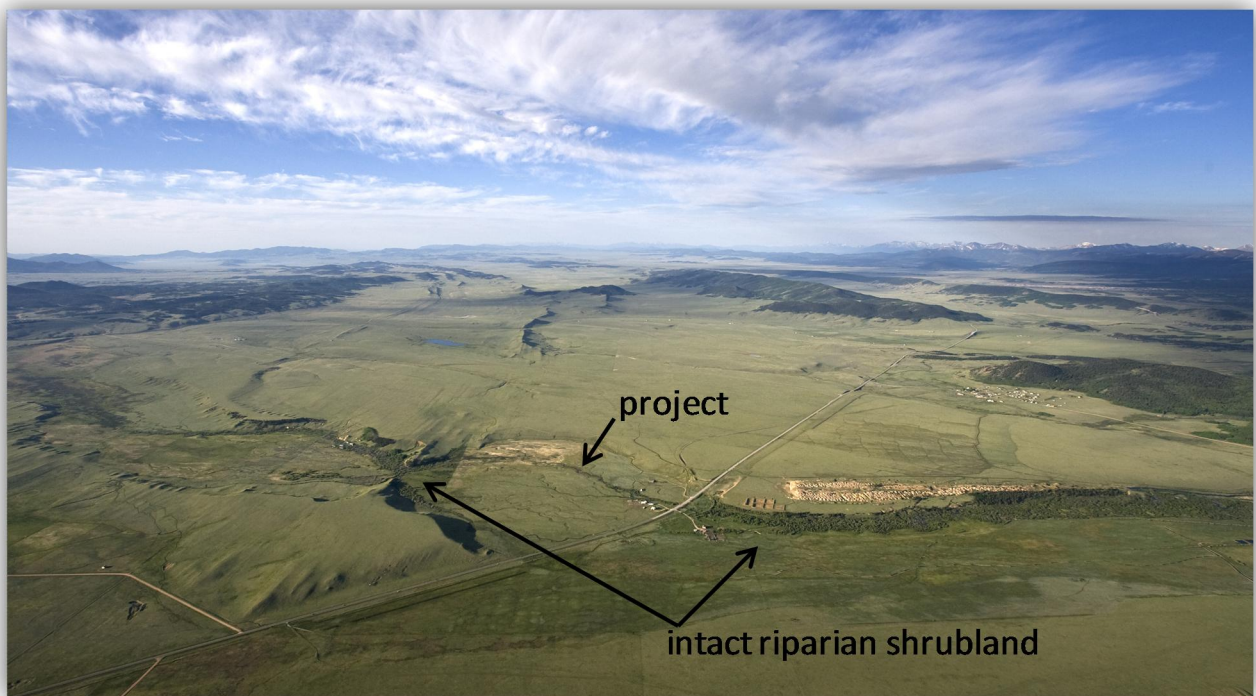
**Figure 1: Project area seen from the north. If successful, the project will fill the gap between the intact riparian shrublands seen upstream and downstream to restore an uninterrupted wetland habitat corridor from the headwaters of Tarryall Creek into the heart of South Park. Note the fence line contrast at the downstream end of the project (near the left arrowhead) formed by harmful land management above and better management below. The first order of business in restoring the project area is to protect it with favorable management.**

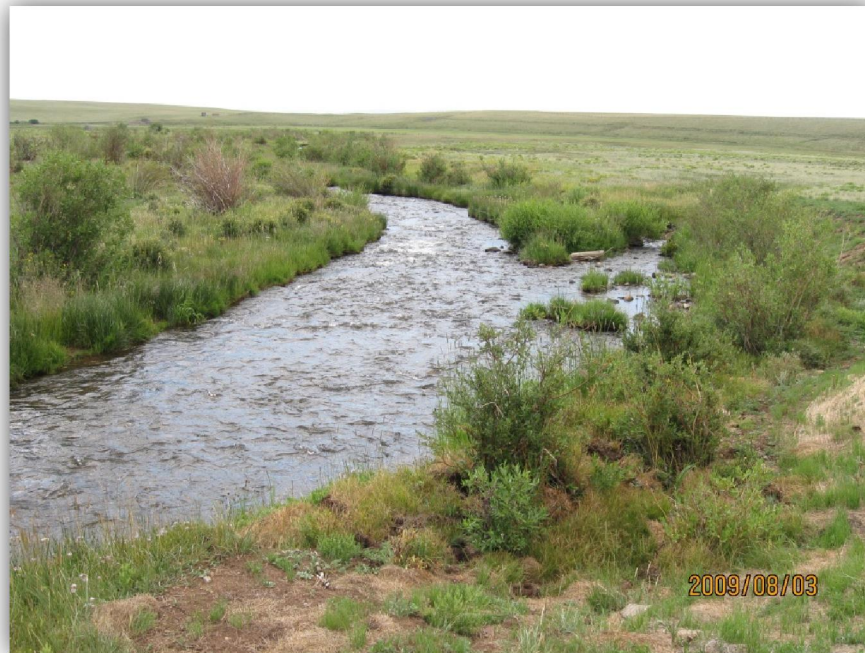
Figure 2: Channel shaping and bank toe treatments were completed in phase 2. The bank toes are constructed of streambed gravel and cobble that can be moved by the stream within a few seasons of high flow. They serve as protection for the banks while planted sod and willows take hold. The channel was gently reshaped to enhance the thalweg, to make the channel deeper and narrower at low flow, and to create pool area. Only native bed materials were used, so the channel is still free to readjust and adapt naturally.

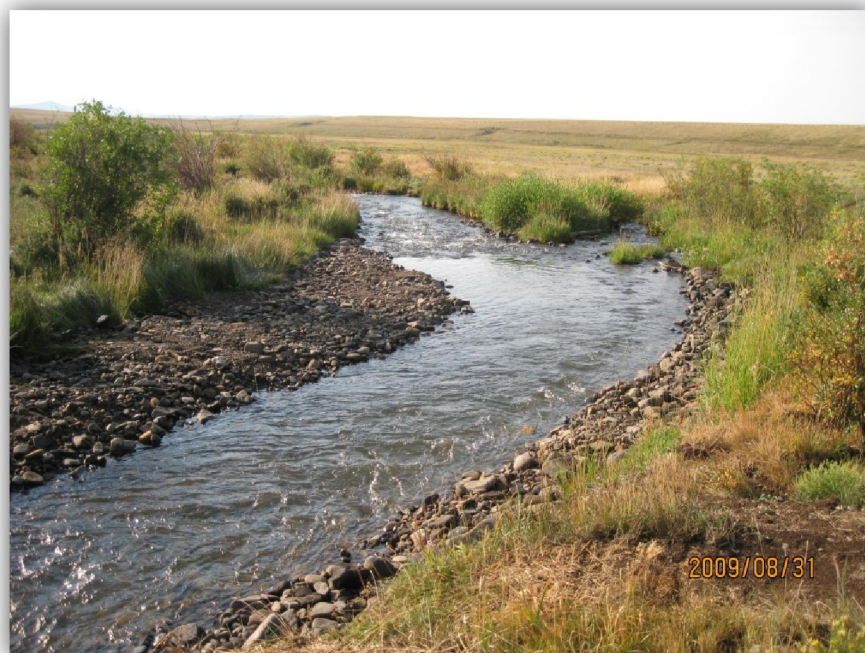
Figure 3: A new bench was created on this rapidly eroding bank during phase 2. The bench was planted with willows and wetland sod, and the channel was realigned to decrease near-bank stress. The bank will eventually continue to erode, but at a slower natural rate now that the appropriate vegetation will be in place.

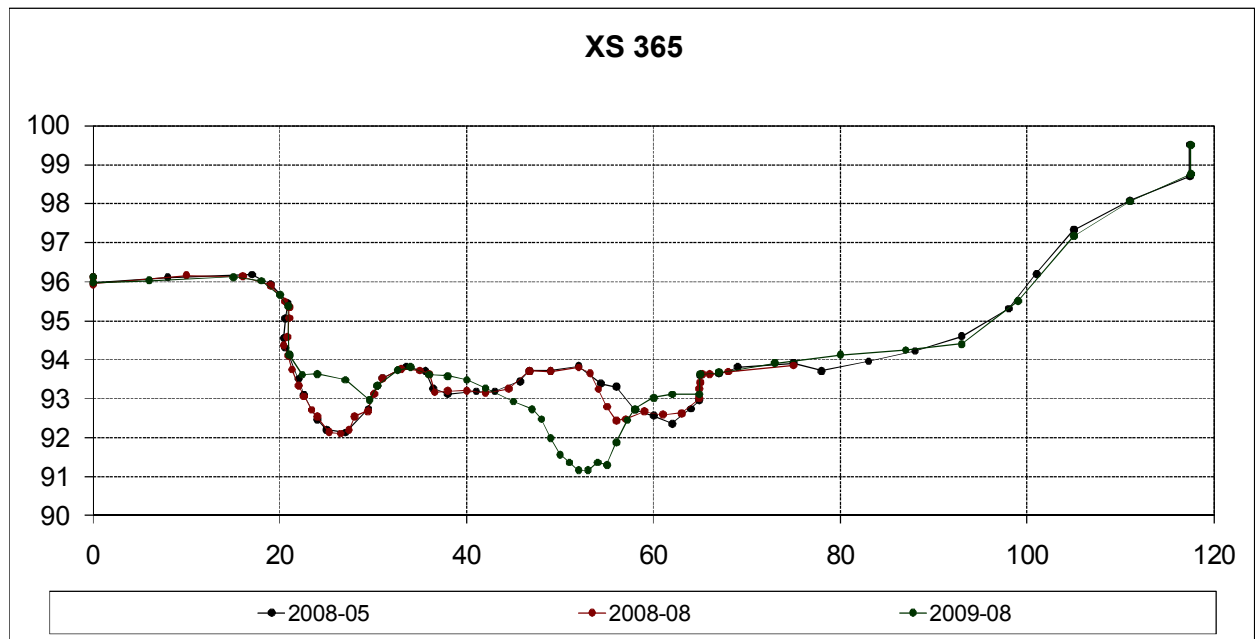
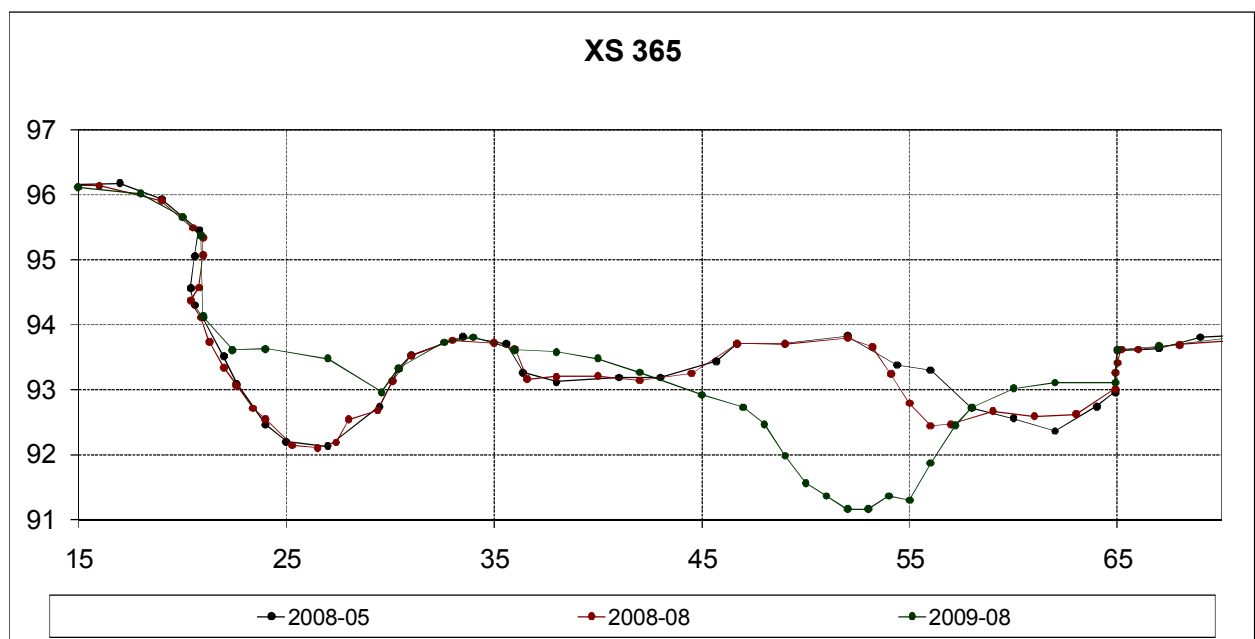
Figure 4: Cross section surveys from XS 365, with axes units in feet. Surveys from May 2008, Aug 2008 and Aug 2009 are overlaid so that changes to dimension can easily be seen. The changes from May to Aug 2008 are channel adjustments from erosion, scour and deposition during runoff. The Aug 2009 survey shows changes that were made during treatment in phase 2. A mid-channel bar was removed and pool formed between 43 and 58. A bench was constructed and planted between 21 and 43, and a mid-flow berm 58 and 65. Annual surveys of all the cross sections will be made to monitor natural response of the channel.

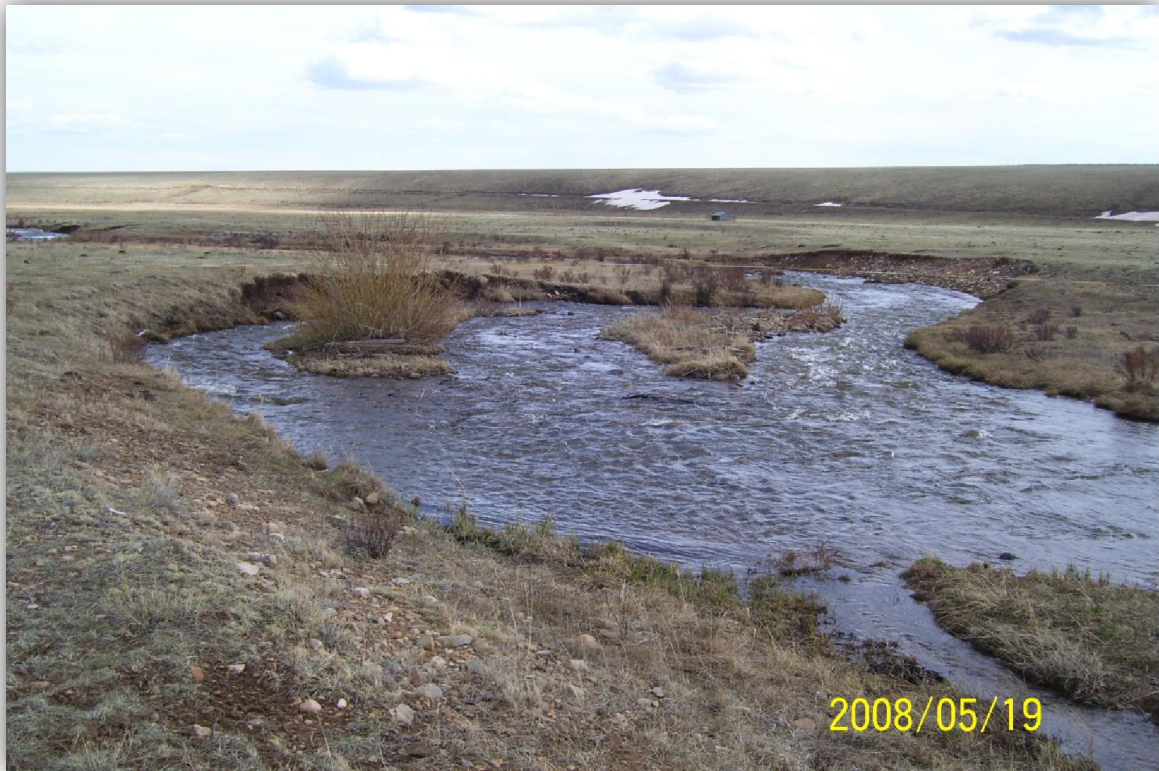
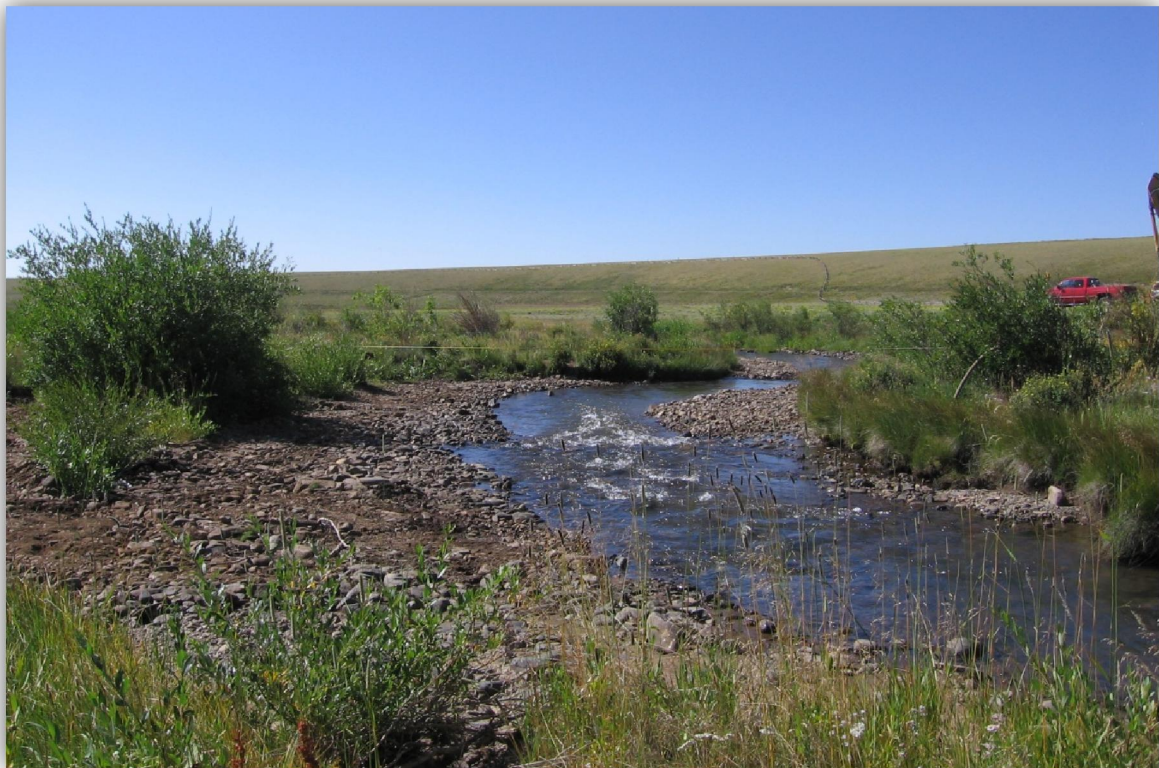
Figure 5: Before and after photos of the treatments on XS 365 (described in the phase 1 report as "bench 0280").

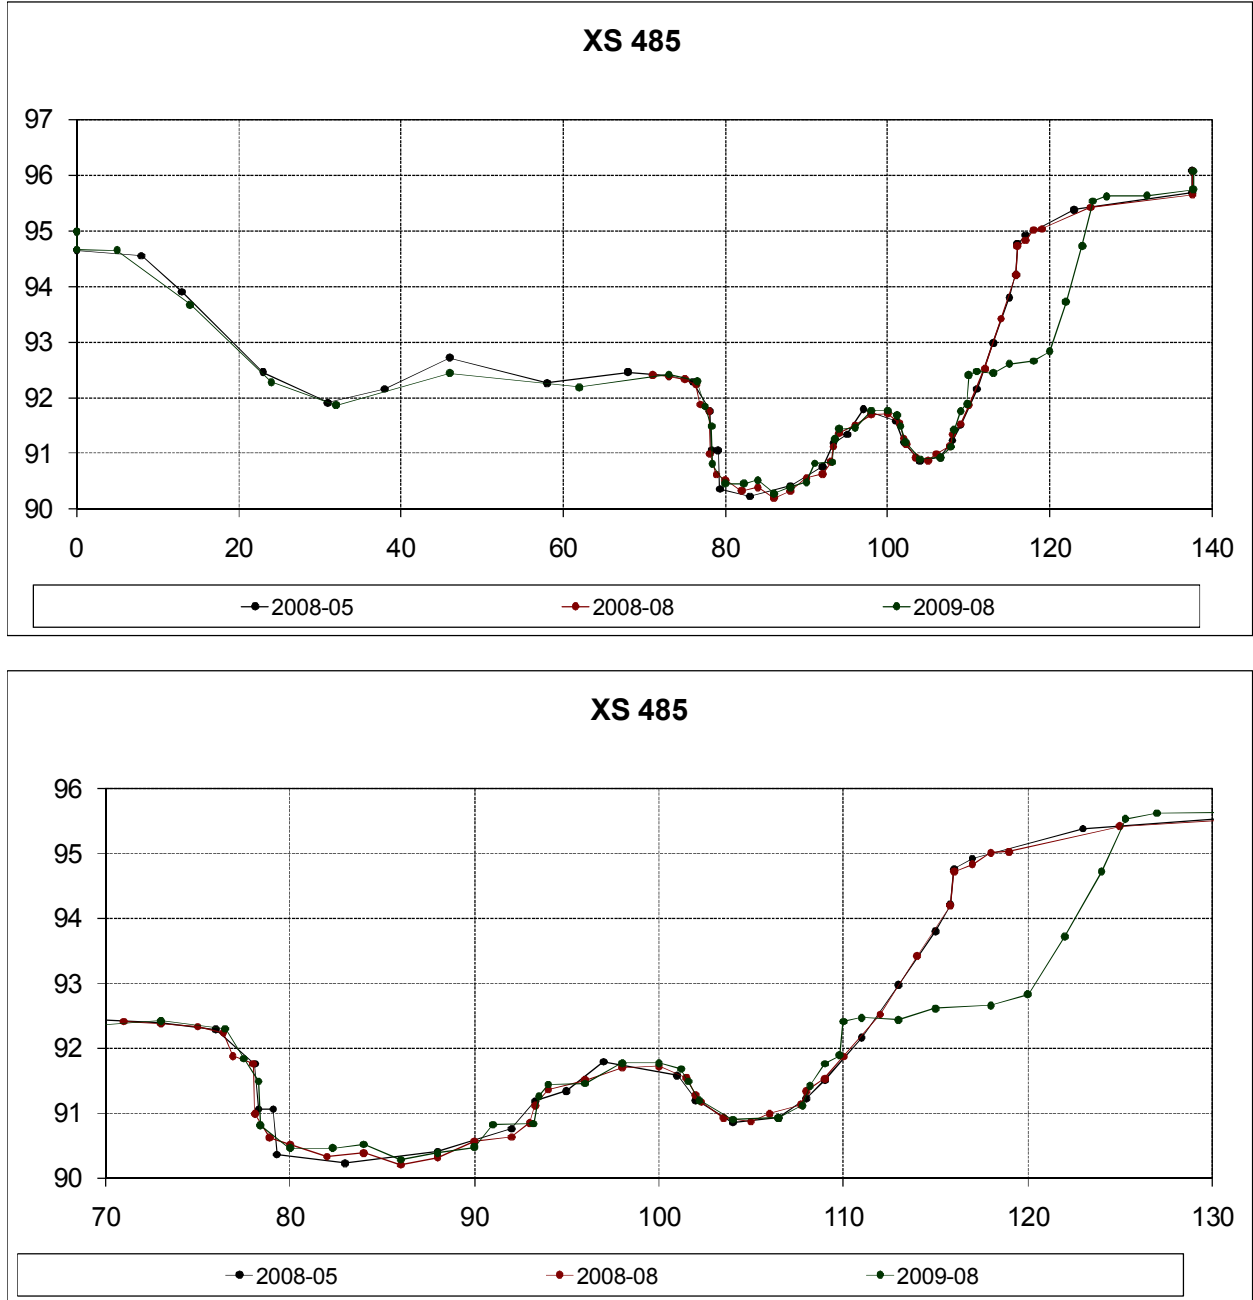
Figure 6: Cross section surveys from XS 485. The slight changes from May to Aug 2008 are channel adjustments from erosion, scour and deposition during runoff. The Aug 2009 survey shows changes that were made during treatment in phase 2. A bench was constructed and planted between 110 and 125, and channel shaping was minimal at this location.

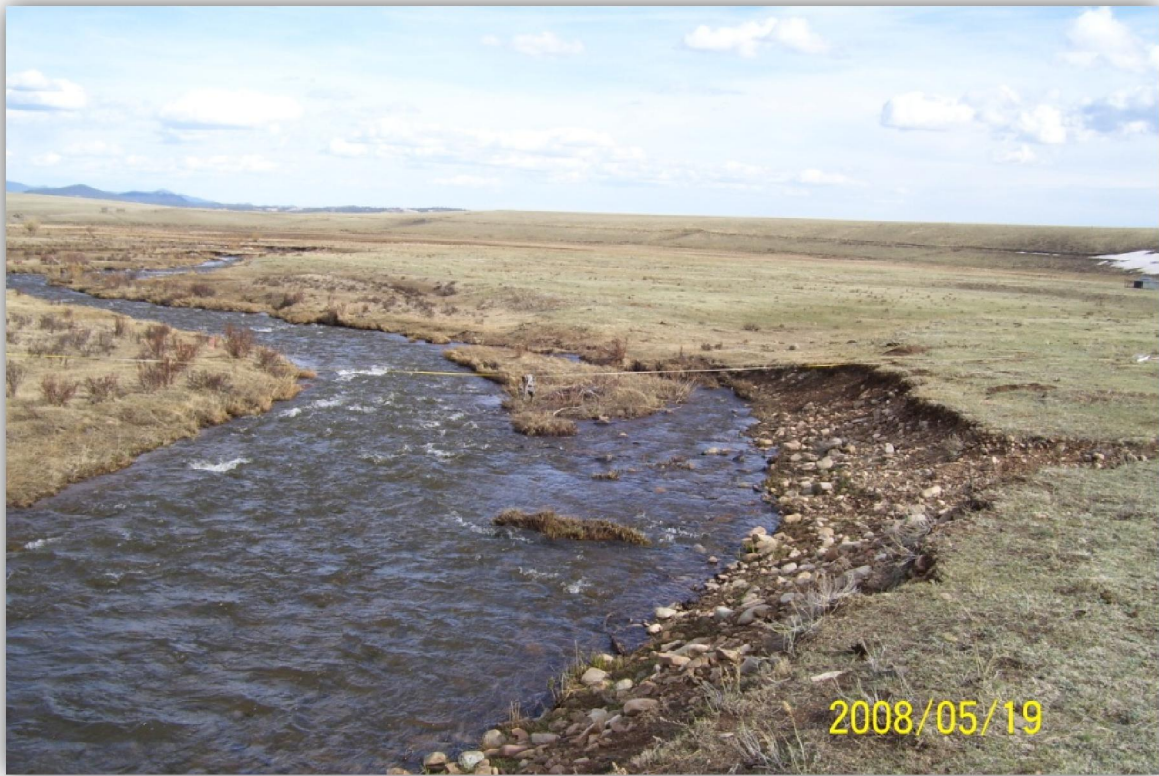
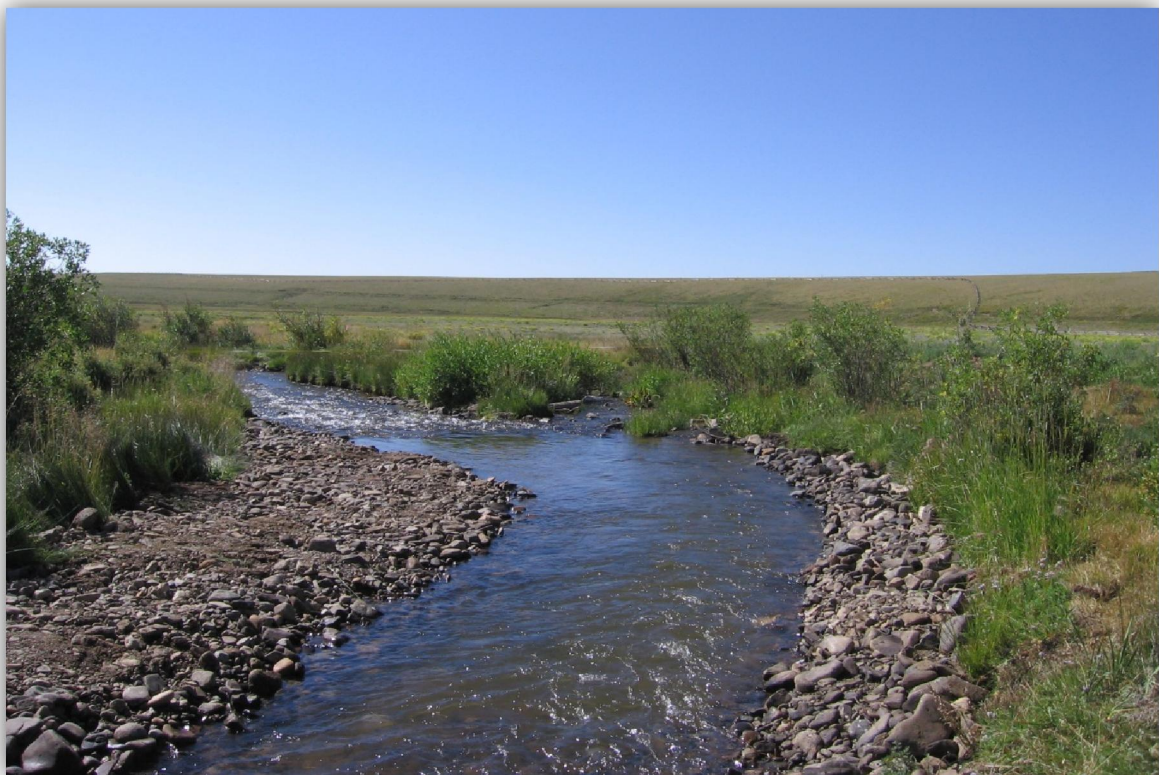
Figure 7: Before and after photos of the treatments on XS 485 (described in the phase 1 report as "bench 0340").

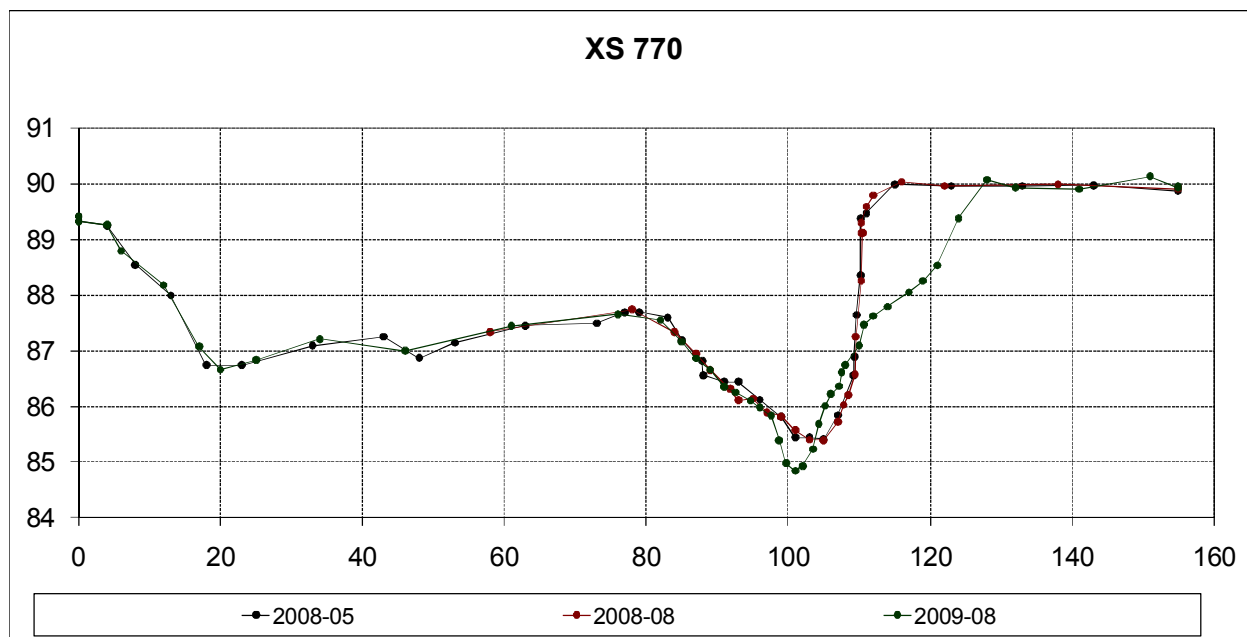
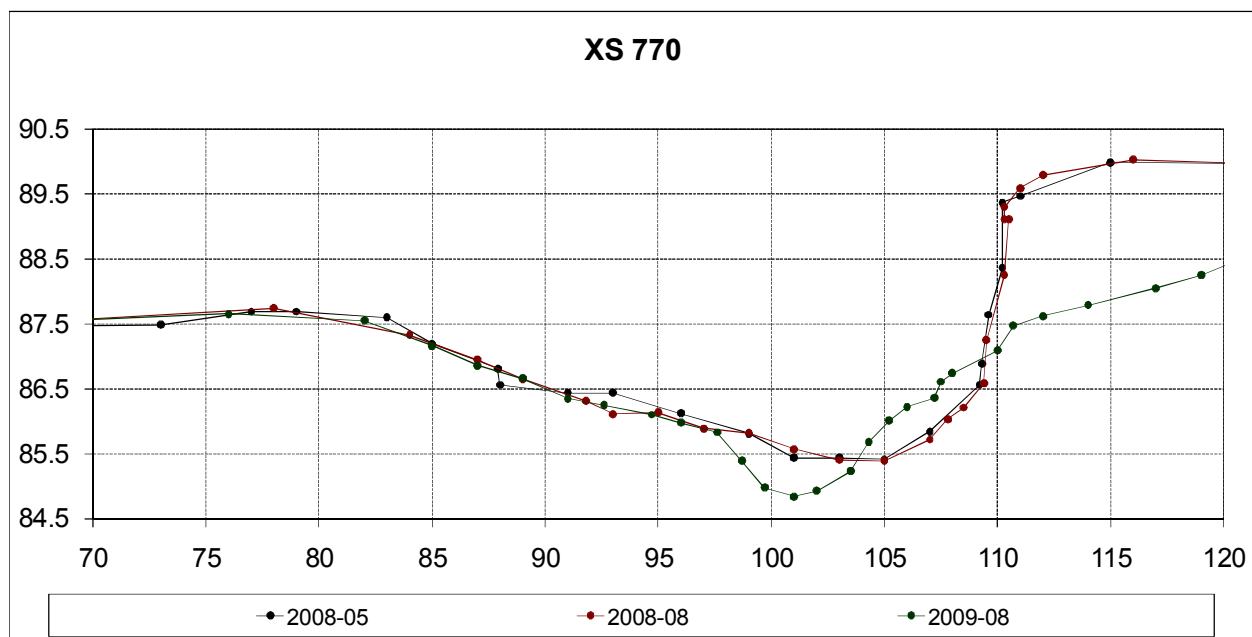
Figure 8: Cross section surveys from XS 770. The slight changes from May to Aug 2008 are channel adjustments from erosion, scour and deposition during runoff. The Aug 2009 survey shows changes that were made during treatment in phase 2. A bench was constructed and planted between 110 and 130. The thalweg was enhanced and cheated to the left to create a narrower and deeper low flow channel and to decrease near-bank stress.

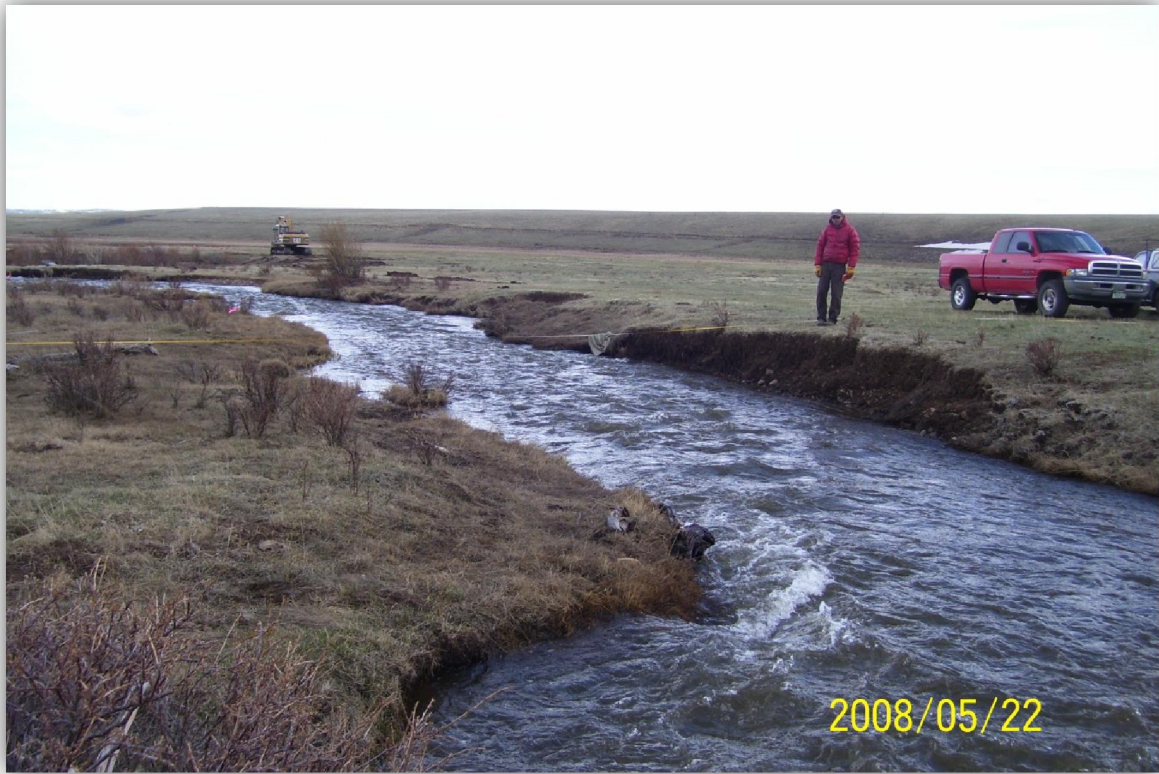
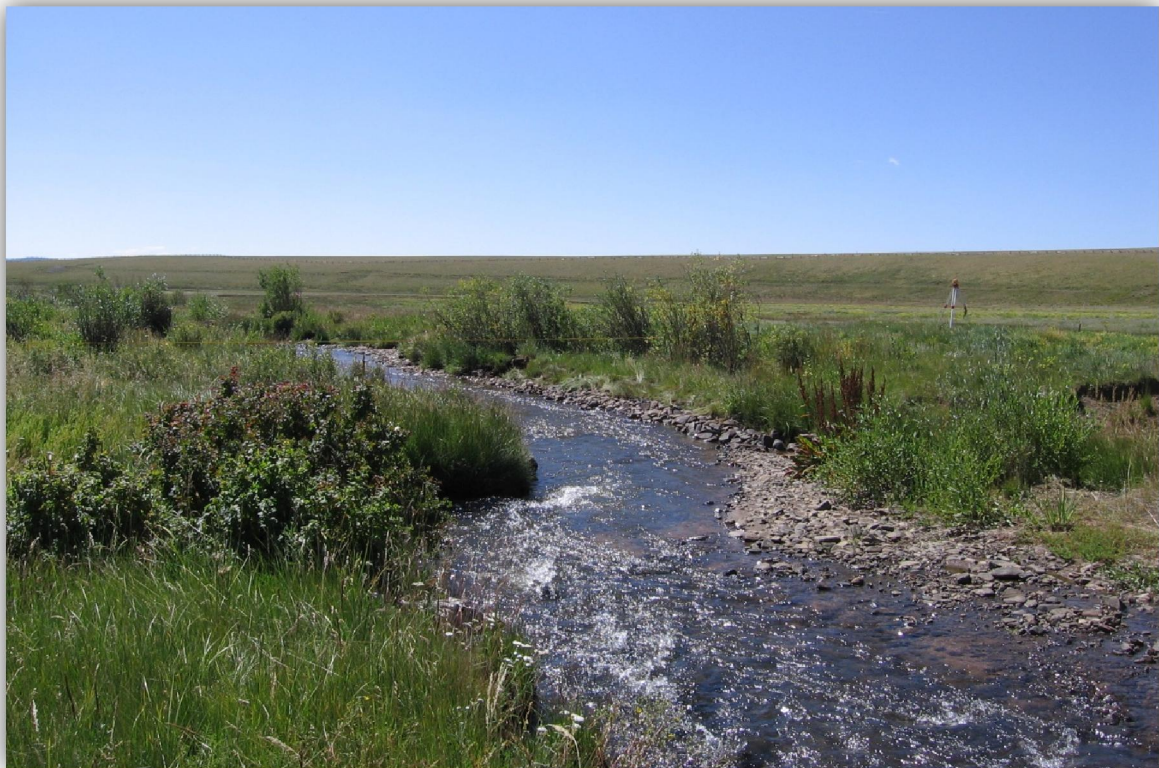
Figure 9: Before and after photos of the treatments on XS 770 (described in the phase 1 report as "bench 0650").

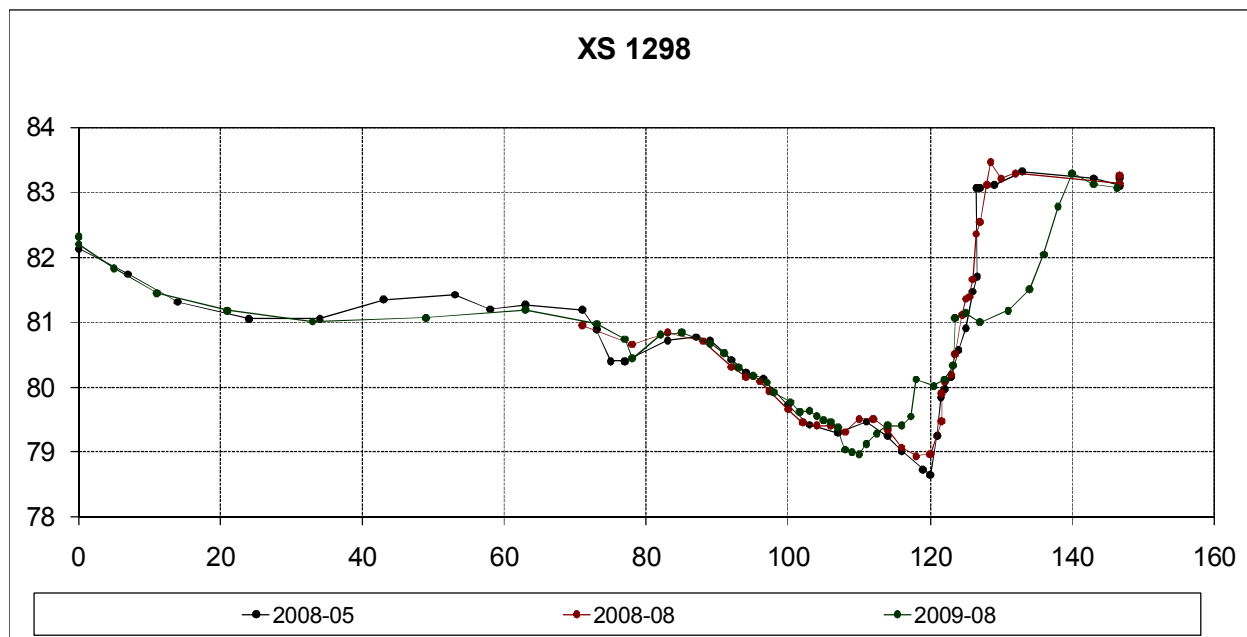
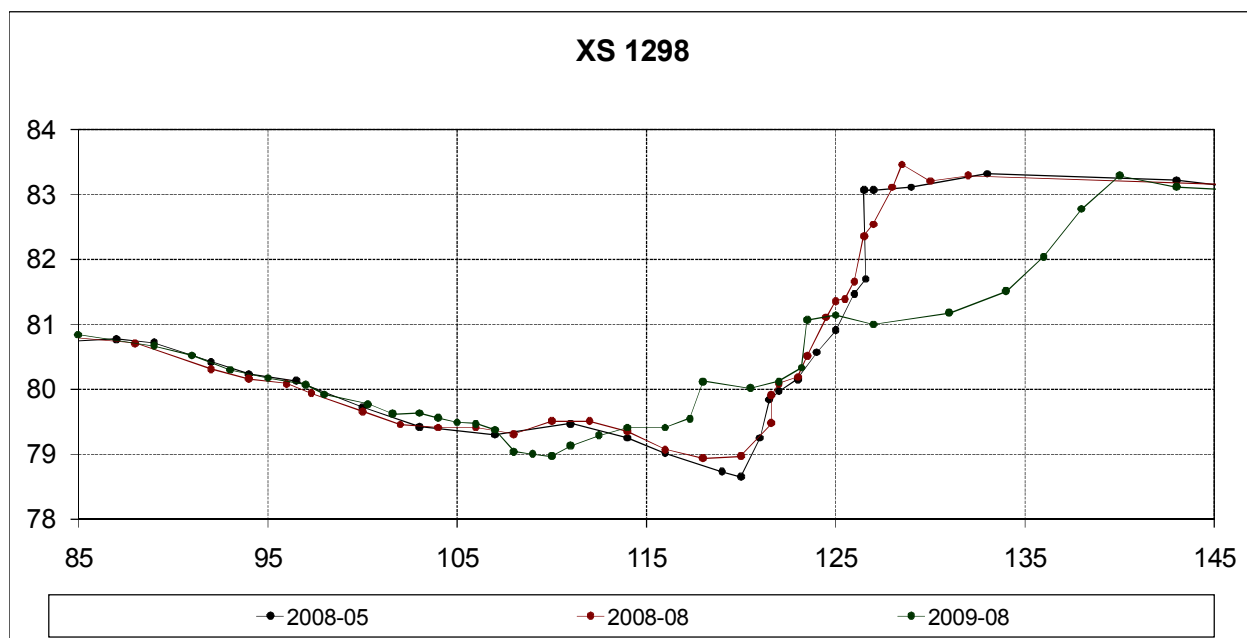
Figure 10: Cross section surveys from XS 1298. The slight changes from May to Aug 2008 are channel adjustments from erosion, scour and deposition during runoff. The Aug 2009 survey shows changes that were made during treatment in phase 2. A bench was constructed and planted between 122 and 140. The toe is between 118 and 122, and the thalweg was moved away from the bank towards the left.

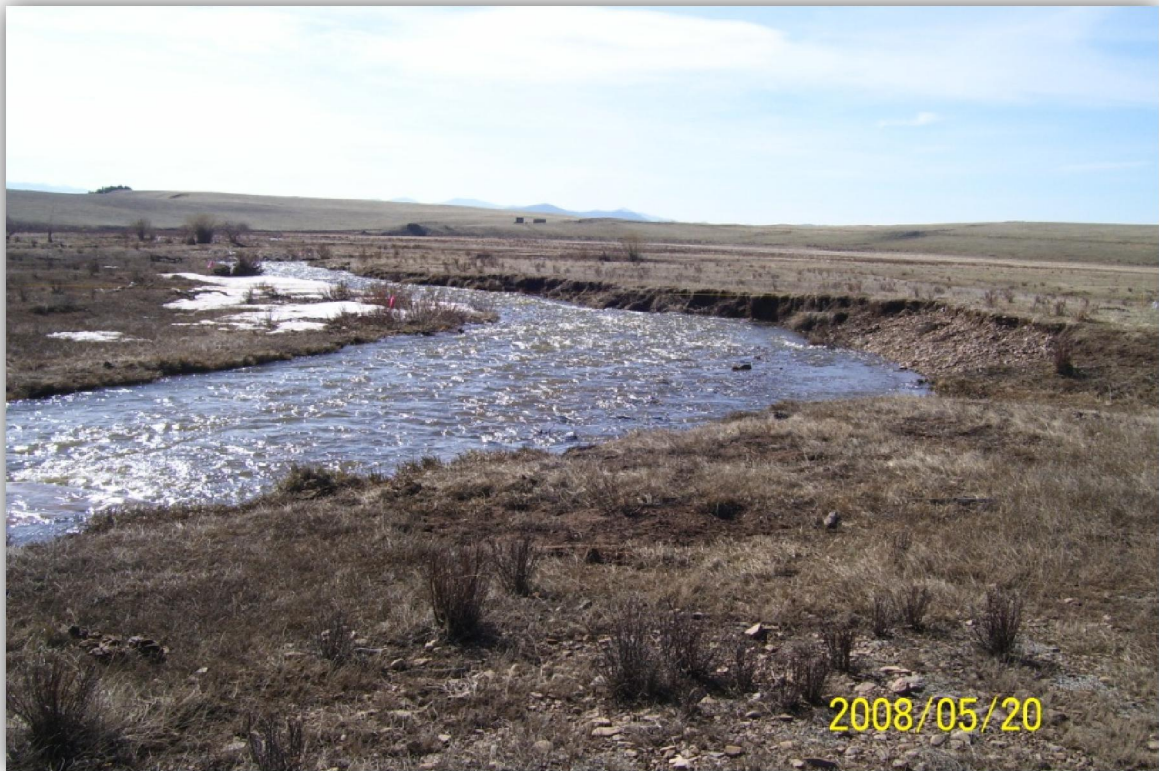
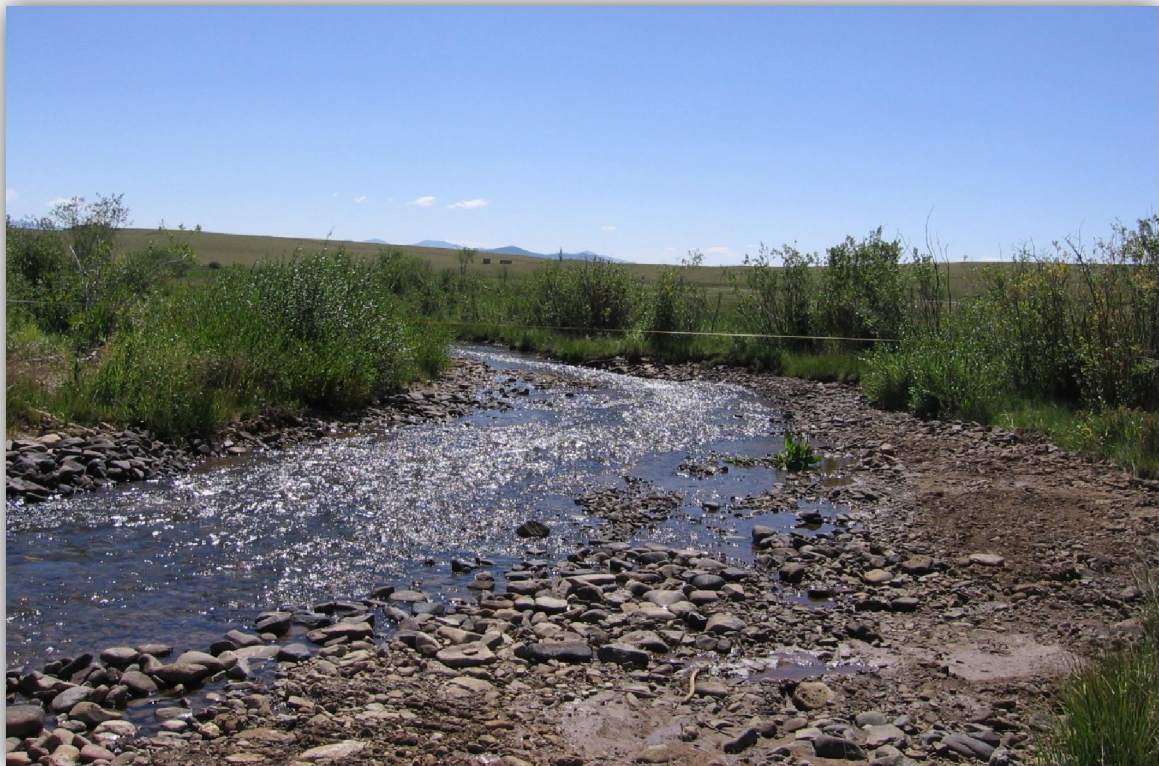
Figure 11: Before and after photos of the treatments on XS 1298 (described in the phase 1 report as "bench 1150").

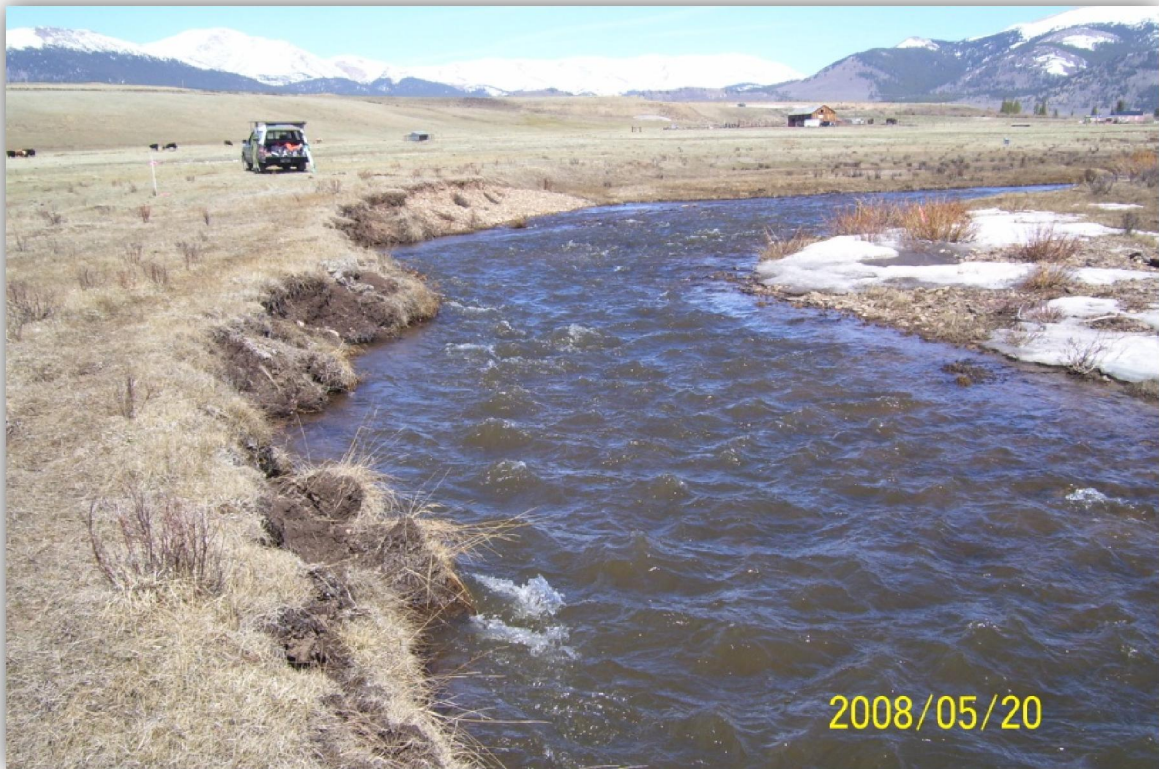
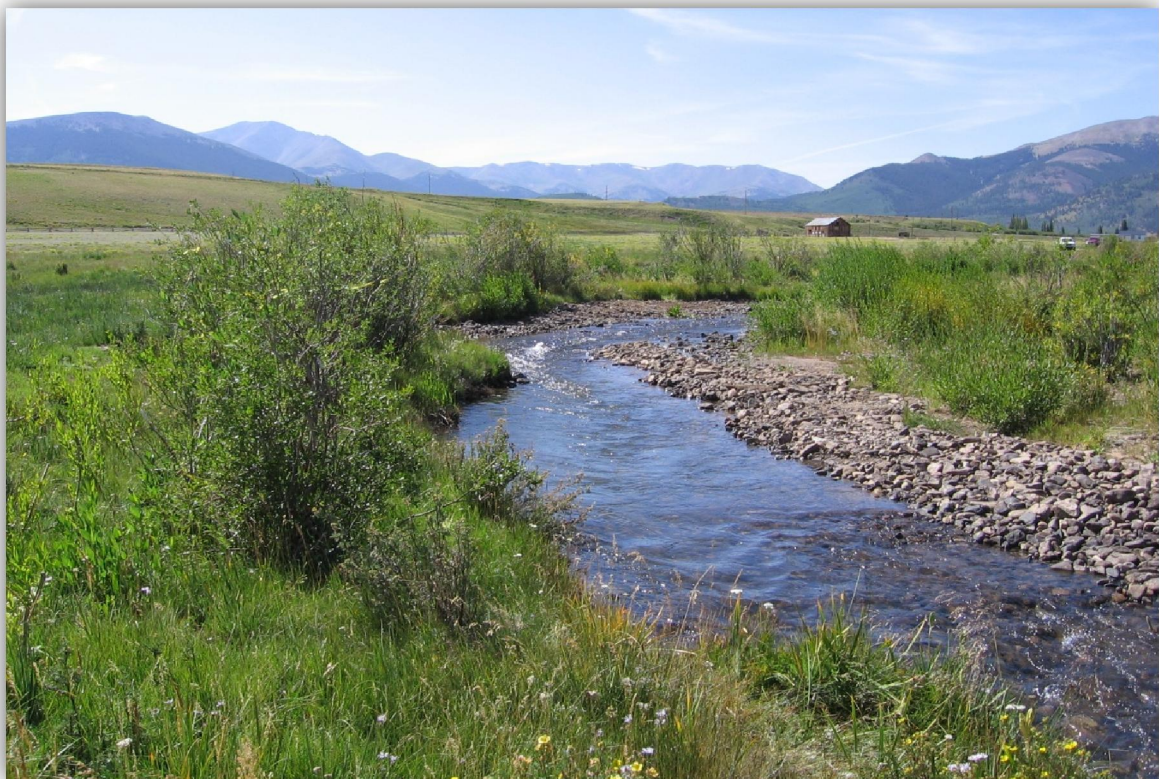
Figure 12: Before and after photos of the treatments near XS 1298 seen from downstream.

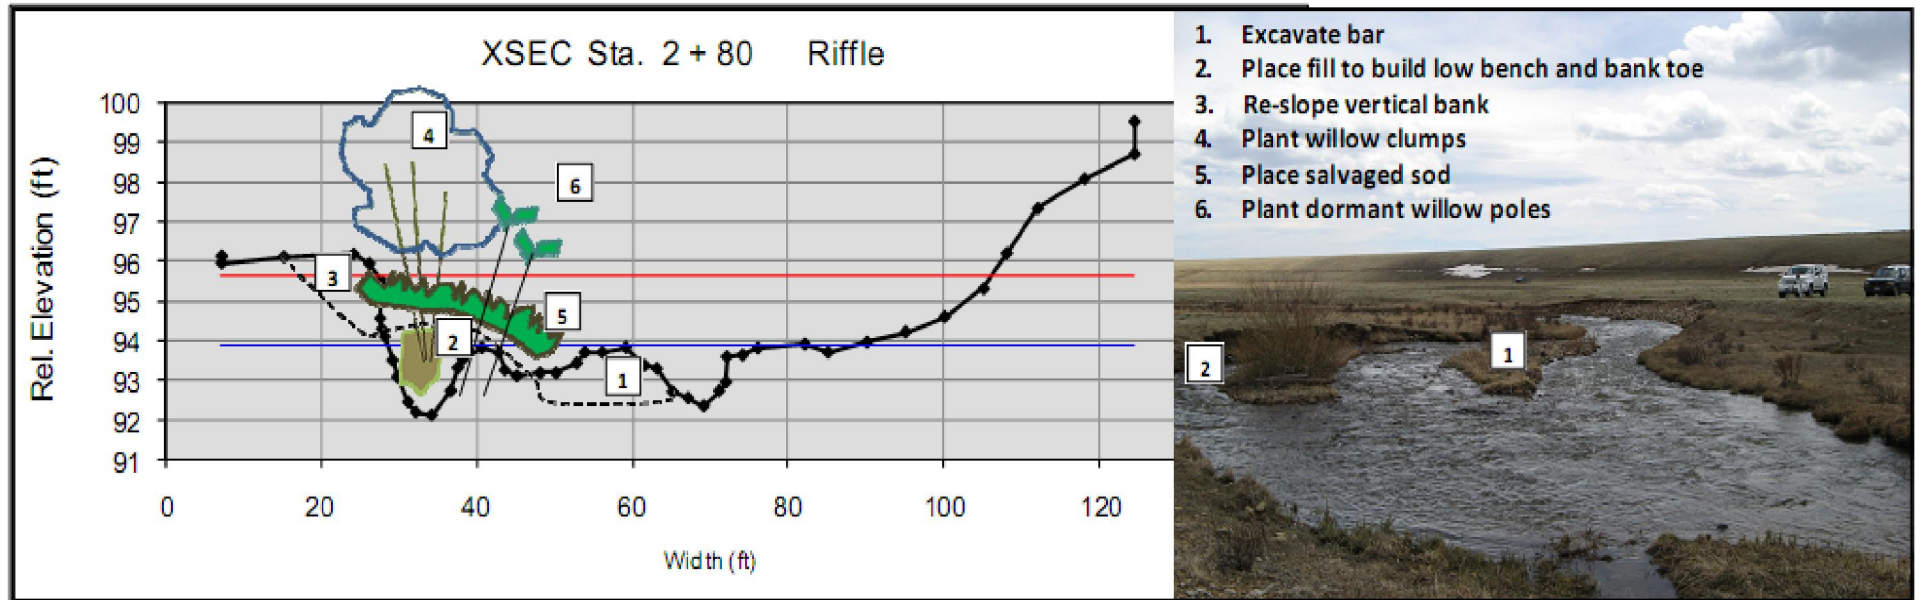
## Bankfull bench 280L

No work was completed on this cross section during phase 1.

No part of this design could effectively be completed without altering the streambed, so we plan to do all of the construction here during phase 2.

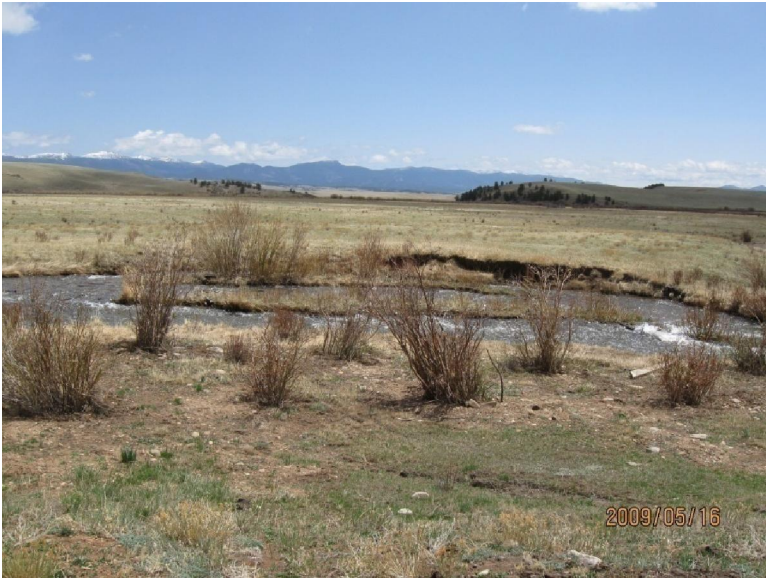
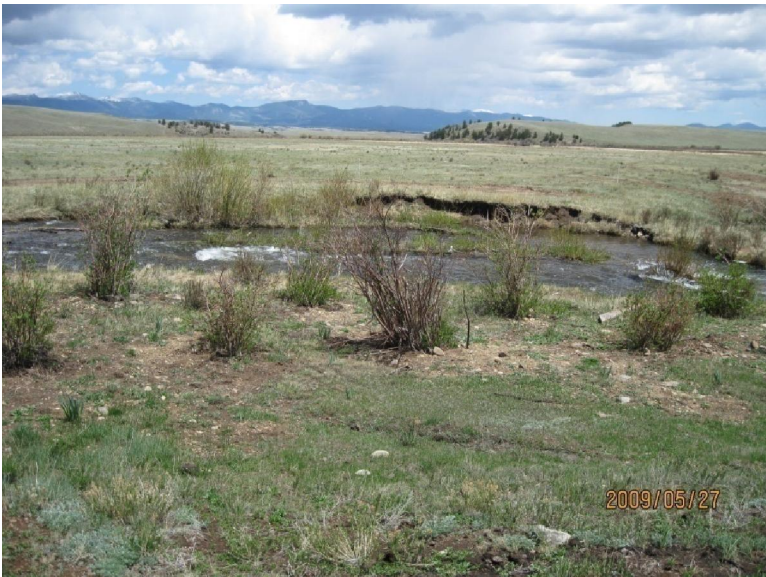
## Bankfull bench 0280R

Before-after photos show that no alterations were made at this location during phase 1.

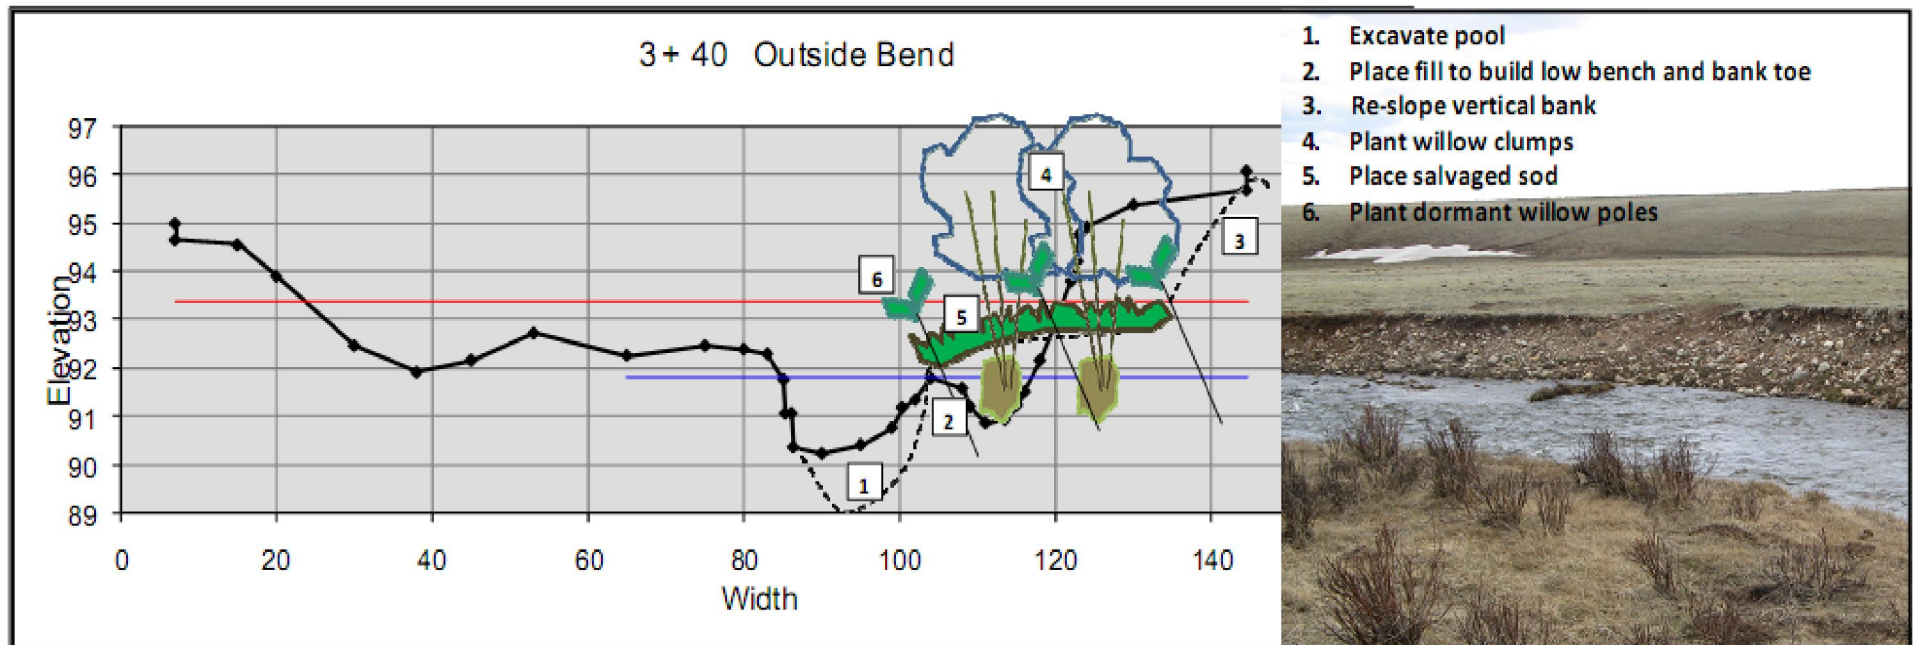
## Bankfull bench 0340R

During phase 1, we cut a bankfull bench into the high terrace on the right bank, planted 20 full willows and 12 willow stem bundles, and finished it with transplanted wetland sod. All bare areas were seeded, and erosion-control fabric was added to parts of the new back-slope.

Pool excavation, low bench, and bank toe construction is planned for phase 2 to finish work at this cross section when streambed disturbance is allowed.

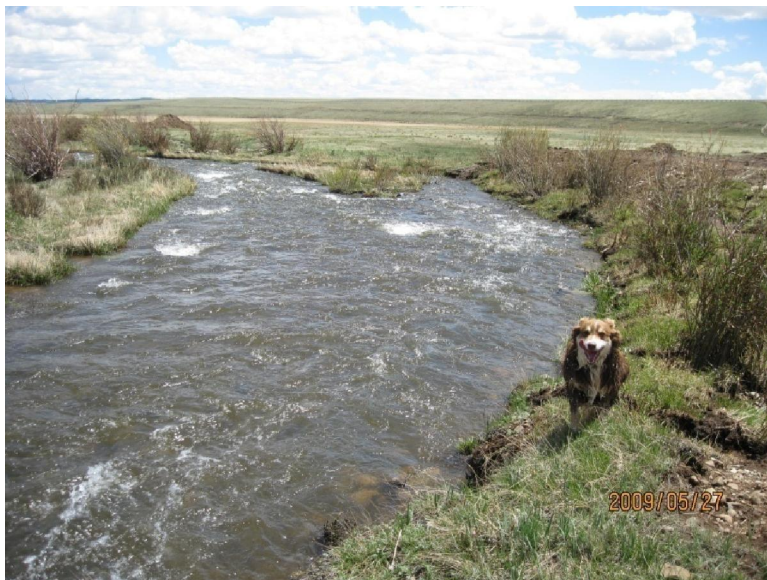
## Bankfull bench 0340R

Before-after photos (left) show how cutting a bench into the steep terrace on the right bank provided space to plant willows and wetland sod. Note that no alterations were made to the stream bed or low banks during phase 1.

The sequence of photos on the right show stages (from top to bottom) in the construction of the bench. The bench was later completed (5-29-09) with additional sod, seed, and fabric on the backslope.

All planned channel alterations and bank toe construction will take place during phase 2.

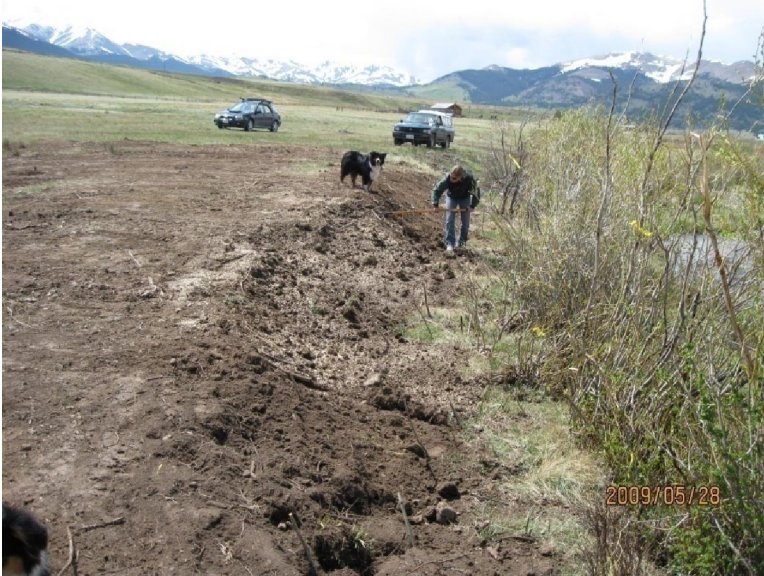
## Bankfull bench finishing

Where quality sod was not available, top soil was placed on bench backslopes. These and other disturbed areas were seeded twice with a mix of native high altitude erosion-control grasses. Seeds were raked in, compacted, and watered.

Where deemed necessary (Bench 340R), erosion-control fabric was placed over seeded backslopes for protection.
