# Tarryall Creek Ranch 2009 Riparian Restoration Project

*Project summary and initial monitoring results*

*Mark Beardsley, M.S. EcoMetrics LLC October 16, 2009*

# Tarryall Creek Ranch Riparian Restoration Project 2009 Phase 1

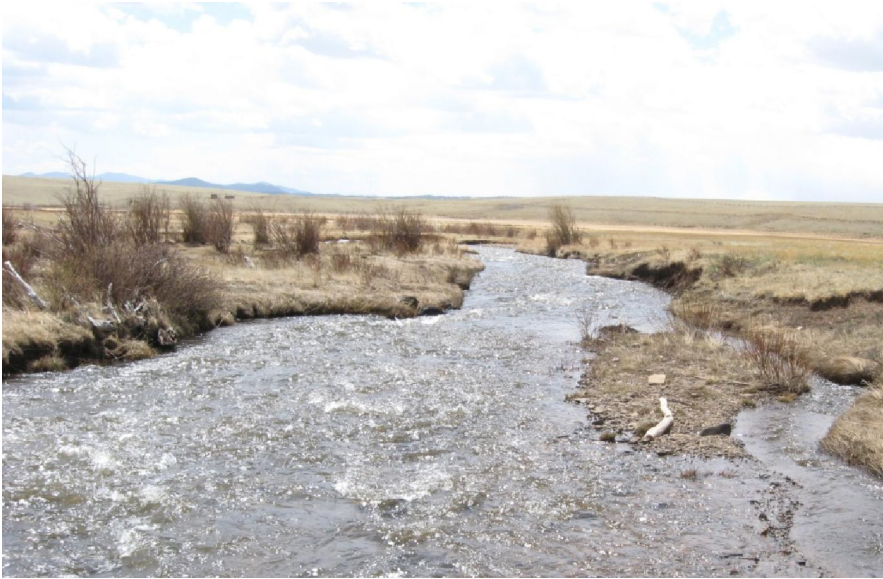
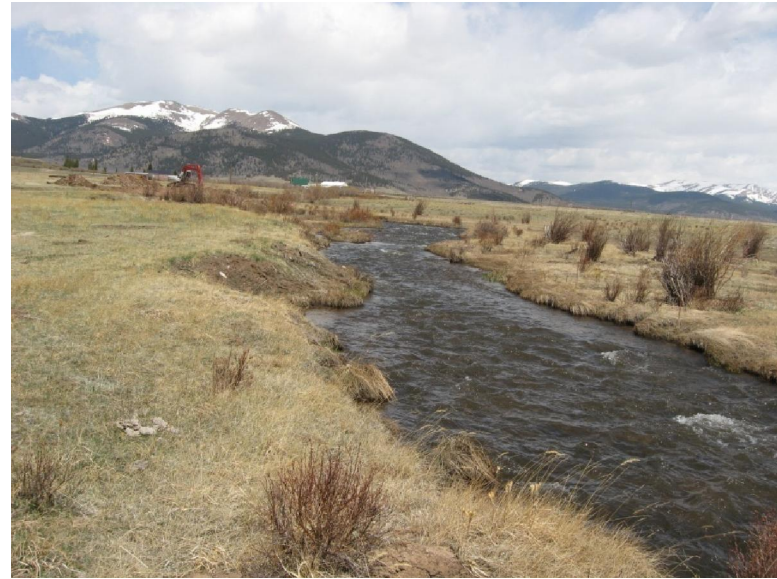
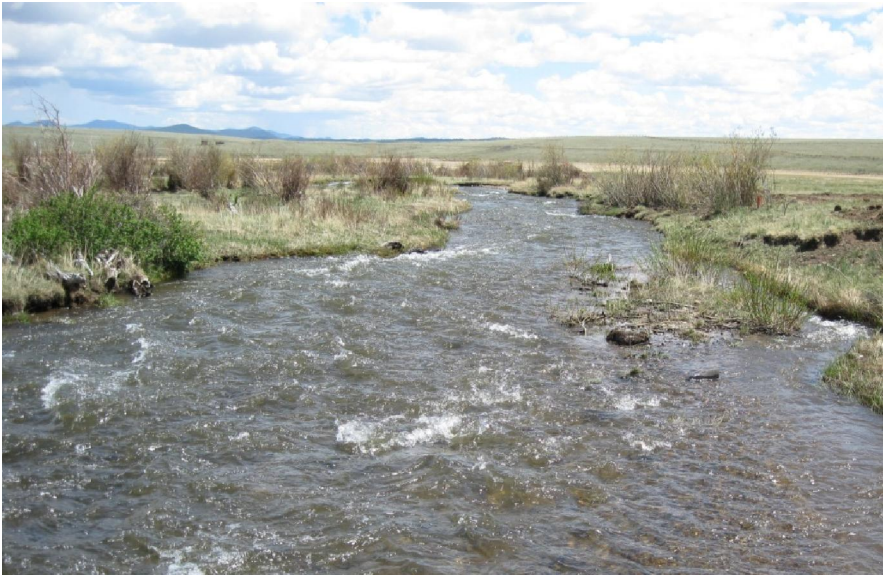
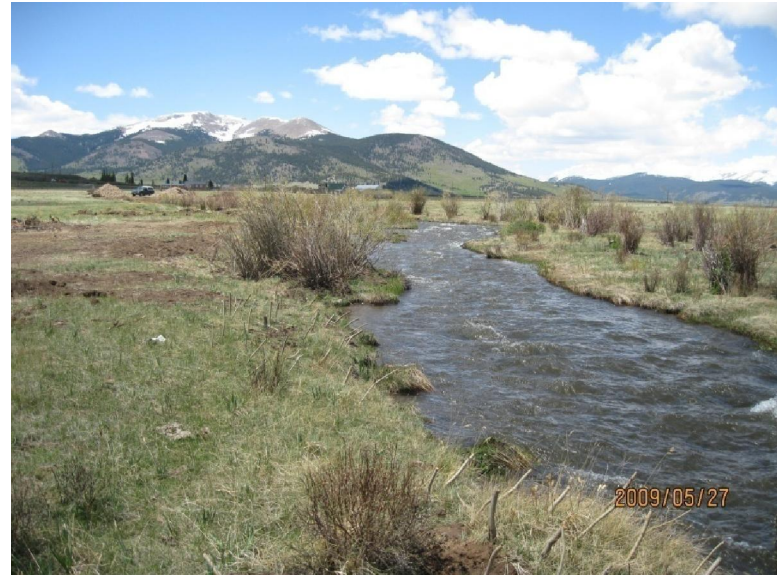
## Bankfull bench 0650R

Before-after photos show bench construction, and planting of sod, willows and stems on the right bank near 0650R. Channel work and toe construction is planned for phase 2.

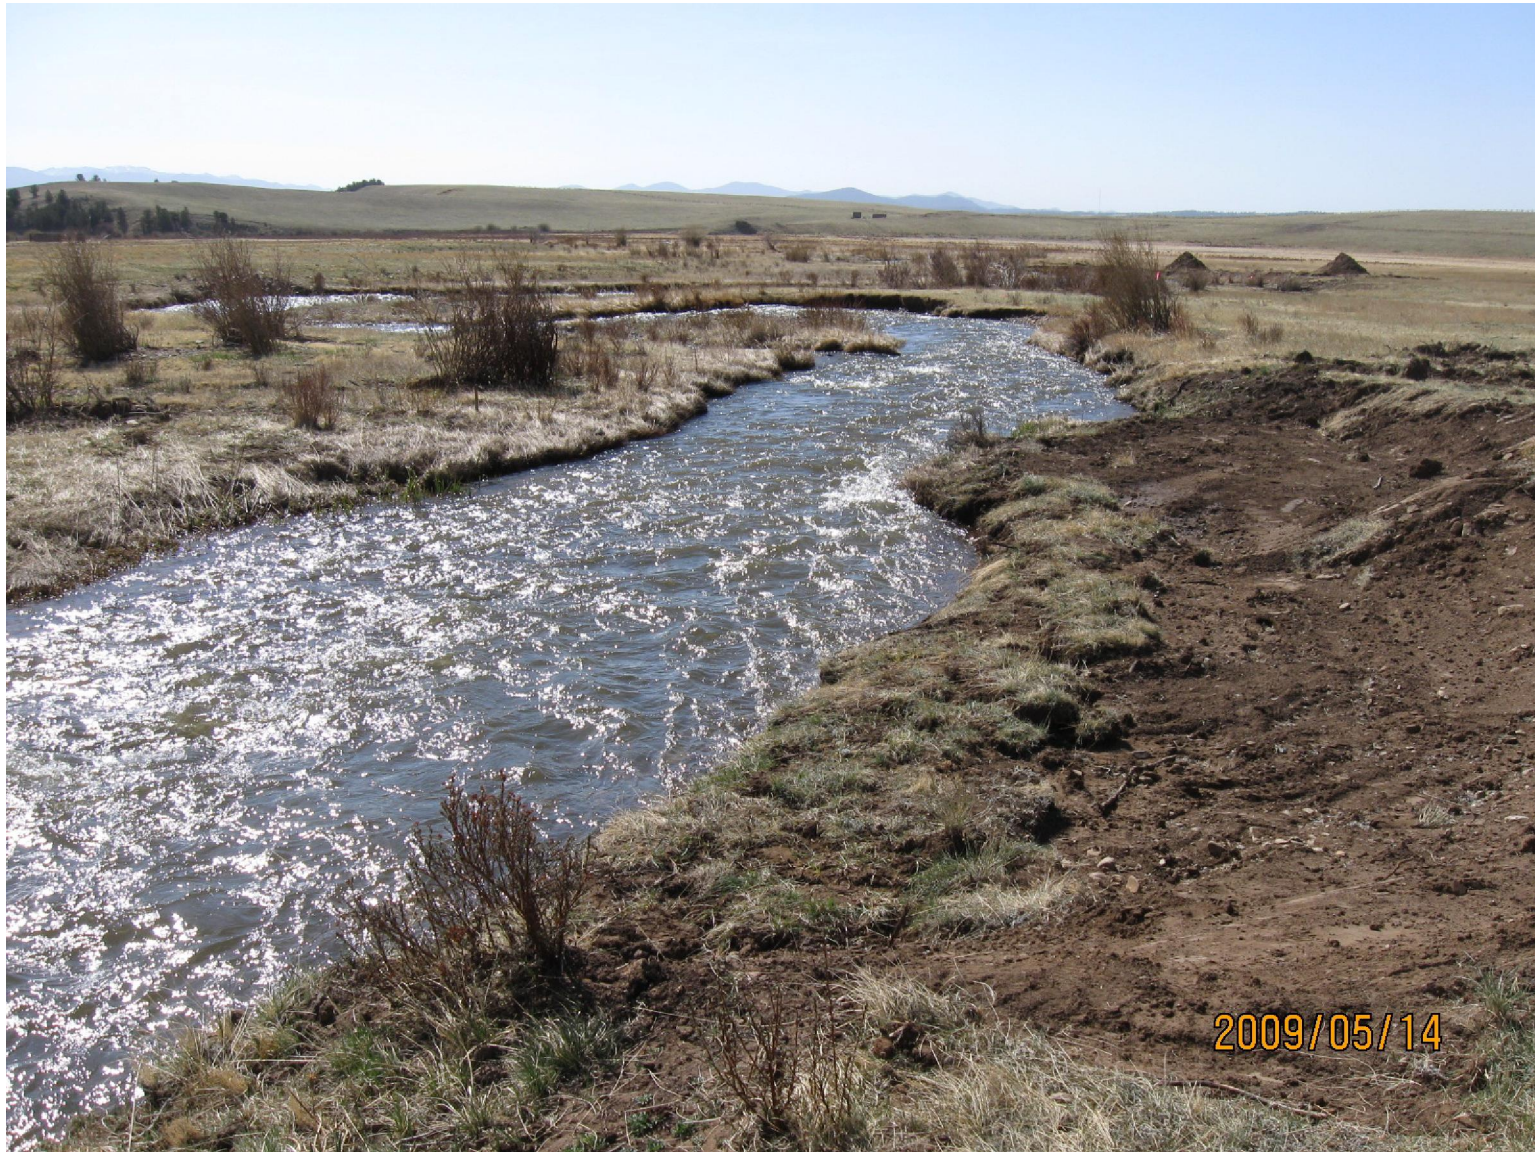
## Bankfull bench 0650R

A shaped bench at 650R is shown after placement of one layer of sod. This bench was completed by planting 24 whole willows and 100 willow stems, and sodding and seeding the backslope. In phase 2, we will gently shape the bed to form a gravel toe.

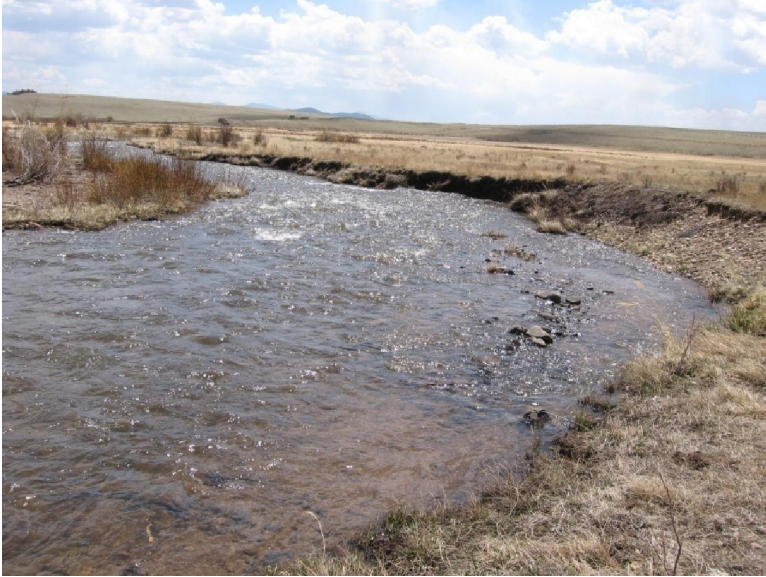
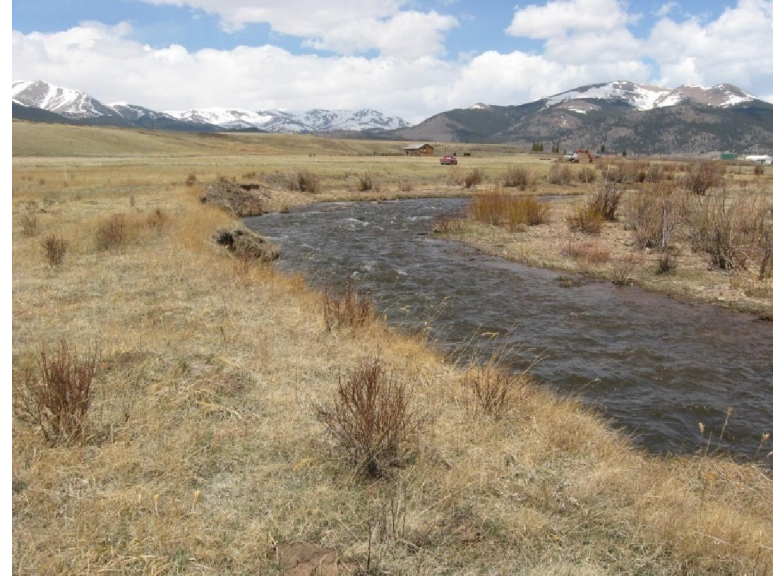
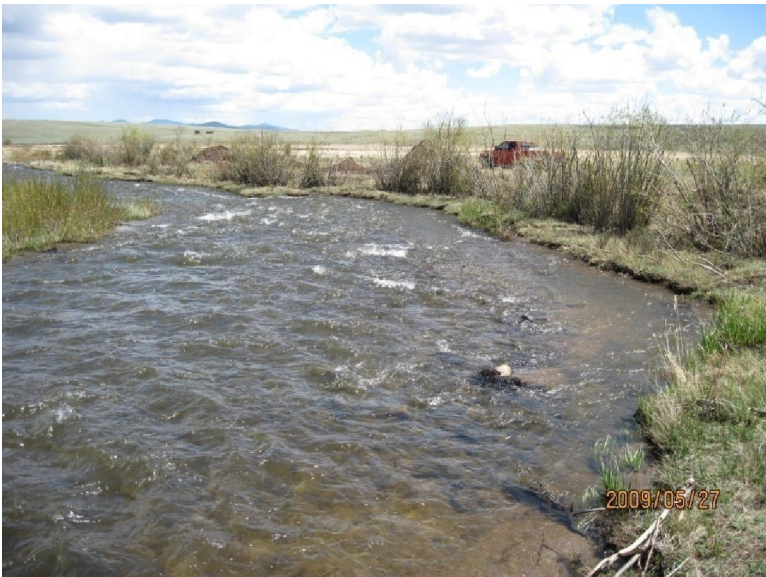
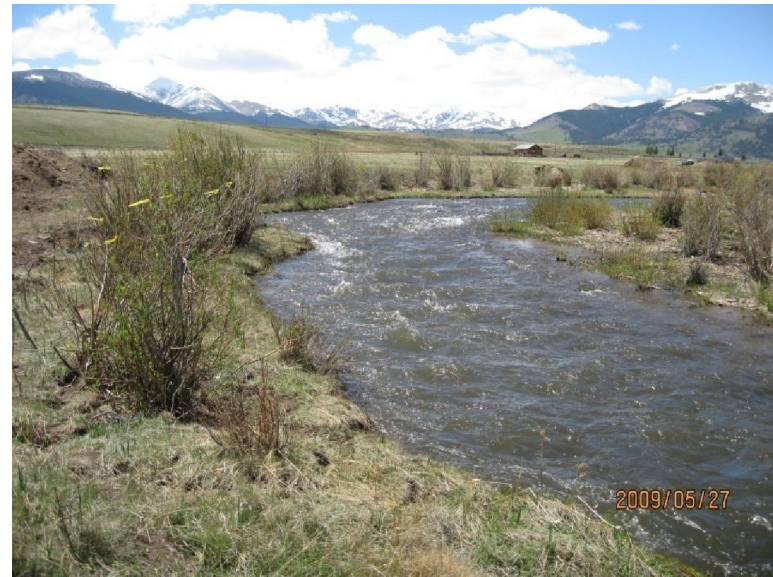
## Bankfull bench 1150R

Before-after photos show bench construction, and planting of sod, willows and stems on the right bank near 1150R. Channel work and toe construction is planned for phase 2.

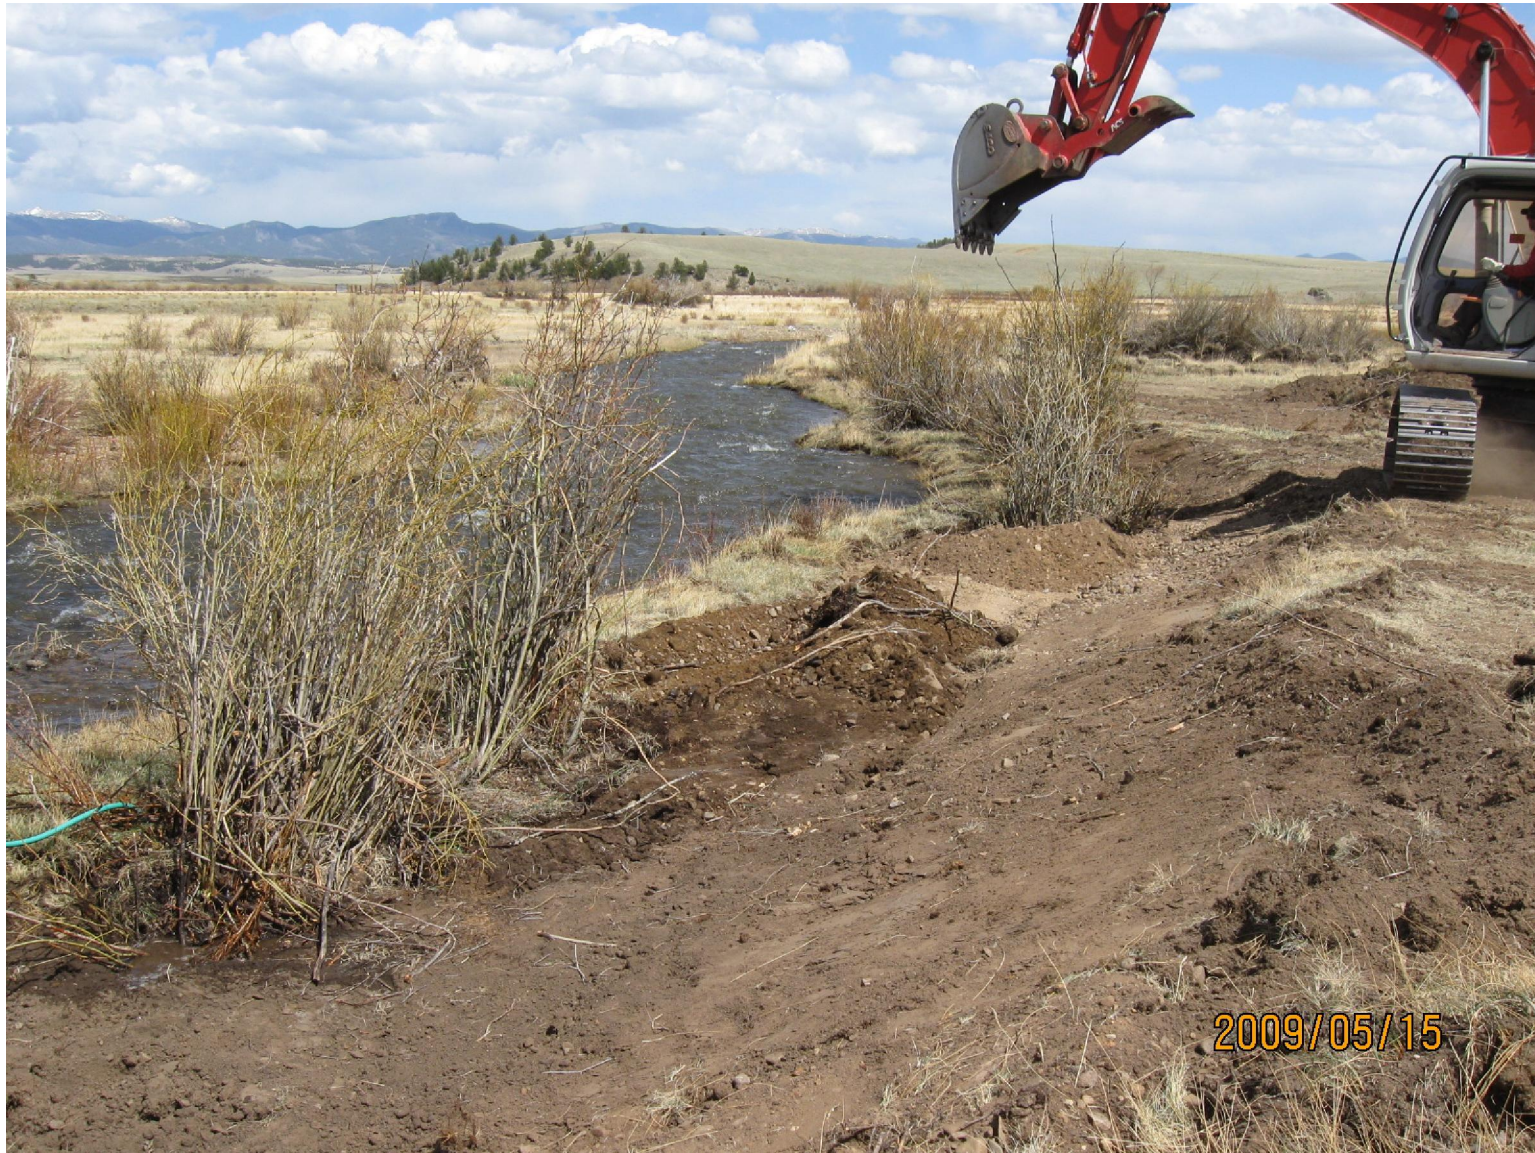
## Bankfull bench 1150R

Willow planting in progress on bench 1150R. New plantings are saturated as they go in. A first layer of sod is already in place, and additional sod is added after willows are all in place.

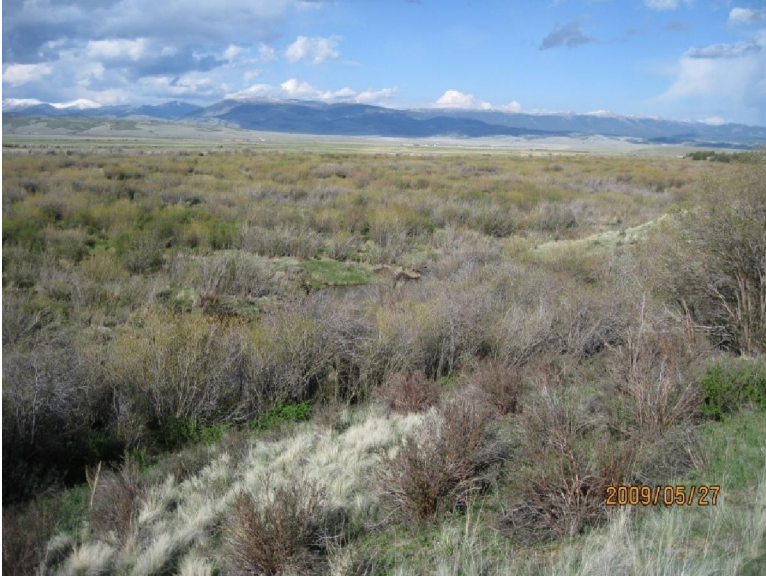
Prior to completion of phase 1, the borrow site was graded and seeded. This area was prepared as a stream access to the upper end of the property. Foot access trails within this “jungle” area were also identified to make it useable for anglers.

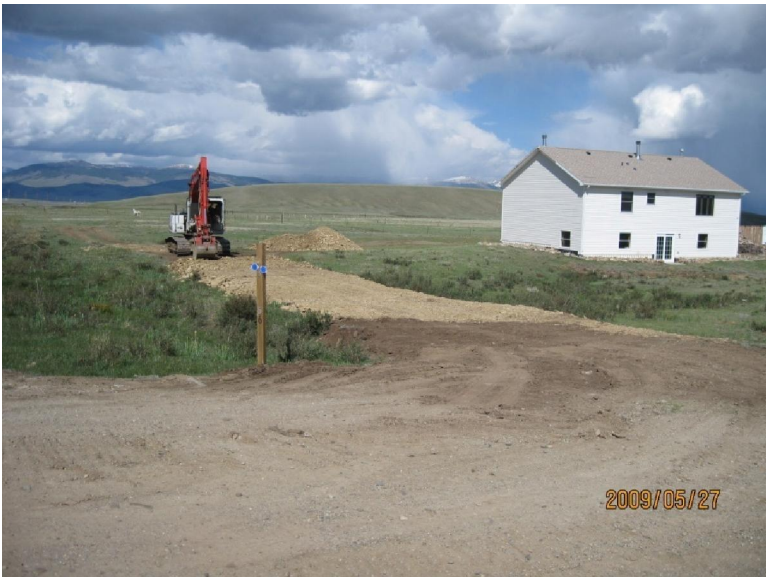
In addition to reclaiming disturbed areas and the borrow site, completing phase 1 involved repairs on the neighbor's driveway which was thankfully offered as access to the north side of the project area. The haulage road saw dozens of semi-load passes during construction.
