Assessement of Riparian and Aquatic Habitat with the Coal Creek Watershed, Gunnison County, Colorado.

Prepared for

Coal Creek Watershed Coalition (CCWC)
c/o Crested Butte, P.O. Box 39
Crested Butte, Colorado 81224

December, 2009

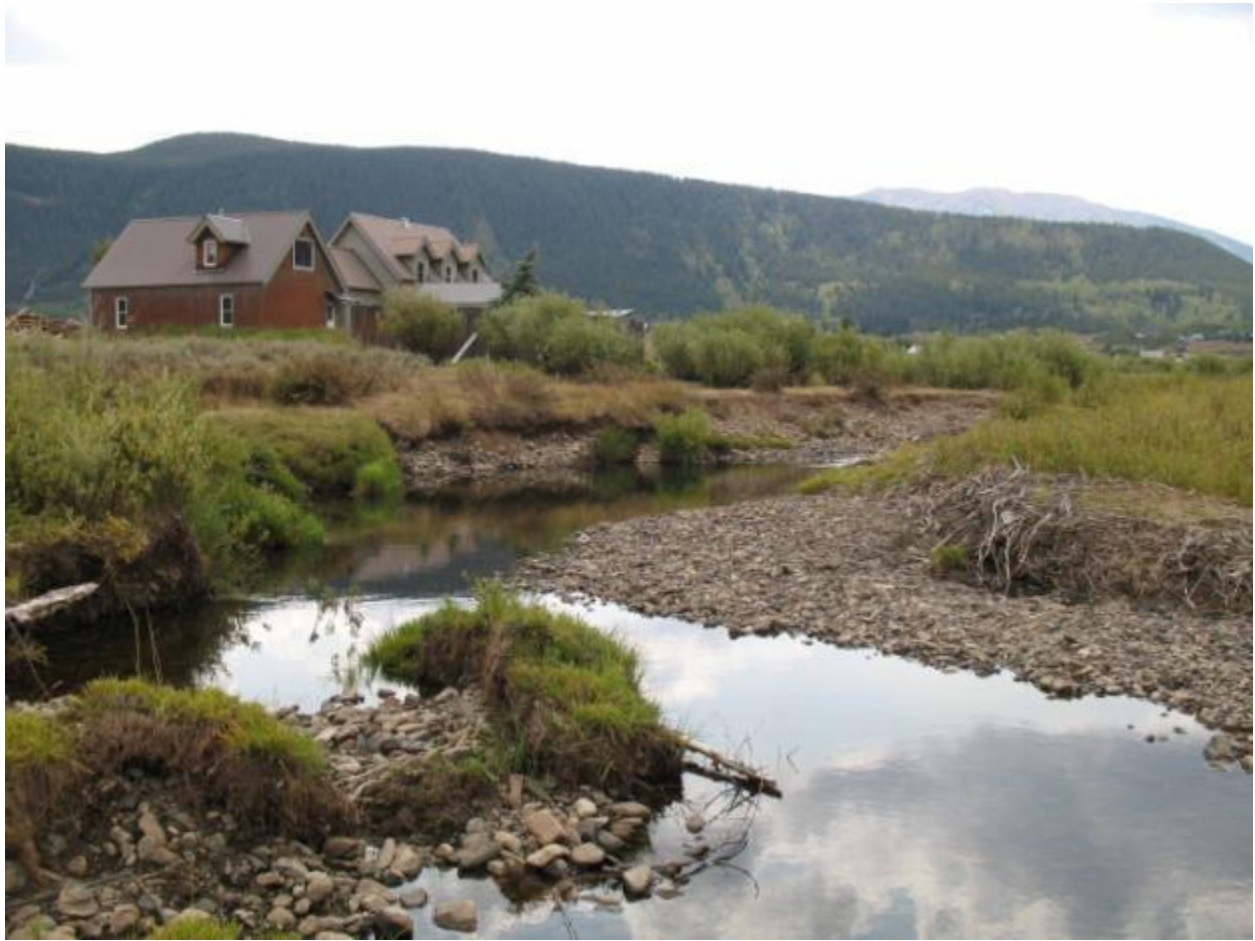
Photograph 1. Photograph taken August 2009 of Coal Creek above the confluence with the Slate River looking upstream in Assessment Segment 1. Note the streambank erosion and the lack of riparian vegetation.

This section is given a high priority for restoration due to the ongoing dramatic riparian impacts that can be easily remedied. It is recommended that CCWC work with the CBLT and those that possess the grazing rights to either fence cattle away from the riparian zone or manage the cattle in a way to reduce grazing pressure on the riparian zone. Unfortunately, after streams of this type become degraded as this one has, complete restoration of the channel and hydrology is difficult and costly (Rosgen 1996).

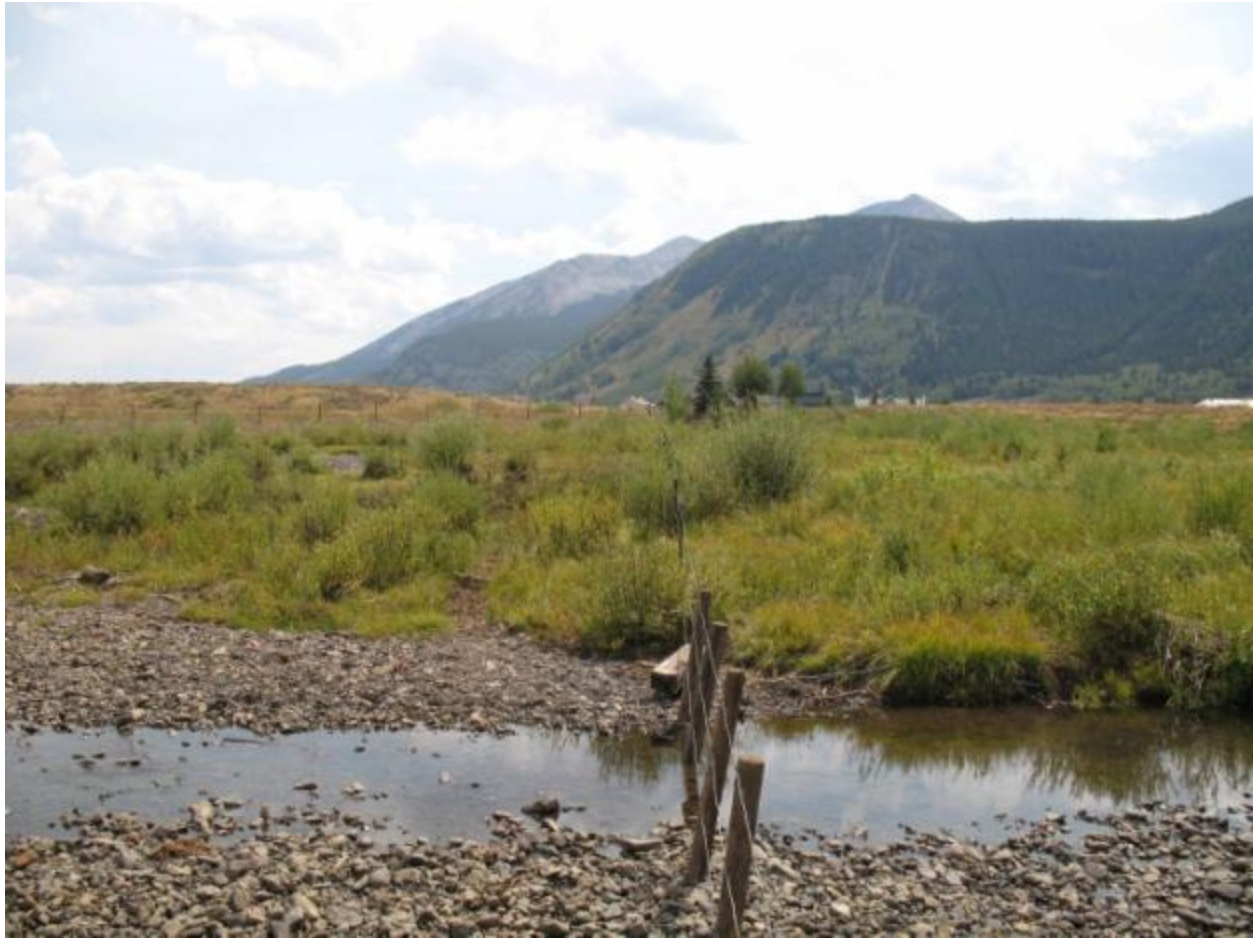
Photograph 2. Photograph taken August 2009 of Coal Creek looking at the fenceline boundary between Assessment Segment 1 (left) and Assessment Segment 2 (right). Note the streambank erosion and the lack of riparian vegetation on the left and the recovering riparian vegetation on the right. Also, note the grazed zone on the right side of the fence where grazing by domestic livestock occurs through the fence.

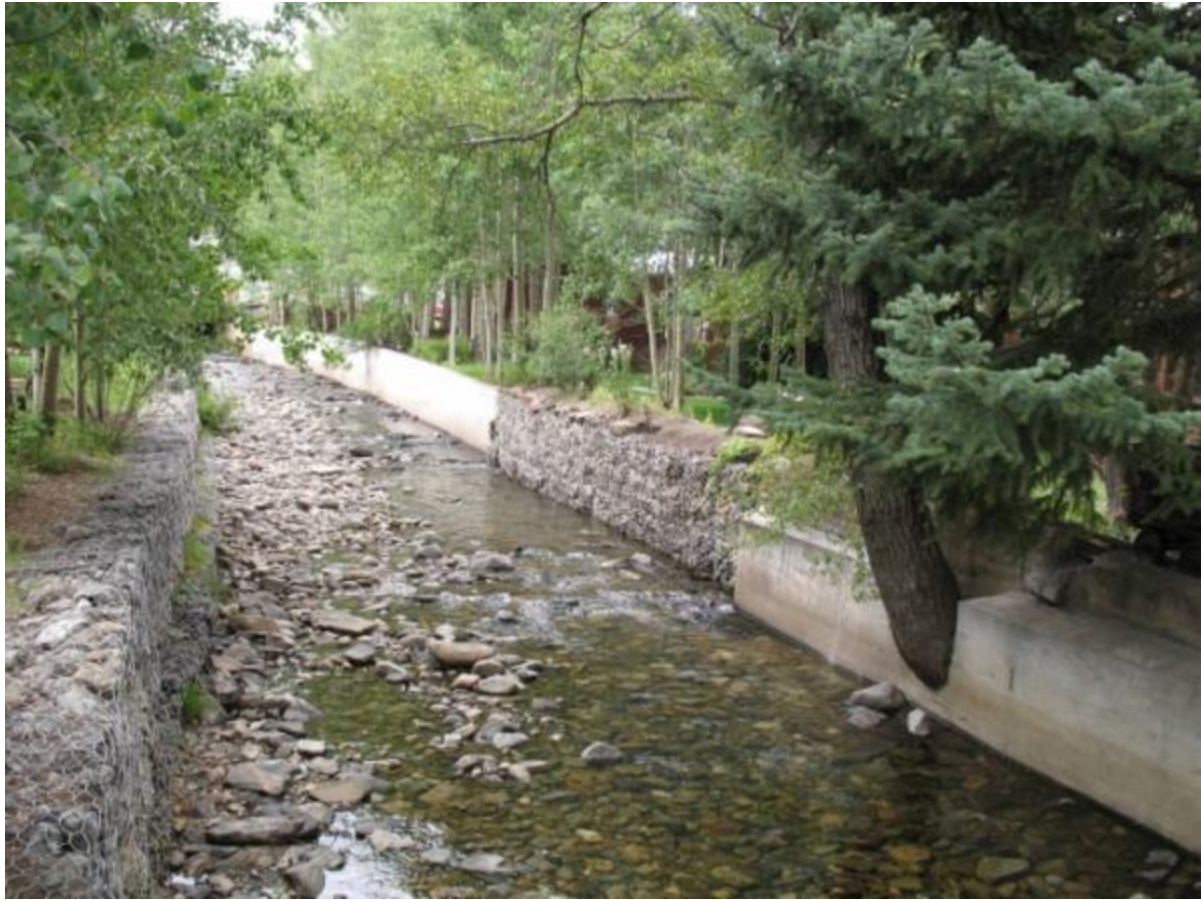
Photograph 3. Photograph taken August 2009 looking upstream along Coal Creek in the Town of Crested Butte from the Totem Pole Park bridge. Note the channelization of the creek with gabions and concrete and the resulting reduced riparian zone.

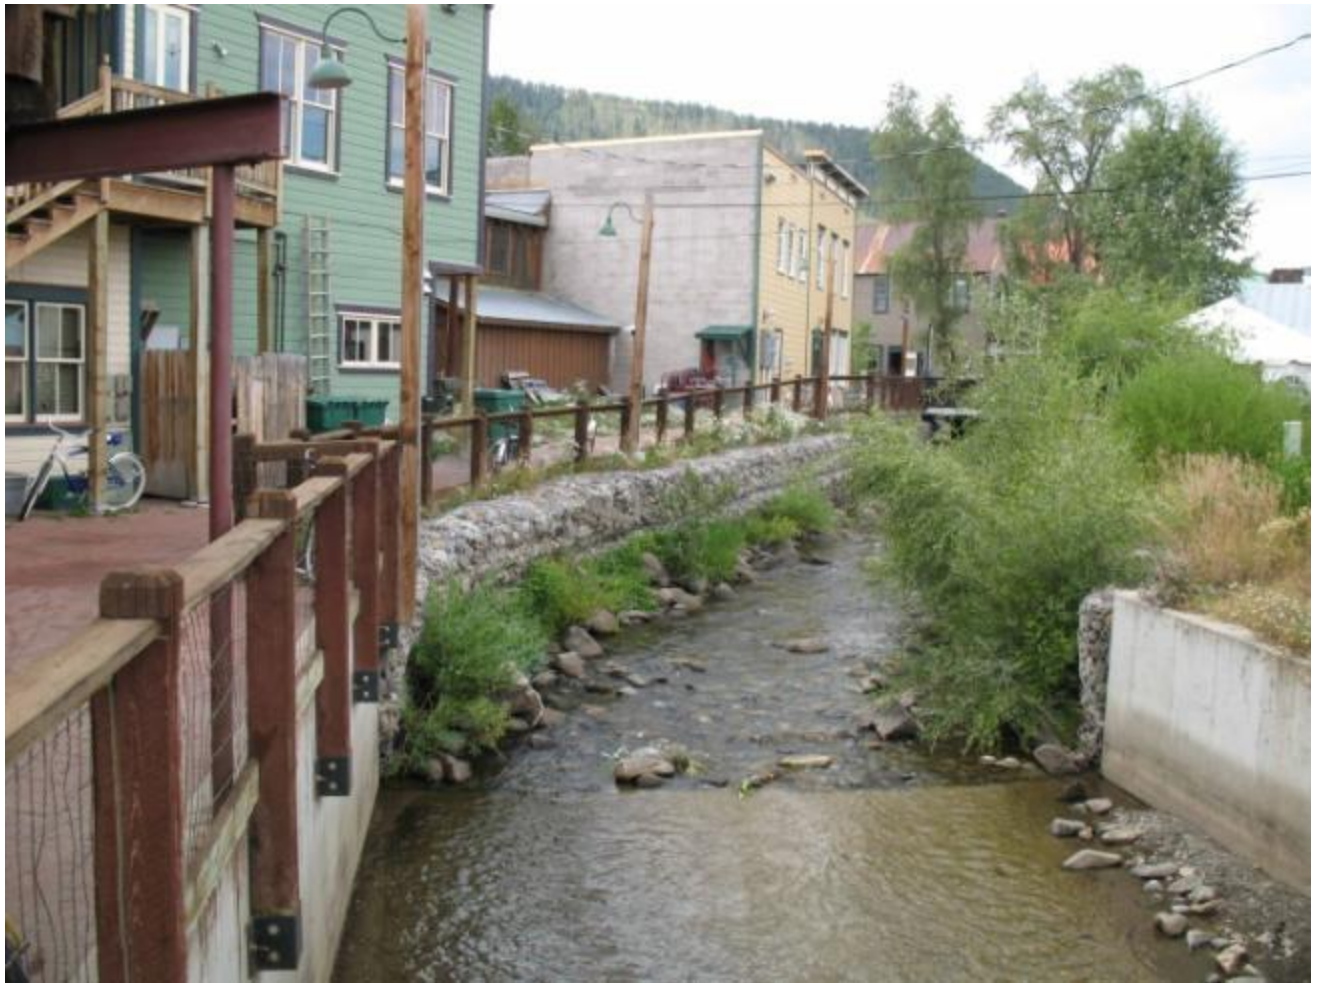
Photograph 4. Photograph taken August 2009 looking upstream along Coal Creek in the Town of Crested Butte behind the Eldo. Note the channelization of the creek and the reduced riparian zone. Also, willows are colonizing the gabions.

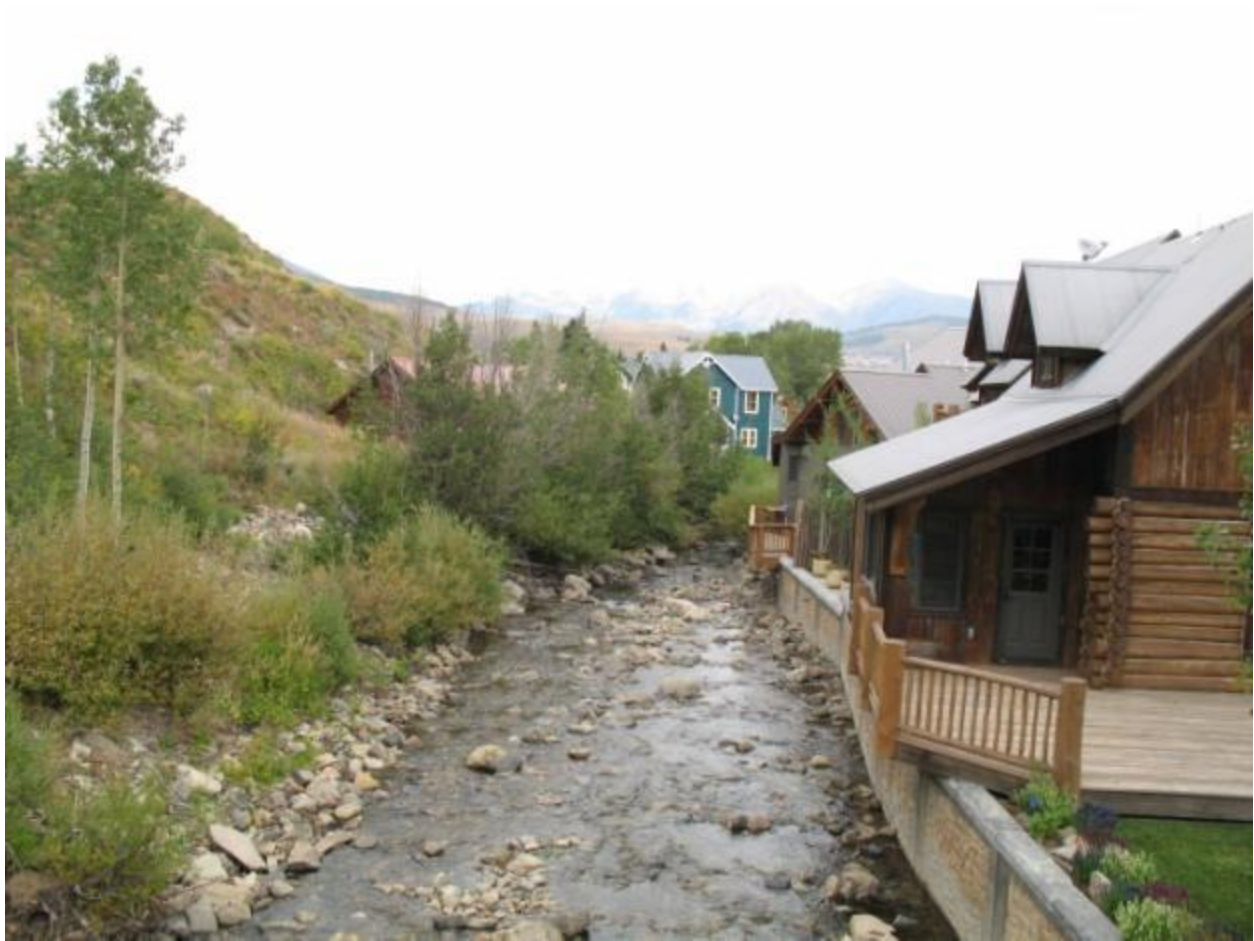
Photograph 5. Photograph taken August 2009 looking downstream along Coal Creek in the Town of Crested Butte near Whiterock Bridge. Note the channelization of the creek and the reduced riparian zone on river right. Also note the dying Alders (*Alnus tenuifolia*) on river left.

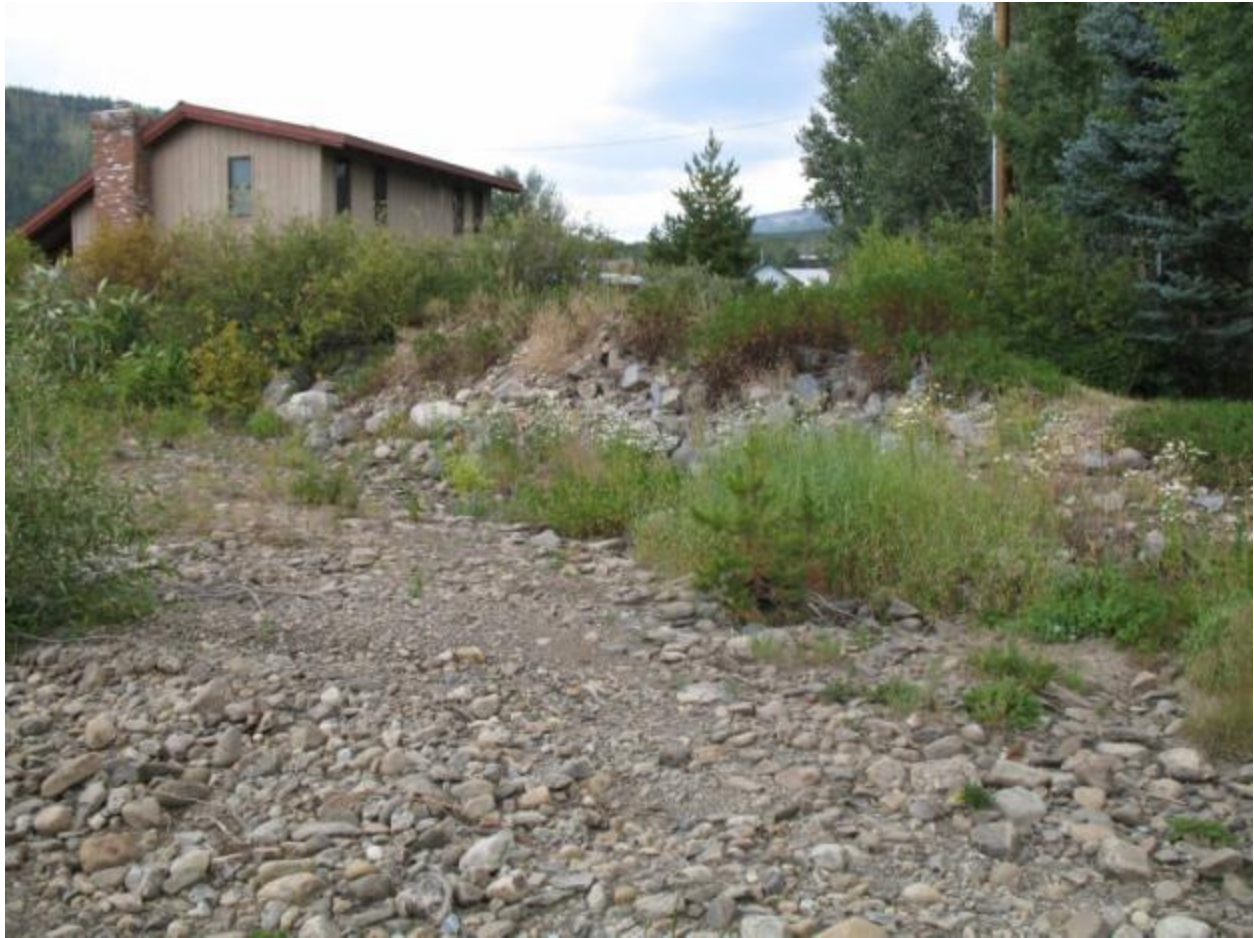
Photograph 6. Photograph taken August 2009 looking across Coal Creek in the Town of Crested Butte near Third Avenue. Note the channelization of the creek, berming to reduce flooding and the disturbance from diversion maintenance.

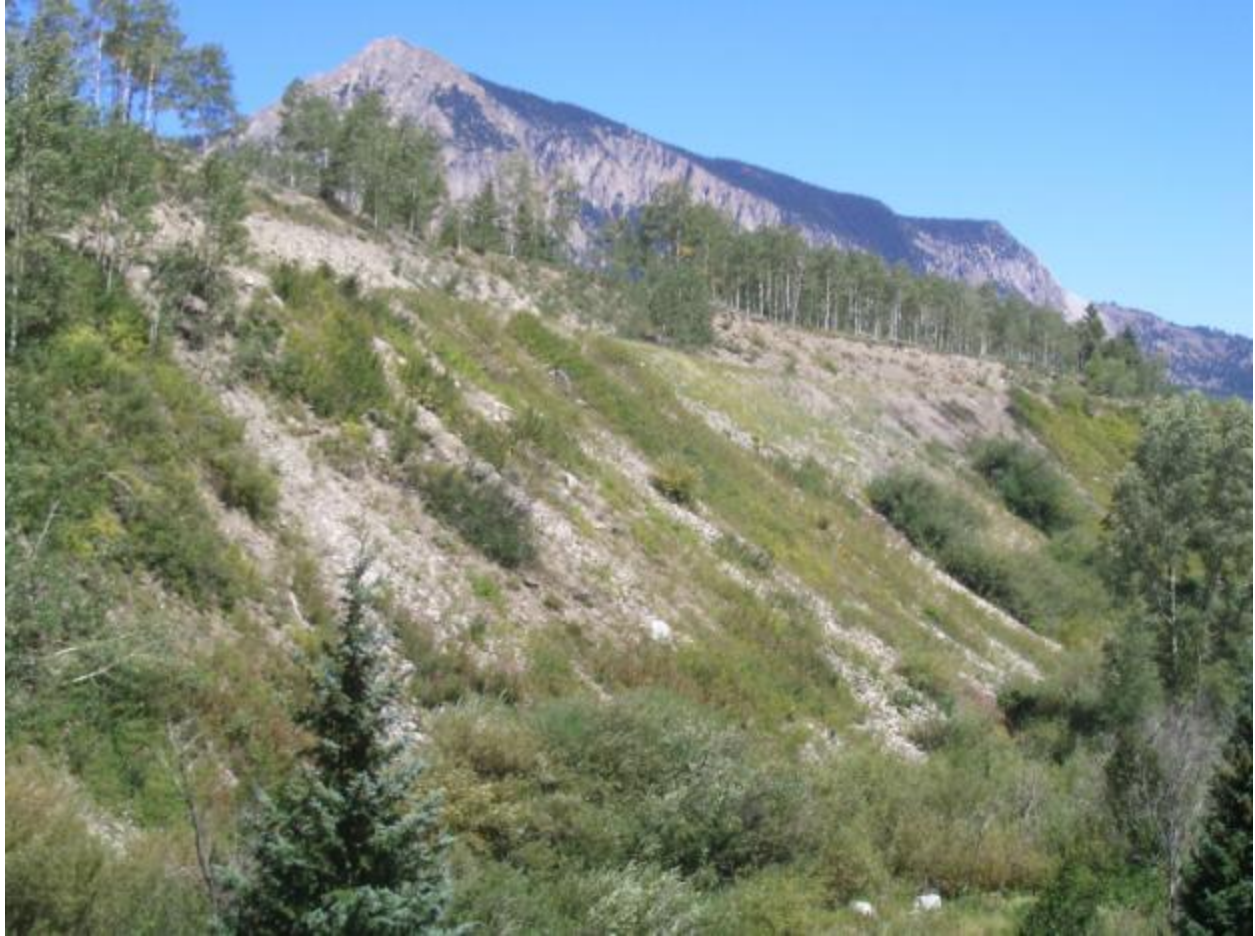
Photograph 7. Photograph taken Fall 2009 looking northeast from Coal Creek along Kebler Pass Road. Note the erosion and sediment entering the road as well as the road impinging on the riparian vegetation. Crested Butte Mountain is in the background.

We recommend reducing sedimentation coming from road and slope by stabilization these sections and using Best Management Practices for road maintenance. To reduce the impacts from the diversions, water users should consider engineering the diversions to minimize repeated seasonal maintenance which involves instream disturbance as well as impacting the

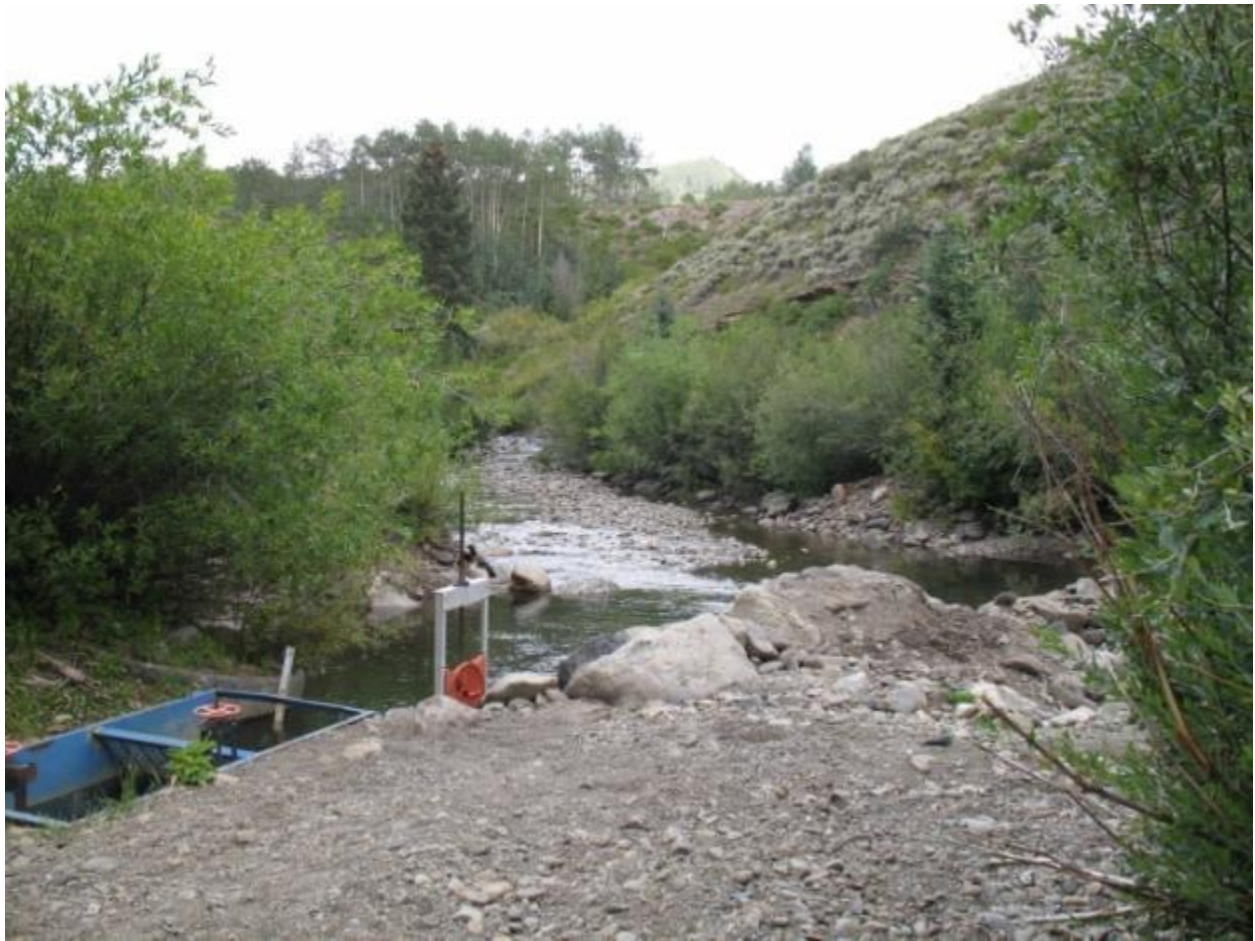
Photograph 8. Photograph taken Fall 2009 looking upstream from Coal Creek from the Halazon Ditch. Note the disturbance to riparian vegetation and the disruption of the streambed from maintenance of the diversion structure.

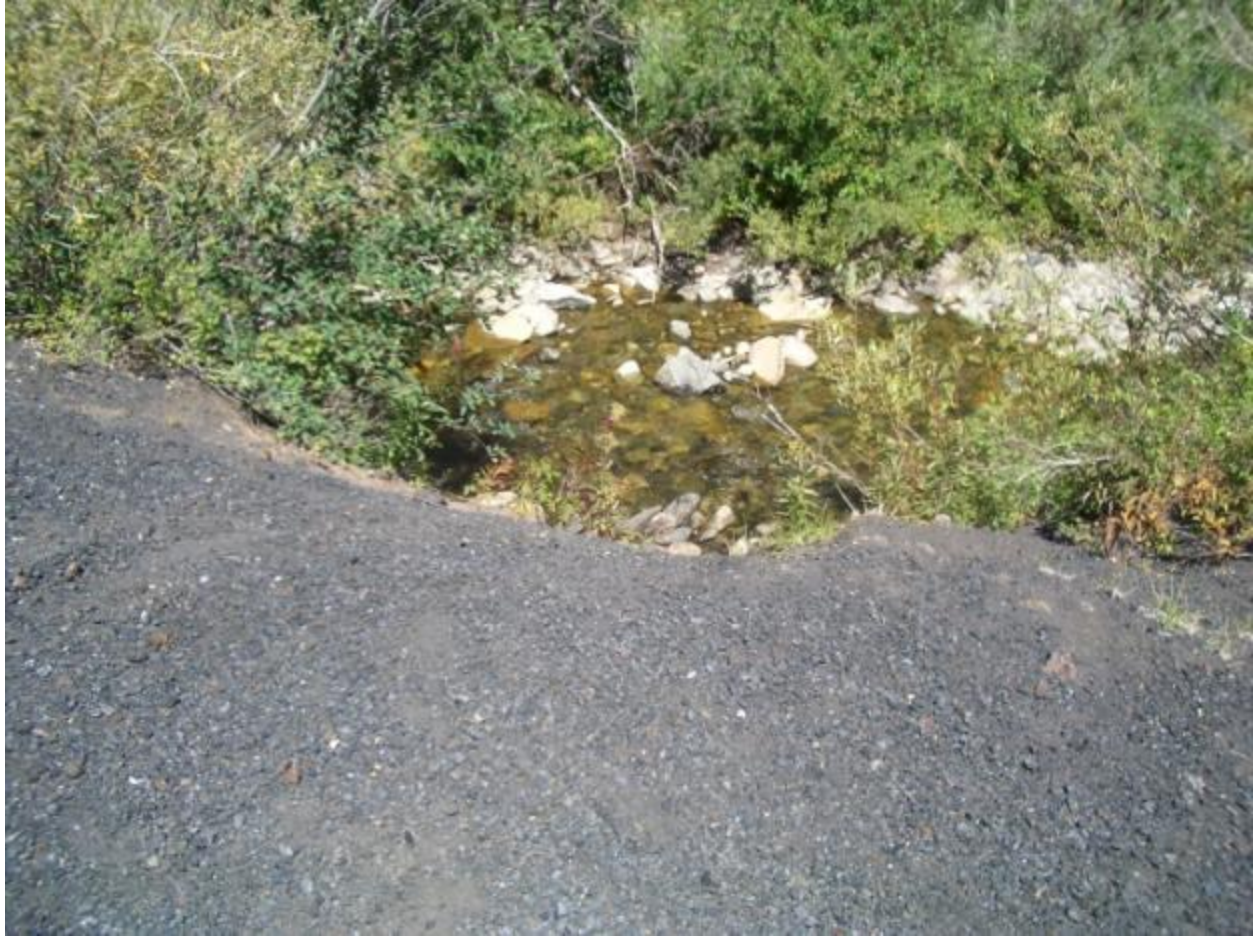
Photograph 9. Photograph taken Fall 2009 looking into Coal Creek with a coke ash pile eroding into Coal Creek.

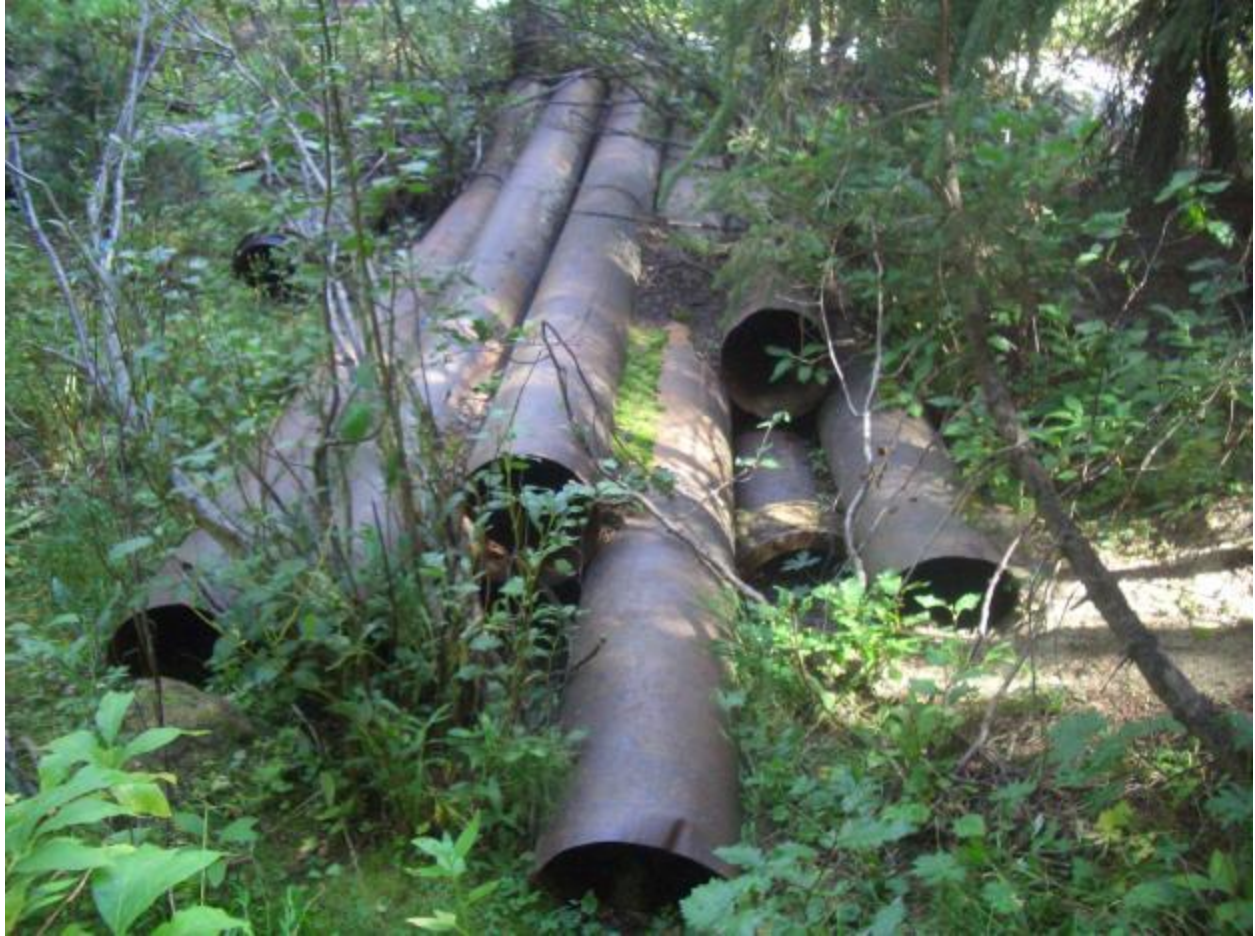
There are several pipes (Photograph 10) from an emergency, Town of Crested Butte water supply replacement during the winter of 1976-1977 that were left in the riparian zone. These are causing minimal disruption of the riparian zone but a strategic removal of these that would minimize the disturbance of riparian vegetation, possibly scheduled while there is snow, would improve the aesthetics of this area.

Photograph 10. Photograph taken Fall 2009 in the riparian zone of Coal Creek near Wildcat Creek showing pipes remaining from an emergency water pipe replacement in 1976.

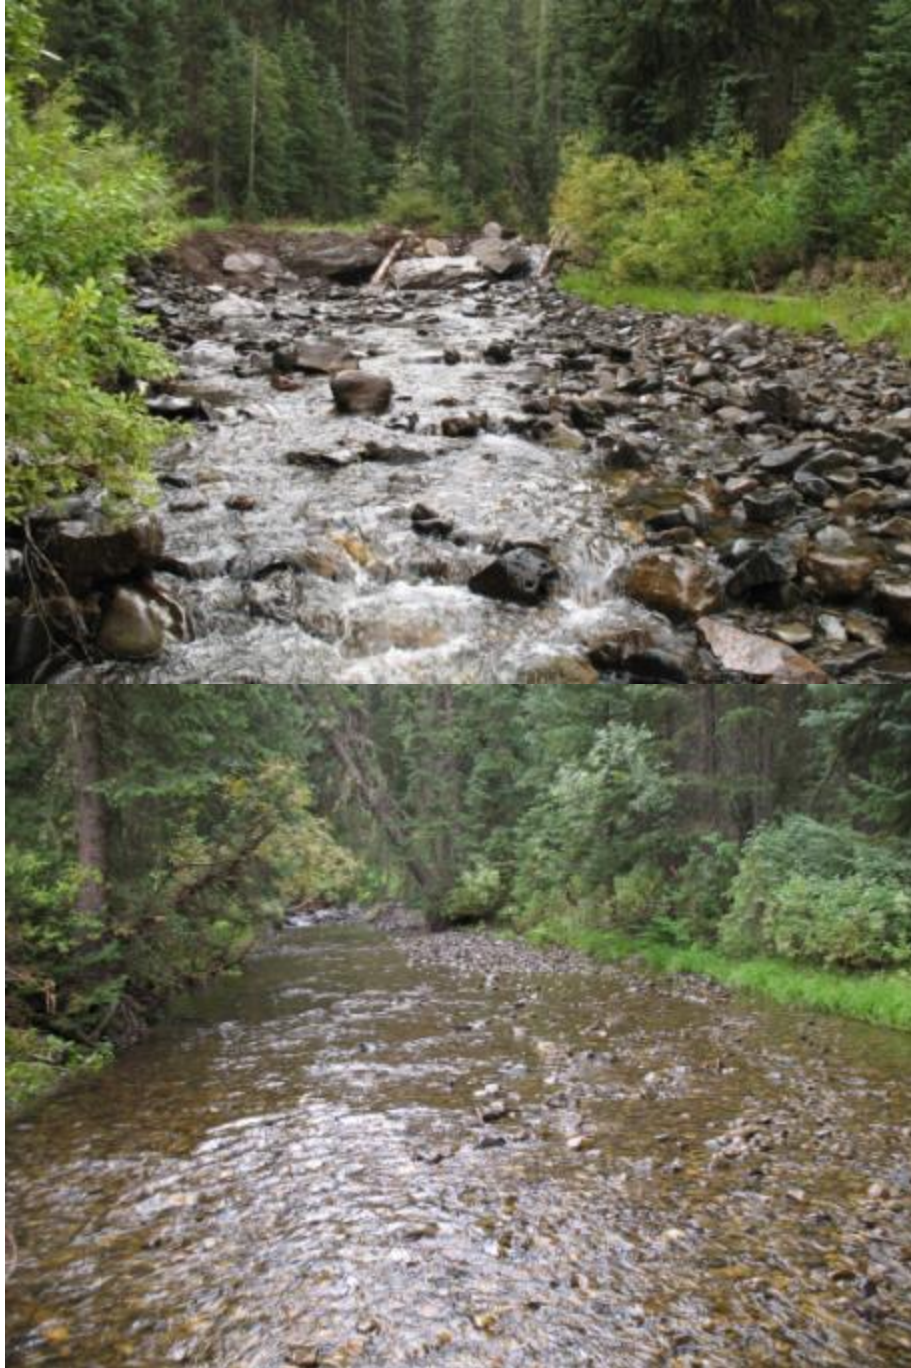
Photograph 11. Photograph taken Fall 2009 in Coal Creek looking upstream towards (top) the Town of Crested Butte Water Diversion and looking upstream from above the diversion (bottom). Note the associated debris in the top photograph and the homogenization of the substrate in the bottom photograph.

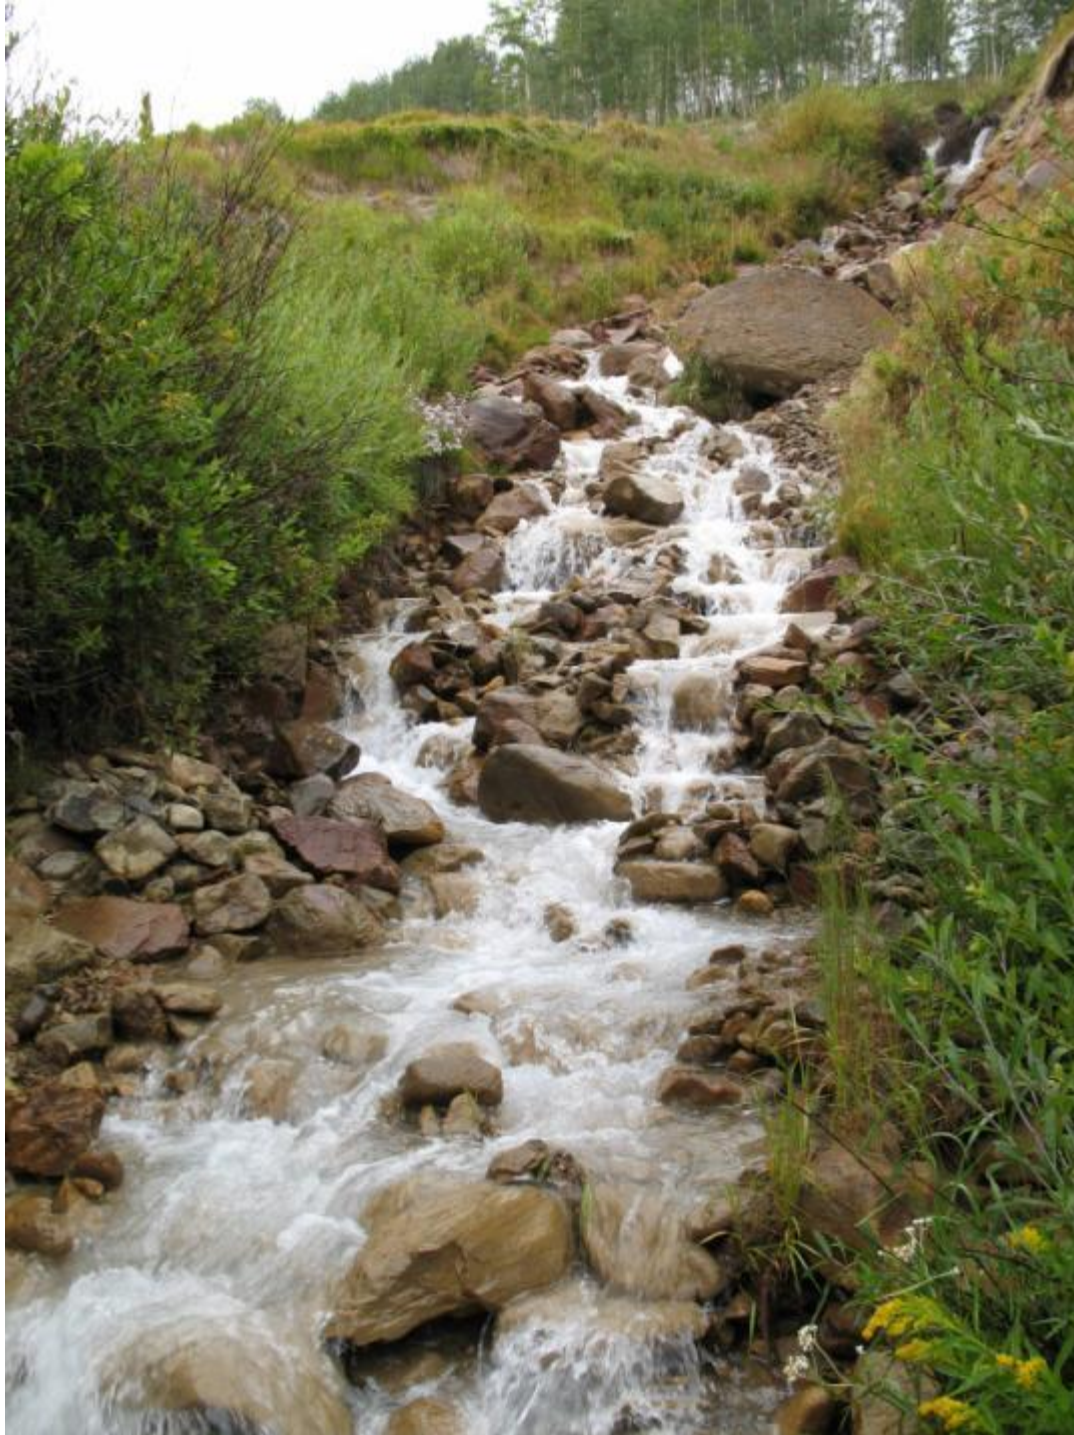
In addition to the reduced water flows downstream from the diversion, there is dramatically fluctuating discharge and mineral deposition on creek substrate from the Keystone Mine outflow and the outflow drainage has reduced riparian vegetation. The Keystone Mine outflow also has eroded down the steep drainage from Kebler Pass Road to Coal Creek (Photograph 12). Reducing the repeated, major and rapid flow fluctuations and restoring the riparian vegetation would be beneficial but the erosion caused by the increased flows from the mine discharge would be difficult to restore due to the steep slope, the nature of the water discharged and the erosion that has already occurred.

Photograph 12. Photograph taken Fall 2009 from Coal Creek looking upstream to the Keystone Mine outflow. Note the precipitate on the rocks and the lack of diverse sizes of sediment indicating erosion from rapid fluctuations in flow coupled with reduced sediment inflow.

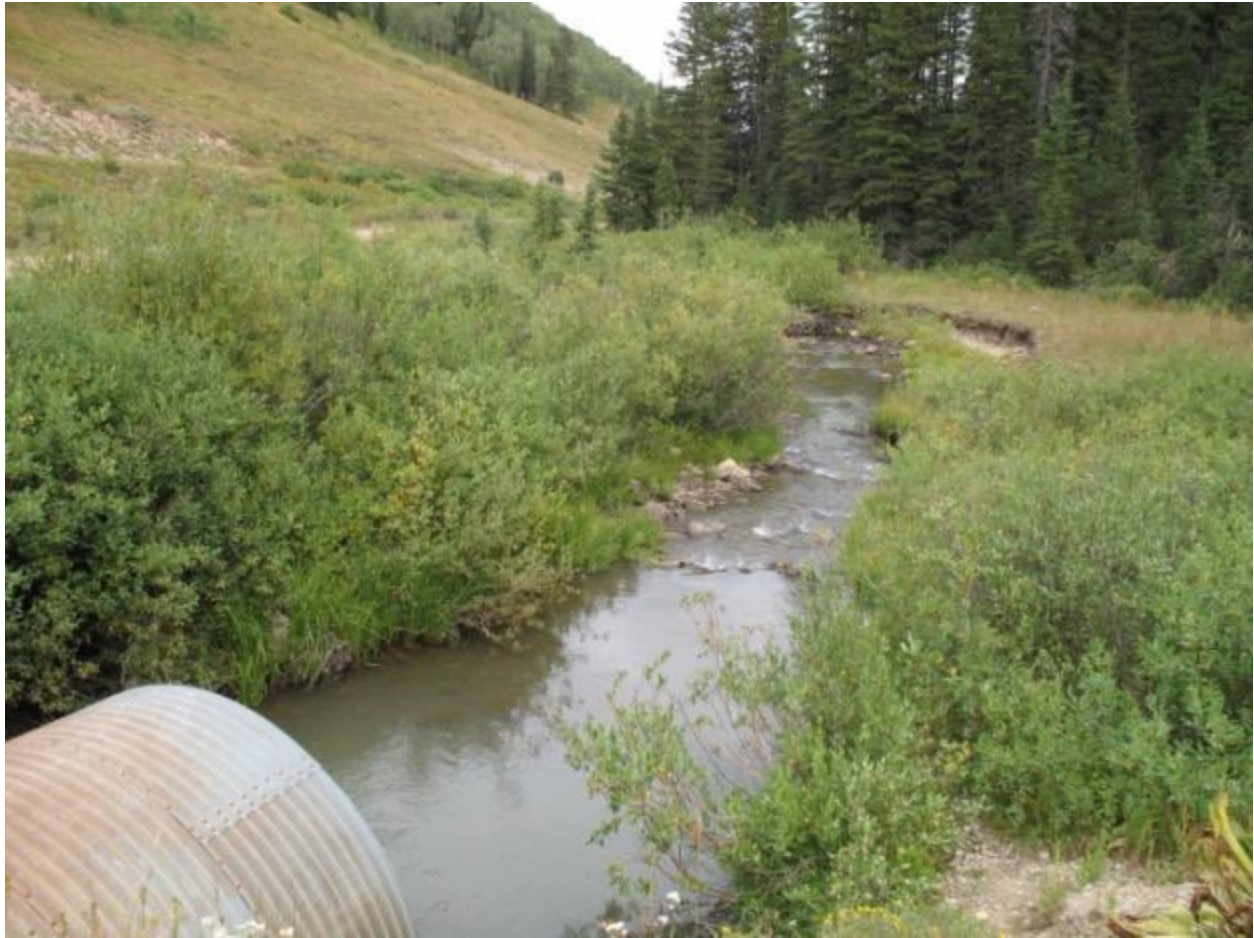
Photograph 13. Photograph taken Fall 2009 from Coal Creek looking downstream from Splains Road. Note Kebler Pass Road impinging on the wetlands on the left hand side of the photograph, the culvert on the lower left hand corner of the photograph and the turbid water with sediment from road maintenance.

Road removal is not a viable option but the use of Best Management Practices or paving to reduce fine sediments entering this section of the stream is recommended. The use of “Bottomless Arch” culverts increases streambed habitat, reduces rapid water flow and may allow for easier fish passage. These impacts are large and the sedimentation affects downstream creek segments thus restoration in this area should be a priority.

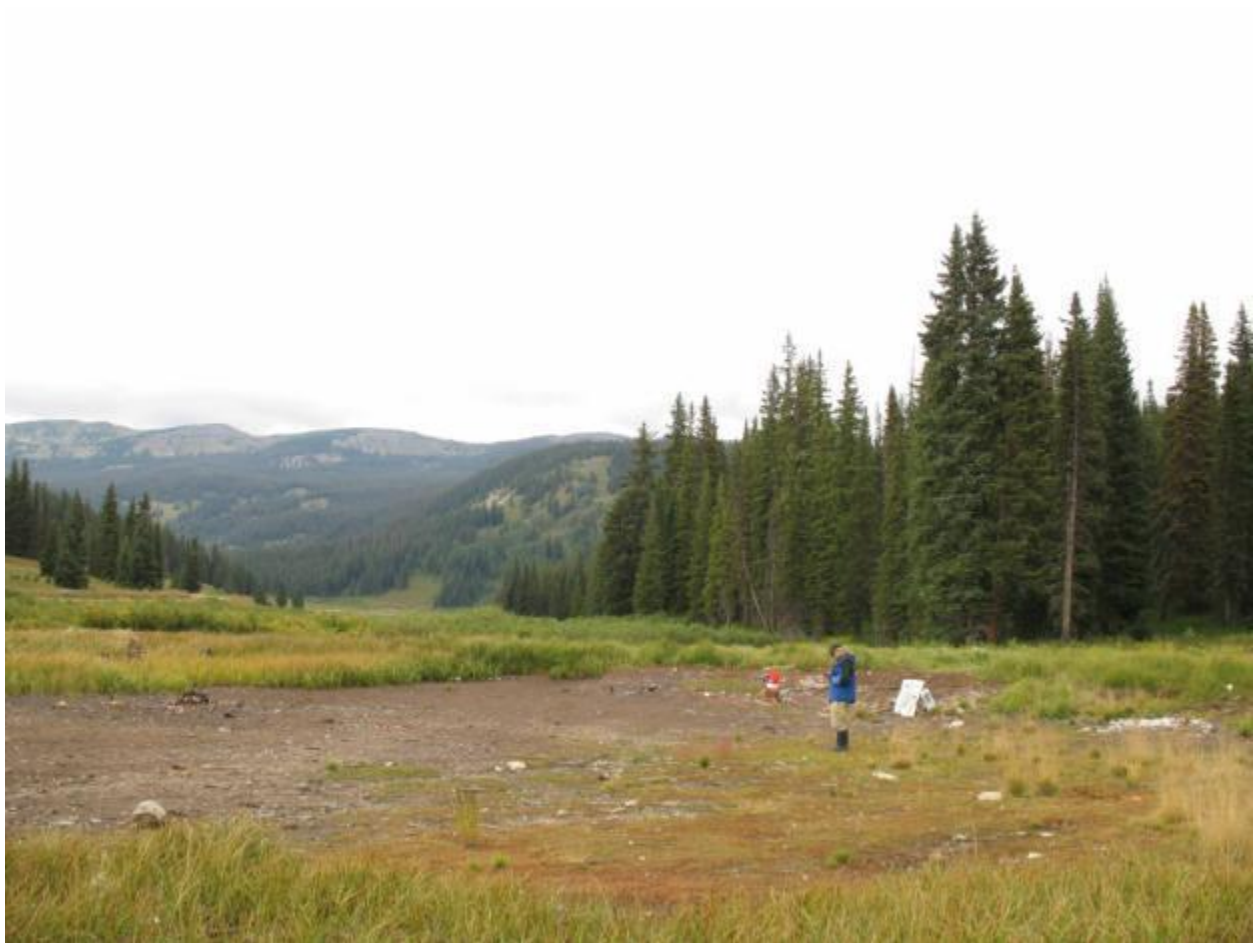
Photograph 14. Photograph taken Fall 2009 at the Kebler Lumber Mill/The Ender Lumber Company (TELCO) mill site that is surrounded by wetland vegetation and hydrology. Wendy Brown is taking GPS reading and note the trash left behind by recreational shooters.

We recommend this area receive high priority for restoration since impacts here also affects the downstream functioning of Coal Creek. It appears that the ground is saturated below the sawdust and thus removing the sawdust, trash and planting locally harvested wetlands plant seeds could restore this area. A water table and soil study should be done that a wetland can be feasibly established prior to proceeding. Additionally, to make this restoration successful, the area should be temporarily closed to human traffic to allow the plants and hydrology to re-establish. This should involve signage and directing recreational shooters to a nearby, more appropriately planned area outside of wetland habitats.

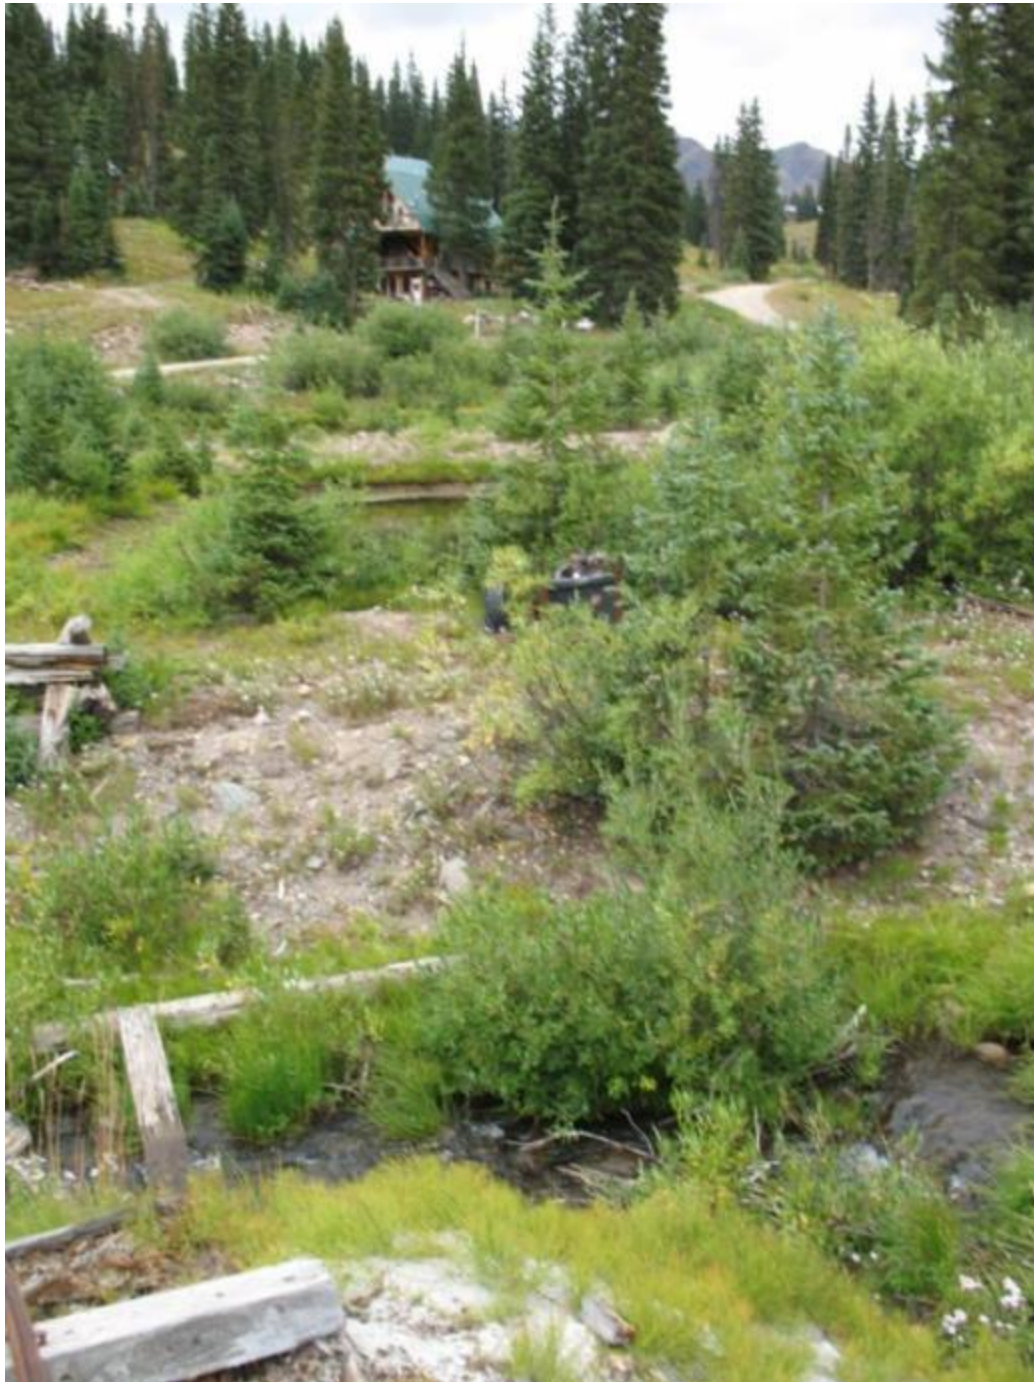
Photograph 15. Photograph taken Fall 2009 of Coal Creek at the Forest Queen Mine Site. Note the altered stream path, the lack of riparian vegetation and the mine waste in the creek and riparian zone.

This is one of the most altered and impacted stream segments in the watershed. Restoration of this segment would involve removing the mine waste, analyzing sediment for toxicity, restoring the original channel, removing the ponds, and replanting riparian vegetation. These restoration costs are probably higher than in other stream segments but the benefits would be great since this is a headwaters zone where riparian function is of high value and there is potential impacts on downstream communities should the condition continue or worsen. Additionally, pond dam failure and sediment release could be a hazard. The Colorado Division of Reclamation, Mining and Safety and federal entities could be a useful partners in this restoration since it is an abandoned mine.

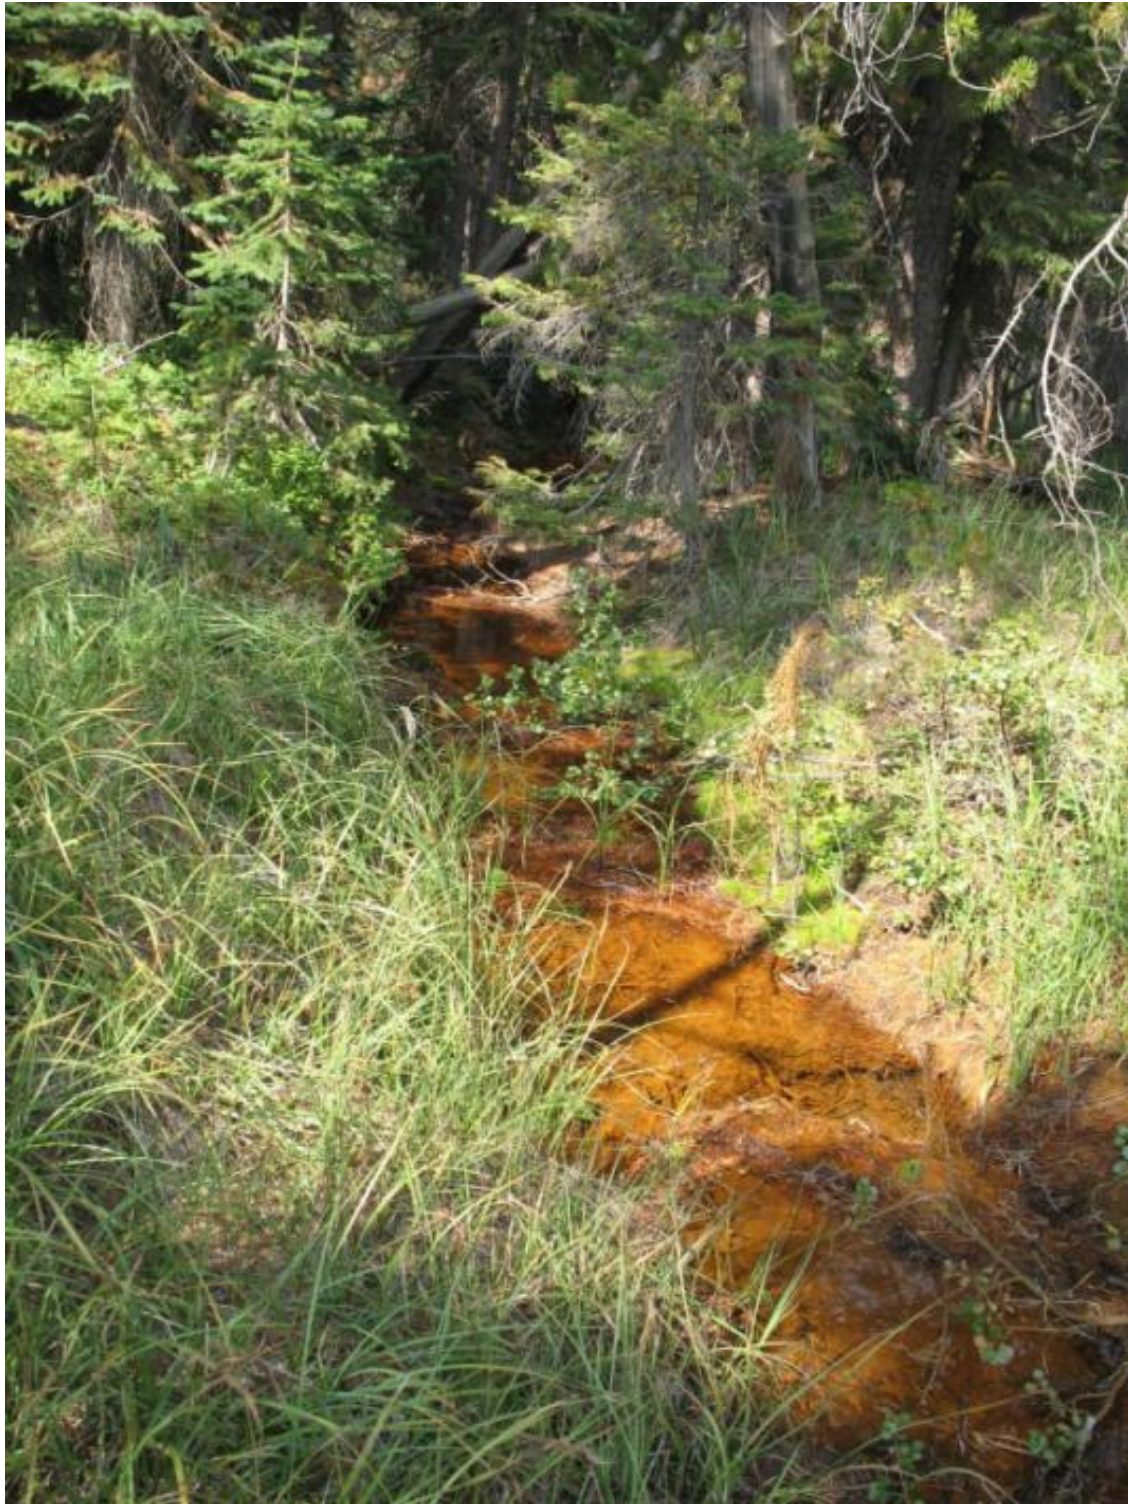
This riparian areas flows out of the Mount Emmons Iron Fen (Photograph 16), across Kebler Pass Road and into Coal Creek. Historically the outflow was channelized (Photograph 17) to divert its flow to the west and down a drainage to prevent it dispersed flow across a slope above Kebler Pass Road. The historical flow pattern caused slumping onto the road and it caused increased road maintenance and safety issues. However, this channelization and relocation of the flow caused a loss of wetlands and riparian communities across a large area and multiple small drainages. Currently, the diversion is clogged by downed trees and the water has recently ceased flowing in lower reaches of the diversion and has returned to areas, including peatlands, of its historical flow. This is naturally restoring the wetlands and riparian zones of its historical drainage but this natural restoration could be assisted by closing the ditch and returning the flow to its natural wetlands and riparian zone.

Photograph 17. Photograph taken Fall 2009 of Mount Emmons Iron fen pond diversion that diverts water away from the wetlands and riparian zone towards a different drainage.

We recommend that for maintaining wetlands and riparian habitats that this natural restoration continue and the flow not be returned to the diversion. However, the road
