Assessement of Riparian and Aquatic Habitat with the Coal Creek Watershed, Gunnison County, Colorado.

Prepared for

Coal Creek Watershed Coalition (CCWC)
c/o Crested Butte, P.O. Box 39
Crested Butte, Colorado 81224

December, 2009

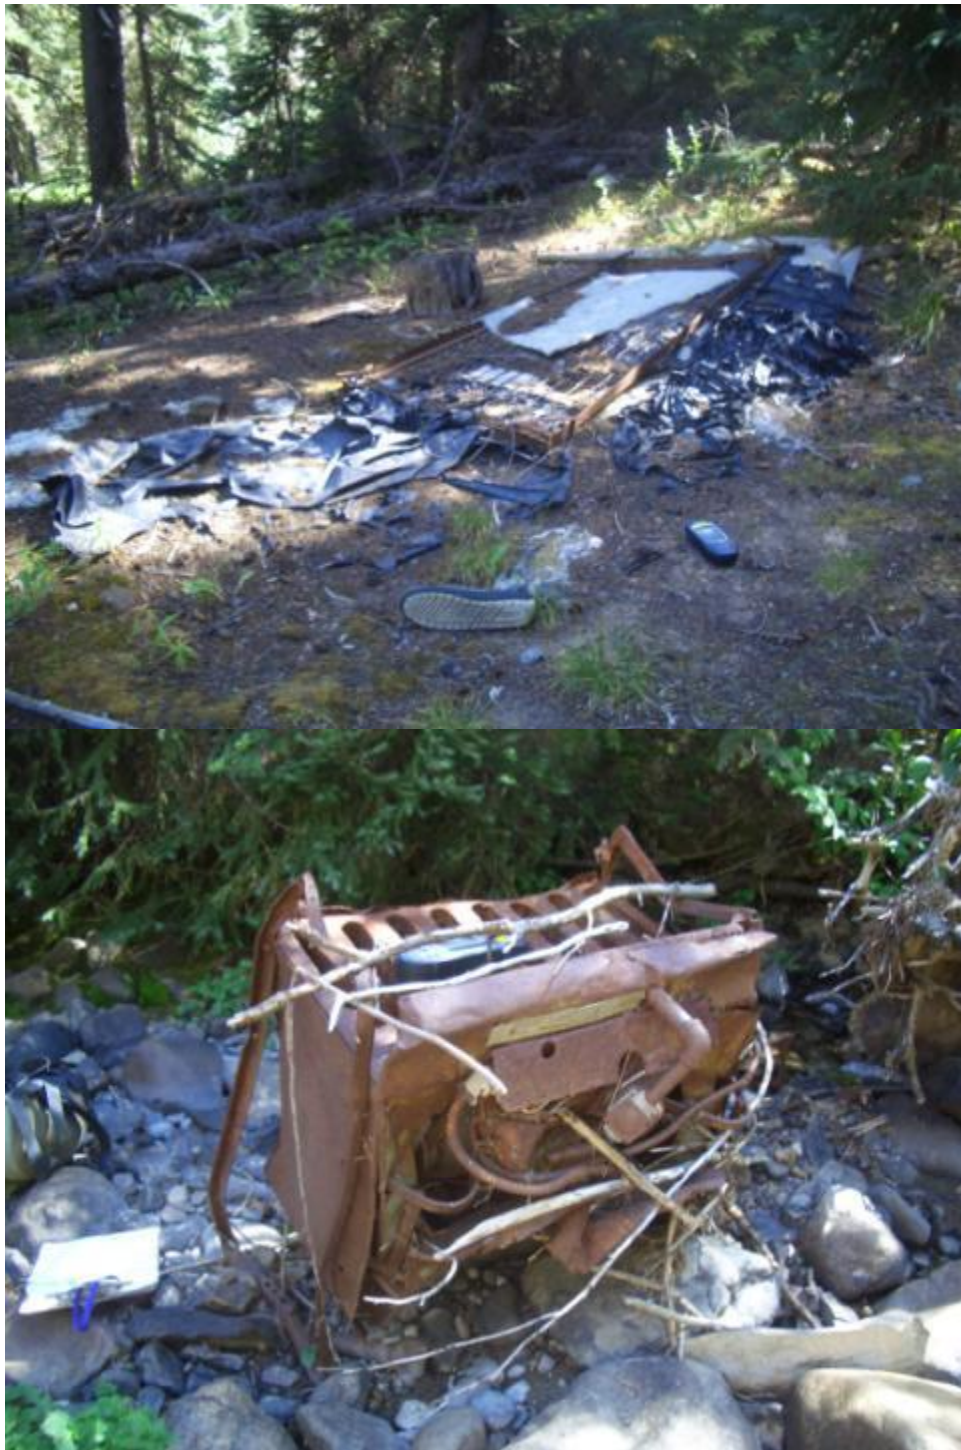
Of low priority, is the removal of trash within the riparian zone of Coal Creek and tributaries. During our assessment, we noticed several areas where trash occurred. Though none of this trash appeared to be hazardous waste or pose a major risk to water quality or riparian vegetation they are an aesthetic issue that can be removed easily with minimal expense and through the organization of volunteers for a trash removal. These areas of where large amounts of trash (Photograph 20) can be found are shown on Map 4.

Photograph 20. Photographs taken Fall 2009 of representative trash found in Coal Creek and its riparian zone.

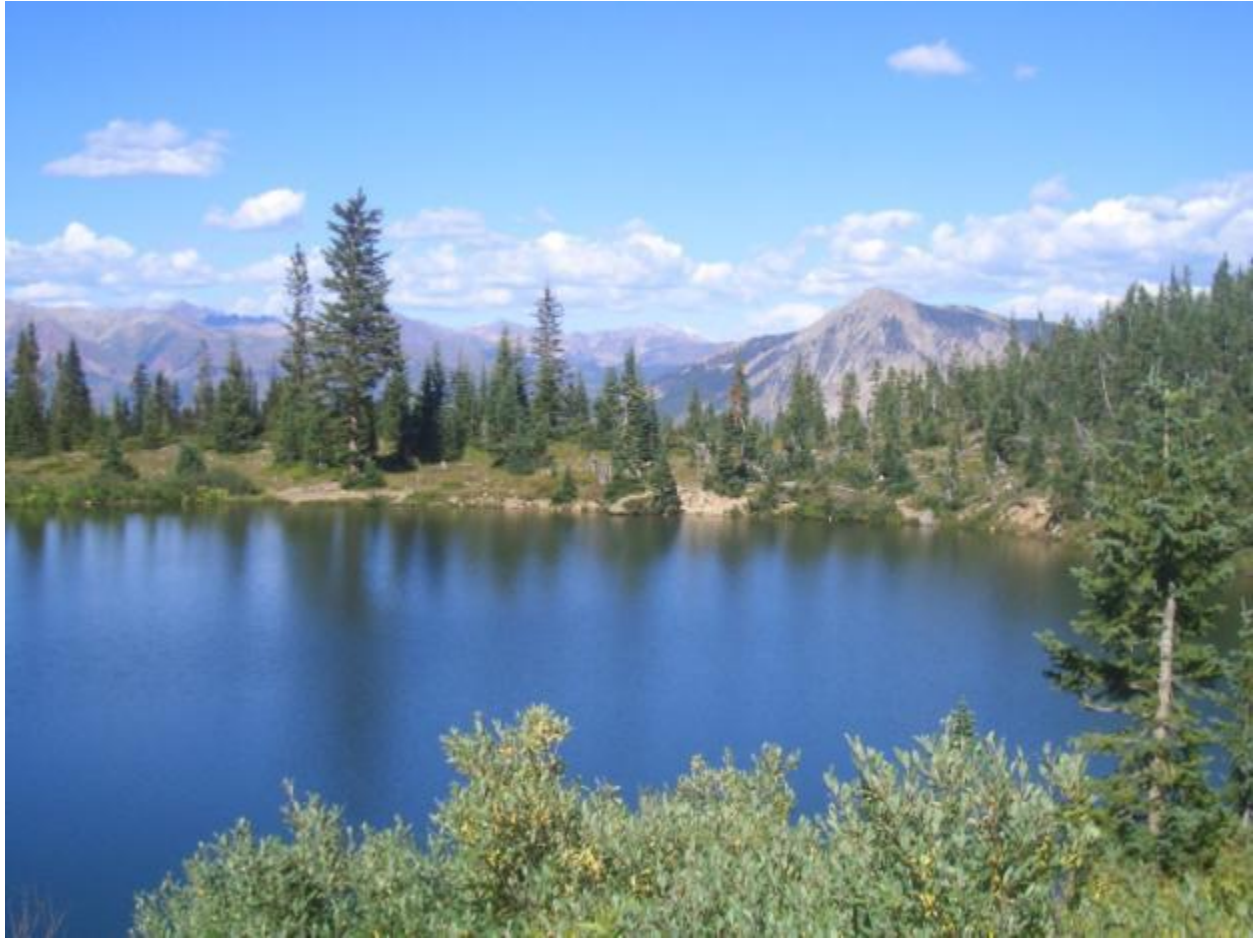
Photograph 21. Photograph taken Fall 2009 of Green Lake. Notice the bare ground under the tallest tree towards the left and other bare spots to the left due to heavy recreational use of the riparian zone.
