Colorado Healthy Rivers Fund Grant 2009 - 2010
OE PDA 10000000038 Line #001

FINAL REPORT

Project Sponsor:

Coal Creek Watershed Coalition
PO Box 39
Crested Butte, CO 81224
www.coalcreek.org
(970) 596-7496
director@coalcreek.org

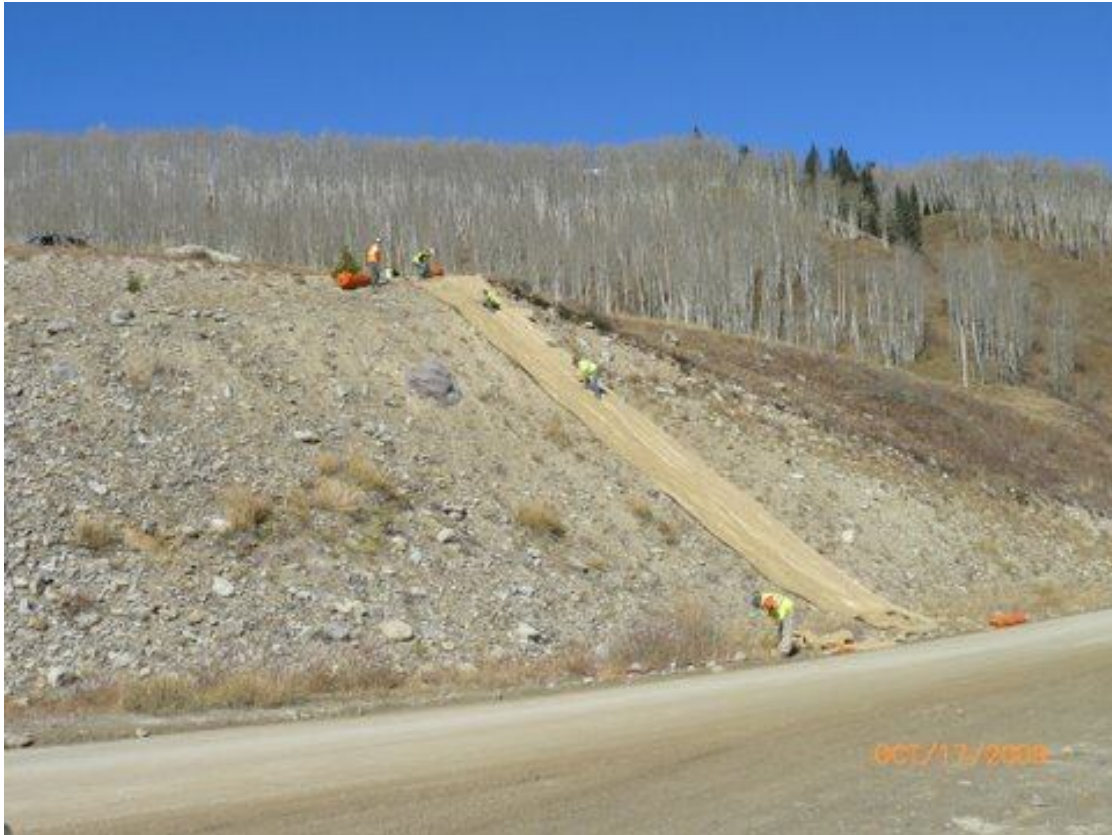
In 2009, the CCWC installed a series of rock check dams with sections of stilling basins and reinforced vegetative swales (Figure 2). In June of 2010, CCWC staff, contractors and volunteers removed sediment from the stilling basins rock check dams installed near mile-marker 30 on County Road 12. In all, over 4.9 tons of sediment were removed by this series of rock check dams captured during erosion periods between the fall of 2009 and June of 2010. For modeling purposes, these estimates should only be used in areas with highly erosive slopes with less than 10% vegetative cover. Though funding from the CHRF is exhausted, additional studies and BMP implementation have continued in 2010 to help further protect the watershed.

Figure 2 - Erosion control mats being installed in the Coal Creek Watershed near Crested Butte, Colorado, in 2009.

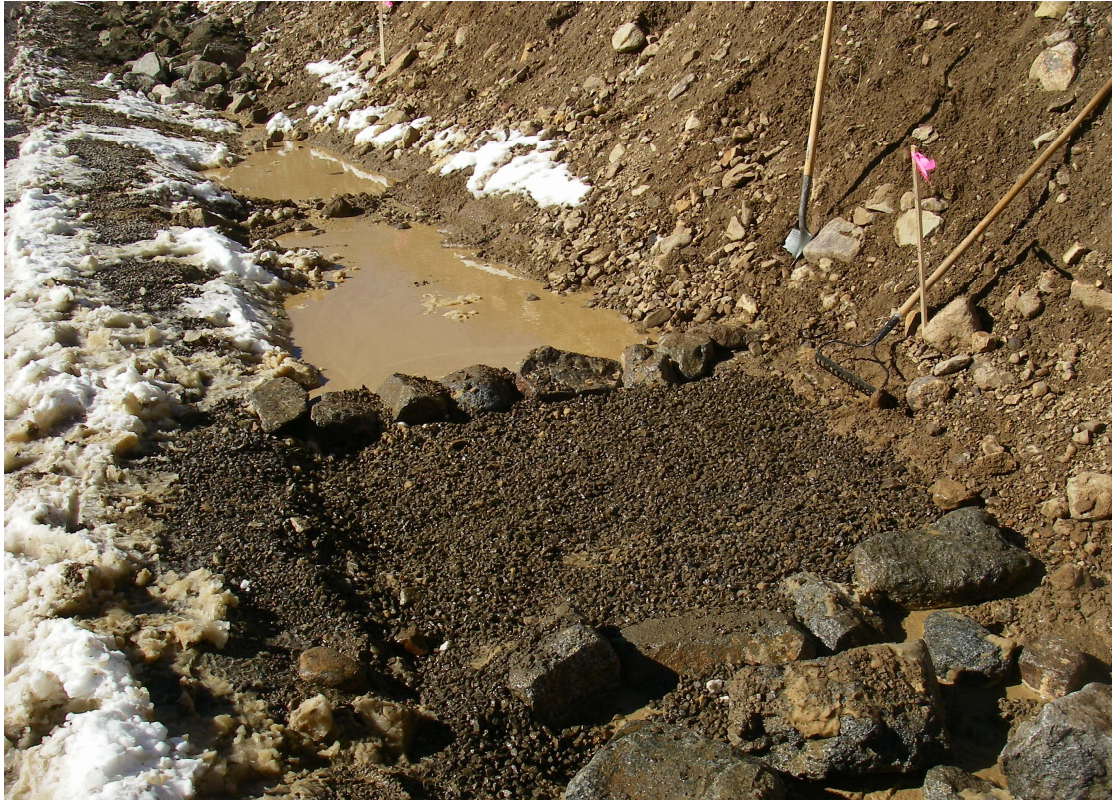
Figure 3- A rock check dam with an upstream stilling basin and downstream reinforced vegetative swale near Crested Butte, Colorado. A larger cap rock was installed to complete the check dam.

During 2010, additional best management practices (BMPs) have been implemented along Kebler Pass Road to reduce sediment and chloride transport to Coal Creek (Figures 3 – 6). These BMP will be assessed to determine sediment capture efficiency. The CCWC will continue to work with the Gunnison County Public Works Department to implement these BMPs and to follow efforts related to road maintenance practices in other parts of Colorado.

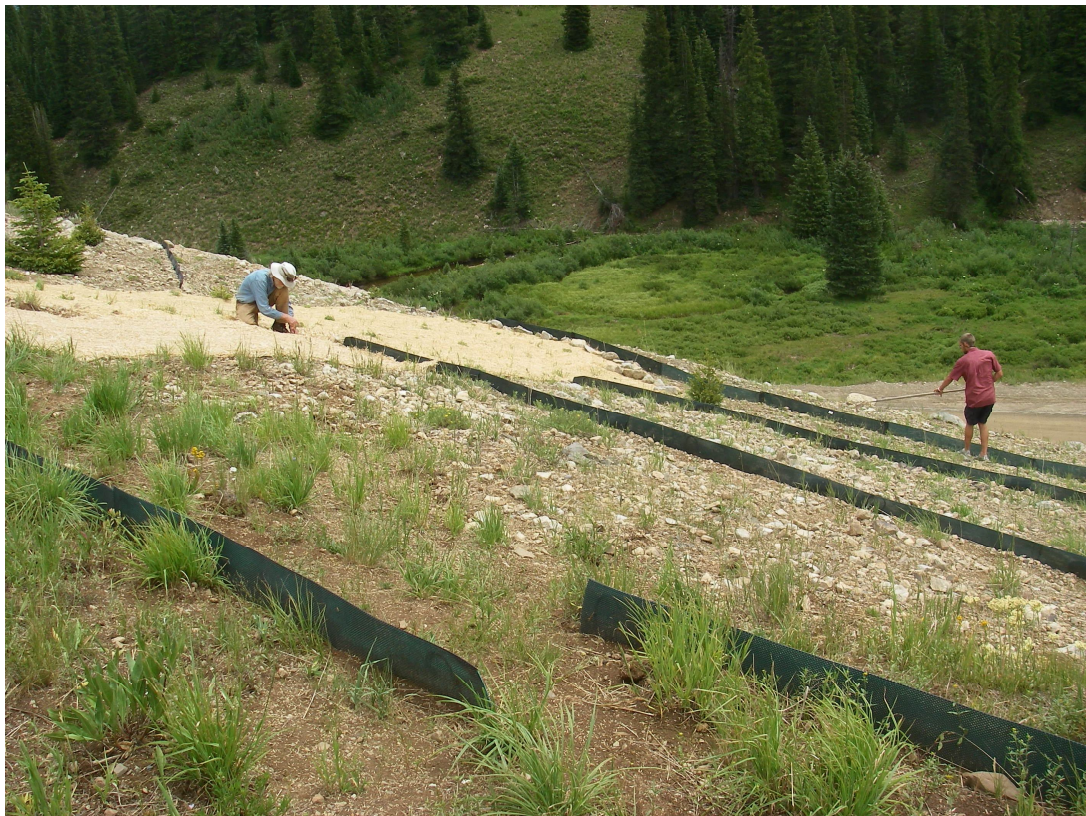
Figure 4 – Erosion control mats and “s-fence” being installed to address erosion on slopes in the Coal Creek Watershed, near Crested Butte, Colorado.

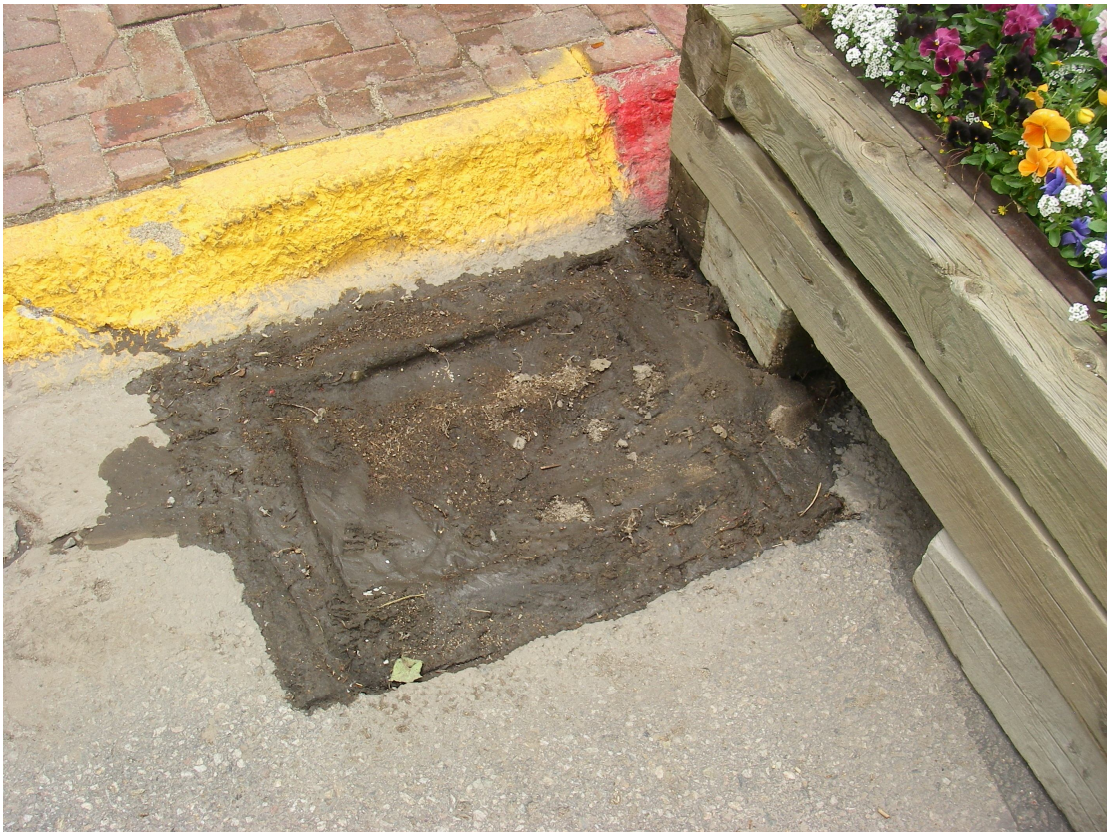
Figure 5 - "Grate guard" filters used to capture stormwater contaminants on Elk Ave in Crested Butte, Colorado.

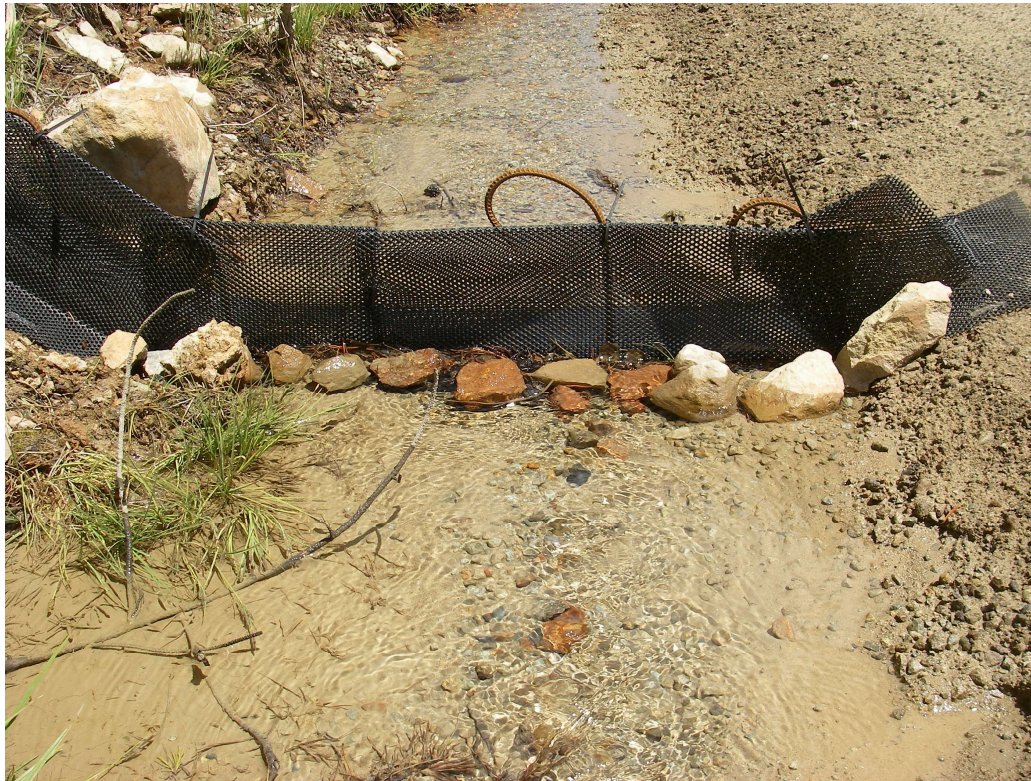
Figure 6 - "Ditch guard" check dams used to reduce roadside runoff on Kebler Pass Road near Crested Butte, Colorado.
