# FINAL REPORT RIVER RESTORATION PROJECT 2009 BLANCO RIVER NEAR PAGOSA SPRINGS, CO

# Submitted To: Colorado Water Conservation Board July 7, 2010

Submitted By:
LOWER BLANCO PROPERTY OWNERS ASSOCIATION

# Lower Blanco River Restoration Project Summary 2009 Phase V

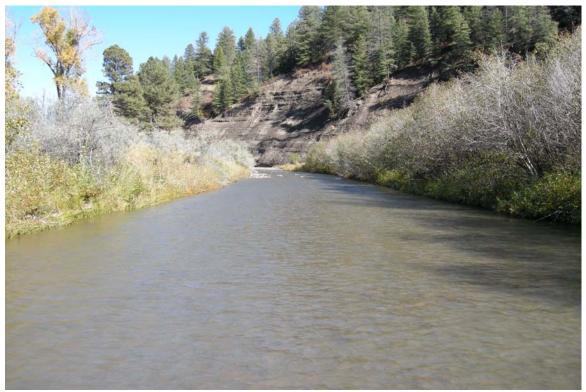
Photo 1. Typical wide shallow channel of a pre-restoration section.

The change in the river hydrology has had a significant impact on the overall health of the Blanco River system. The wide shallow channel lacks the shear stress required to move the larger sediment particles in the system. This has contributed to sediment deposition, increased erosion, and could potentially increase flood stages. The water quality is compromised by an increase in temperature due to wide shallow stream segments. Increased water temperatures lead to a decrease in dissolved oxygen. The fish habitat is negatively affected due to lack of deep cool water and the accumulation of fine sediment in potential spawning gravels during low flow. To offset the effects of the change in river hydrology and resulting changes in river form, the project design consists primarily of channel shaping and fish habitat construction.
