Hartland Diversion Dam Fish Passage

Final Report

Submitted by:
Painted Sky Resource Conservation and Development Council, Inc.
P.O. Box 208
Delta, CO 81416
(970) 874-3379

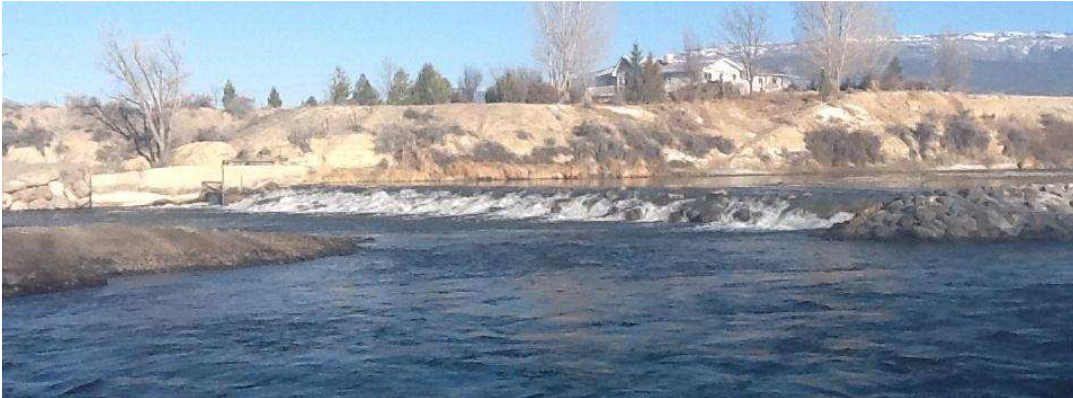
Figure 7 – Dam Modifications

The remaining section of the existing Hartland Dam, approximately 150’, was modified to improve the structural stability and reduce the hazard to river users. A roughened grouted boulder slope was constructed extending from the face of the existing dam downstream approximately 20’. Painted Sky and Hartland Irrigation Company worked directly with Kissner General Contractors to develop the dam modifications. MWE did not provide the design, engineering or construction observation for the dam modifications.

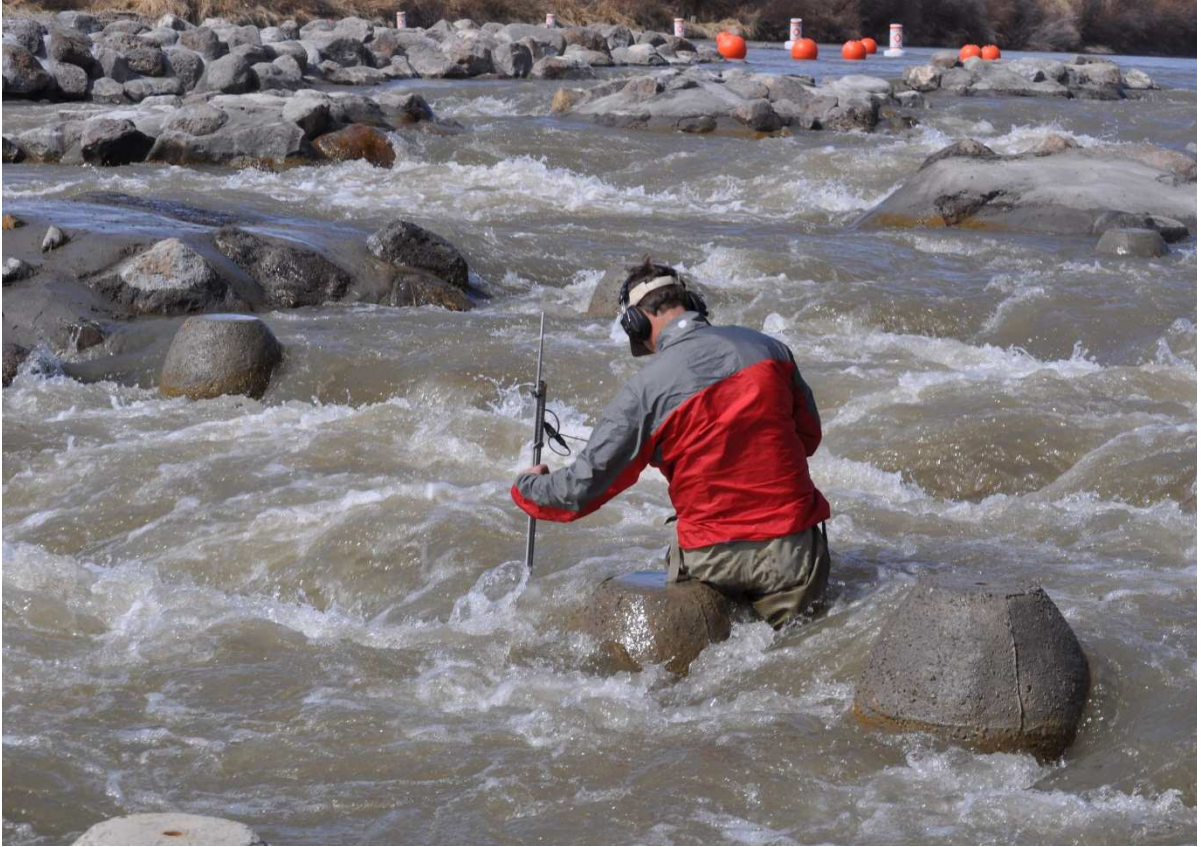
Figure 8 – Monitoring: Velocity Measurements in Chevron Channel

MWE and TU have developed preliminary protocols for monitoring. Periodic site inspection of the structure and project reach will be conducted to monitor and evaluated performance and conditions over a range of river flows. Fish passage monitoring will include measurements of velocity and depth and inspections for debris. Hydraulic conditions are to be observed in the boat passage particularly for conditions that pose safety risks, such as, debris accumulation, “keeper” waves, and flow alignment. Observations of the sloped grouted boulder dam modifications (west side) for similar safety risks will be conducted including inspections for the presence of a reverse roller keeper hydraulic at the toe of the dam. Debris accumulated on the dam or boat and fish passages will be removed immediately due safety concerns and negative performance implications. Cary Denison of TU has conducted two site visits to perform monitoring of the project. Velocity measurements are included in Appendix C.

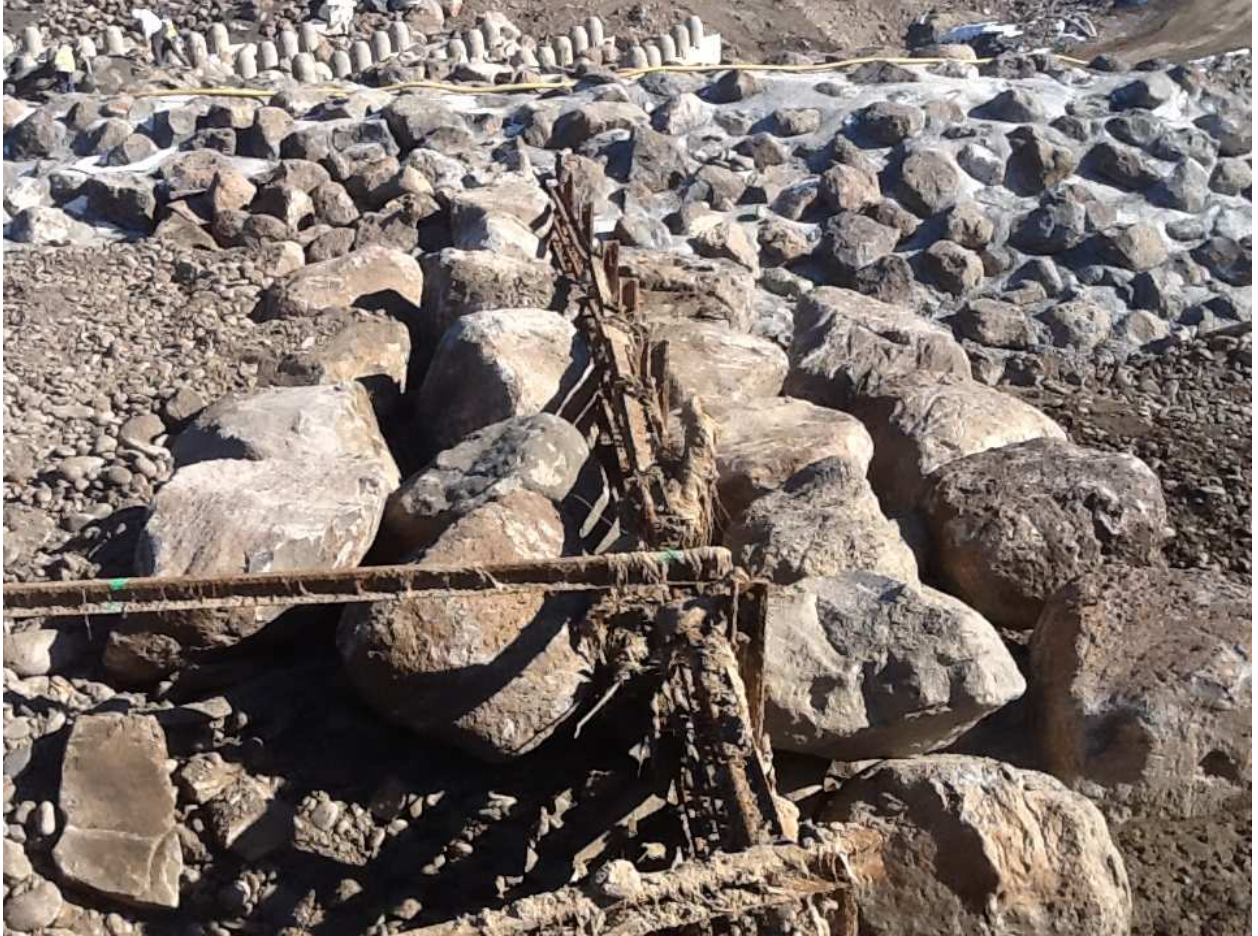
Dam modifications to remaining existing dam

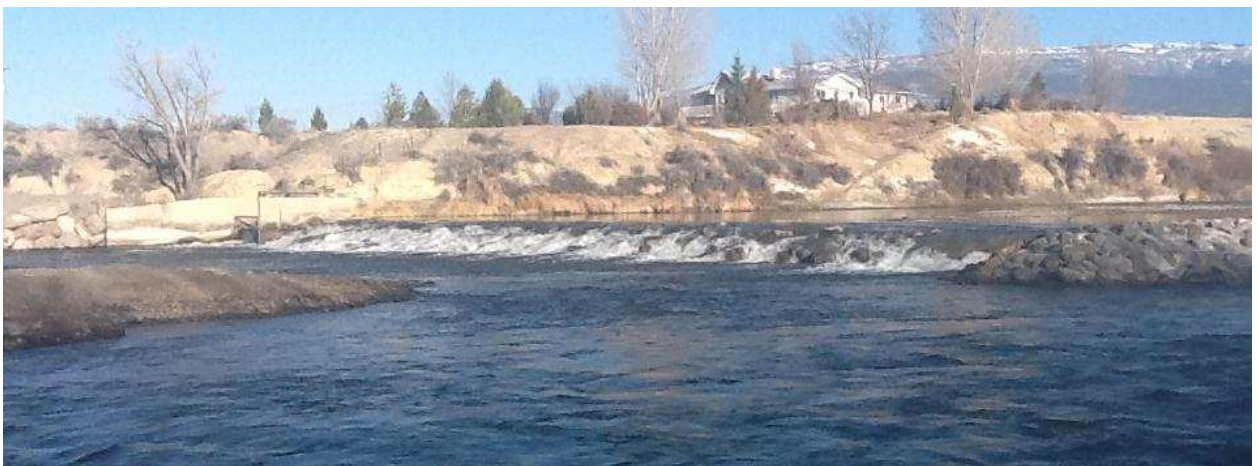
Dam modifications completed.
