**RE: MOLAS LAKE PROJECT**  
**Town of Silverton, Colorado**  
**Identification #SPK-200675417**

# Second Annual Mitigation As Built Report

Molas Lake Project  
Town of Silverton, CO

Identification # SPK-200675417-DC

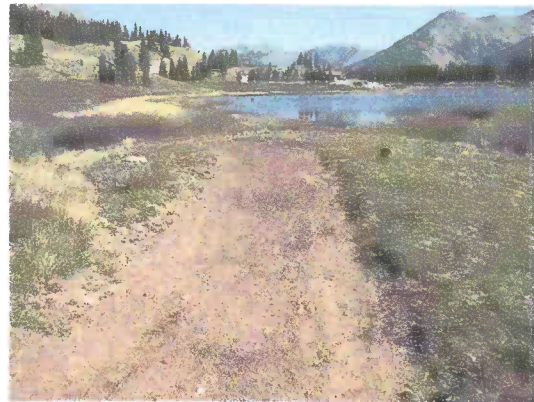
Mt-7 (2008 after transplants)

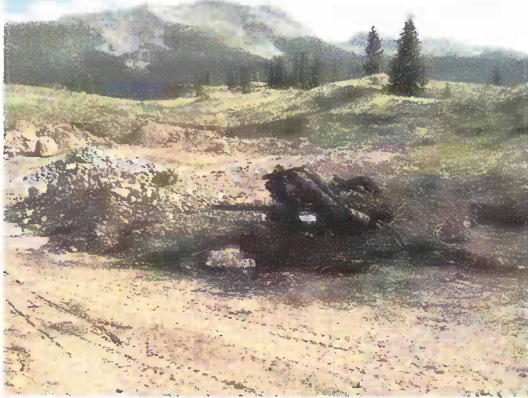
During dam embankment construction (Action I), a depression was created in an upland area from here forward referred to as Mt – 8. In the fall of 2009 the area was compacted and soil was added in hopes that water would collect in the area and be able to sustain a wetland community. It was seeded with hairgrass (*Descampsia caespitosa*), a hydrophytic native grass. This depression retained surface water up to 1' in depth throughout the growing season of 2010 and a substantial cover of the hairgrass was developed. This could result in a bonus wetland to ensure a higher ratio of created wetlands than the 1.5 to 1 originally anticipated.

Mt-8 Barrow pit area (2009)

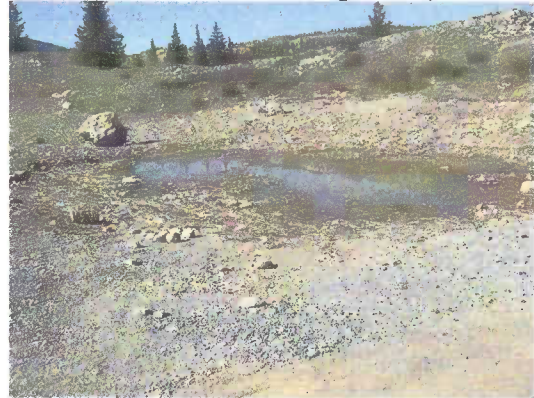
Mt-8 Barrow pit w/wetland feature (2010)
