**Re: Colorado Water Conservation Board (CWCB)
Helena Diversion Structure/ BV Boat Chute Improvement
Project Arkansas River Basin Phase 2
UAWCD Reimbursement --\$43,125.00**

Field Inspection Reports
&
Project Photos

Field Inspection Report

PROJECT: Helena Ditch Diversion Dam & Headgate Phase II		
JOB NO: 572.12	WEATHER: Pcloudy 45° 11:30 am	DATE: Thursday, feb-27-2014
CONTRACTOR PERSONNEL: ACA (general contractor) Foreman Justin Koch, 2 laborers		
CONTRACTOR EQUIPMENT: Excavator		
Inspectors: Shaun Gordon CDPW		
SUMMARY OF CONSTRUCTION ACTIVITIES: <ul style="list-style-type: none">- ACA was installing gate, approved sealing gate frame with sealant instead of grout pad. Lift mechanism base plate provided by manufacturer needs to be replaced in order to operate gate, ACA contacted manufacturer to ship new base plate. Gate to be grouted into channel invert concrete block out.- Noted damage to top of riverside concrete wall near bypass turnout. ACA to grout repairs.- Bypass channel to river constructed ok, recommended extra rock on site be placed near channel outfall.- Reviewed past inspection reports by Shaun Gordon prior to visit, bar spacing's o.k.. reviewed temperature and concr

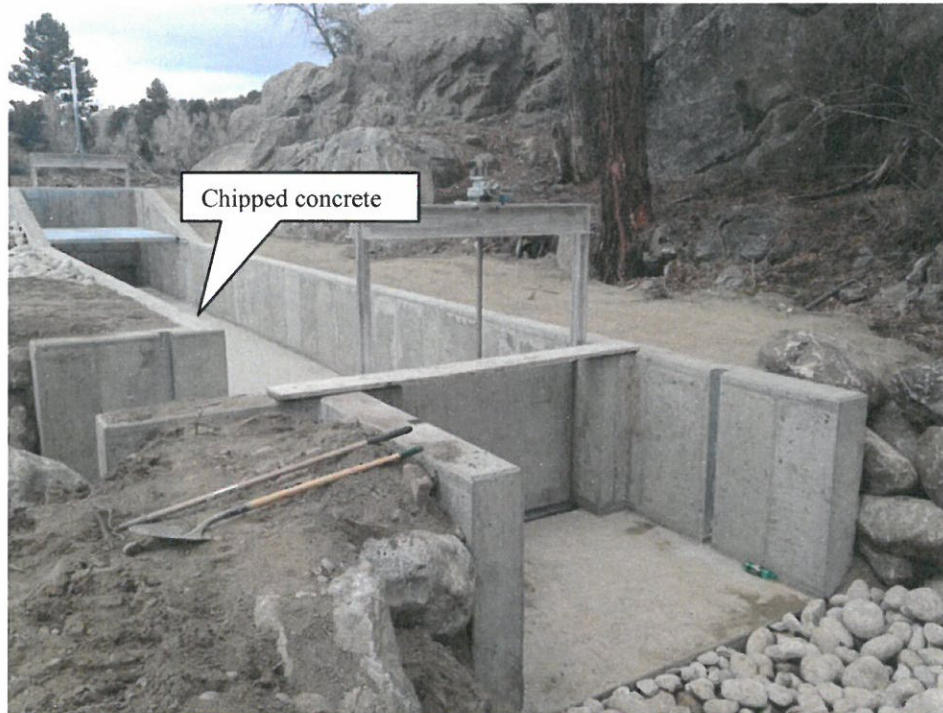
Phase II Concrete Channel & Gate

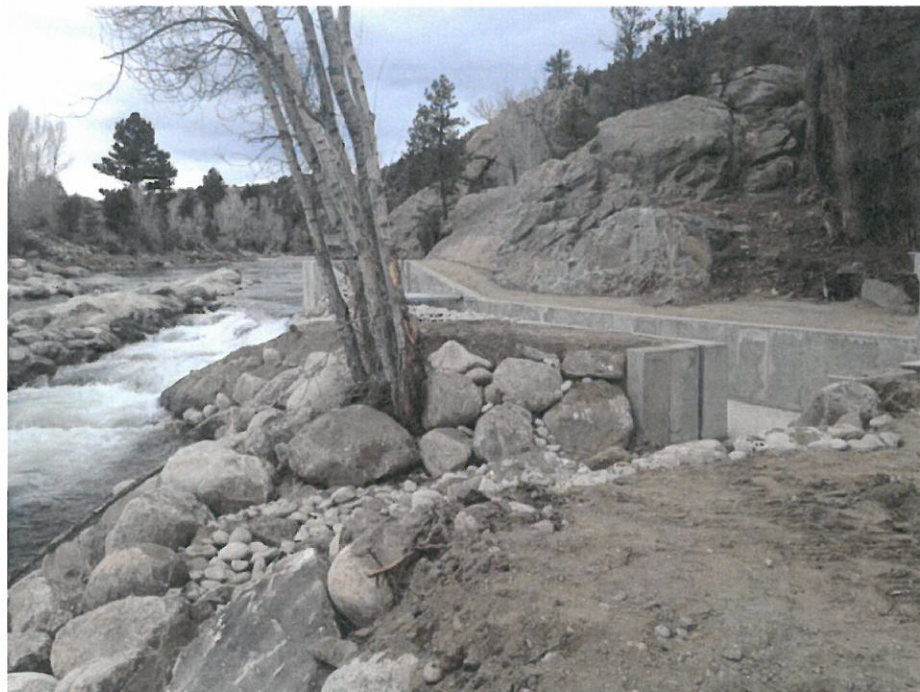
Bypass Channel to River

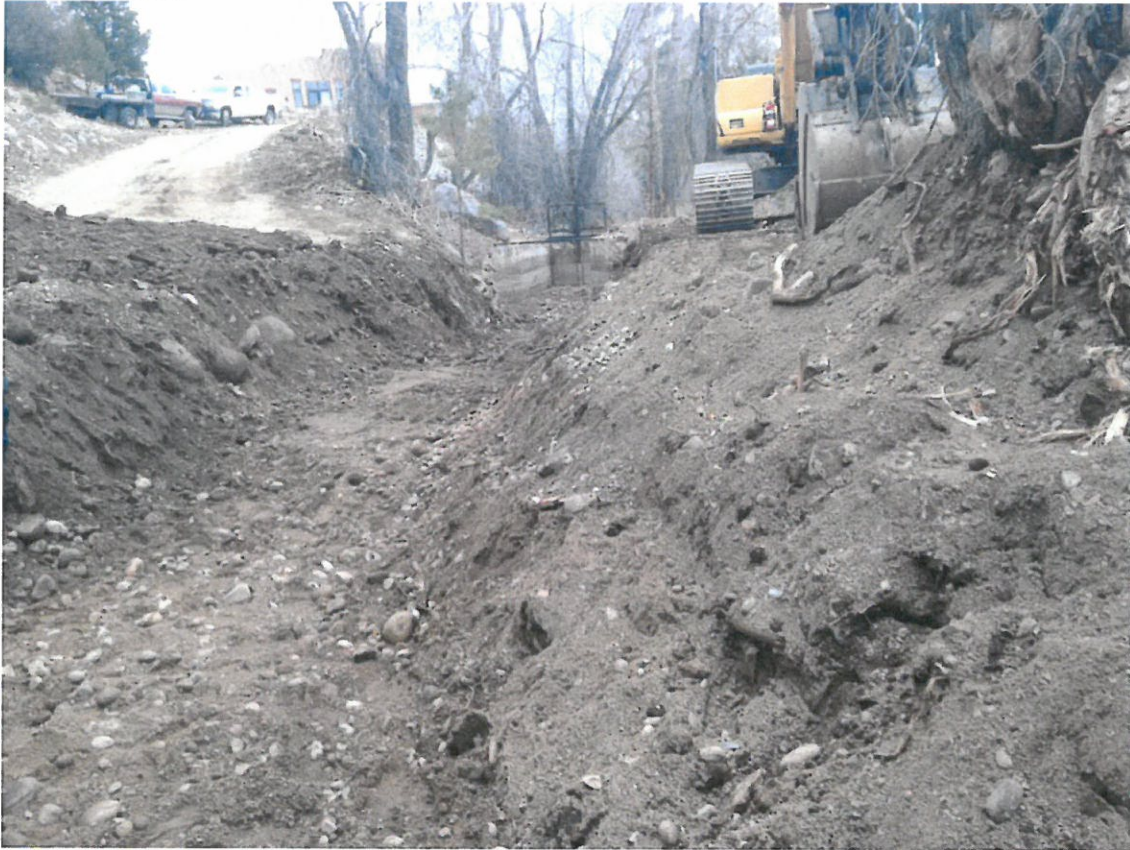
Excavating Ditch between Phase II and Downstream Bypass Structure

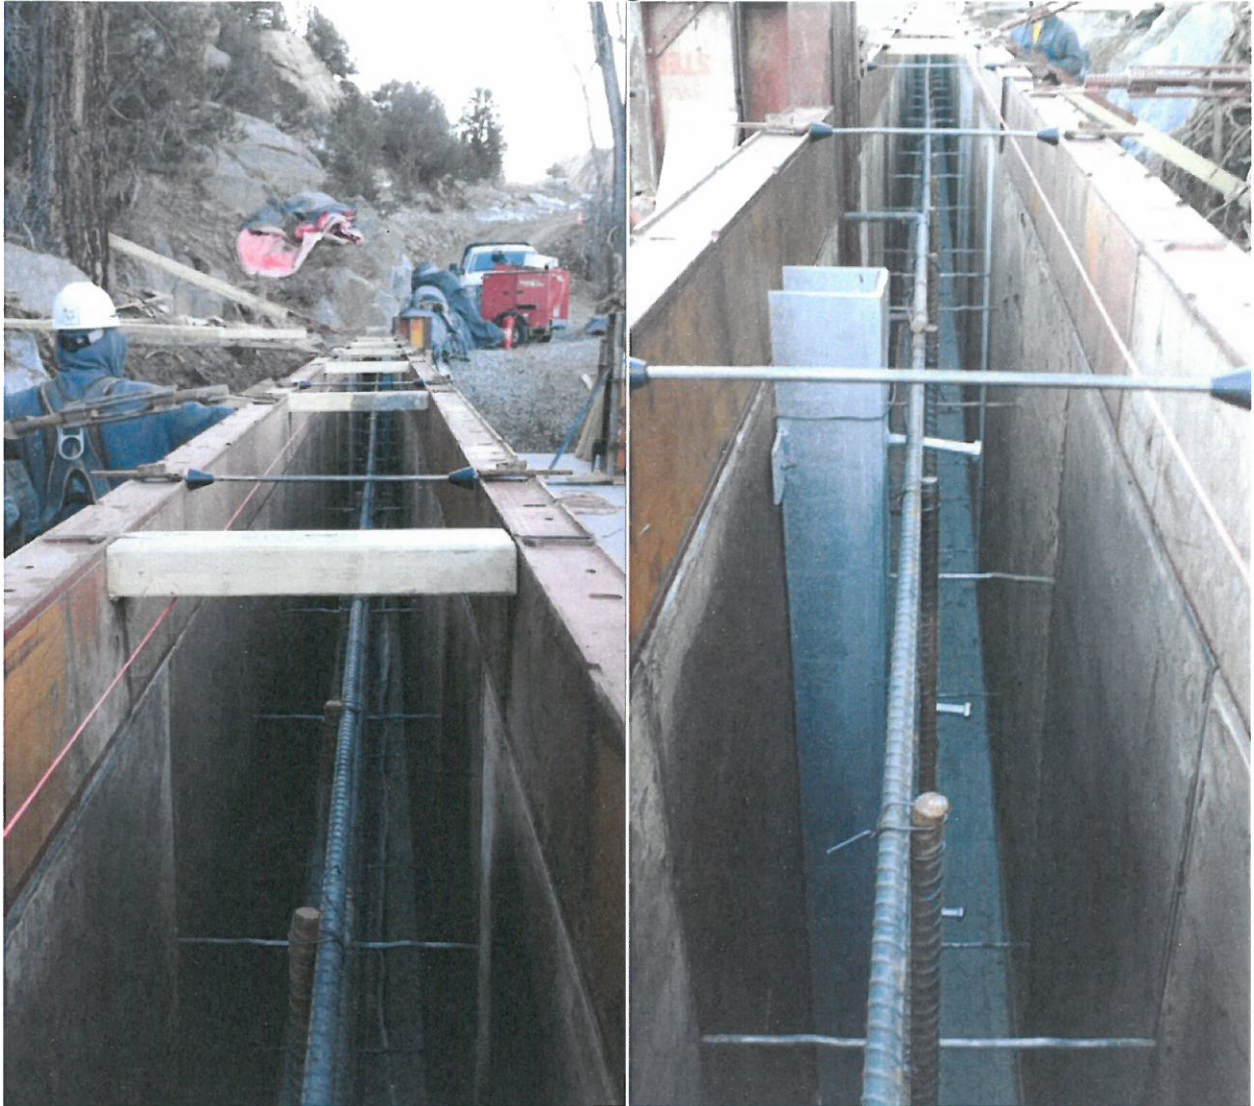
Results of Inspection: Checked form and rebar layout/dimensions, concrete placement, vibration, consolidation and finish work. Appears to meet or exceed minimum requirements of the plans and specifications.	
Other: ACA anticipates forms off by Wednesday and installing gate and backfill operations to take place week of Feb. 24 th .

Wall Forming & Rebar

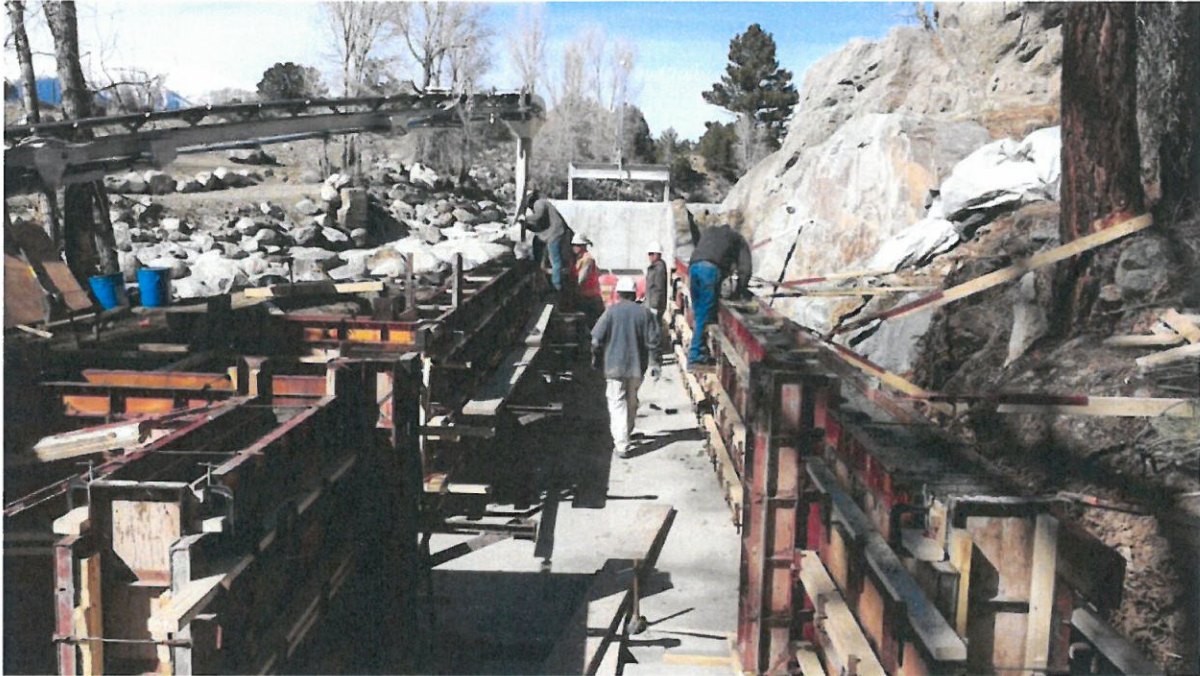
Concrete pour of wall

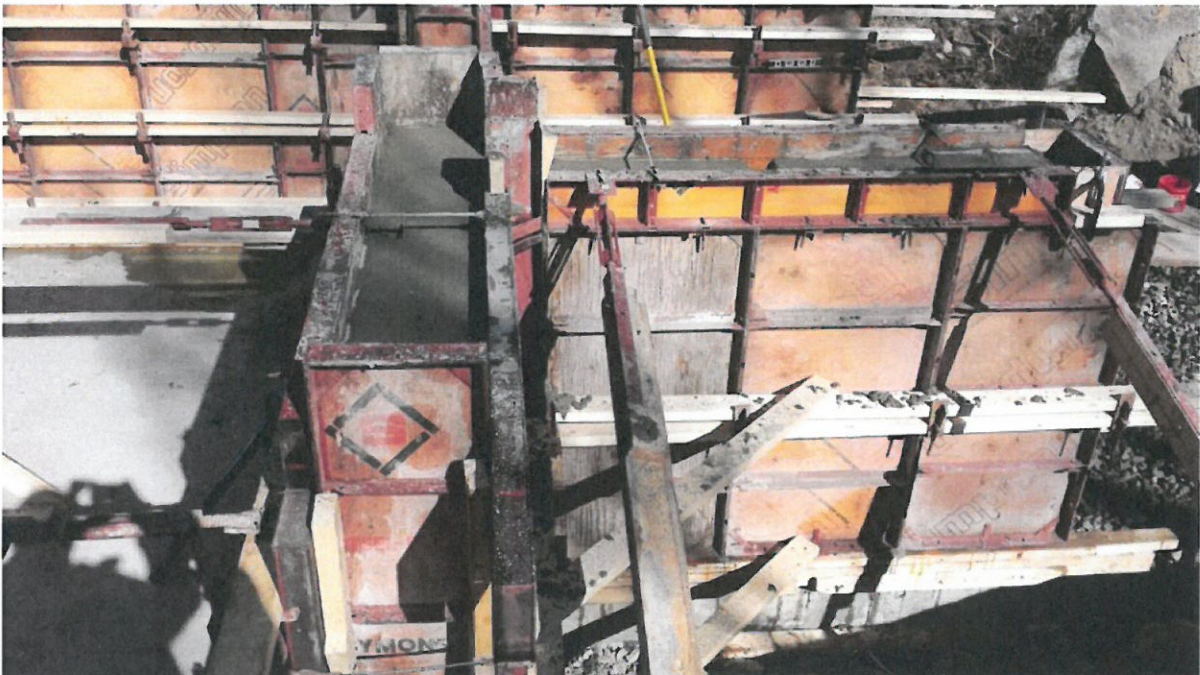
Concrete pour of wall

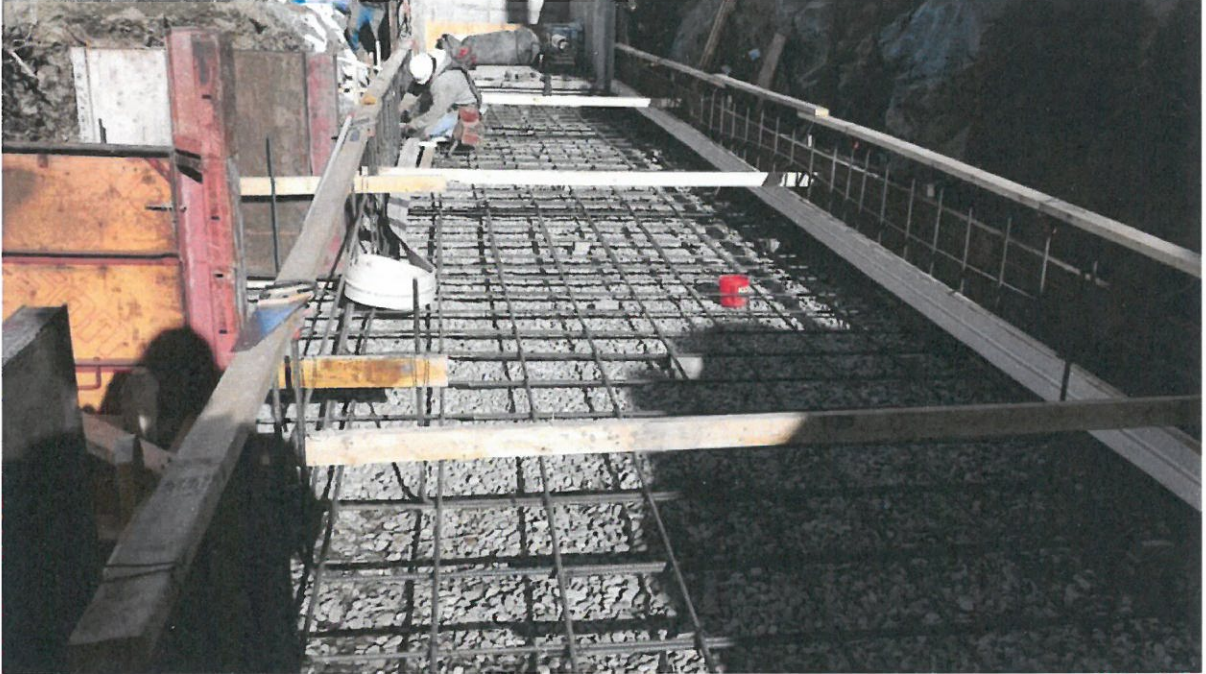
<p><u>Results of Inspection:</u> Checked form and rebar layout/dimensions, concrete placement, vibration, consolidation and finish work. Appears to meet or exceed minimum requirements of the plans and specifications.</p>	
<p><u>Other:</u></p>

Forming & Rebar

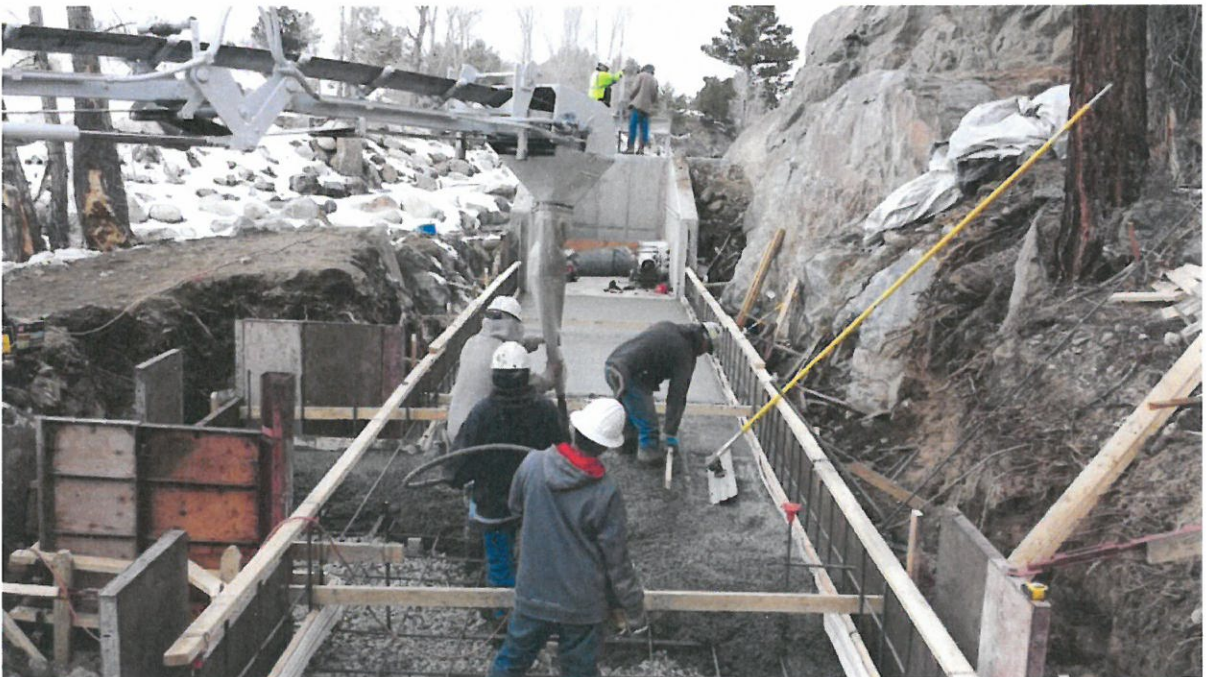
Concrete pour of floor

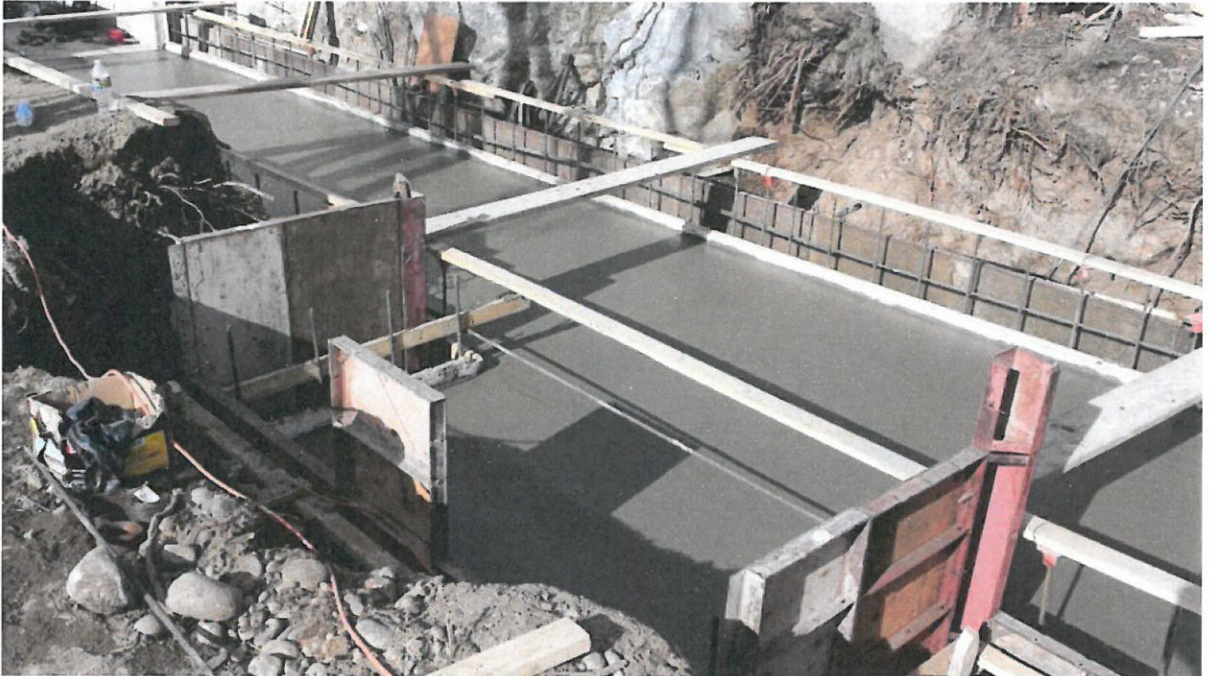
Concrete pour of floor

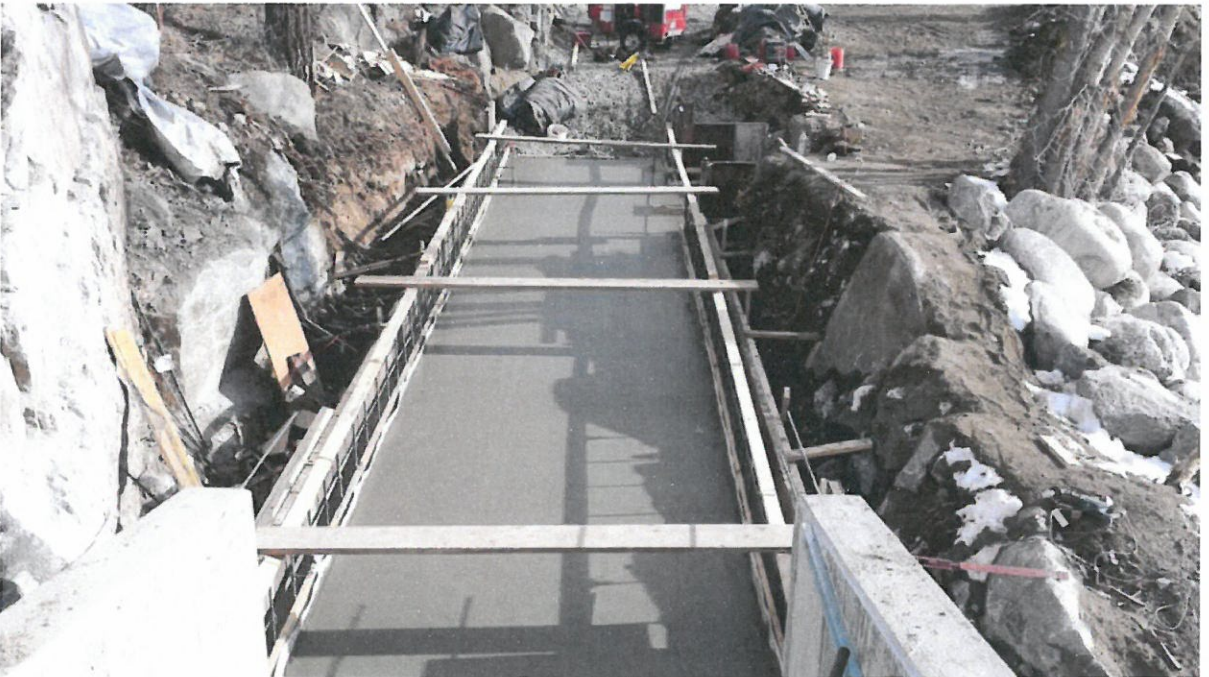
Concrete pour of floor

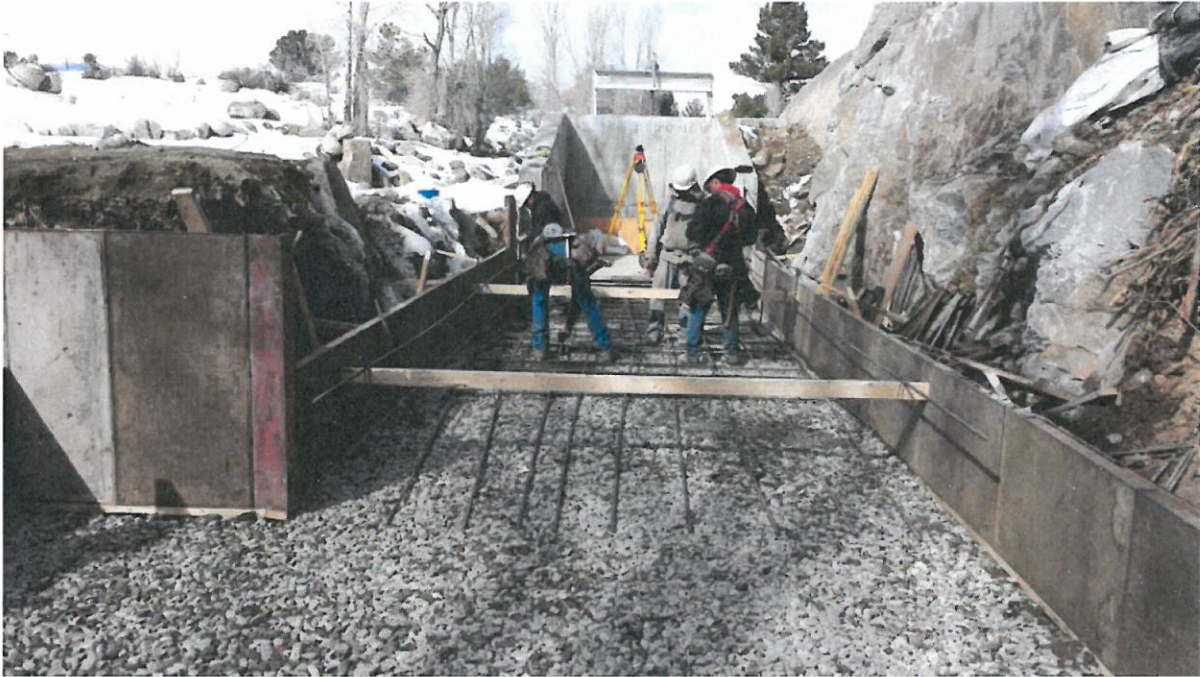
<u>Results of Inspection:</u> Checked form and rebar layout/dimensions. Appears to meet or exceed minimum requirements of the plans and specifications.	
<u>Other:</u>

Forming & Rebar

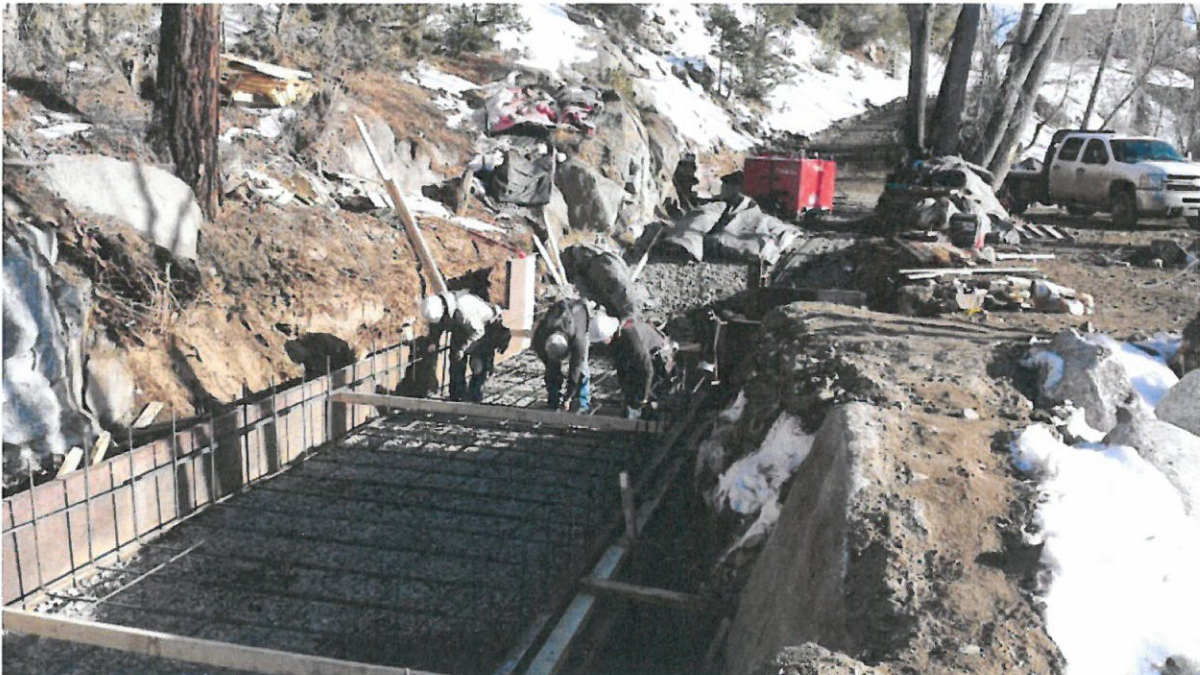
Forming & Rebar

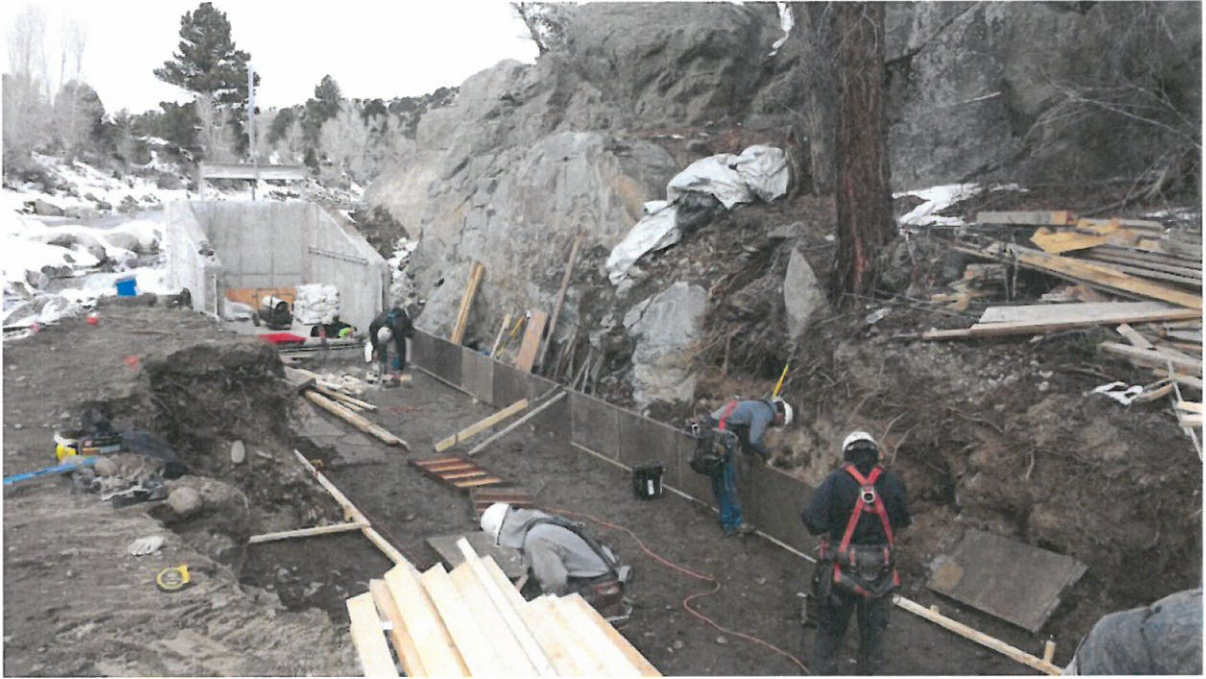
Project: <u>AHRA – Helena Boat Chute and Diversion – Phase I</u> <u>(UAWCD – Helena Ditch Diversion Structure – Phase II)</u>	Date: <u>February 11, 2014</u>
Project Location: 28107 County Road 301, Buena Vista, CO N38° 49' 43.5", E106° 06' 35.5"	Weather: 9 deg. up to 32 deg. at site clear w/ wind.
Contractor: <u>ACA Products, Inc.</u>	
Project Manager/Inspector: <u>Shaun Gordon</u> On Site: <u>8am – 12:30pm</u>	
<u>Contractor Equipment:</u> Komatsu PC220LC Excavator w/ Thumb (inactive) Komatsu 320 Front End Loader (inactive) Concrete/Ground Heater (inactive)	<u>Contractor Personnel:</u> <u>ACA</u> Jon Hollenbeck – Project Manager <u>Moltz Constructors (concrete sub)</u> Scott Canchola – Foreman Three Laborers
<u>Summary of Work:</u> 1. Flatbed truck with forms showed up at 9am – Moltz started setting forms.	
<u>Results of Inspection:</u> Checked layout/dimensions. Appears to meet or exceed minimum requirements of the plans and specifications.

Setting Forms for Diversion Structure

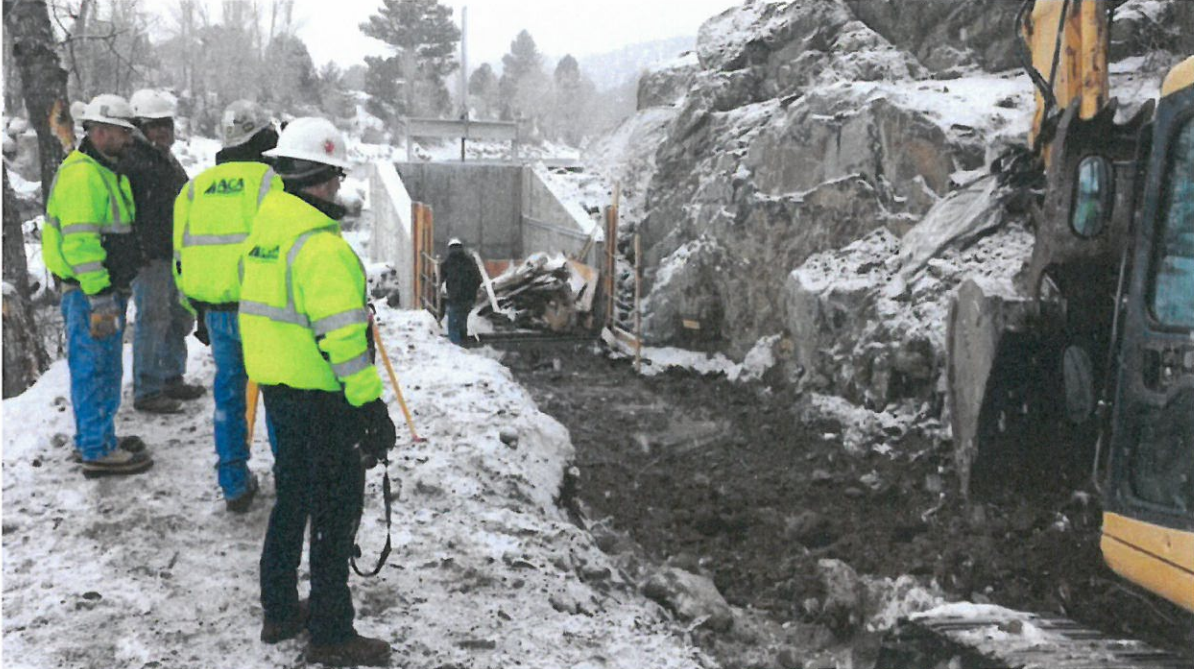
<u>Results of Inspection:</u> Appears to meet or exceed minimum requirements of the plans and specifications.	
<u>Other:</u>

Excavation for Diversion Structure

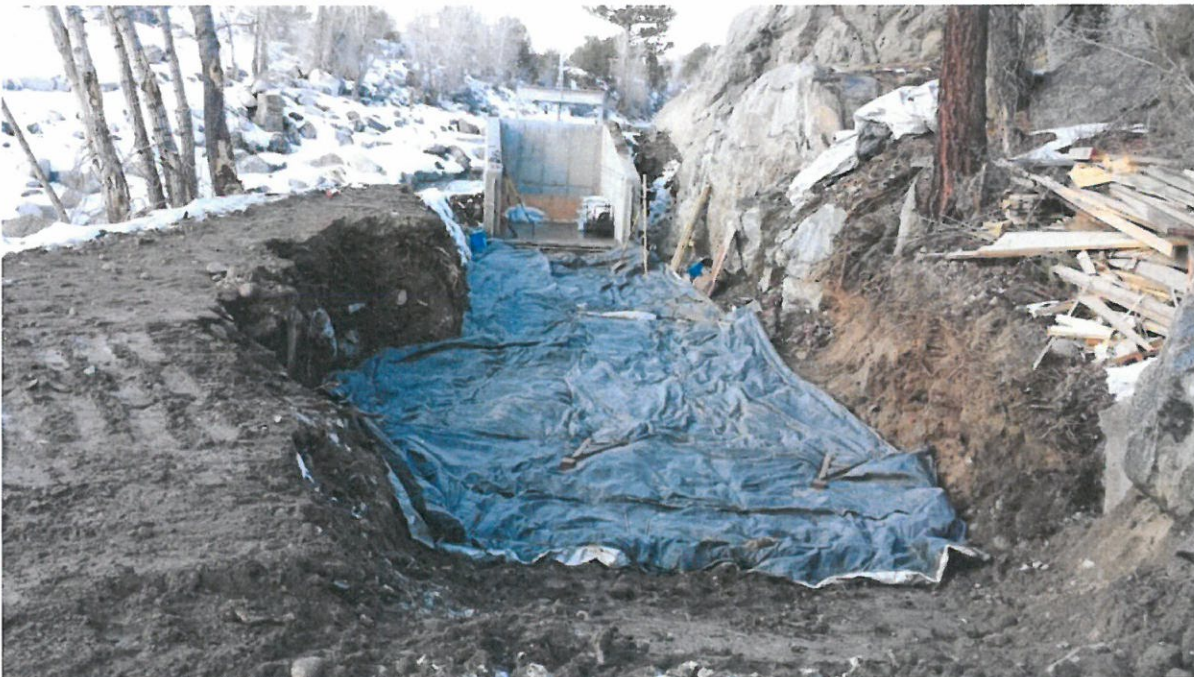
Installed Blankets following compaction
