Campbell Valley Restoration 2013 Final Report

September 13, 2012 – September 30, 2013

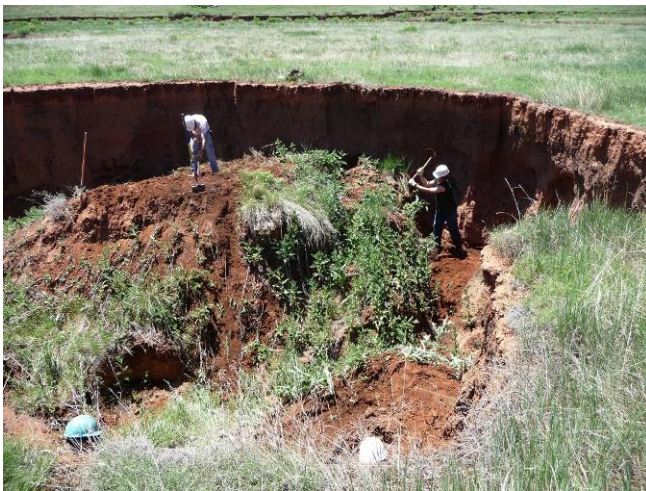
Regrading soil pillars by hand to reduce snow-based saturation points near headcuts and the base of valley walls. Additional grading was completed by excavator.

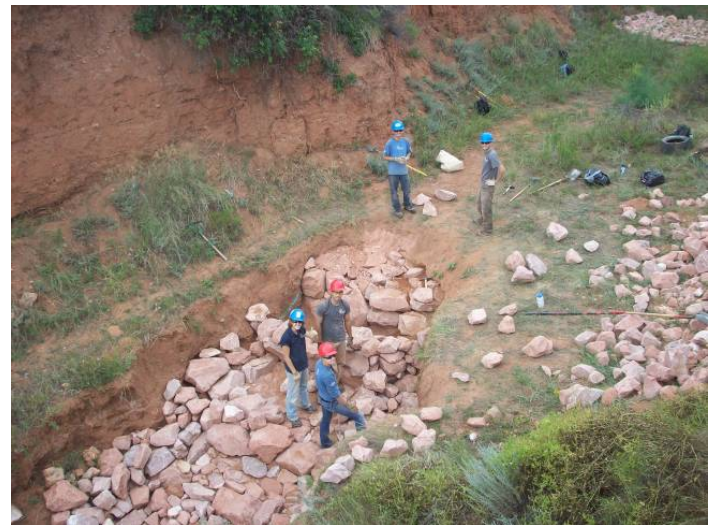
Construction of 4-step step pool with 6-foot headcut.

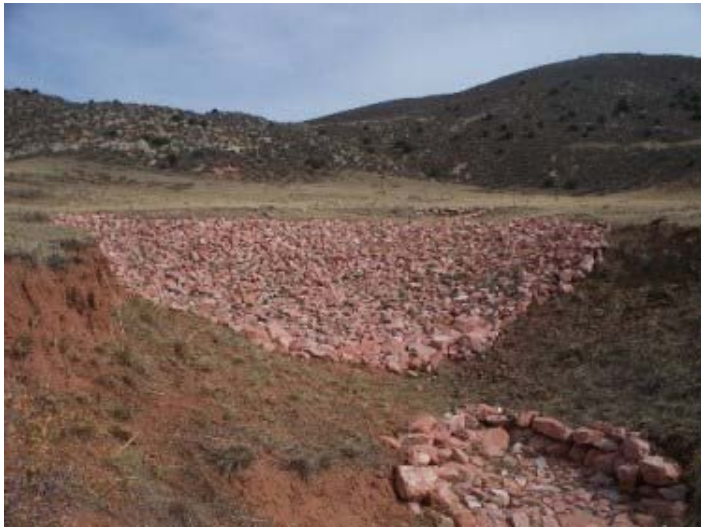
Regraded and rock ramped headcut. This experimental treatment was done with all hand labor. Future treatments be regraded using an excavator.

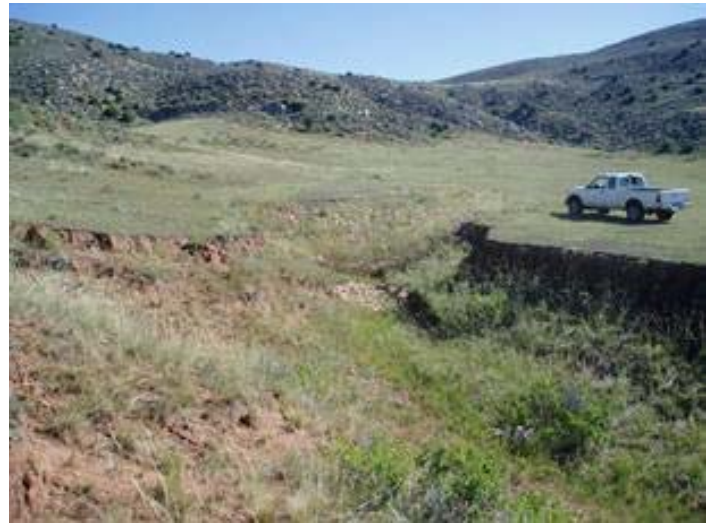
This is the same structure after a season of vegetation establishment. This picture was taken immediately after the flooding in September 2013.

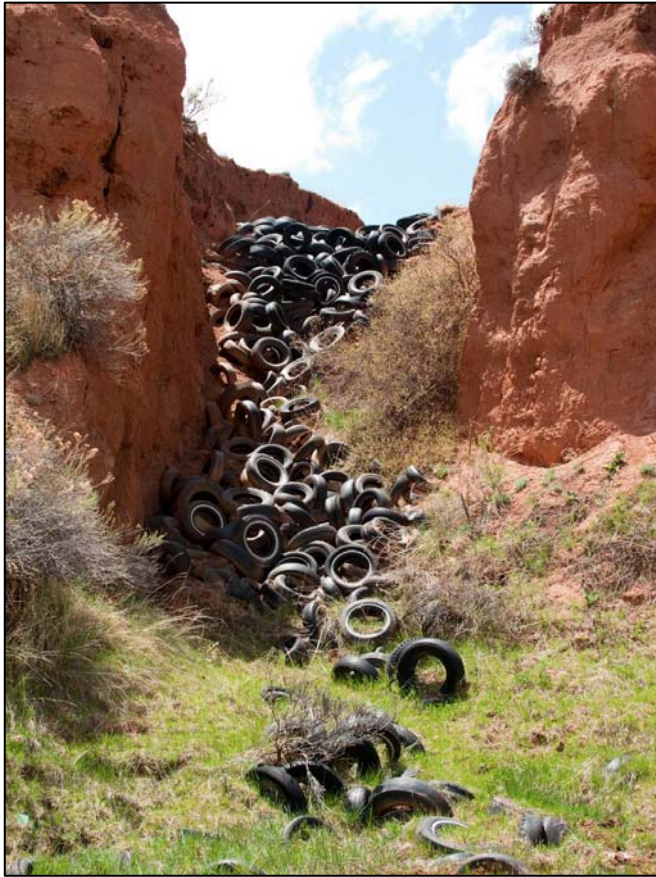
The tire problem at Campbell Valley (just a fraction of it).

NOTE: tires do not work well for stabilizing gullies, at least using this dump-n-run method.

Left Tires dumped into a side gully. There are ten others like it with tires remaining, and many more that were washed out into the main channel during flood events.

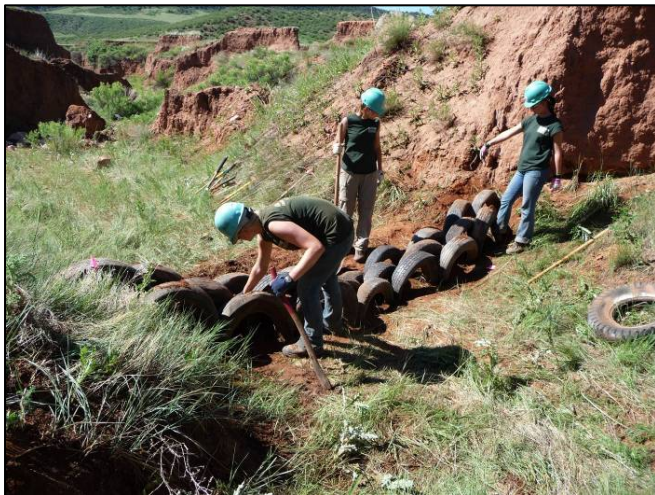
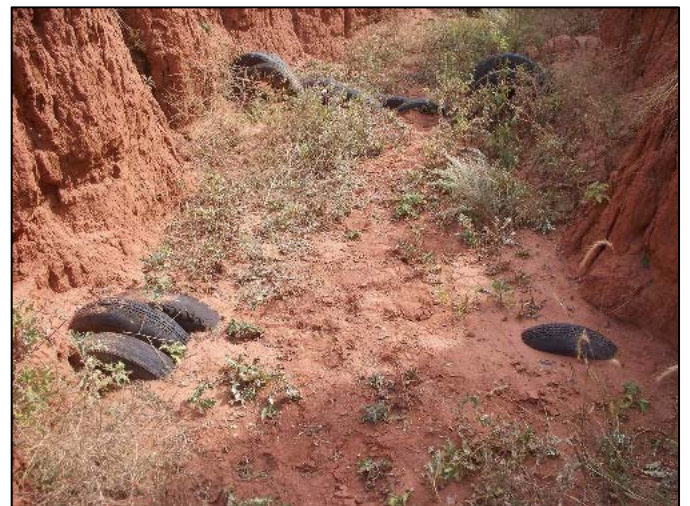
Bottom Left: Tire check under construction by volunteers.

Bottom Right: Tire checks with one season's sediment accumulation. 100% of these treatments have held up through this seasons flood events including a 1.8"/hour storm in June.

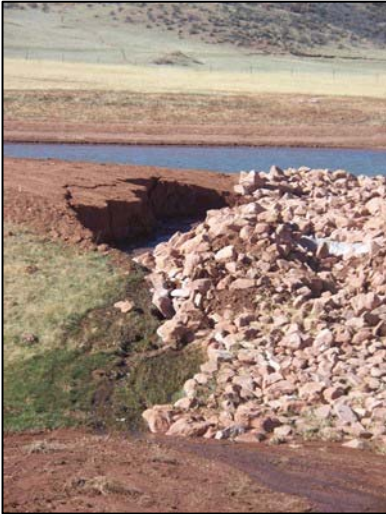
Breach in Evans Reservoir

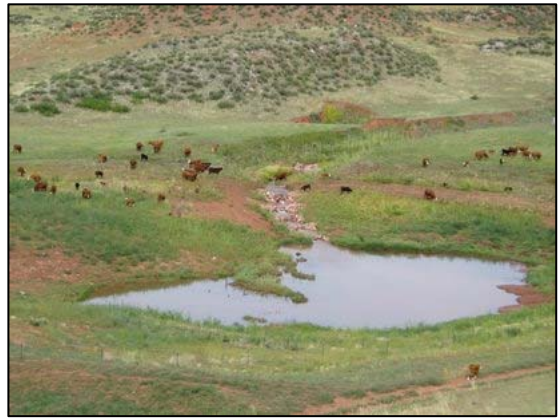
Wetland mid summer with repairs.

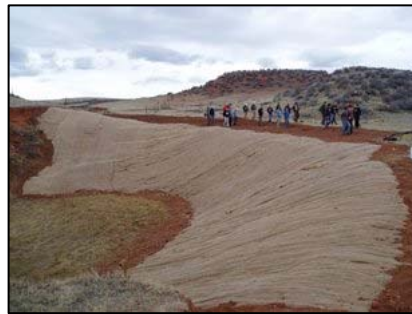
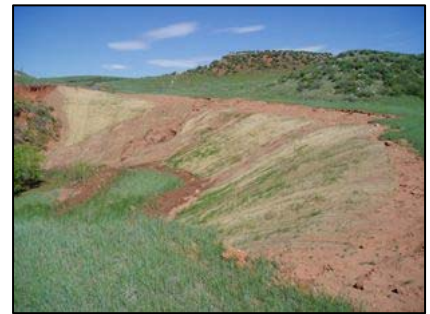
After 1.8"/hour storm

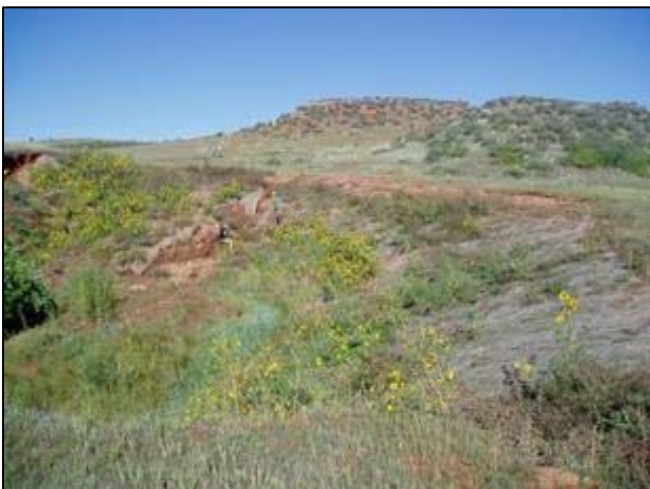
Fill slope after storms in September

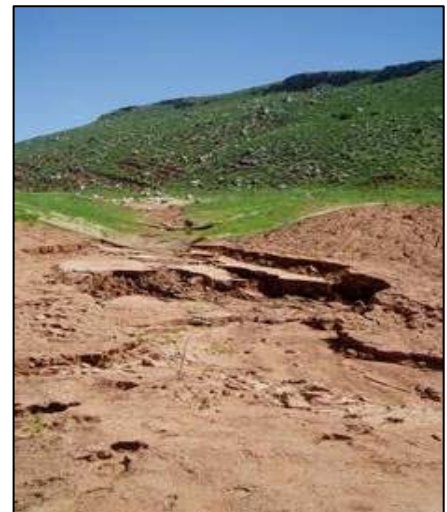
Storm damaged inlet
