Paonia River Park Project Final Report

August 30, 2013

Introduction

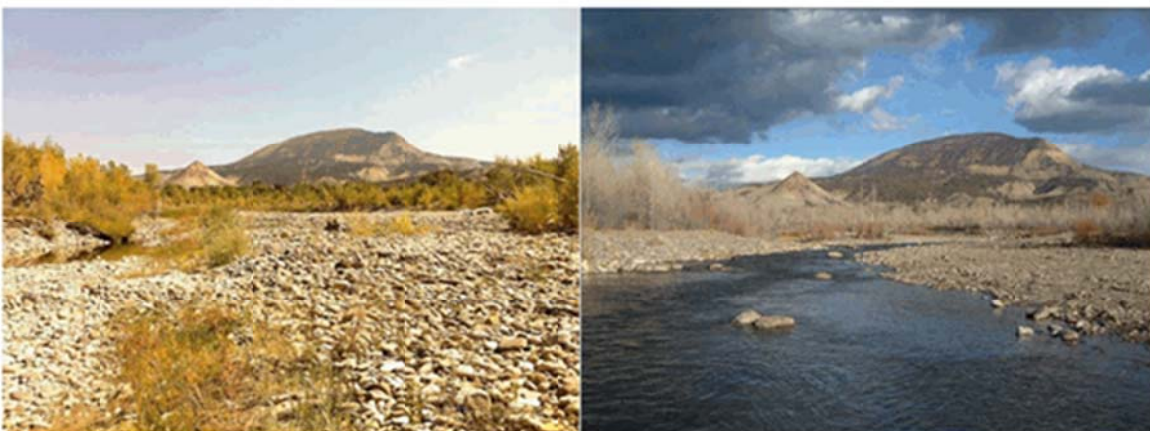
BEFORE RESTORATION 9/12

AFTER RESTORATION 12/12

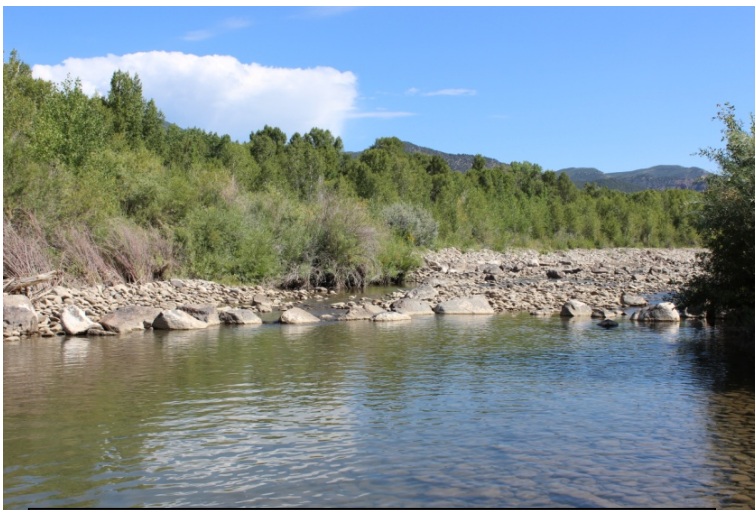
5+80 – This cross section traverses the previous south side channel where it met the current main channel upstream of Minnesota Creek. The side channel was filled at the confluence and stabilized with large rock. A series of wetlands were developed in the side channel for aquatic and terrestrial habitat. Willows, bulrush and cattails were planted around the perimeter of the wetlands. Two piezometers were installed along this cross section to measure the depth of groundwater relative to the surface water of the river. The main channel at this location deposited a new gravel bar on the north side of the river and is forming a new point bar. The main low flow channel was narrowed substantially and the depth decreased by about one foot. The floodplain is thriving with new riparian vegetation and the revetments along the south side of the bank remained unchanged. It is expected that the new point bar will grow over time and generate new vegetation as well. This would be a good location for additional adaptive management to stabilize the point bar and create additional fish holding structures above the bar.

New gravel point bar with main channel on left

- Construction of flow inhibitors across the new gravel point bar at cross section 5+80 to prevent future braiding;
- Additional rock at the lower two weirs where the channel widened by 25' to further consolidate low flows;
- An addition weir above the gravel point bar to enhance the pool there and maintain additional fish holding.

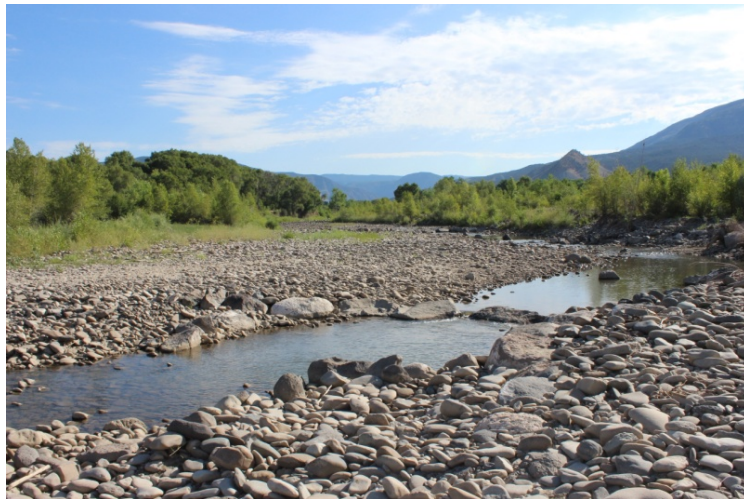
15+11 – This cross section is located above the previous south side channel and the new

Looking upstream at cross section

meander bend to the right. It also cuts across a new point bar and the previous side channel on the north side that was filled. This section shows no appreciable change from pre and post runoff. It only indicates the filling of the upper portion of the side channel and the removal of a past dyke. A rock cross vane was installed at this cross section and it remained unchanged from pre to post runoff. Vegetation is establishing along the upper reaches of the point bar.
