**Beaver & Willis Irrigation Diversion
Construction Project
Final Report
Mancos Conservation District
May 21, 2011**

CWCB GRANT PURCHASE ORDER INFORMATION

October 26, 2011

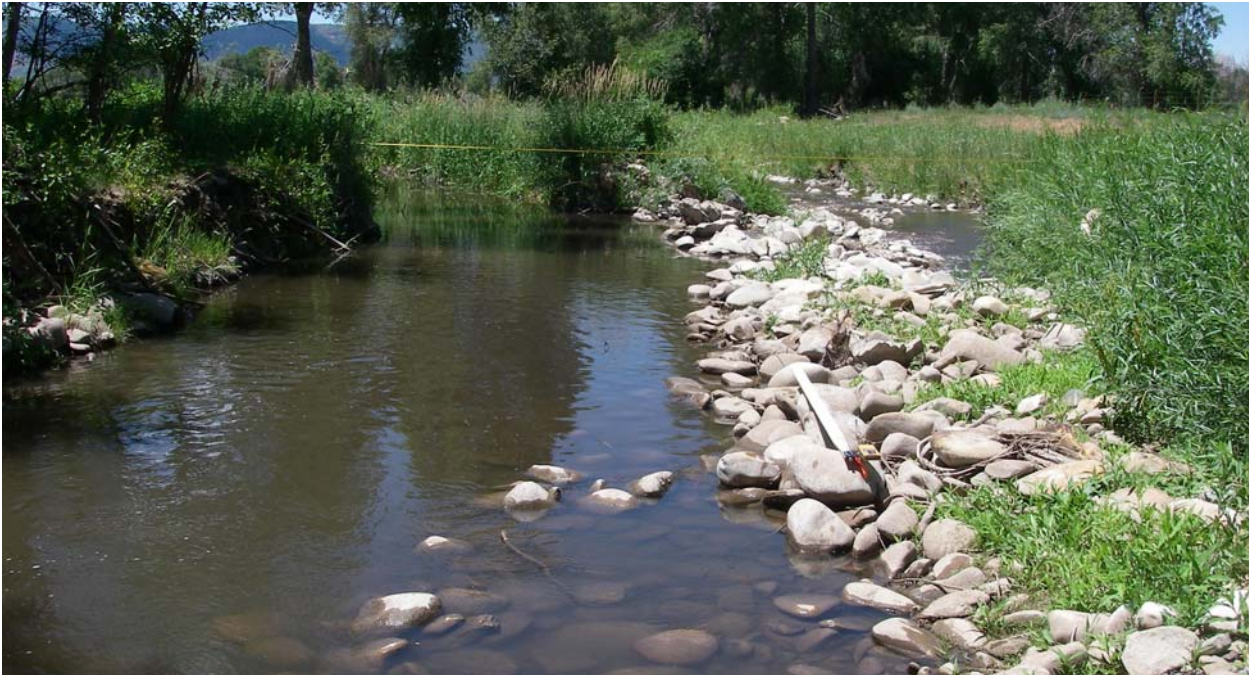
Prior to this project, the Beaver diversion's method of diverting water from the river channel consisted of an in-channel gravel berm that required reconstruction after high flow events. During low flow periods, the Beaver could generally divert its full water right by constructing a gravel berm across the channel which basically diverted the entire river to its heading. As a result of this berm having to be reconstructed each year, channel bed and bank disturbances occurred. The berm created a fish barrier and dewatered approximately 170 feet of channel between the ditch inlet and where the heading's overflow system (a pipe and channel) returned water back to the channel.

PRE: Downstream view of ditch inlet (left), diversion berm and river channel (right).

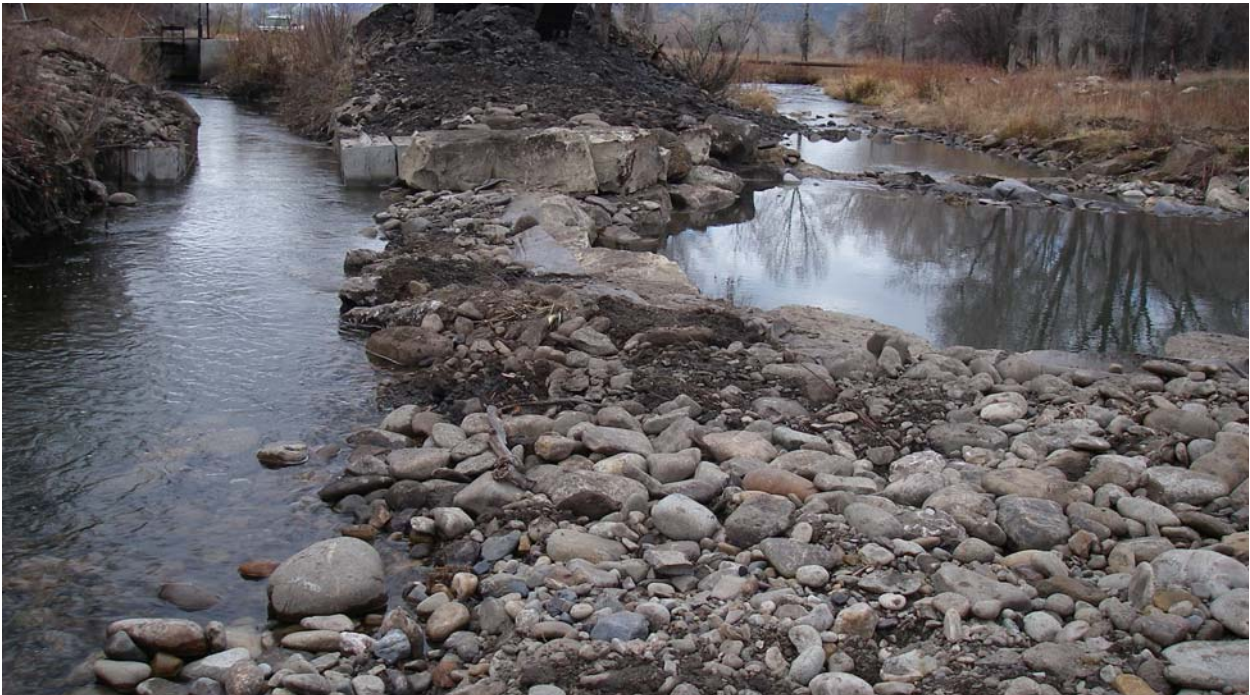
POST: Downstream view of ditch inlet and upstream rock structure (partial, see image below).

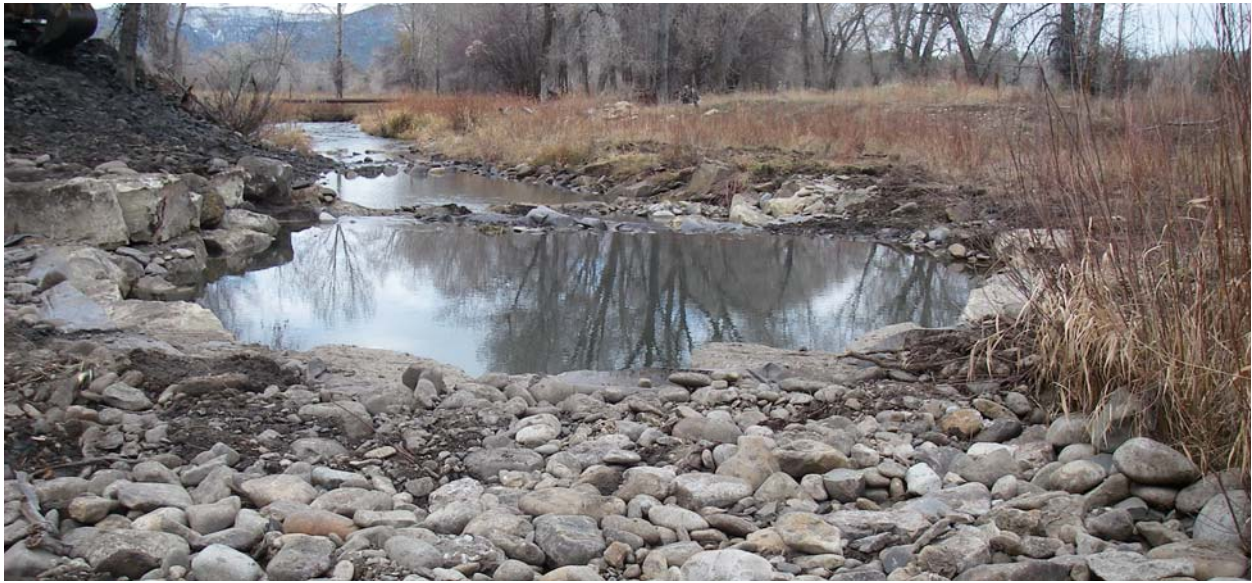
POST: Downstream view of upstream rock structure and channel.

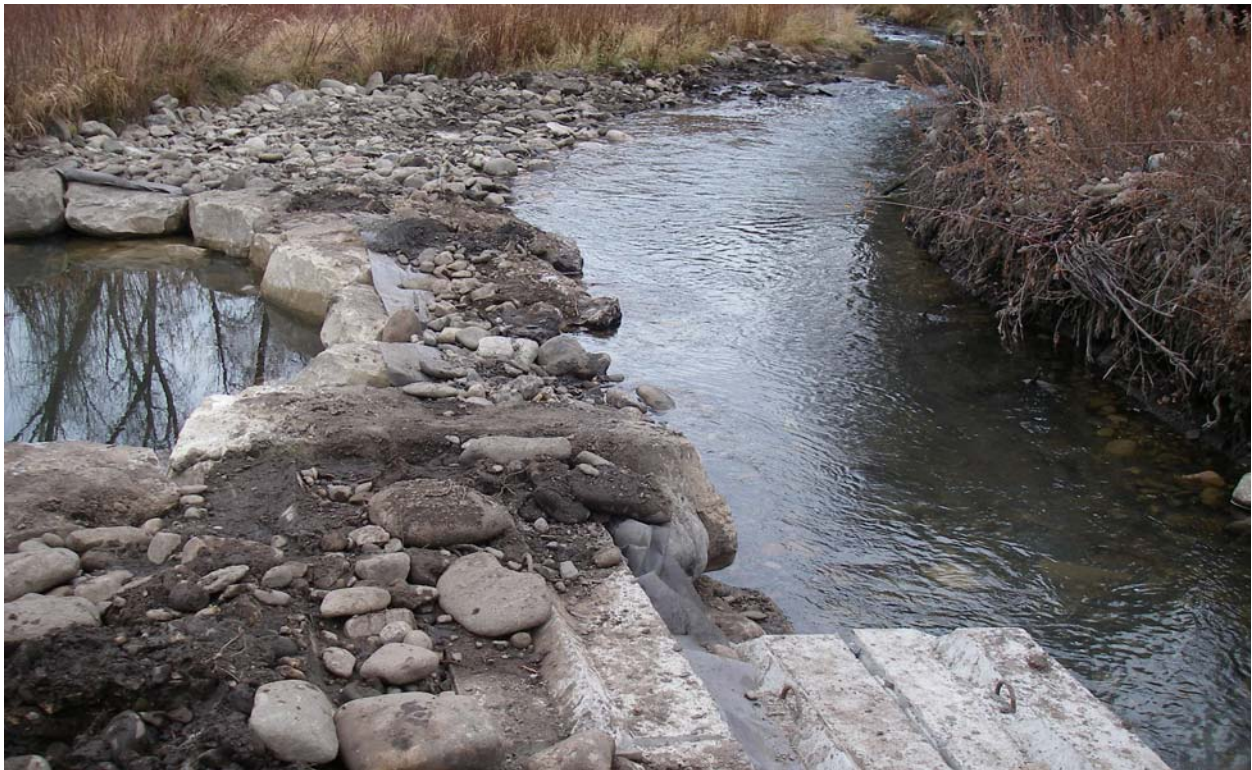
POST: Upstream view of ditch inlet and upstream rock structure.

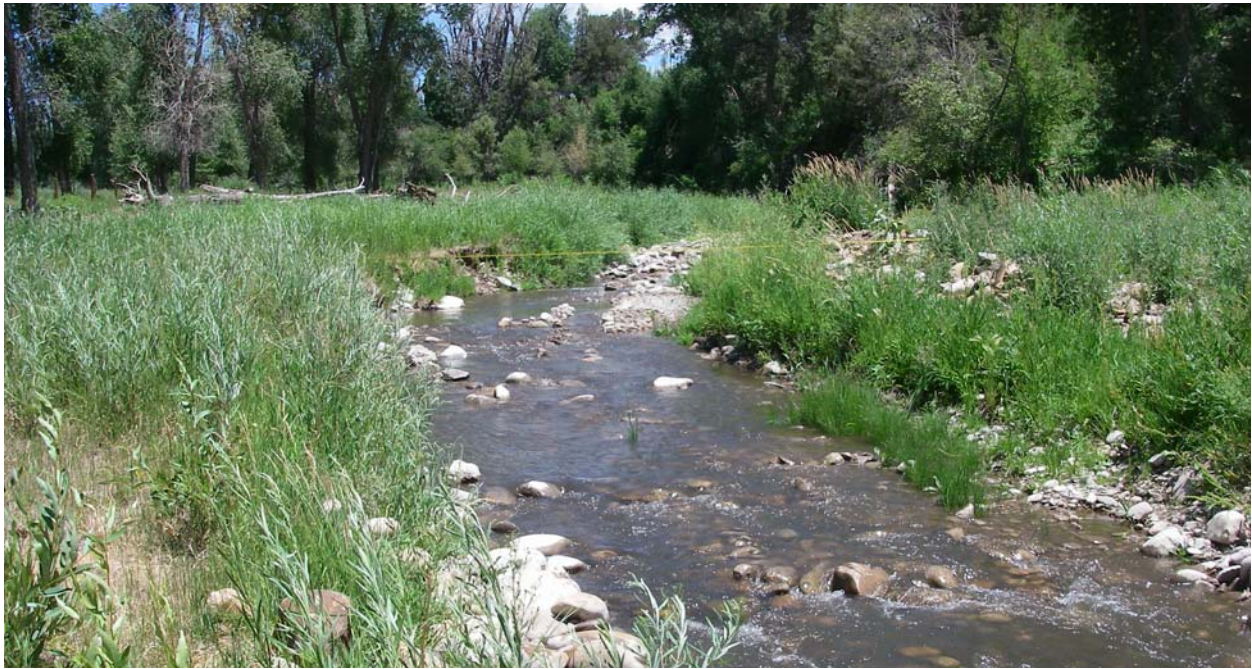
PRE: Upstream view of diversion berm and river channel.

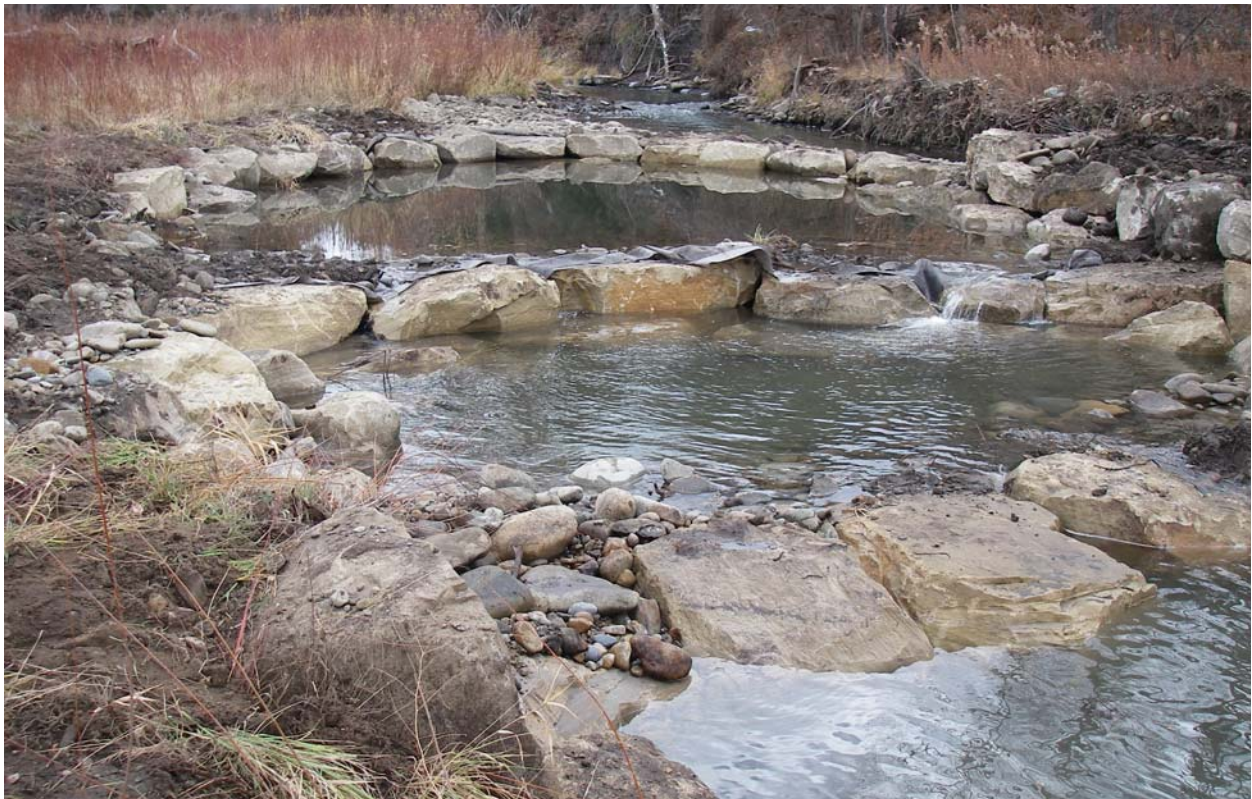
POST: Upstream view of cross vane structures.

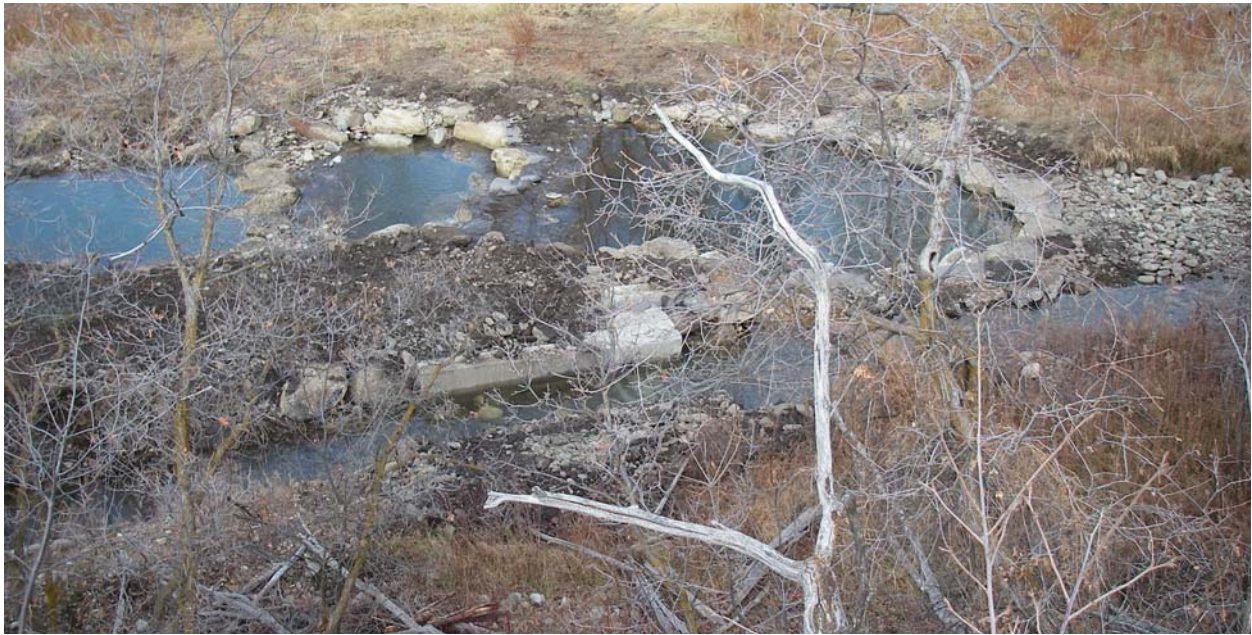
POST: Hillside view of diversion inlet and cross vane structures (river flow is right to left).

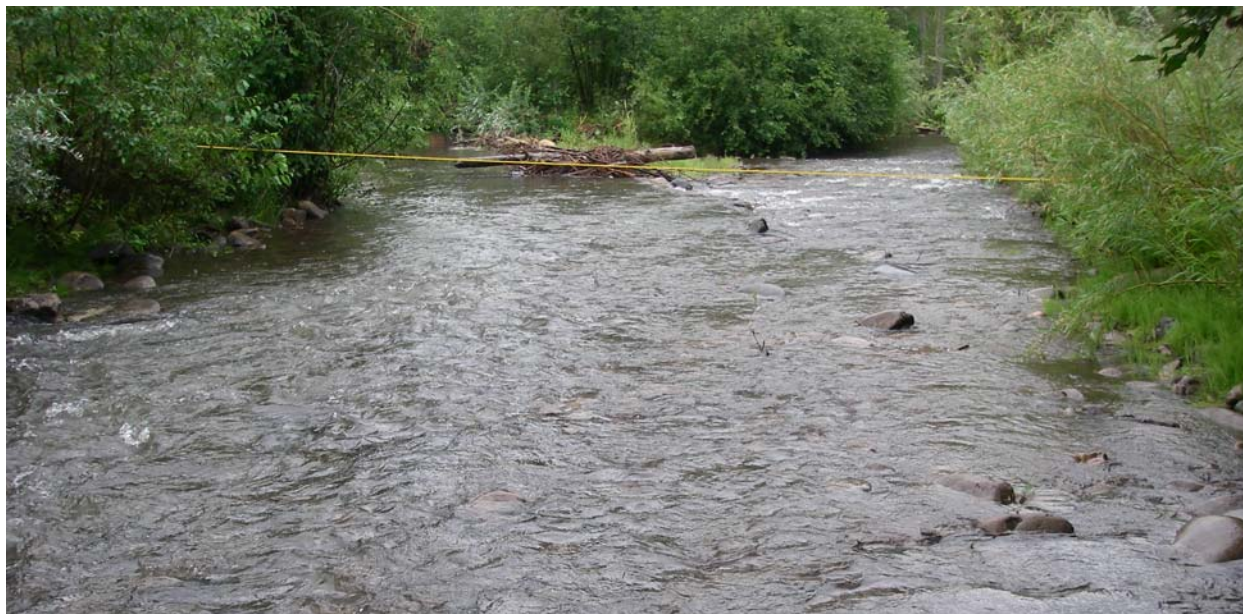
The Willis could not divert its full water right during low flow periods due to the lack of a formal in-channel diversion structure. The Willis diversion's method of diverting water to an old and non-adjustable heading consisted of hand placed rocks in the river with one bank of the diversion inlet channel comprised of a collection of hand-placed rocks, tree limbs and fabric.

PRE: Downstream view of ditch inlet (left) and river channel (right).

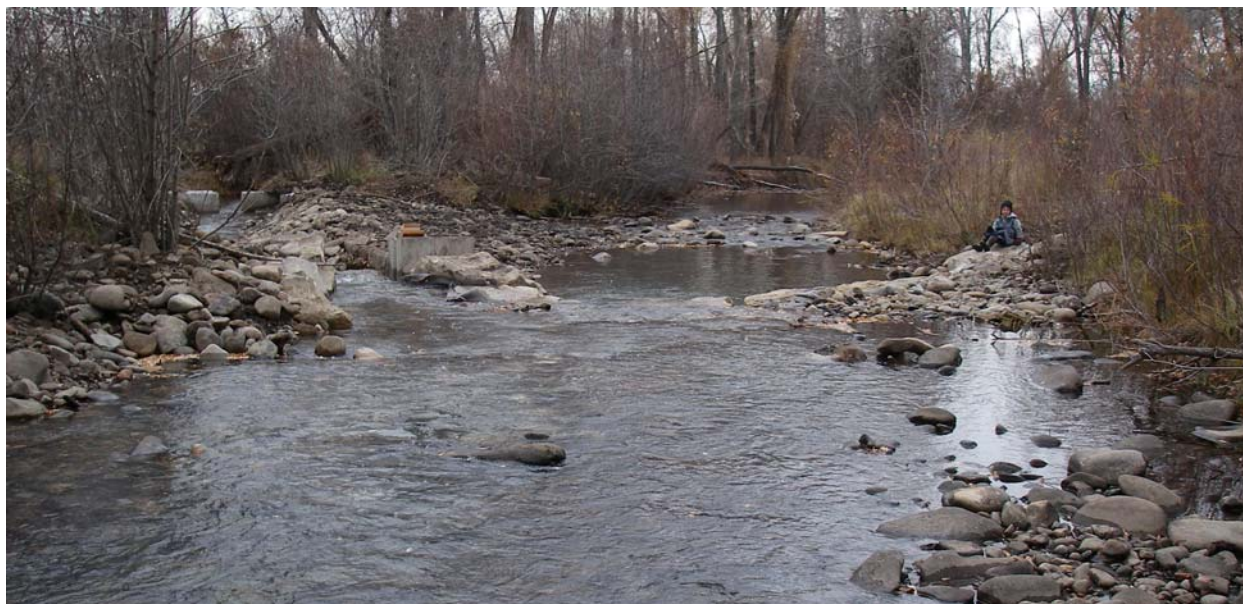
POST: Downstream view of ditch inlet (left) and river channel (right).

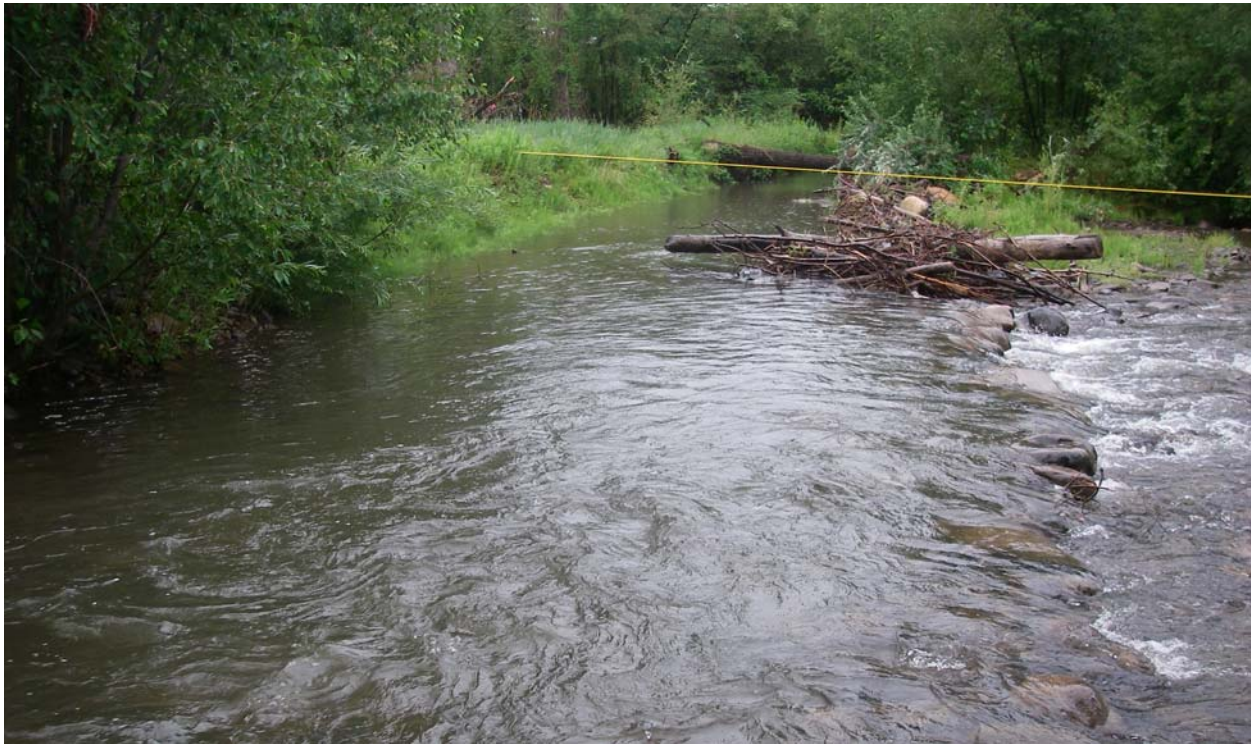
PRE: Downstream view of ditch inlet (left) and hand-placed diversion rocks (right).

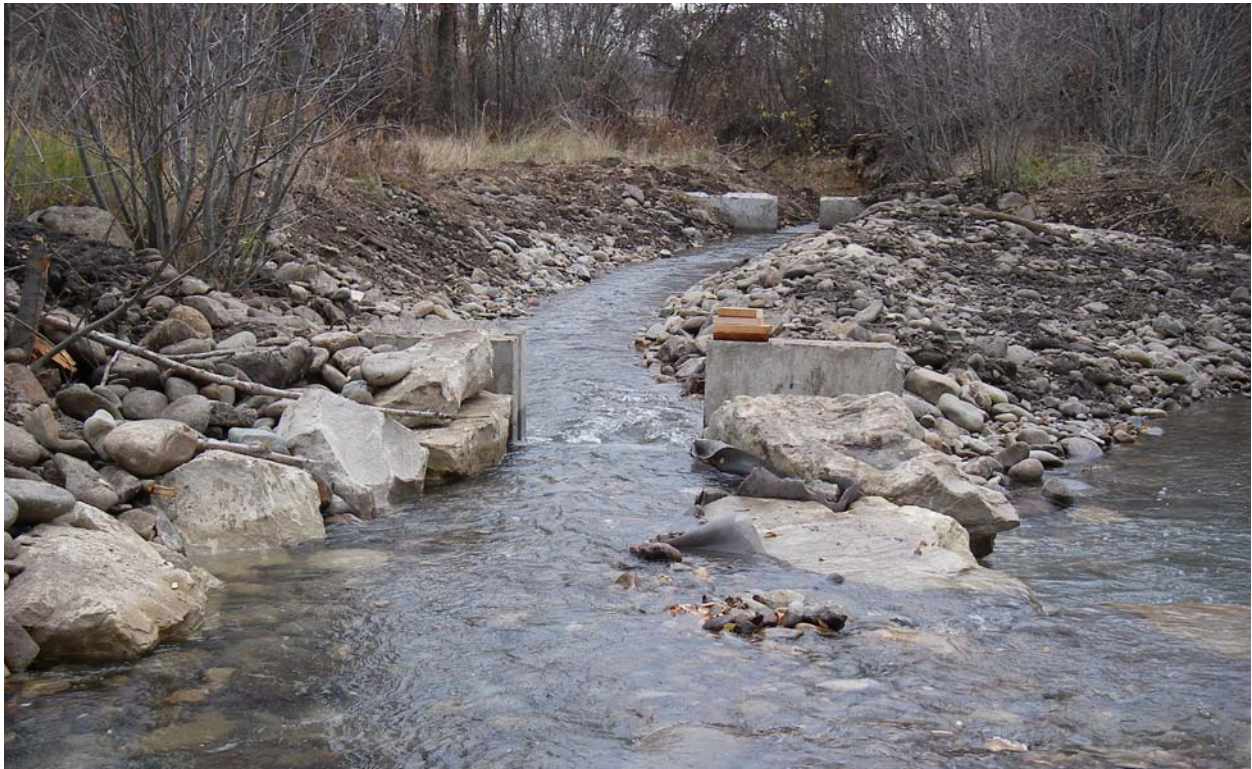
POST: Downstream view of ditch inlet (left) and river channel (right).

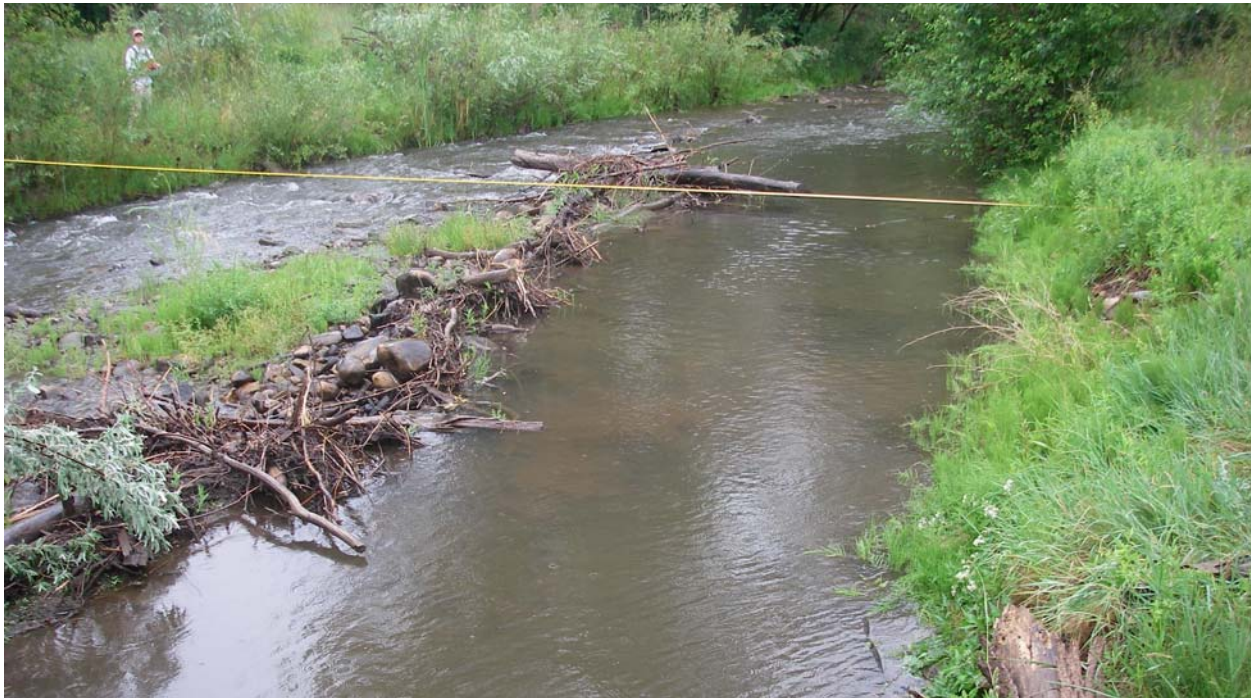
PRE: Upstream view of diversion inlet channel and river.

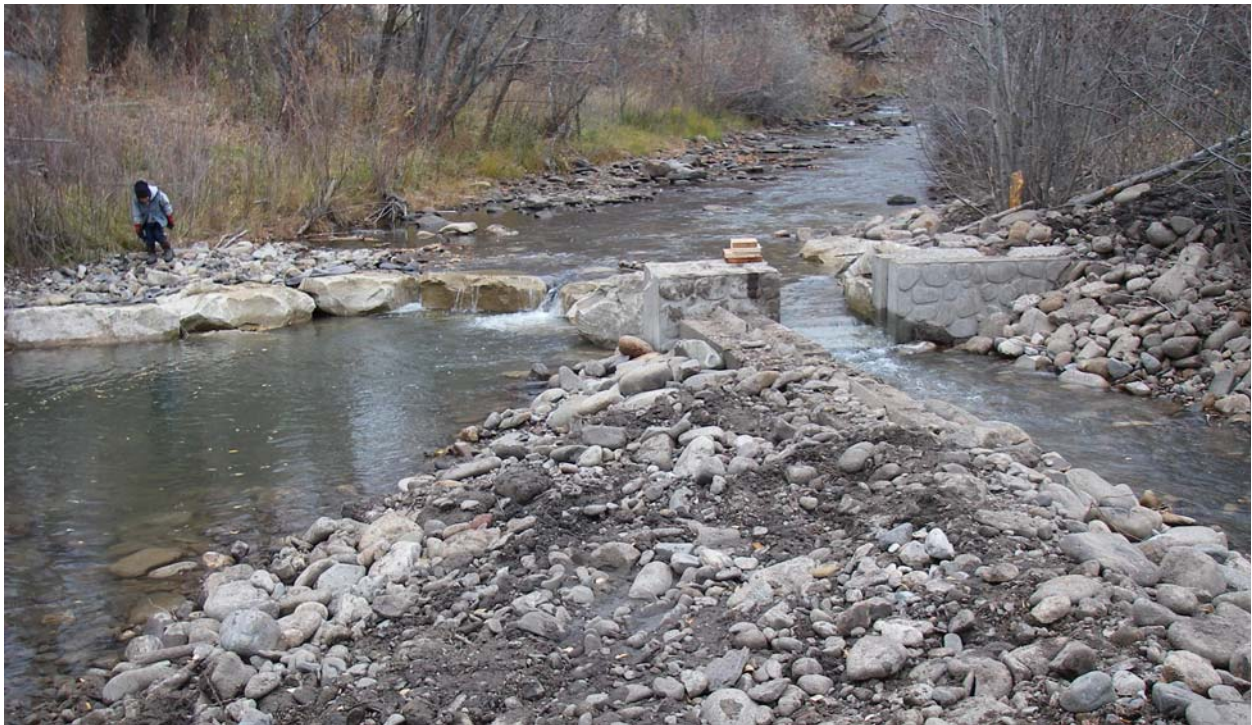
POST: Upstream view of diversion inlet, diversion channel and cross vane structure.

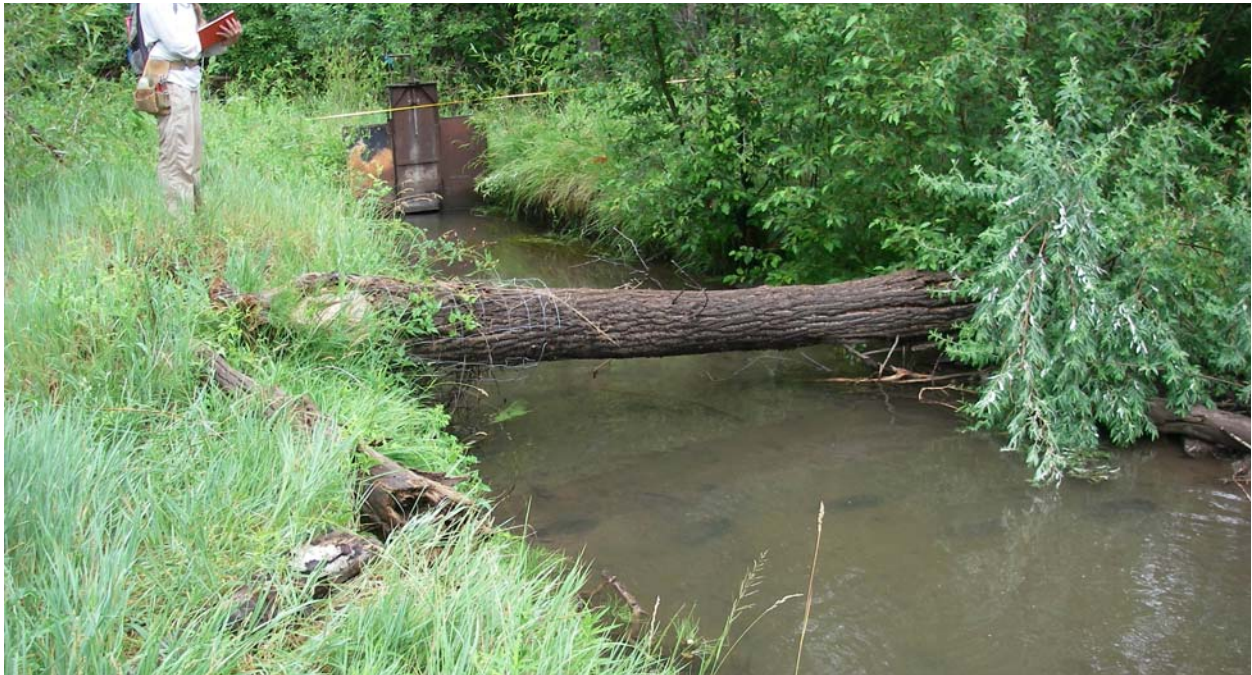
PRE: Downstream view of non-functional heading structure.

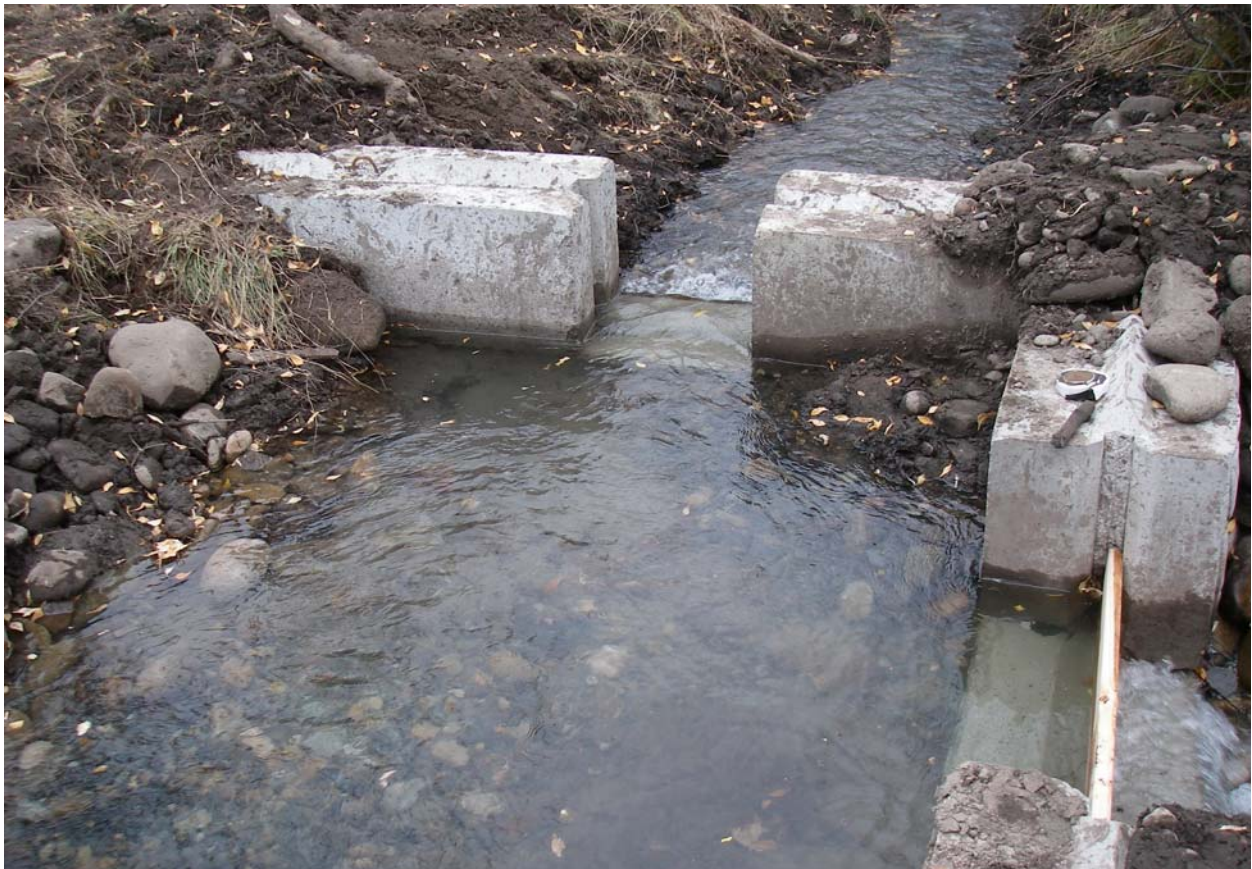
POST: Downstream view of new heading (left) and sluice opening (right).

Concrete blocks (the same as those used at the Beaver diversion), were used to construct a restricted opening at the diversion inlet channel, to define the right bank of the diversion inlet channel, a sluice opening and a new heading structure. Rather than mechanical gates, the groove portion of the concrete blocks was notched out using a masonry blade on a demolition saw in order to define the entrance to the diversion inlet channel, the sluice gate adjacent to the heading and the heading gate. The notch is approximately 2½" wide to accommodate a 1½" wide board. Several 2"x 8" boards were cut to the appropriate length so that each opening can be closed off or have a restricted opening. The sluice opening is intended to provide sufficient drop from the diversion inlet opening to the sluice to scour the inlet ditch of accumulated fines. Approximately 32 CY yards of rock and 35 concrete blocks were used. Construction was completed in approximately 4 days. A copy of the construction plans is attached (Attachment B). This plan largely represents the as-built conditions. Pre and post construction photographs are included below.
