Campbell Valley Restoration 2011 Final Report

Wildlands Restoration Volunteers, in partnership with The Nature Conservancy, US Fish and Wildlife Service, and the Robert's Ranch.

July 1, 2010 – August 31, 2011

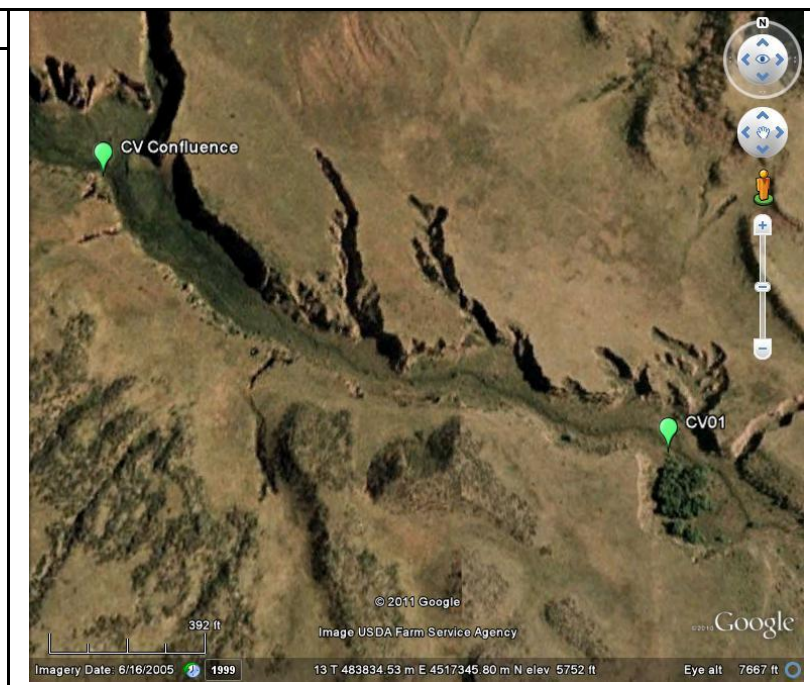
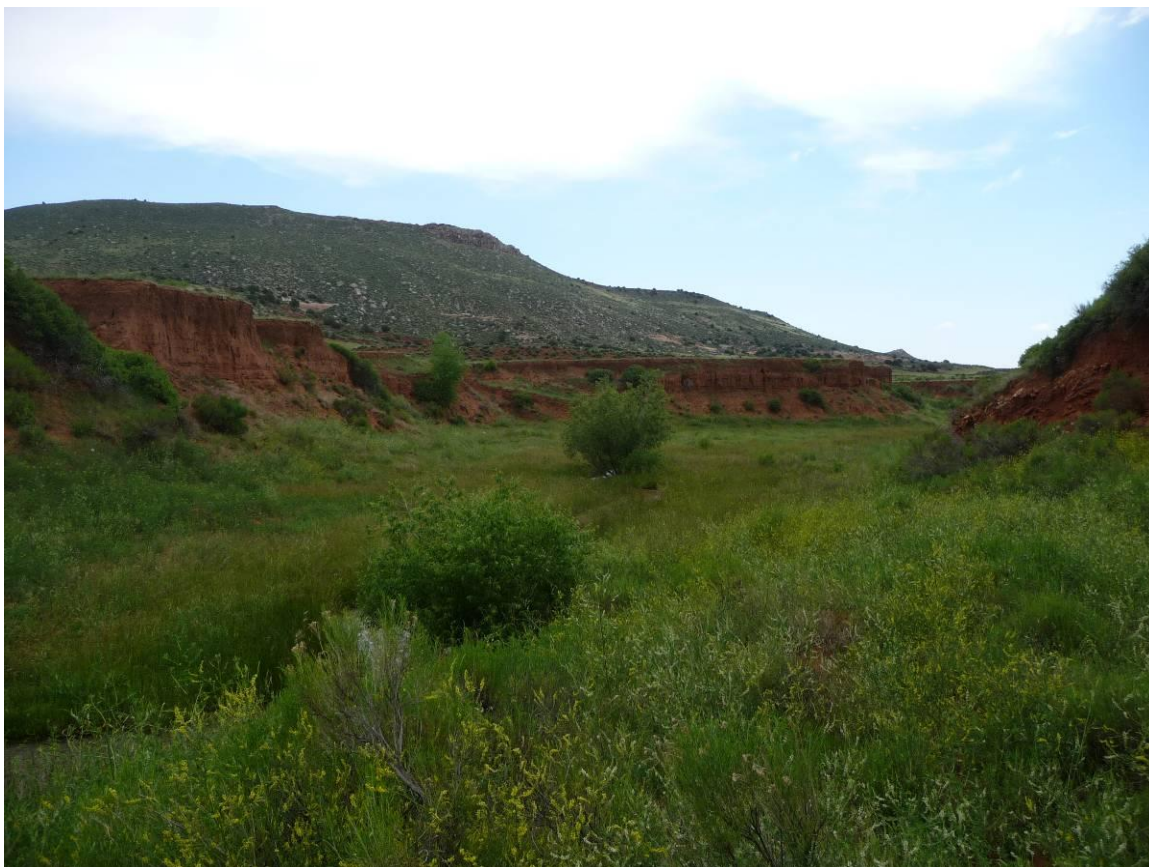
Section:	1	
Zone 13T	Northing	Easting
Beginn	4517493	483559.5
End	4517251	484055.8
Length M	552	
Acres	4.56

C

Extensive restoration already begun in this section.

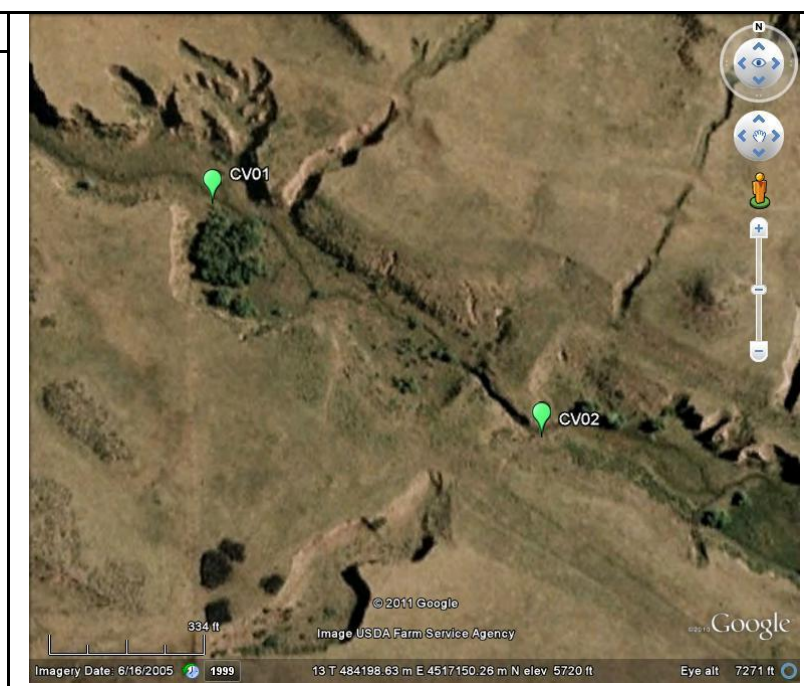
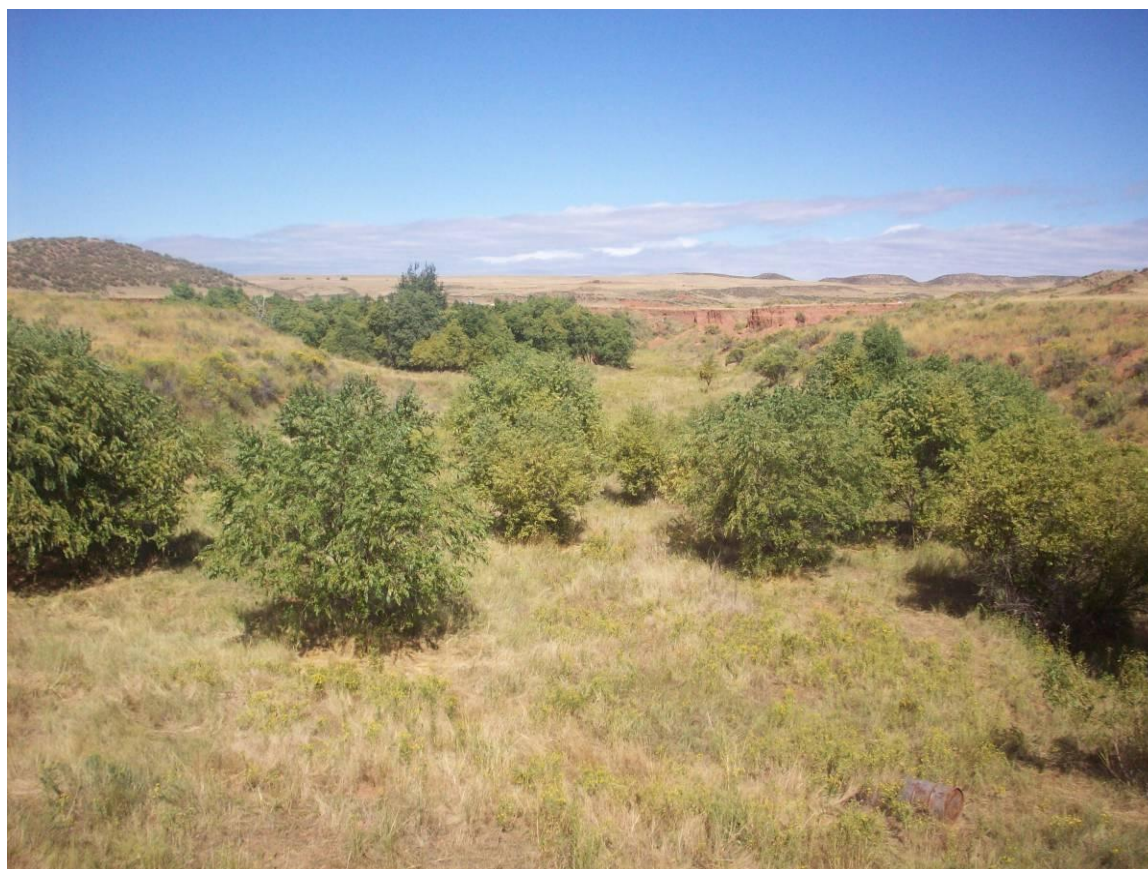
Section:	2	
Zone 13T	Northing	Easting
Beginn	4517251	484055.8
End	4517087	484288.1
Length M	284	
Acres	3.82

Some restoration begun in this section.

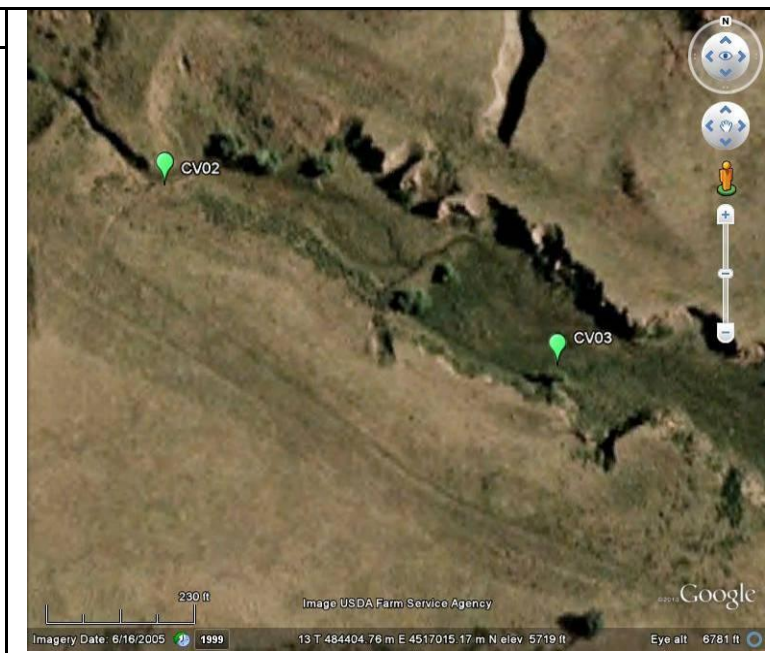
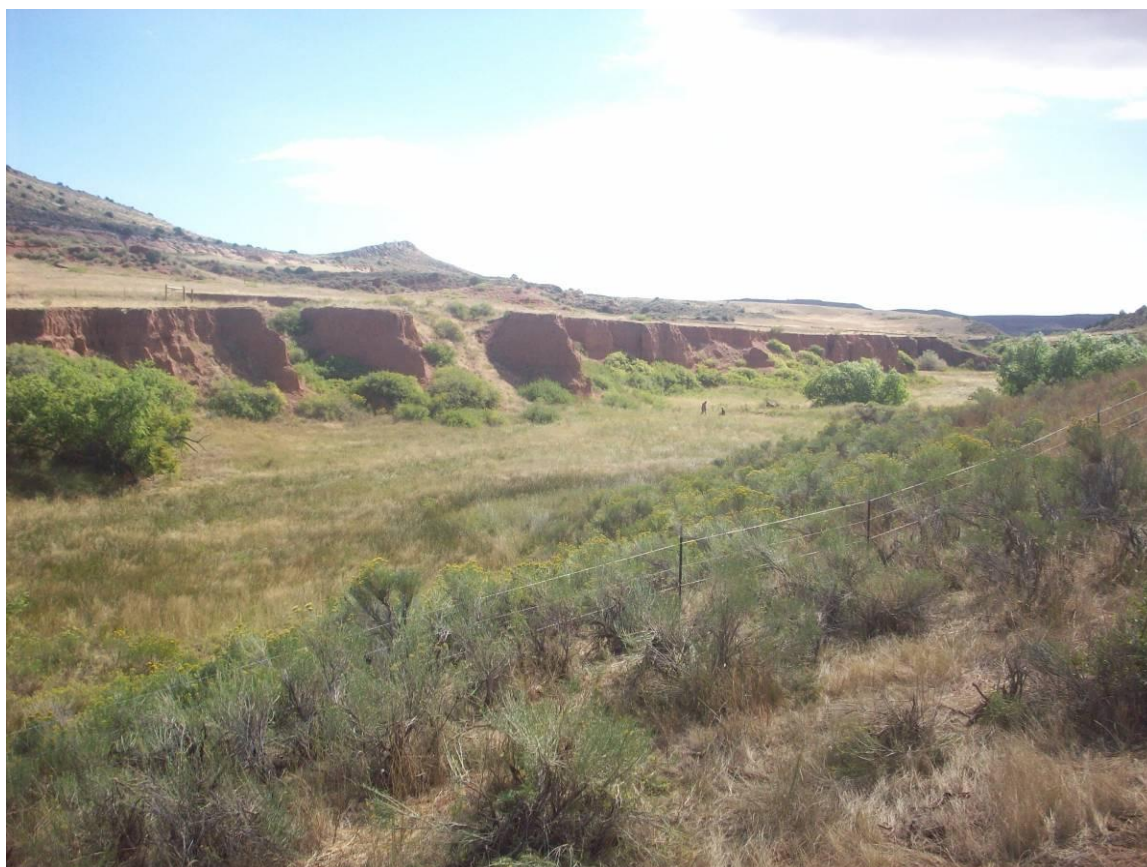
Section:	3	
Zone 13T	Northing	Easting
Beginn	4517087	484288.1
End	4516996	484487.2
Length M	219	
Acres	2.04

Highly incised stream. Minimal riparian community.

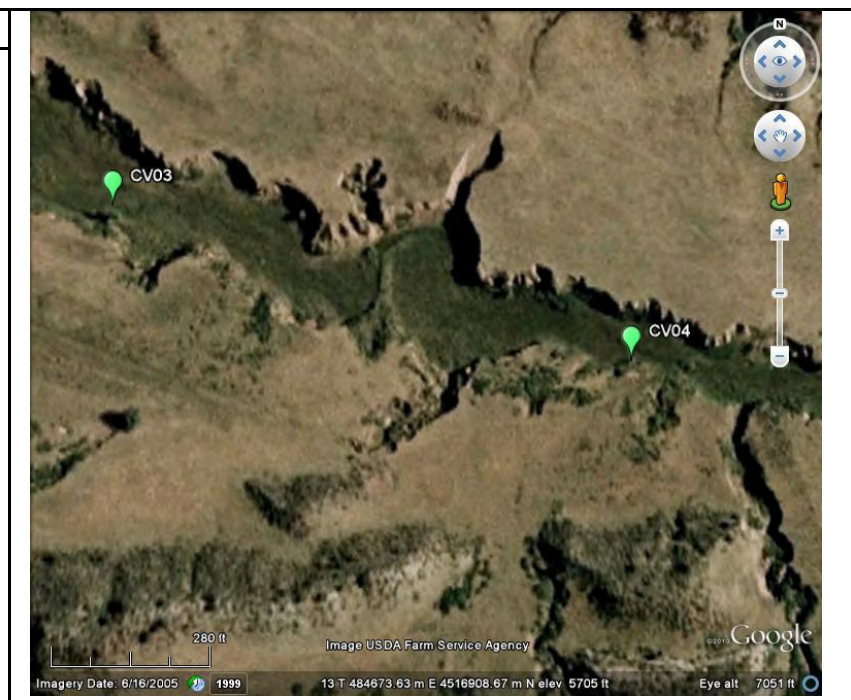
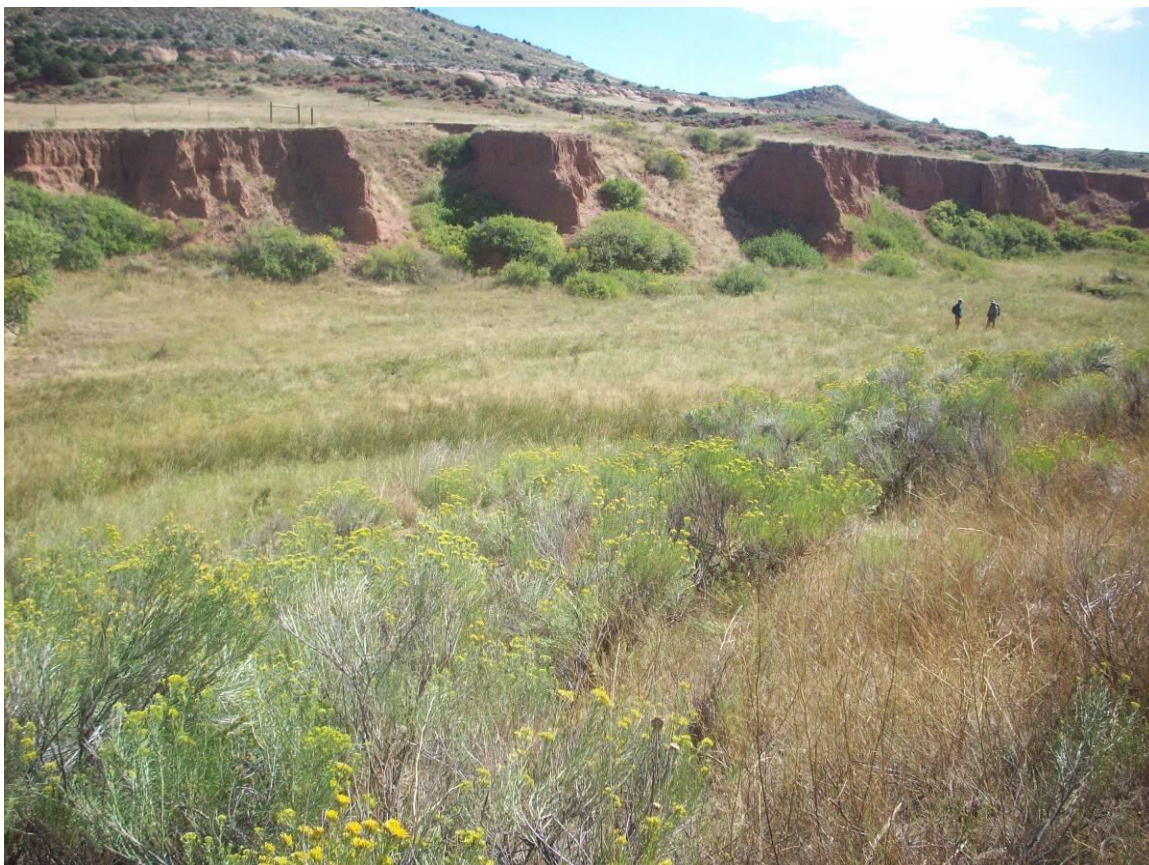
Section:	4	
Zone 13T	Northing	Easting
Beginn	4516996	484487.2
End	4516903	484796.5
Length M	323	
Acres	3.00

Healthy young willow population. Recommend introducing Cottonwood and addressing invasive.

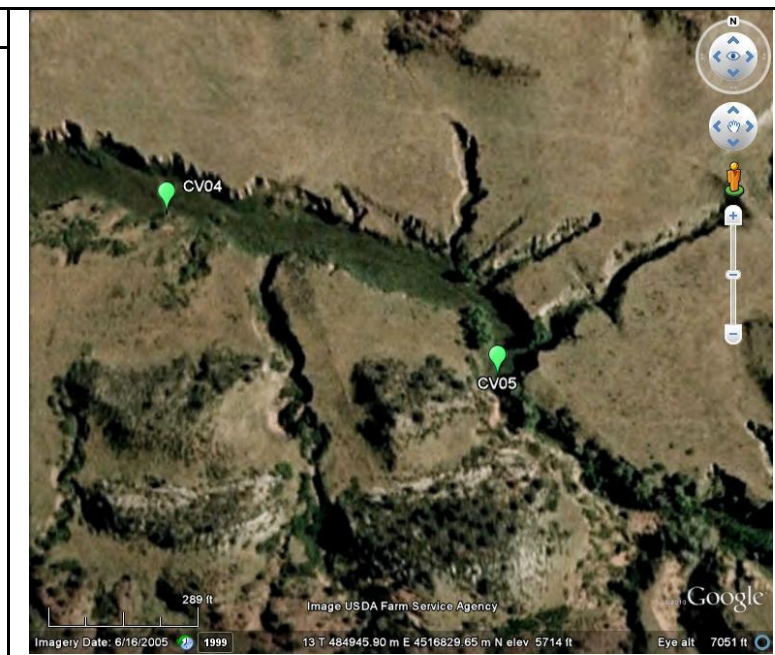
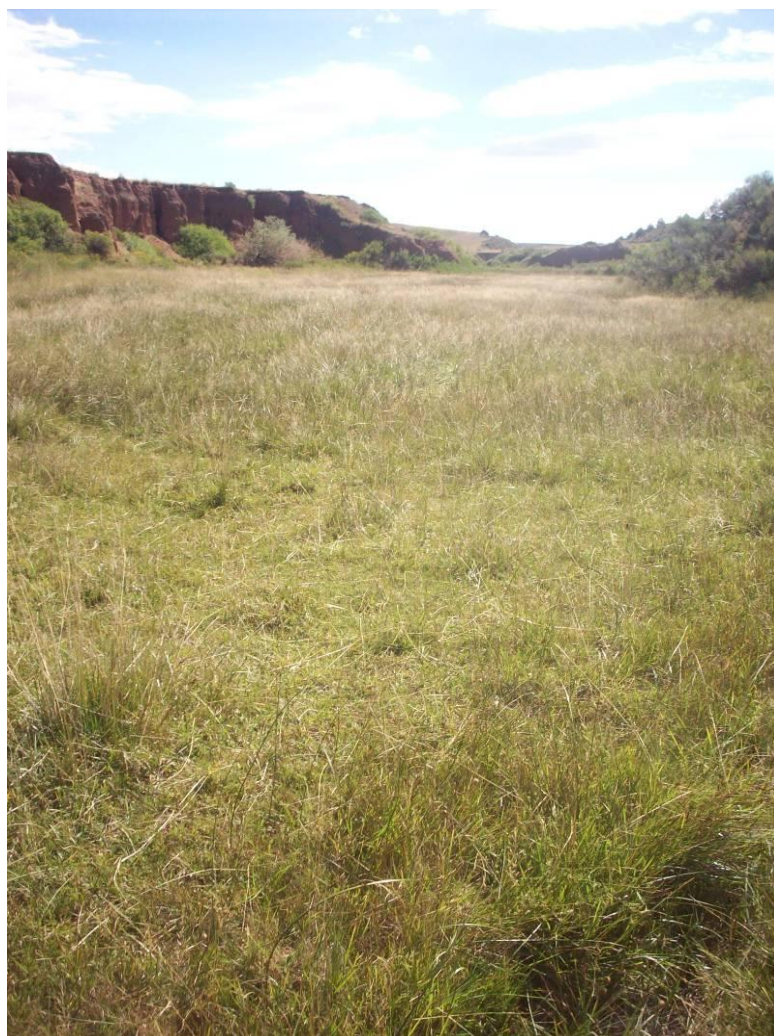
Section:	5	
Zone 13T	Northing	Easting
Beginn	4516903	484796.5
End	4516799	485007.1
Length M	235	
Acres	1.46

C

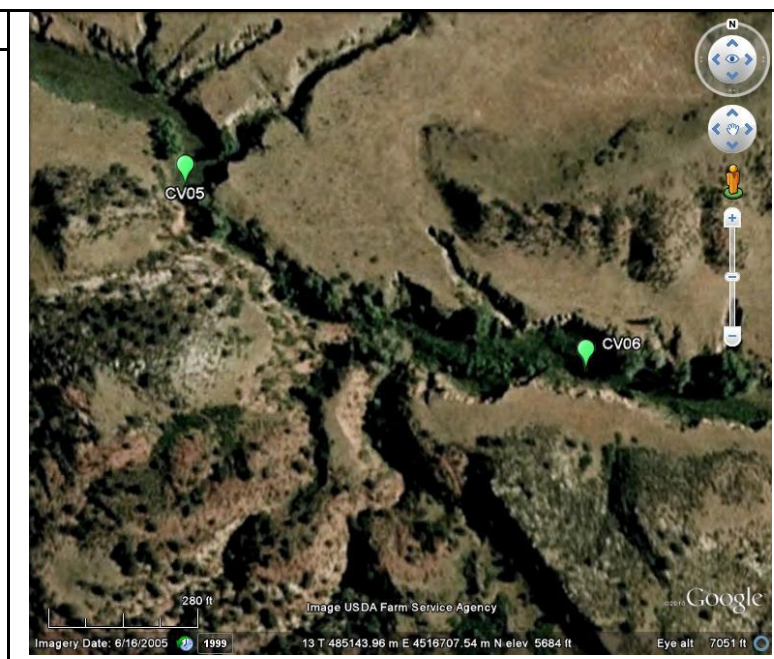
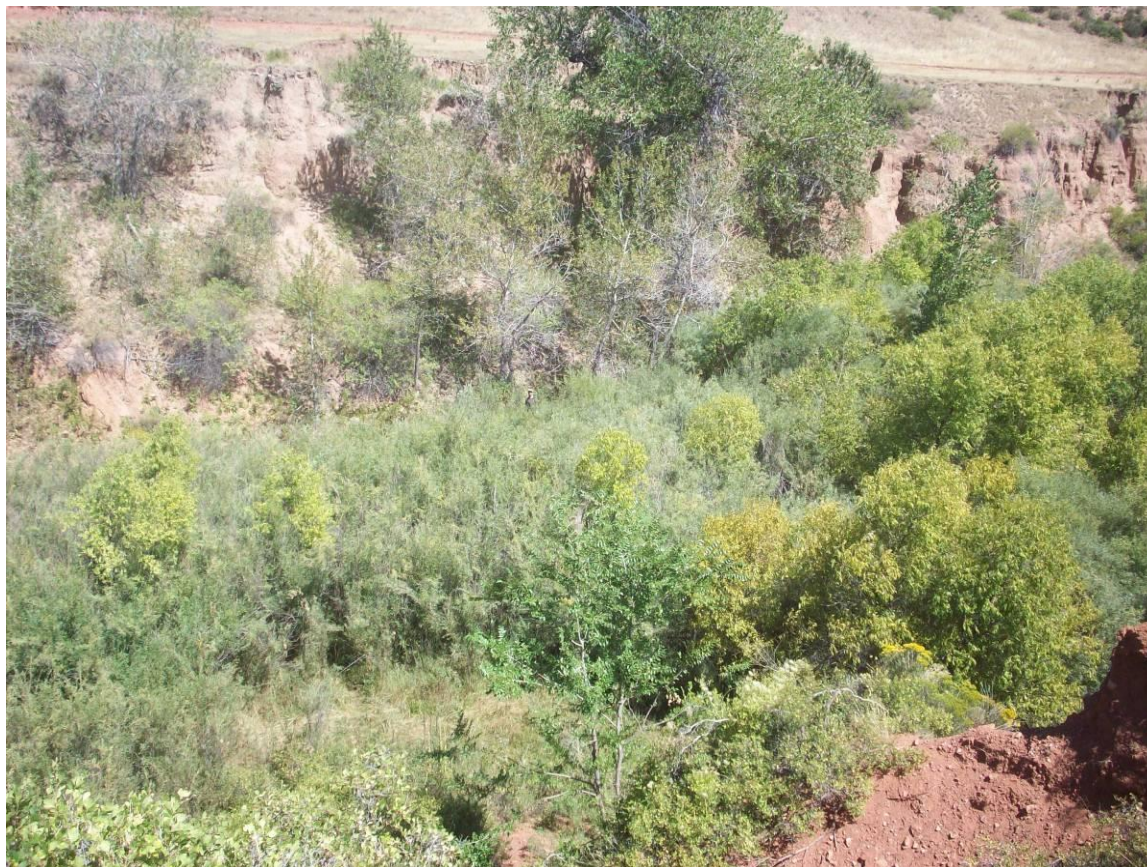
Section:	6	
Zone 13T	Northring	Easting
Beginn	4516799	485007.1
End	4516682	485265
Length M	283	
Acres	1.76

Very active riparian community. Cattle excluded from this area by topography.

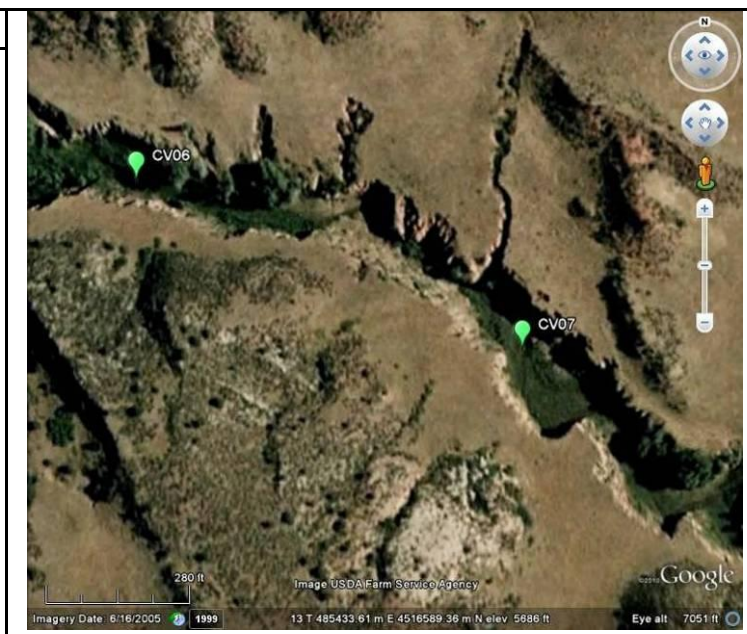
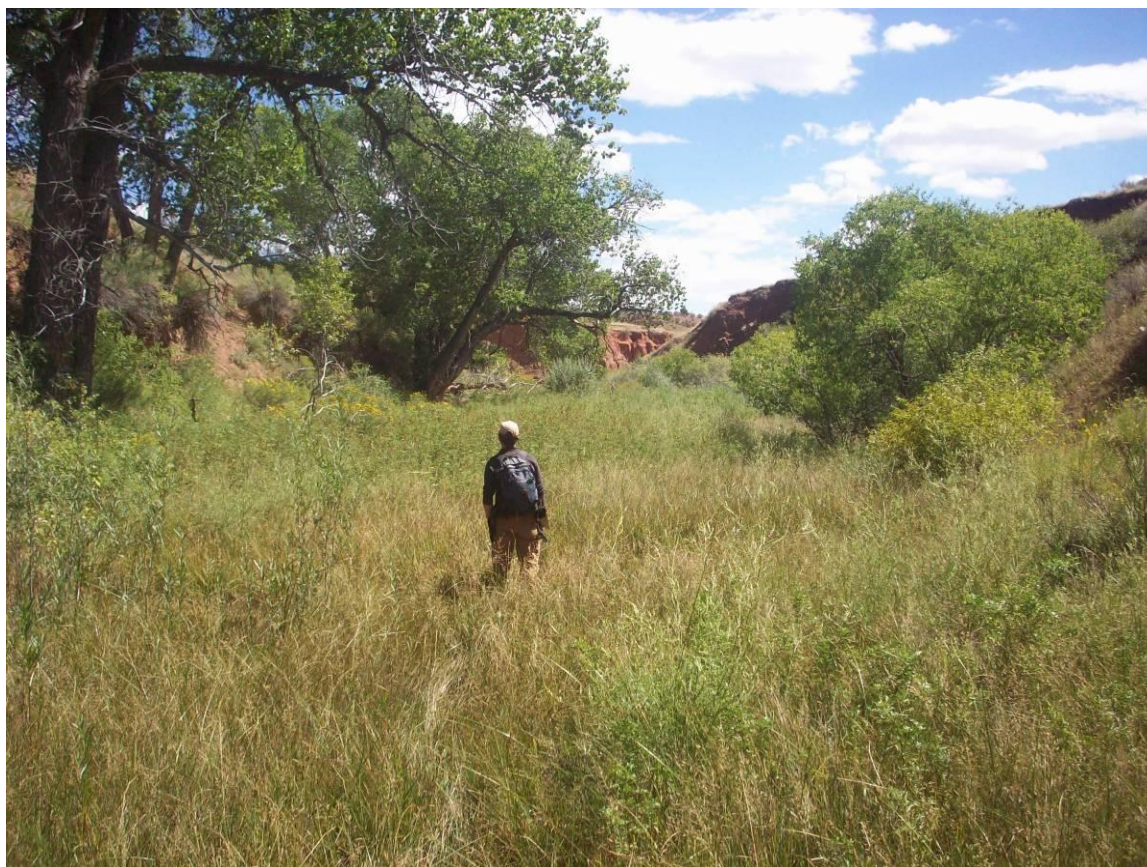
Section:	7	
Zone 13T	Northing	Easting
Beginn	4516682	485265
End	4516567	485528.3
Length M	287	
Acres	1.78

Strong riparian representation. Needs invasive species mitigation.

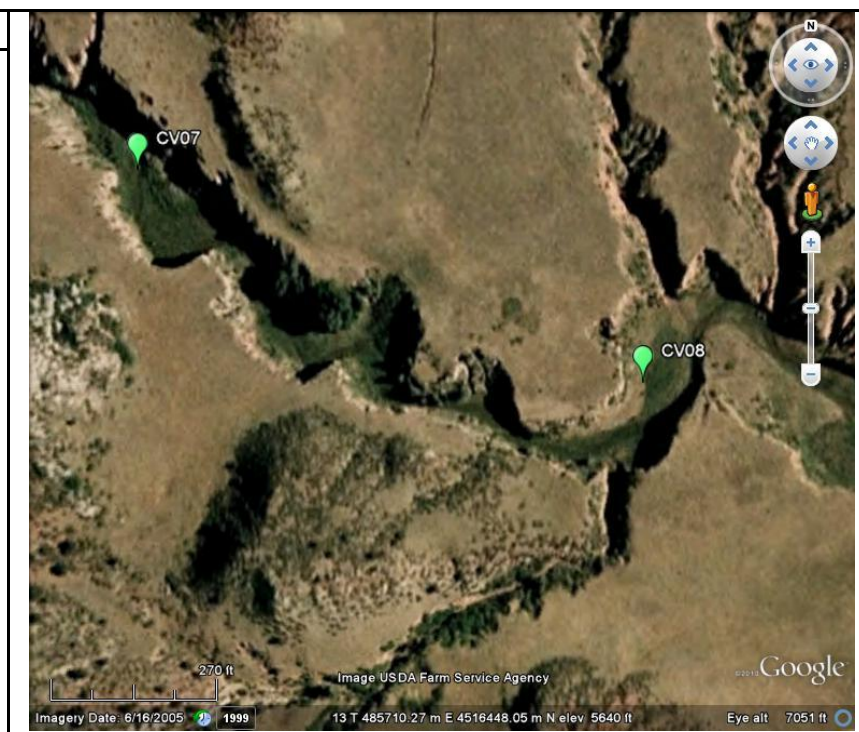
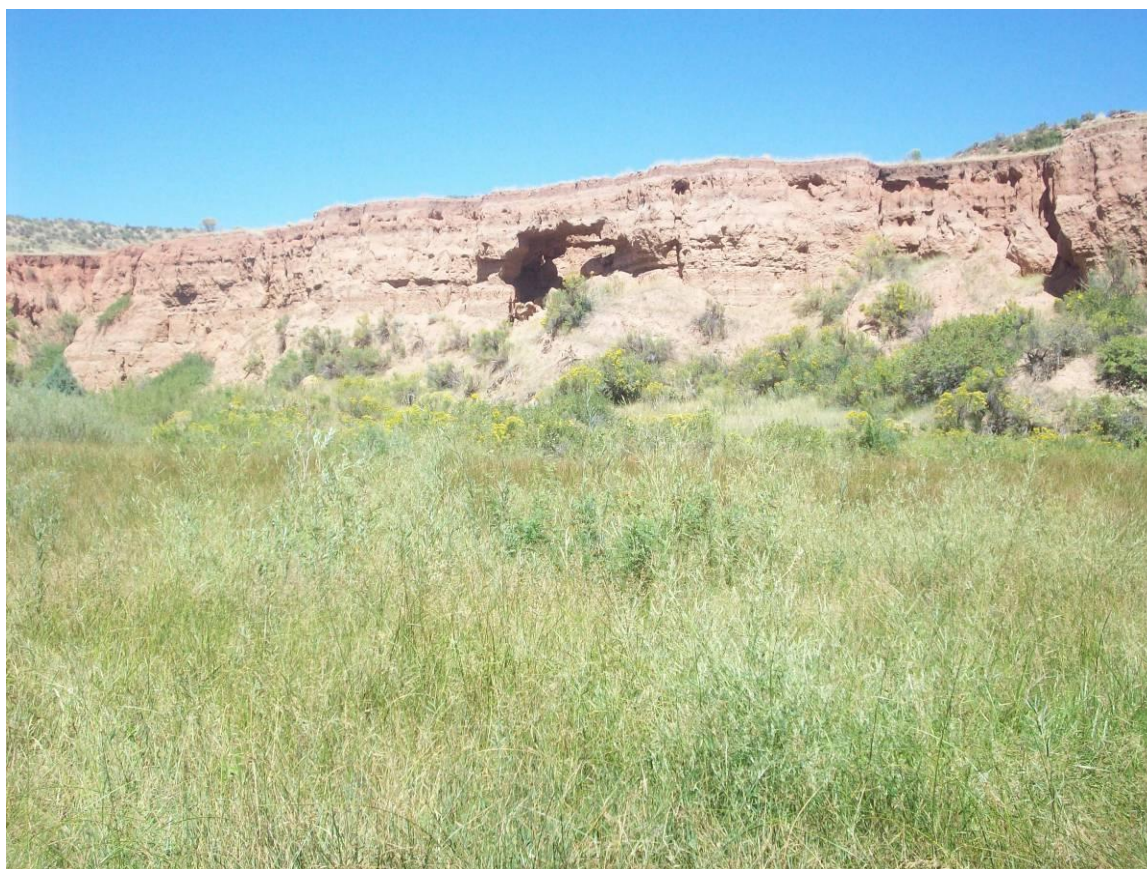
Section:	8	
Zone		
13T	Northing	Easting
Beginn	4516567	485528.3
End	4516440	485831.5
Length		
M	329	
Acres	2.38

Some young willow establishment. Stream highly incised.

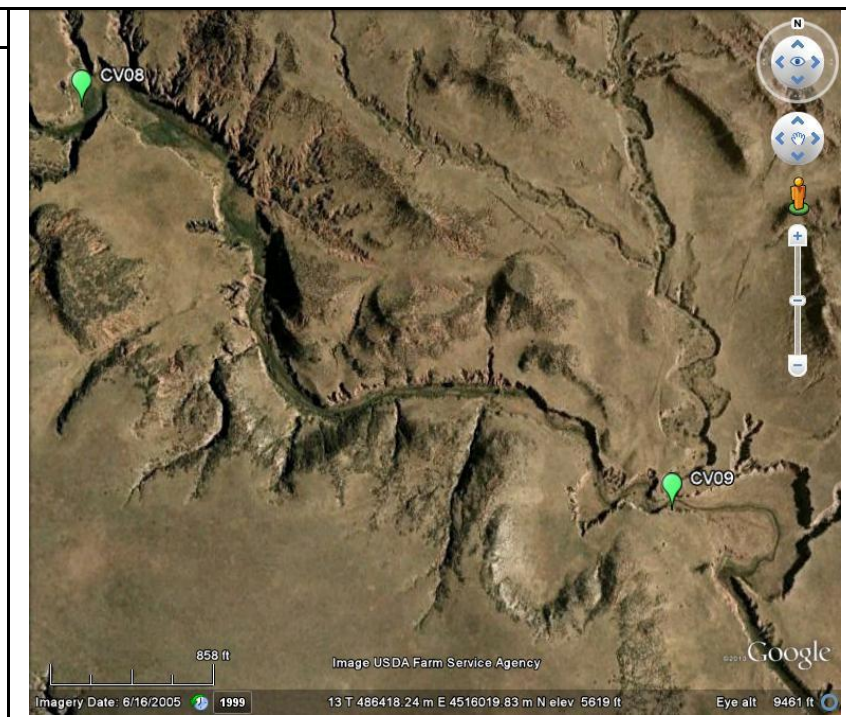
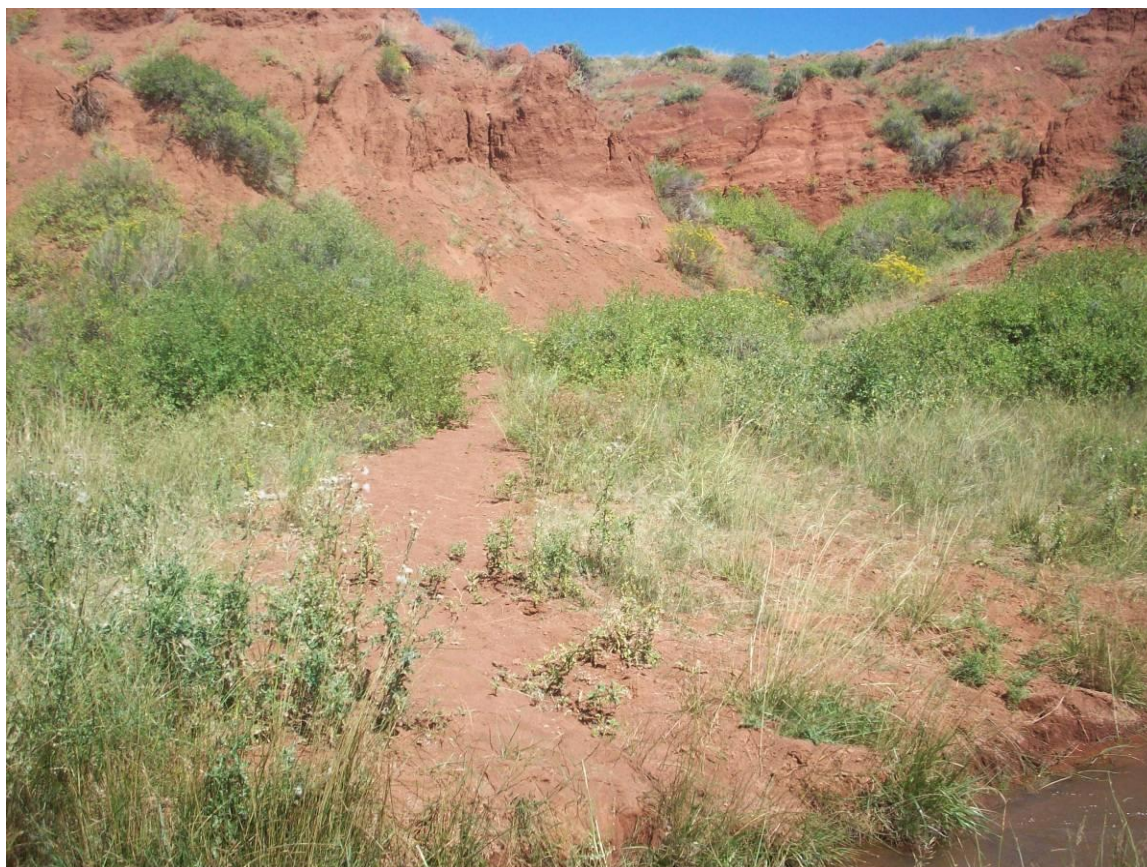
Section:	9	
Zone	13T	
Beginn	Northing	Easting
End	4516440	485831.5
Length	4515771 486815.8	
M	1190	
Acres	15.98

High historical grazing impact. Some willow beginning to re-establish.

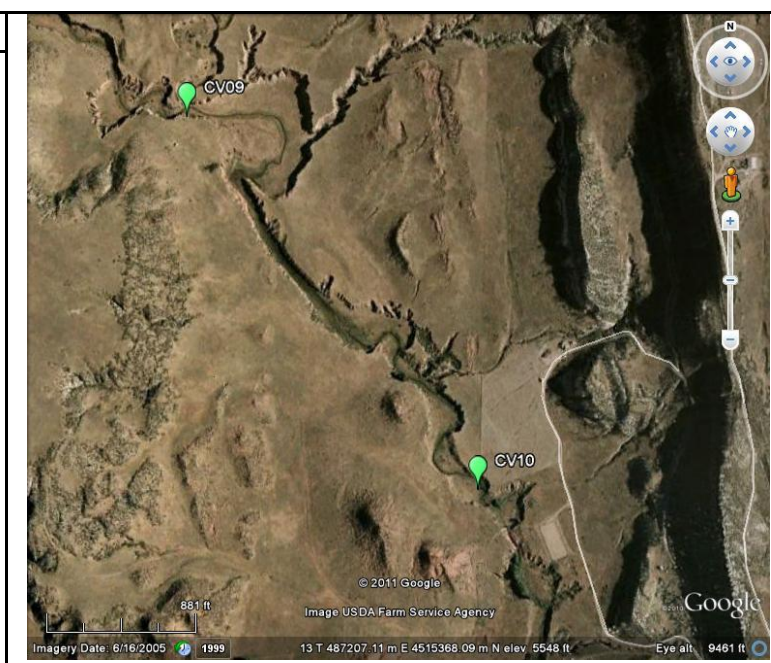
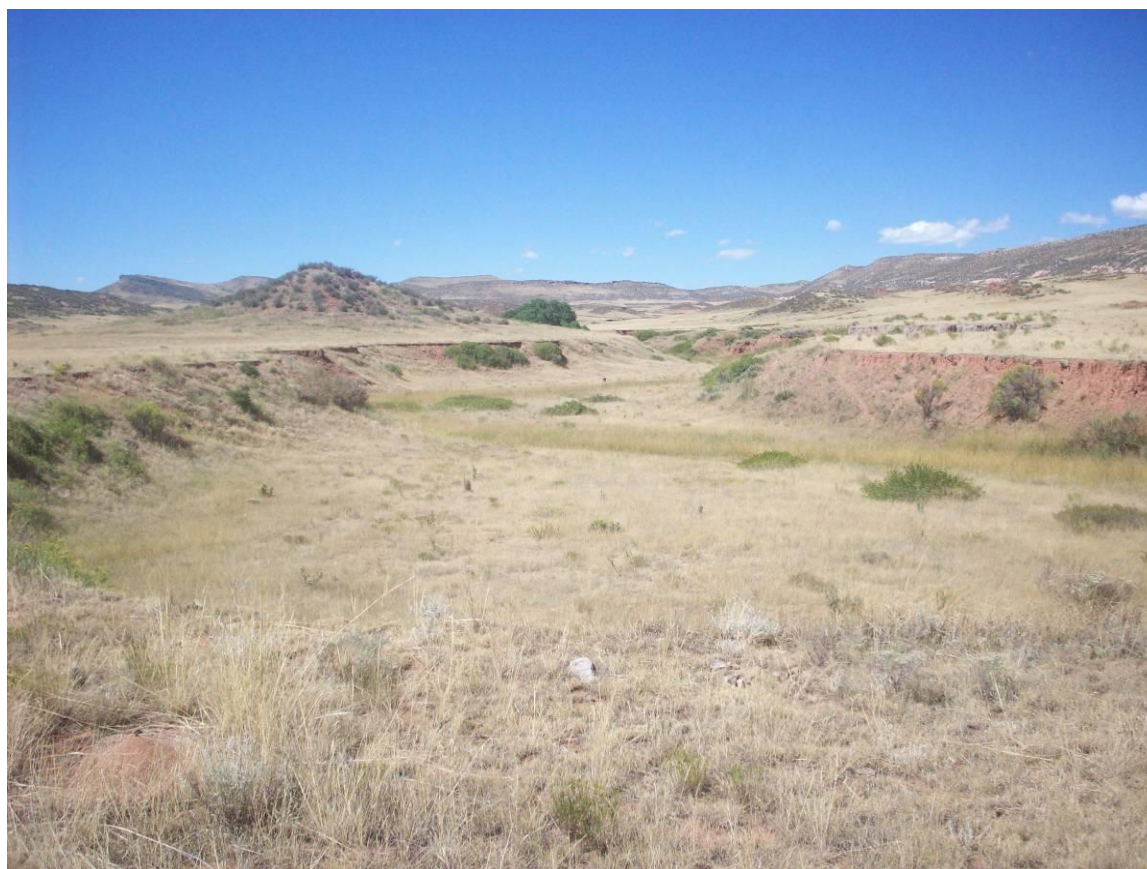
Section:	10	
Zone 13T	Northing	Easting
Beginn	4515771	486815.8
End	4515086	487352
Length M	870	
Acres	6.29

Highly impacted by active grazing.

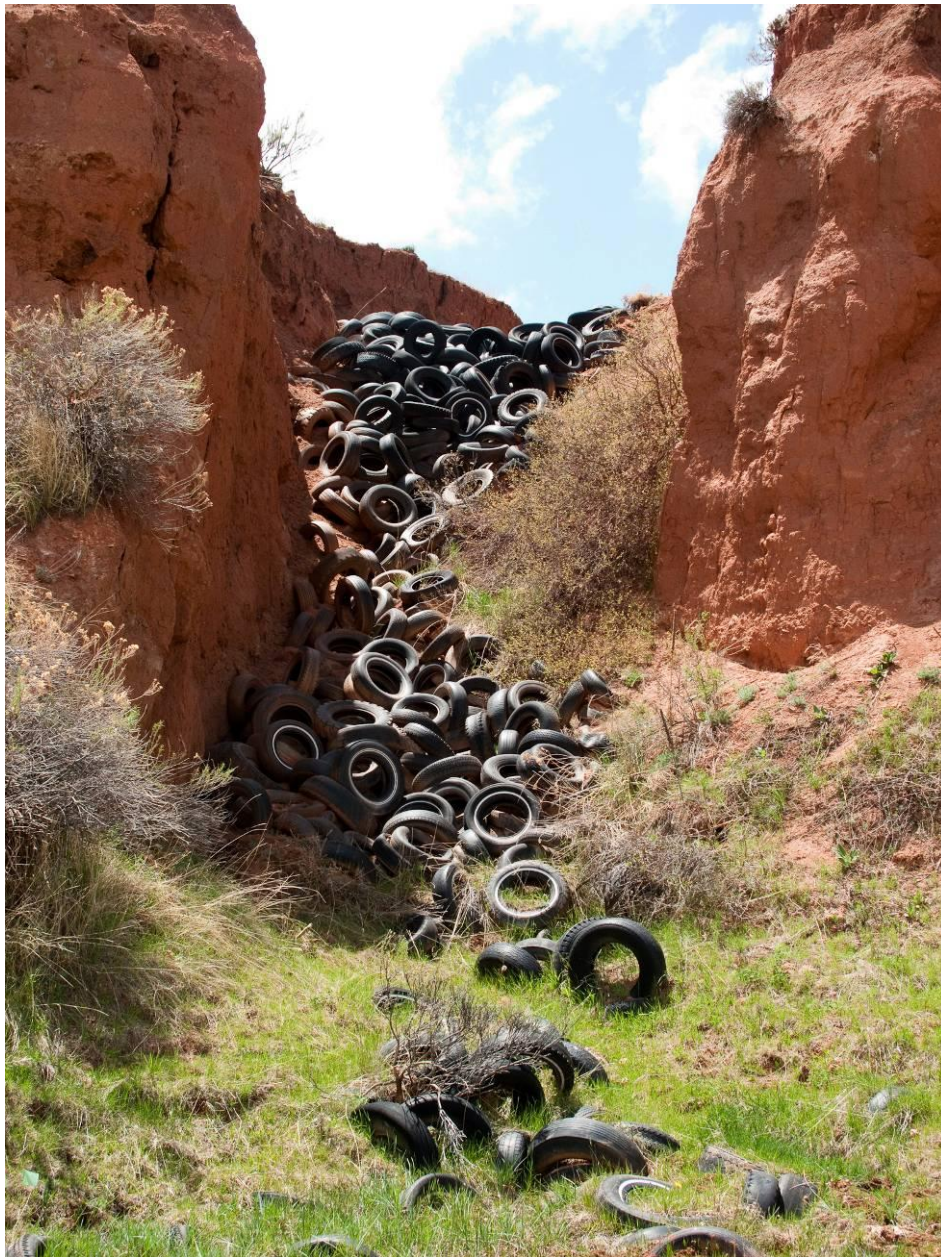
The tire problem at Campbell Valley
(just a fraction of it).

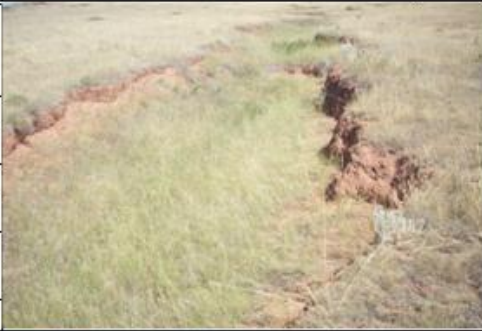
Left headcut	
camera height: ----- 5 ft on rebar				
approx. camera angle: ----- -5				
photo bearing: ----- 355				
intraday photo #: 10				
view #2:

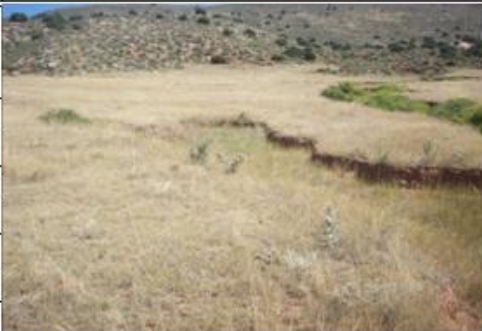
Right headcut	
camera height: ----- 5 ft on rebar				
approx. camera angle: ----- -5				
photo bearing: ----- 050				
intraday photo #: 11				
view #3:				
camera height: ----- 0				
approx. camera angle: ----- 0				
photo bearing: ----- 0				
intraday photo #:
