FINAL REPORT

Upper Fountain Creek and Cheyenne Creek Flood Restoration Master Plan

Fountain Creek Watershed Flood Control and Greenway District

June 26, 2015

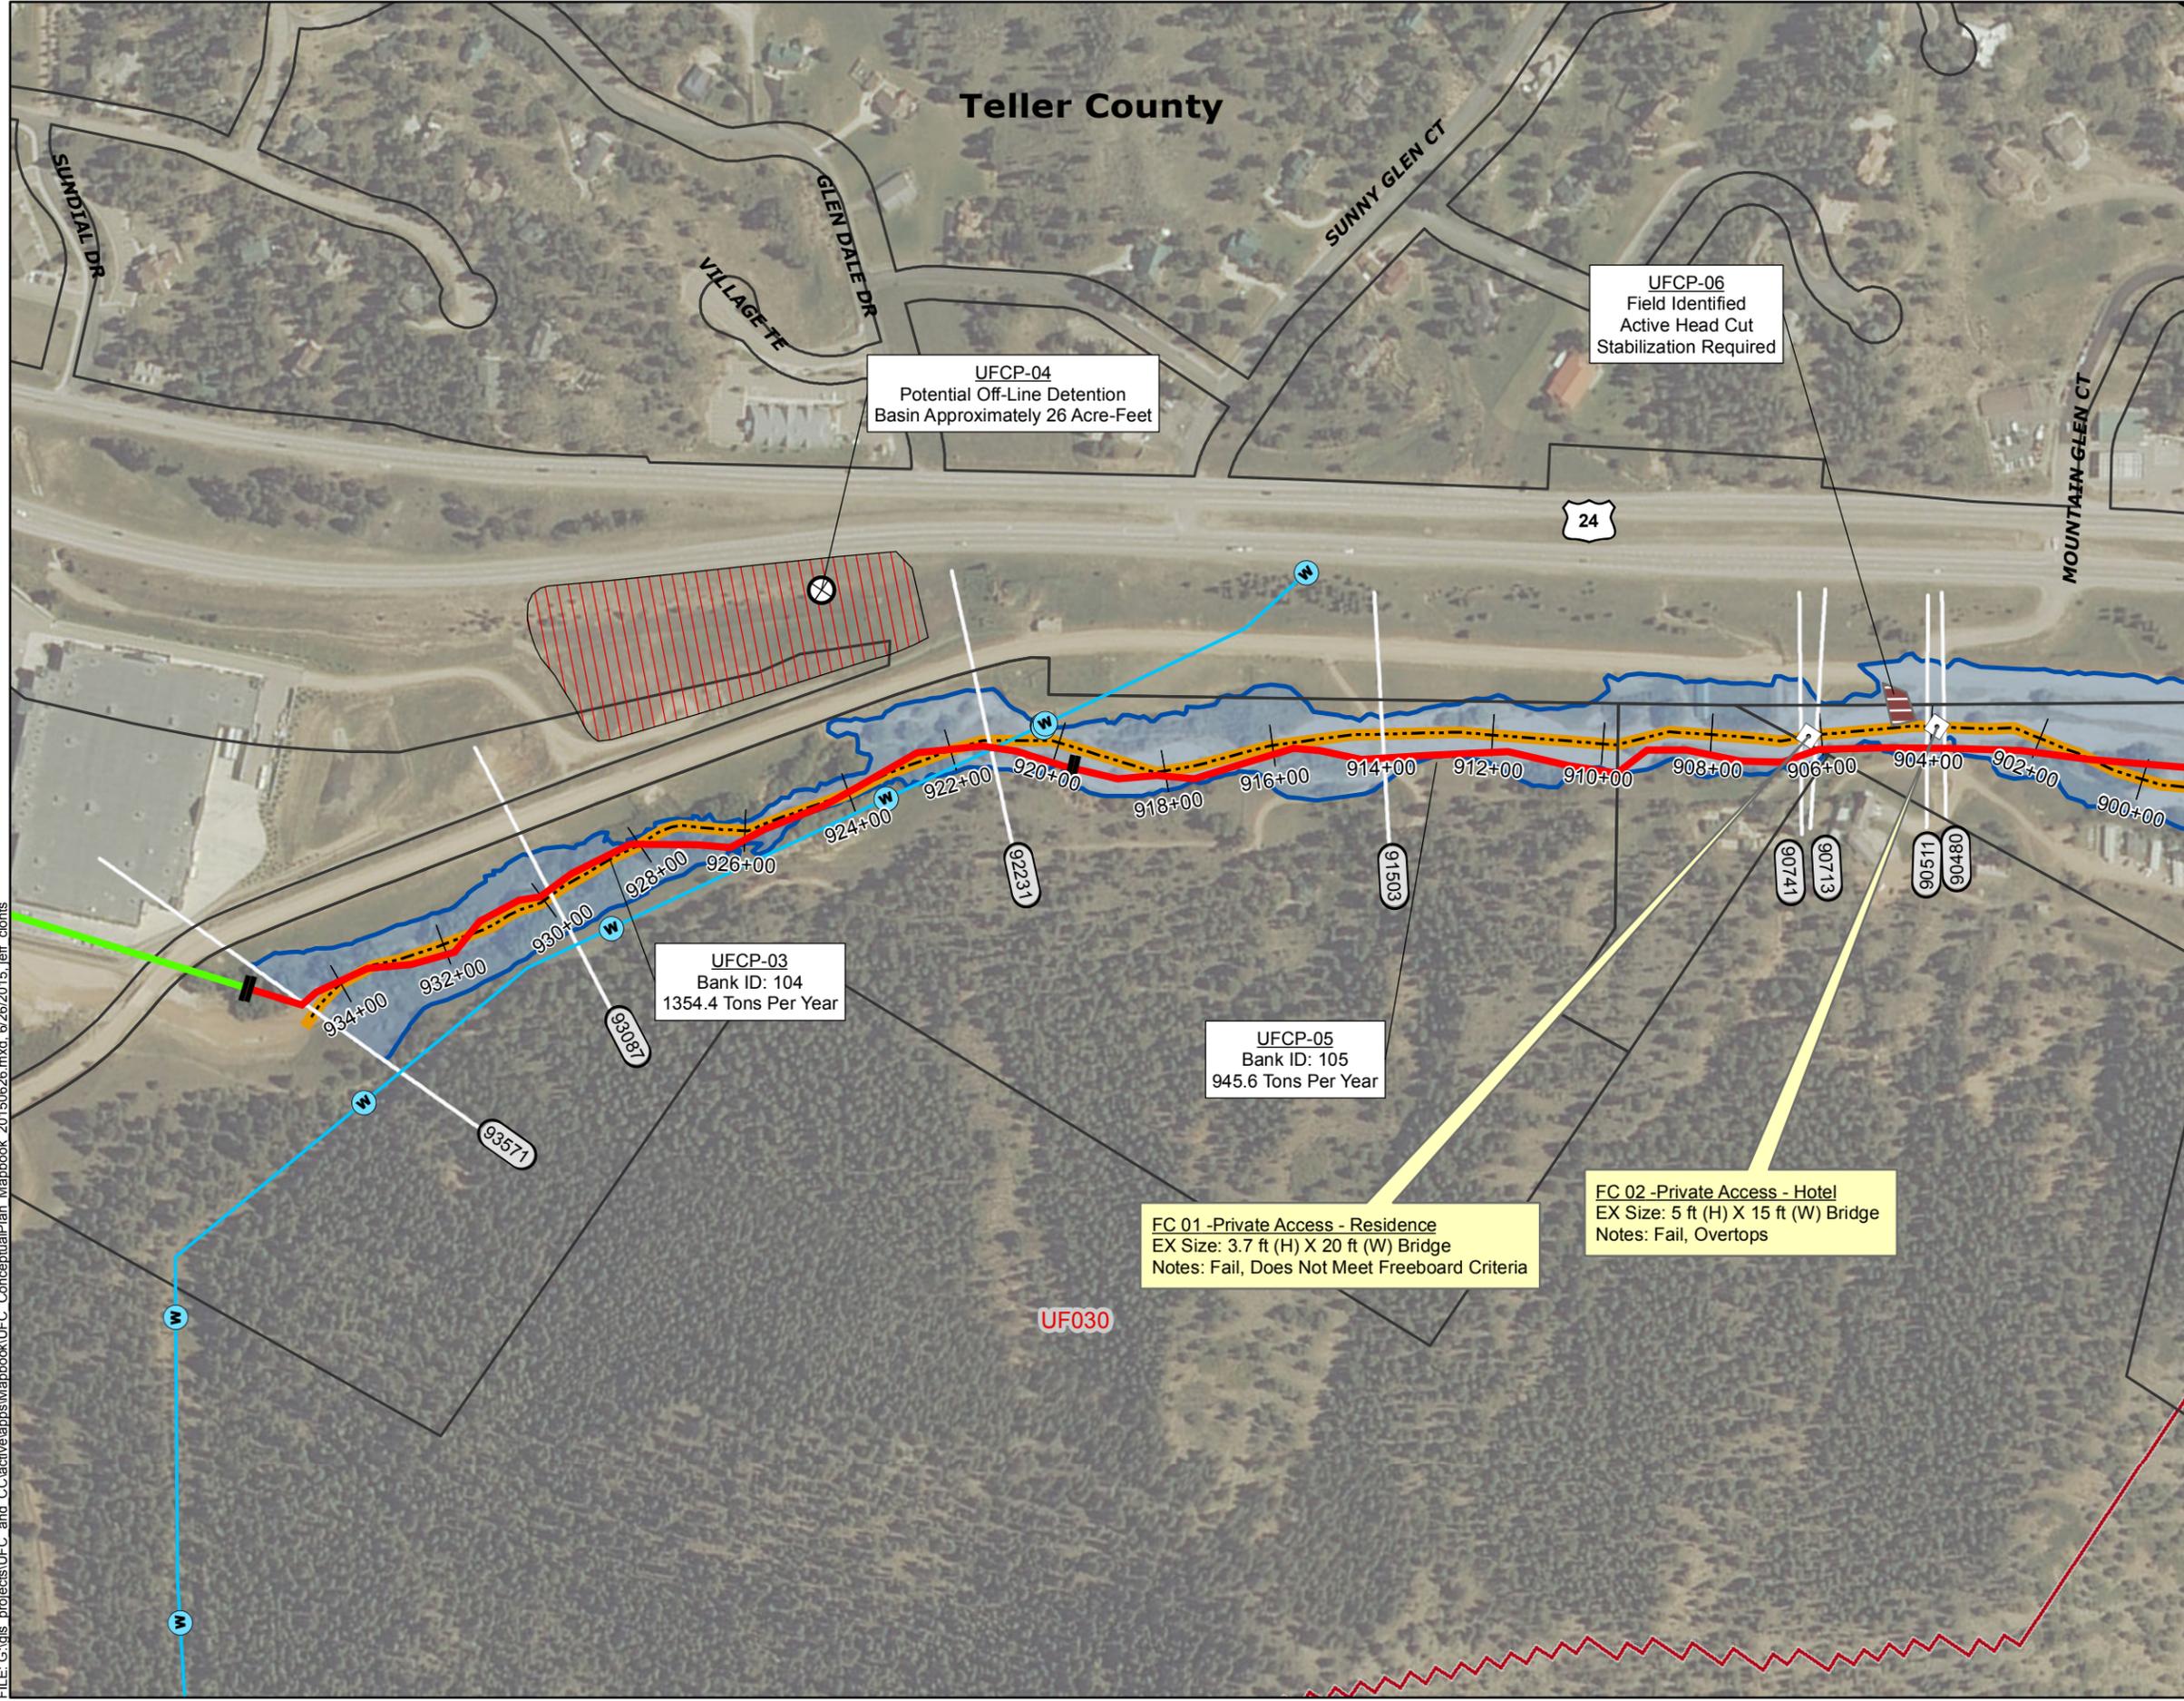
Sheet 3 of 25
 UFCP-03 thru UFCP-06
 Upper Fountain Creek
 Conceptual Plan
 El Paso County, CO

FC 01 -Private Access - Residence
 EX Size: 3.7 ft (H) X 20 ft (W) Bridge
 Notes: Fail, Does Not Meet Freeboard Criteria

FC 02 -Private Access - Hotel
 EX Size: 5 ft (H) X 15 ft (W) Bridge
 Notes: Fail, Overtops

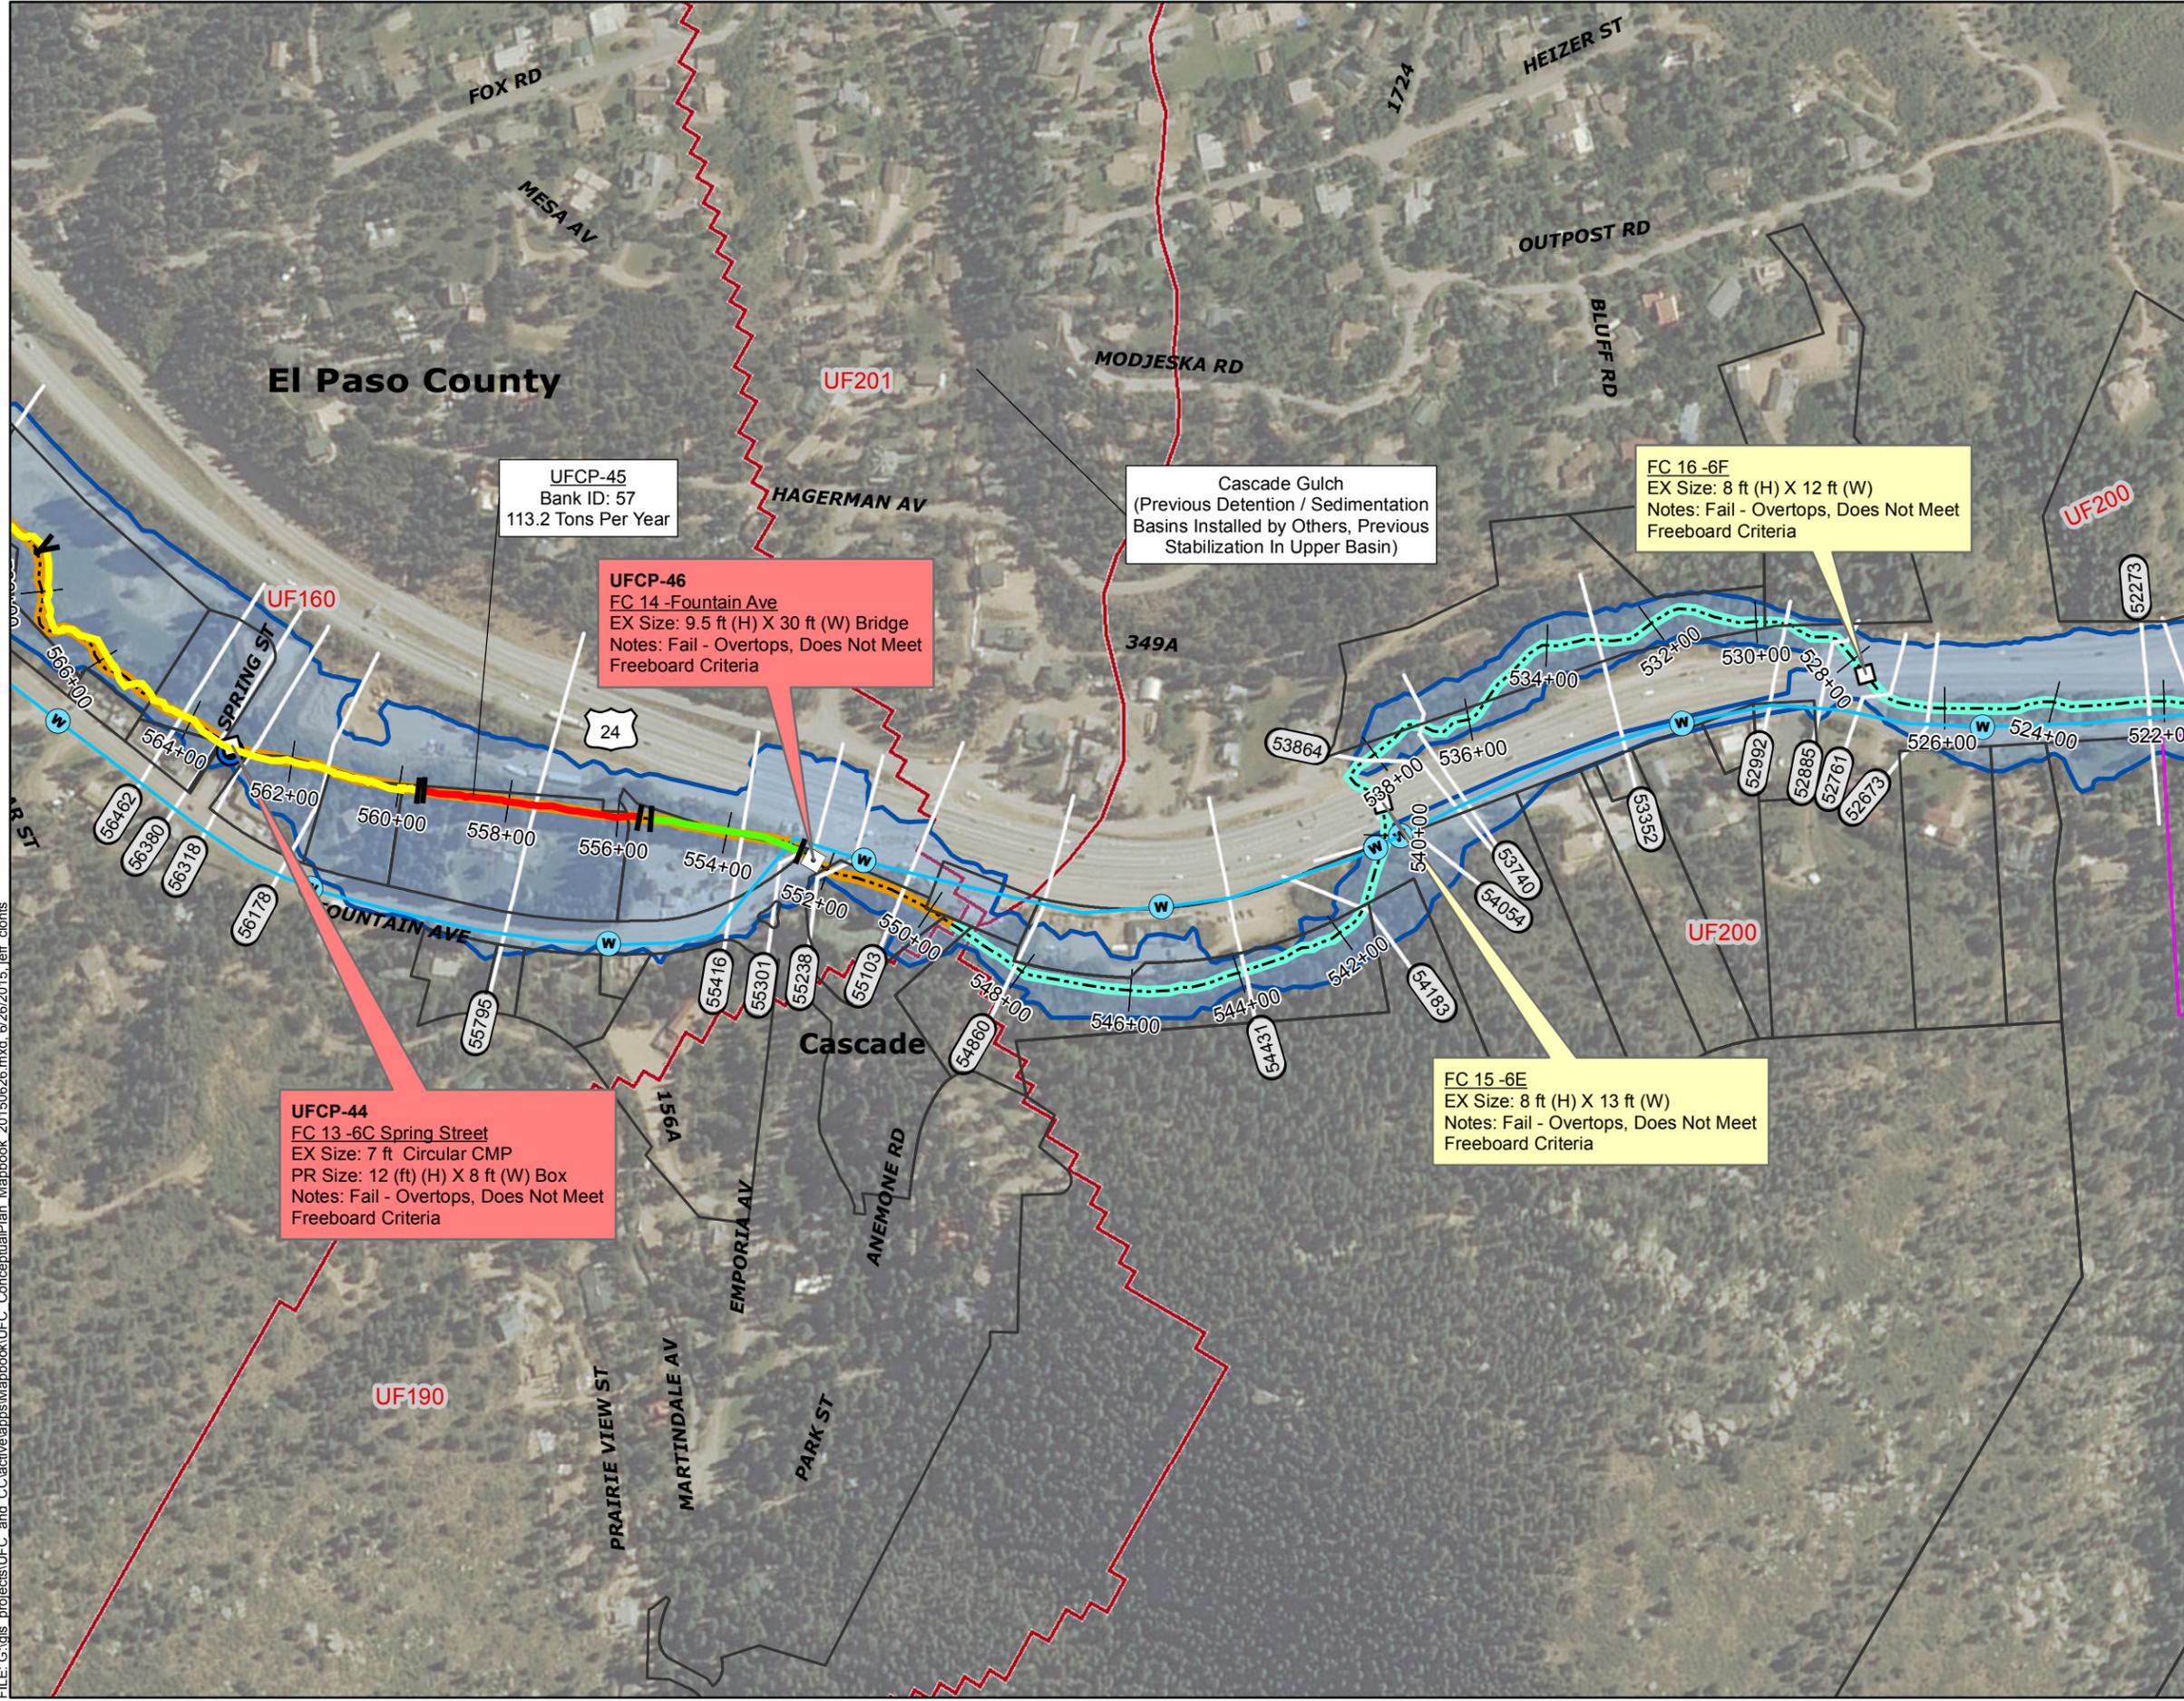
UFCP-45
Bank ID: 57
113.2 Tons Per Year

UFCP-46
FC 14 -Fountain Ave
EX Size: 9.5 ft (H) X 30 ft (W) Bridge
Notes: Fail - Overtops, Does Not Meet Freeboard Criteria

UFCP-44
FC 13 -6C Spring Street
EX Size: 7 ft Circular CMP
PR Size: 12 (ft) (H) X 8 ft (W) Box
Notes: Fail - Overtops, Does Not Meet Freeboard Criteria

FC 16 -6F
EX Size: 8 ft (H) X 12 ft (W)
Notes: Fail - Overtops, Does Not Meet Freeboard Criteria

FC 15 -6E
EX Size: 8 ft (H) X 13 ft (W)
Notes: Fail - Overtops, Does Not Meet Freeboard Criteria

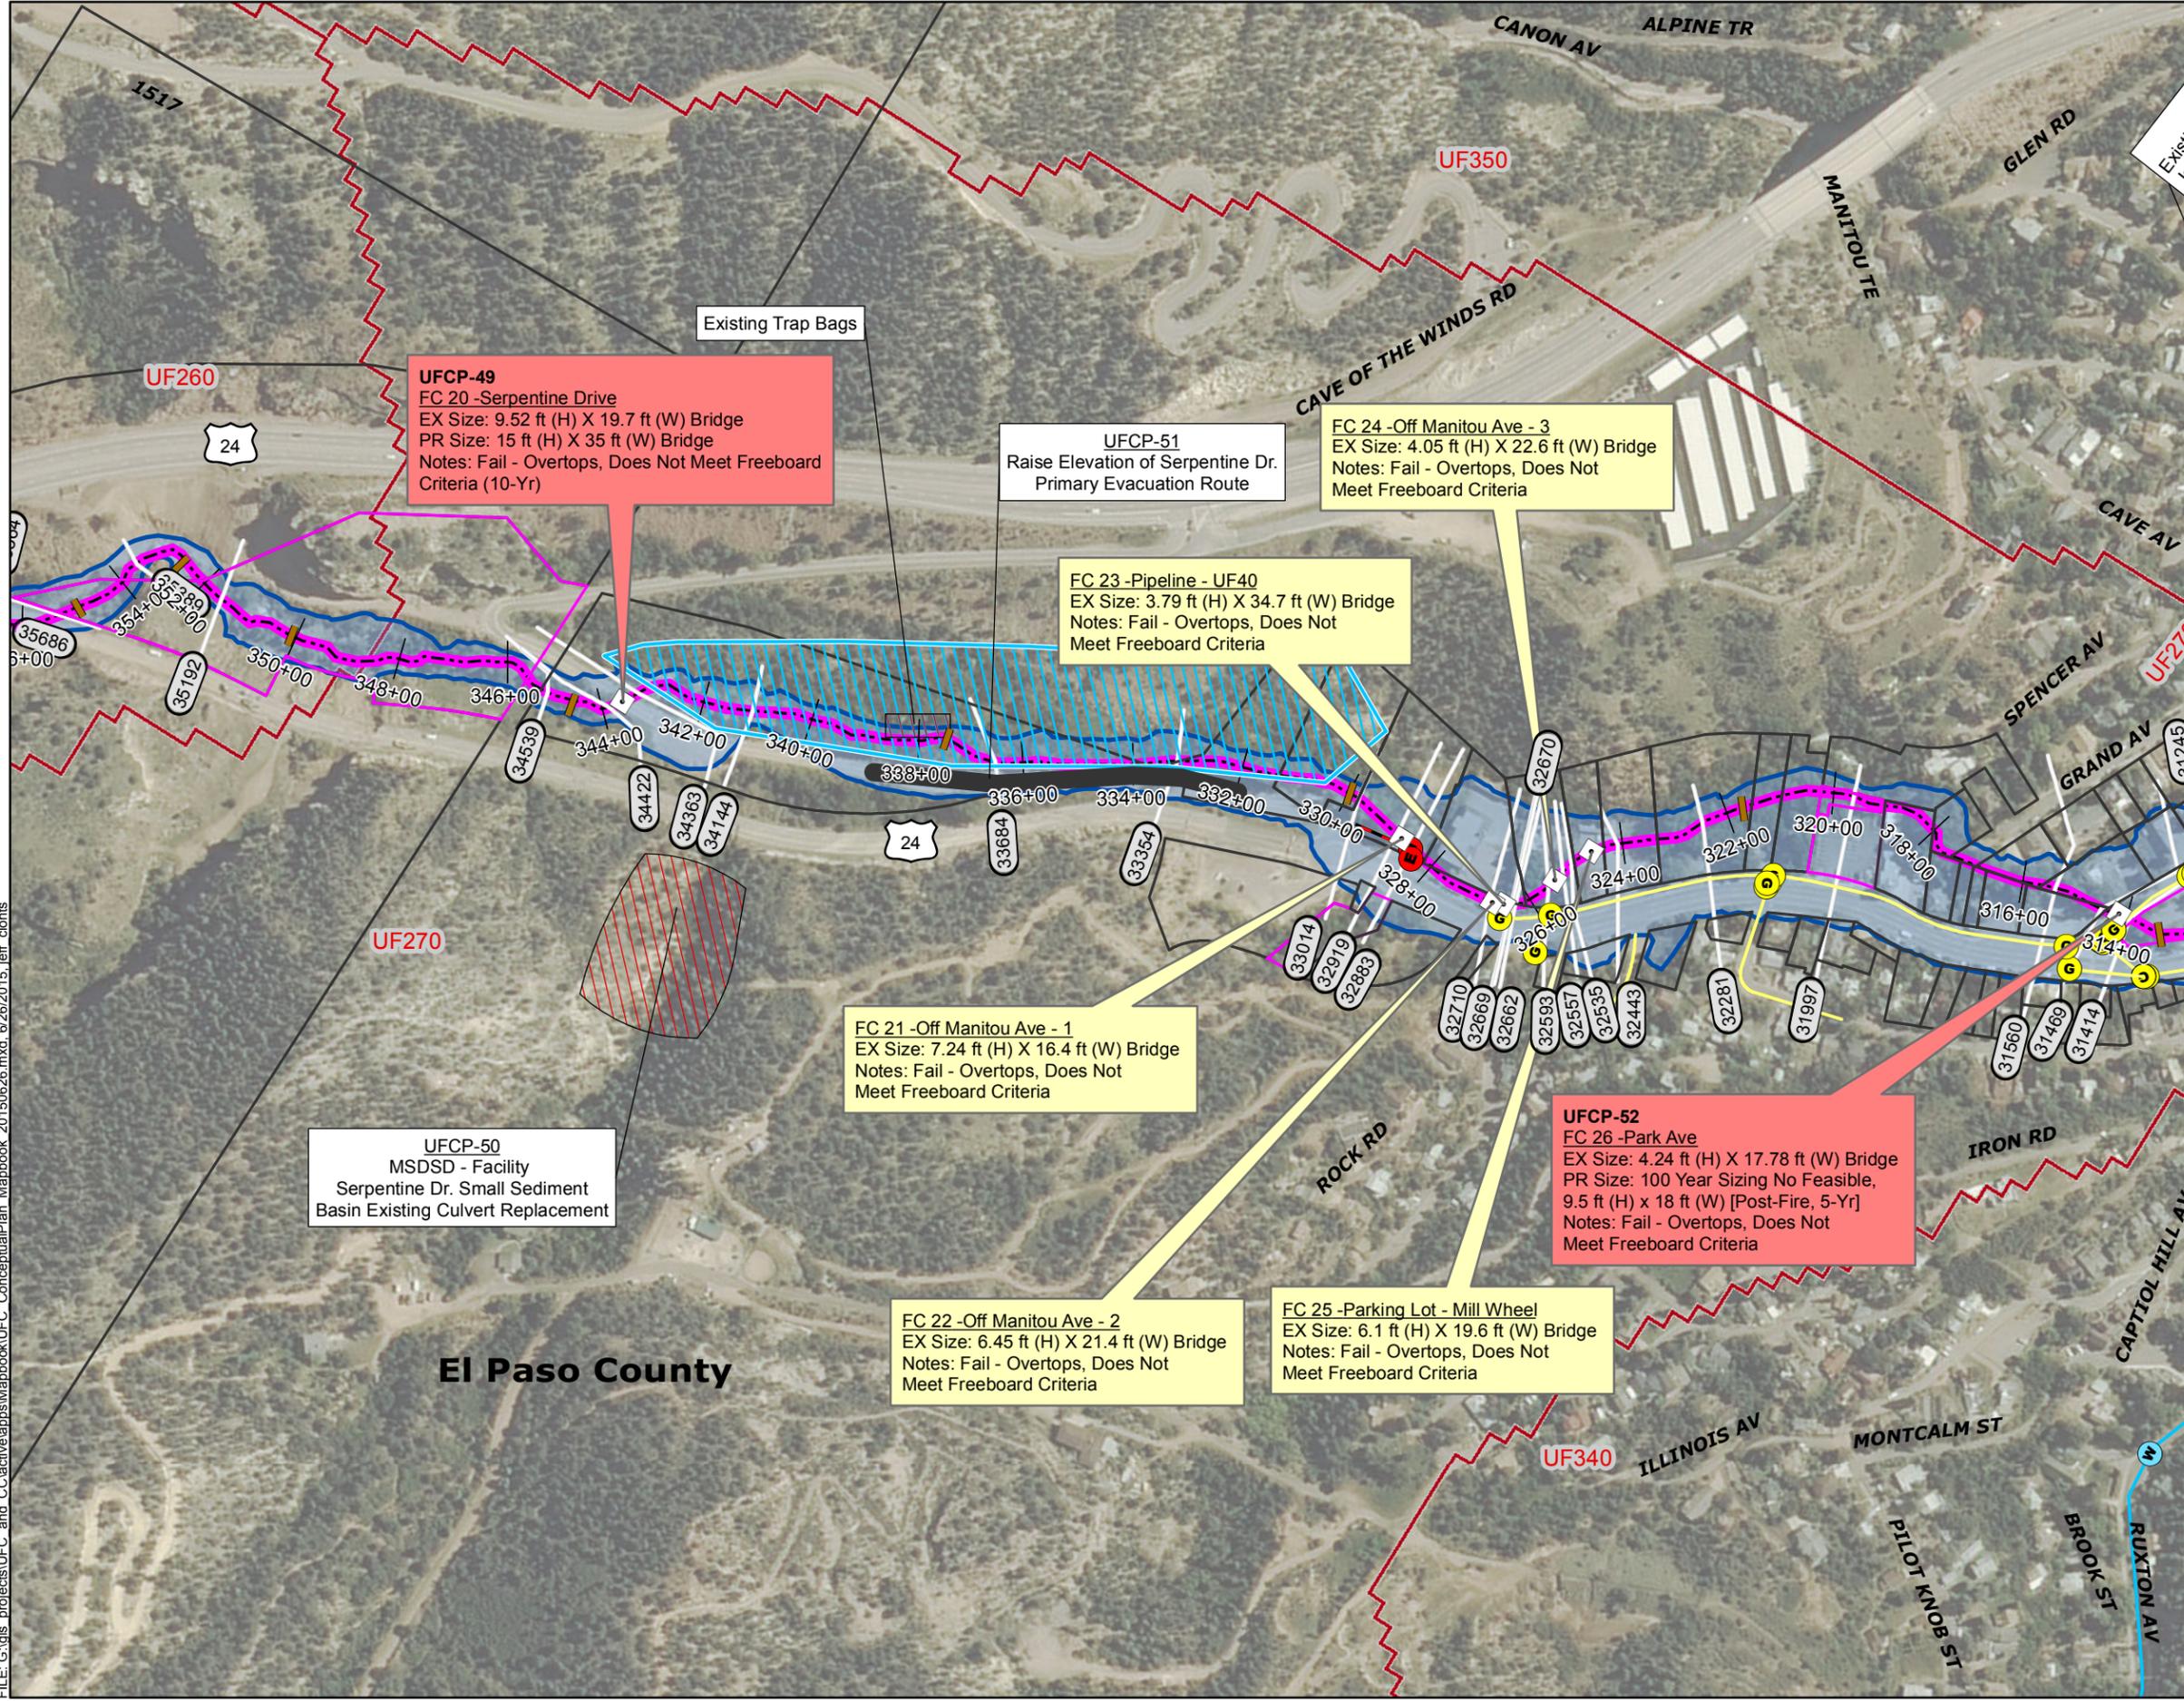
UFCP-49
 FC 20 -Serpentine Drive
 EX Size: 9.52 ft (H) X 19.7 ft (W) Bridge
 PR Size: 15 ft (H) X 35 ft (W) Bridge
 Notes: Fail - Overtops, Does Not Meet Freeboard Criteria (10-Yr)

FC 24 -Off Manitou Ave - 3
 EX Size: 4.05 ft (H) X 22.6 ft (W) Bridge
 Notes: Fail - Overtops, Does Not Meet Freeboard Criteria

FC 23 -Pipeline - UF40
 EX Size: 3.79 ft (H) X 34.7 ft (W) Bridge
 Notes: Fail - Overtops, Does Not Meet Freeboard Criteria

FC 21 -Off Manitou Ave - 1
 EX Size: 7.24 ft (H) X 16.4 ft (W) Bridge
 Notes: Fail - Overtops, Does Not Meet Freeboard Criteria

FC 22 -Off Manitou Ave - 2
 EX Size: 6.45 ft (H) X 21.4 ft (W) Bridge
 Notes: Fail - Overtops, Does Not Meet Freeboard Criteria

FC 25 -Parking Lot - Mill Wheel
 EX Size: 6.1 ft (H) X 19.6 ft (W) Bridge
 Notes: Fail - Overtops, Does Not Meet Freeboard Criteria

UFCP-52
 FC 26 -Park Ave
 EX Size: 4.24 ft (H) X 17.78 ft (W) Bridge
 PR Size: 100 Year Sizing No Feasible, 9.5 ft (H) x 18 ft (W) [Post-Fire, 5-Yr]
 Notes: Fail - Overtops, Does Not Meet Freeboard Criteria

UFCP-50
 MSDSD - Facility
 Serpentine Dr. Small Sediment Basin Existing Culvert Replacement

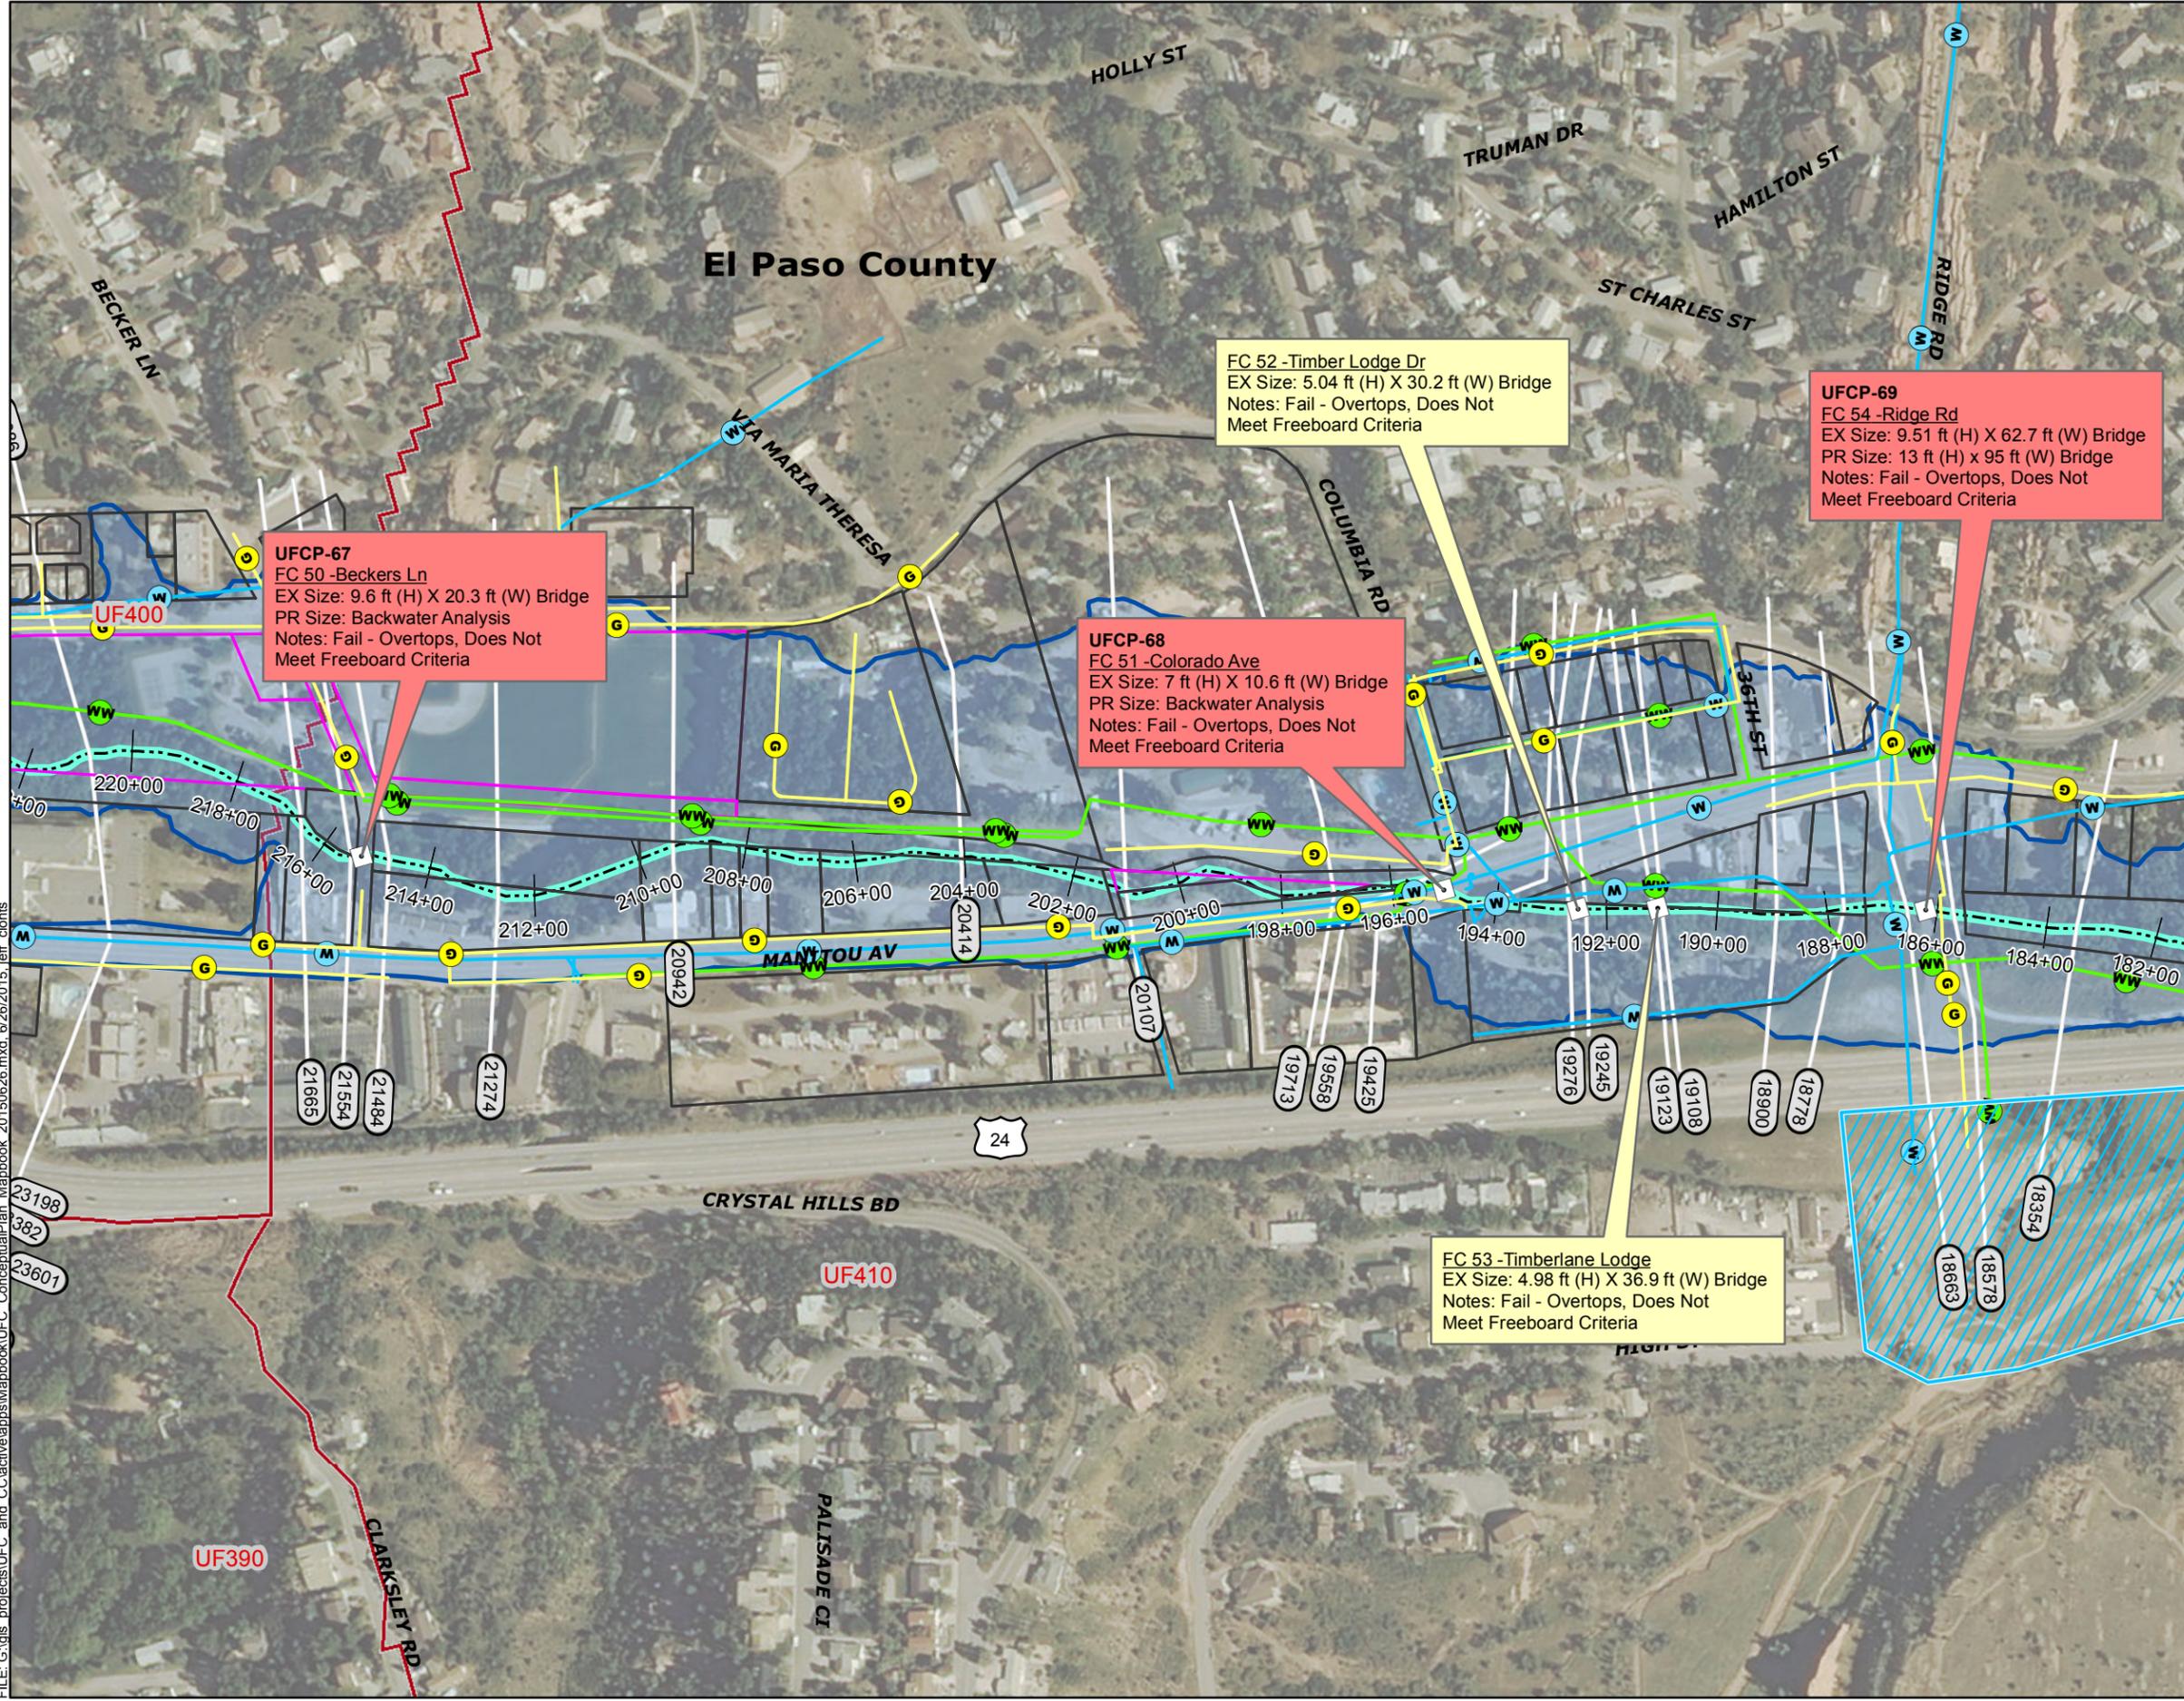
UFCP-67
 FC 50 -Beckers Ln
 EX Size: 9.6 ft (H) X 20.3 ft (W) Bridge
 PR Size: Backwater Analysis
 Notes: Fail - Overtops, Does Not Meet Freeboard Criteria

FC 52 -Timber Lodge Dr
 EX Size: 5.04 ft (H) X 30.2 ft (W) Bridge
 Notes: Fail - Overtops, Does Not Meet Freeboard Criteria

UFCP-69
 FC 54 -Ridge Rd
 EX Size: 9.51 ft (H) X 62.7 ft (W) Bridge
 PR Size: 13 ft (H) x 95 ft (W) Bridge
 Notes: Fail - Overtops, Does Not Meet Freeboard Criteria

UFCP-68
 FC 51 -Colorado Ave
 EX Size: 7 ft (H) X 10.6 ft (W) Bridge
 PR Size: Backwater Analysis
 Notes: Fail - Overtops, Does Not Meet Freeboard Criteria

FC 53 -Timberlane Lodge
 EX Size: 4.98 ft (H) X 36.9 ft (W) Bridge
 Notes: Fail - Overtops, Does Not Meet Freeboard Criteria

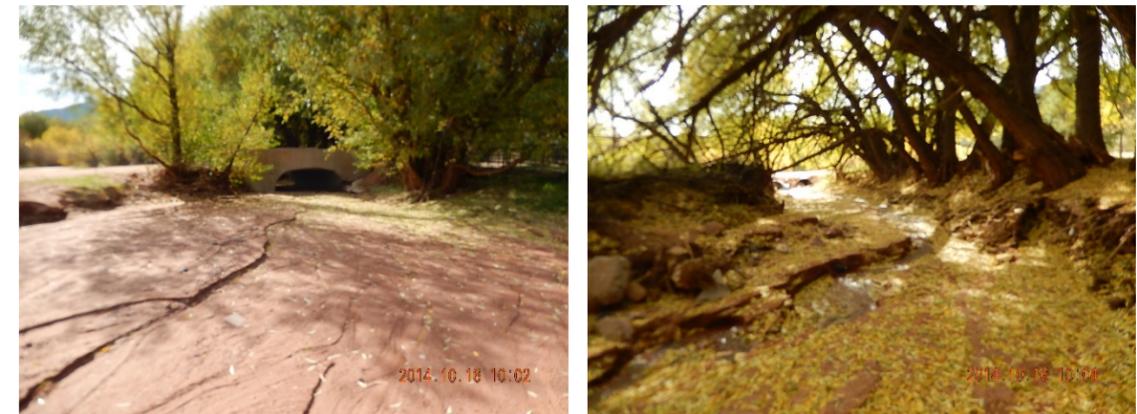
Figure 3-3. Culvert FC 03, Sediment, and Channel Degradation

This group of projects consists of replacing the downstream culvert (FC 04 – Creek Side Dr.), adding an offline sediment basin (approx. 6 ac-ft), performing a backwater analysis on Culvert FC 03 – Crystola Canyon Road and stabilizing bank 02 which generates 145 tons/year of sediment to Upper Fountain Creek. A flood levee wall is also proposed to be considered for flood risk reduction.

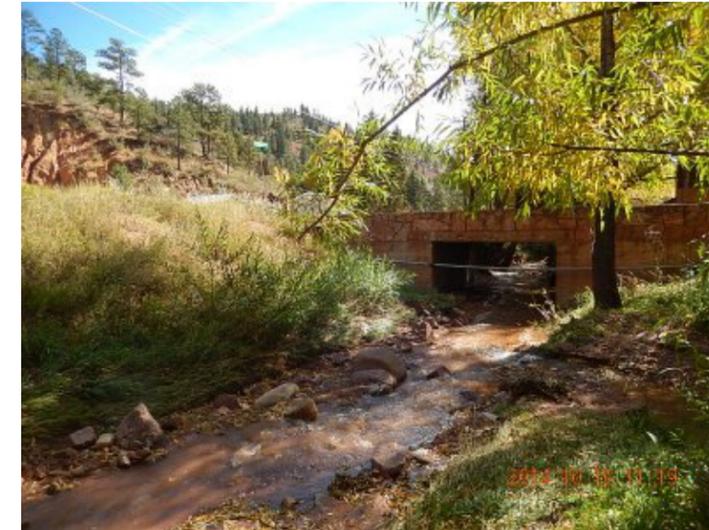
Figure 3-6. Bridge at Hotel St. and El Paso Ave

A backwater analysis is recommended to be performed as part of flood risk reduction. The project will alleviate flooding issues on upstream property and prevent further degradation of the creek.

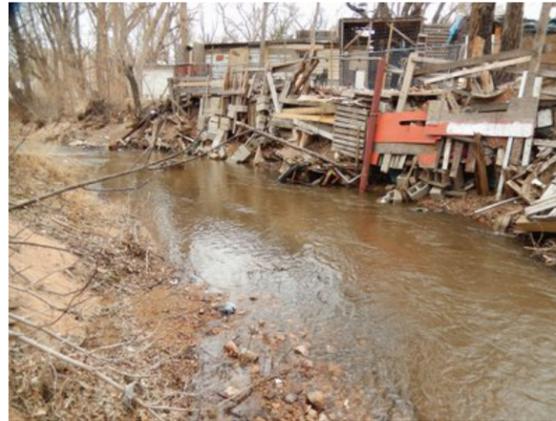
Figure 3-12. Trash and Debris along Bank

This project consists of removing trash and debris from a specific property on the creek. A flood event may cause piles to break apart and obstruct crossings or damage property downstream. Trash and debris also threatens safety and habitat along the creek. This is an immediate risk.
