# **Fish Habitat Enhancement at the Paonia River Park Final Report**

January 26, 2015

**The Western Slope Conservation Center**

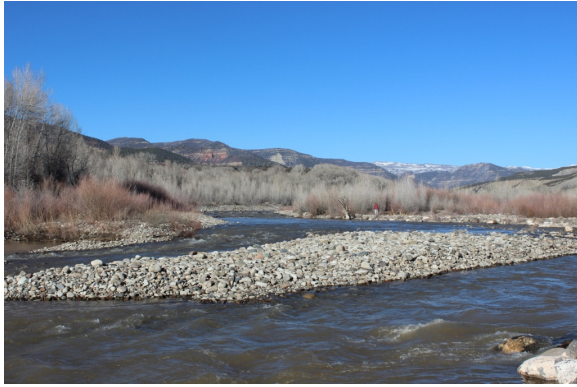
*March 2014, before construction*

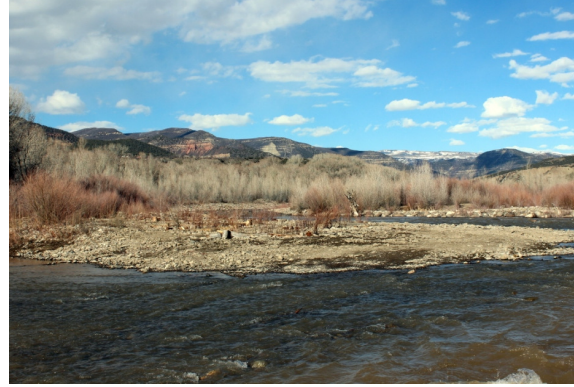
*March 2014, after construction*

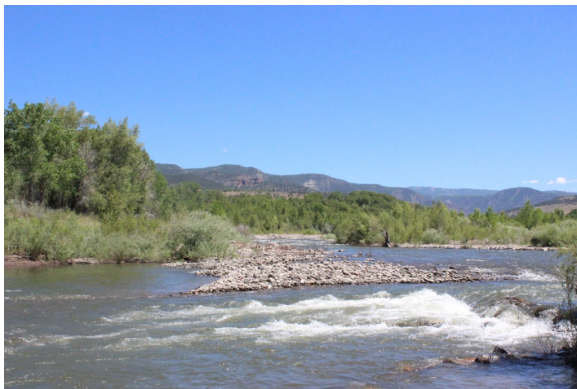
*June 2014, after spring runoff*

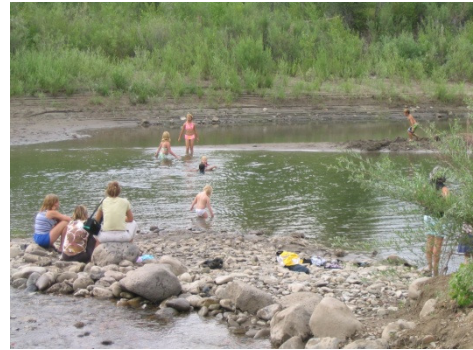
3+00 – This cross section was located downstream of the project boundaries across the popular “swimming hole” at the confluence of Minnesota Creek. The purpose of this plot was to identify any changes in the pool due to the project. The horizontal dimensions of the pool remained primarily unchanged but the depth of the pool increased by close to 3 feet. It is speculated that the concentration of flow from one channel instead of three improved the scouring capability of the river at the pool.

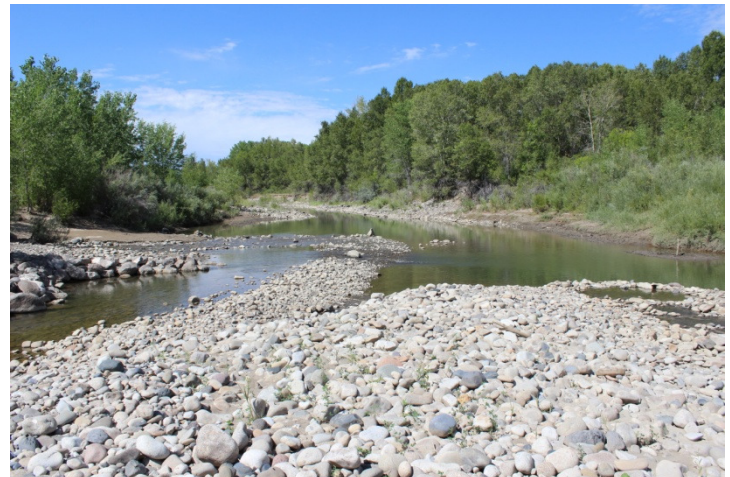
5+80 – This cross section traverses the previous south side channel where it met the current main channel upstream of Minnesota Creek. The side channel was filled at the confluence and stabilized with large rock. A series of wetlands were developed in the side channel for aquatic and terrestrial habitat. Willows, bulrush and cattails were planted around the perimeter of the wetlands. Two piezometers were installed along this cross section to measure the depth of groundwater relative to the surface water of the river. The main channel at this location deposited a new gravel bar on the north side of the river and is forming a new point bar. The main low flow channel was narrowed substantially and the depth decreased by about one foot. The floodplain is thriving with new riparian vegetation and the revetments along the south side of the bank remained unchanged. It is expected that the new point bar will grow over time and generate new vegetation as well. This would be a good location for additional adaptive management to stabilize the point bar and create additional fish holding structures above the bar.

*New gravel point bar with main channel on left*

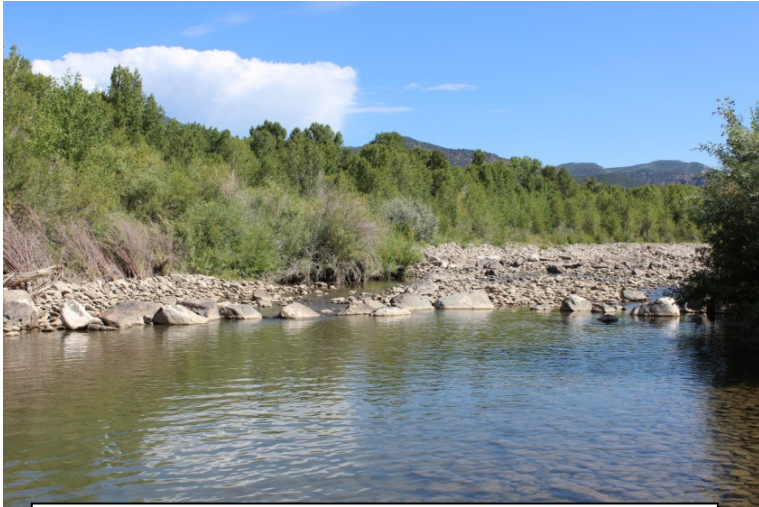
*Looking upstream at new pool*

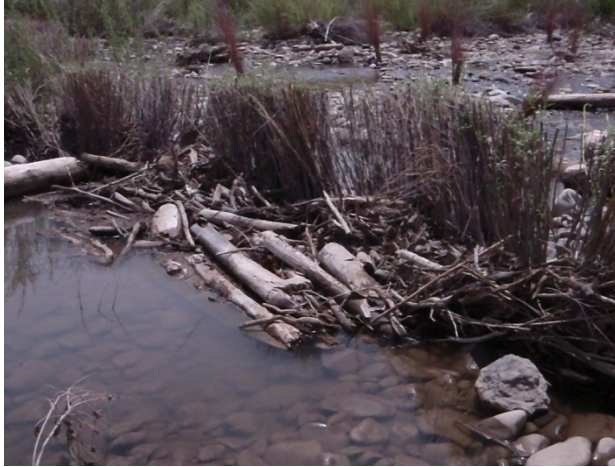
The ones planted in trenches across the side channels were primarily used as live willow silt fences. Their purpose was to filter out sediment and debris while allowing water to pass and slow flow velocities. These silt fences worked very well for their intended purpose but few of them established new vegetative starts. There are no definitive reasons for why most of these did not grow but possible reasons include too much water and too thick of a bundle. These silt fences were placed in locations of varying depth to groundwater with varying densities of sediment around the bundles but only about 20% of the willows in these trenches actually survived.

*Debris and sediment captured & some growth*

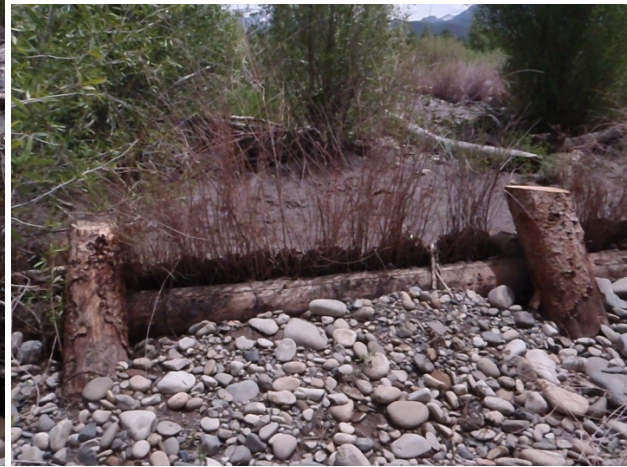
*Sediment upstream, gravel downstream & no growth*

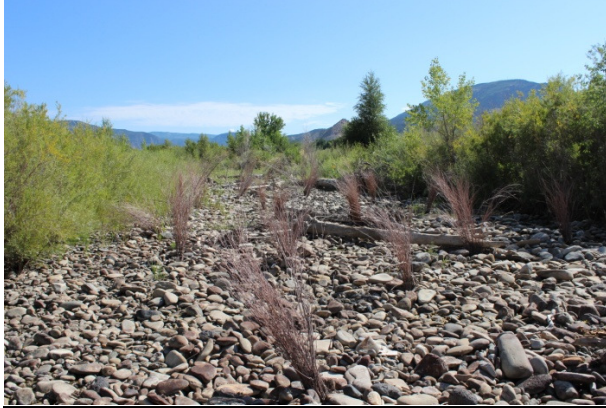
The individual willow plantings come with a mixed review. Some did well where others did not survive at all. There did not seem to be any definitive reason for the varied success. Overall the success rate was measured at 59%.

*Unsuccessful willows in gravel bed*
