**South Platte River Restoration Design and  
Demonstration Project Final Report  
(April – June 2013)**

**April 3, 2015**

Prepared By:  
Ecological Resource Consultants, Inc

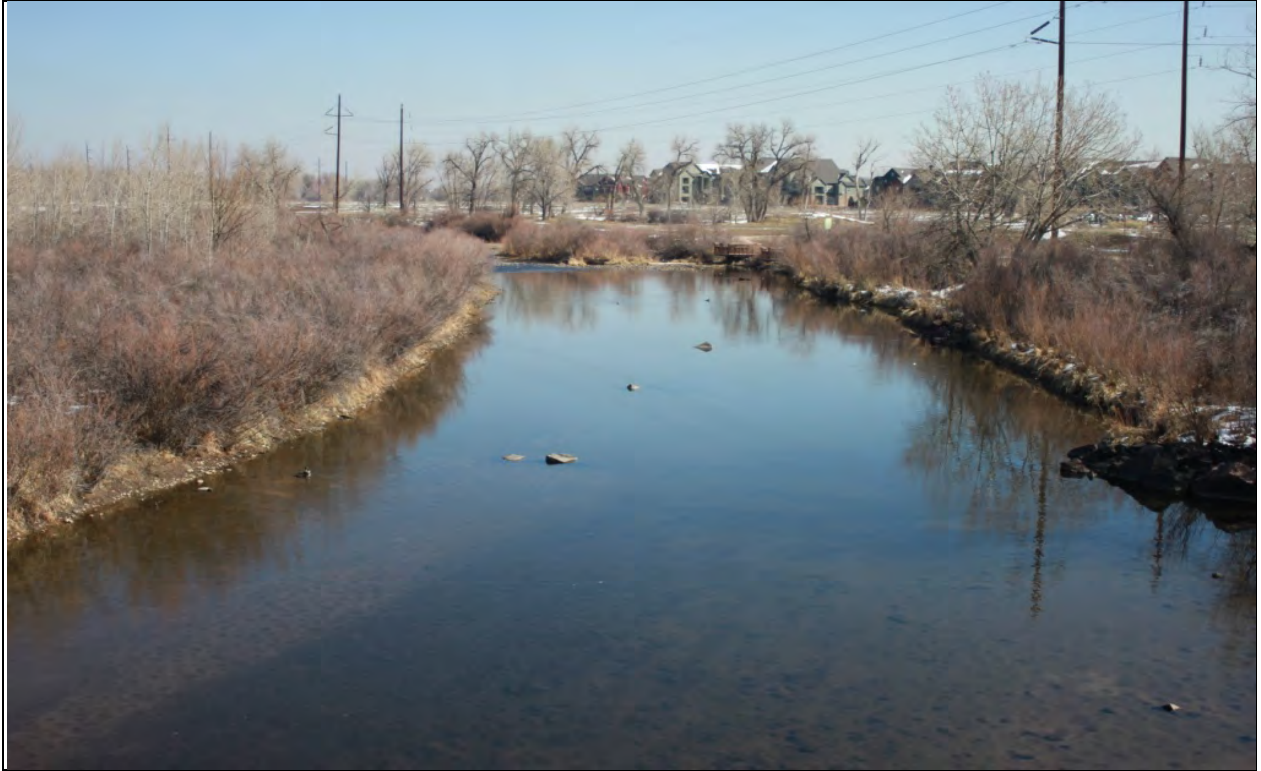
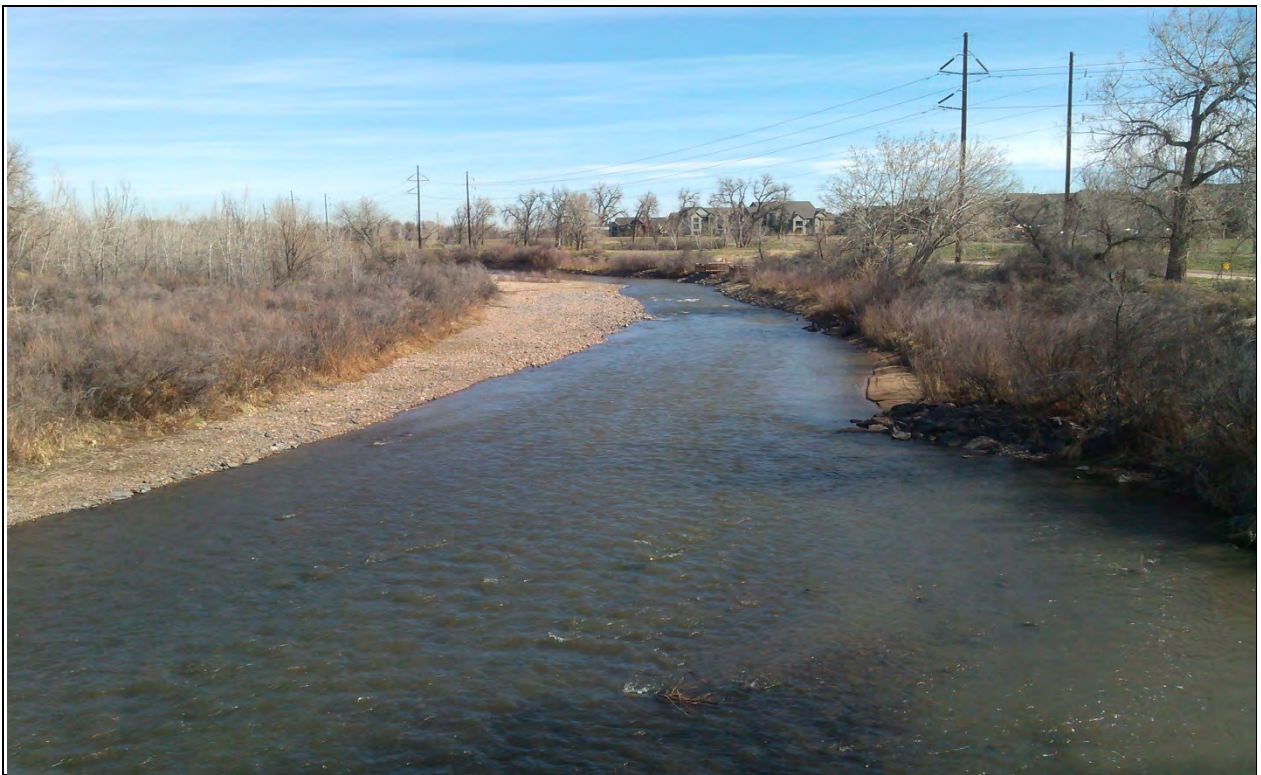
**Top:** Looking downstream at overly wide channel (before).

**Bottom:** Constructed low flow channel and vegetated point bar (after).

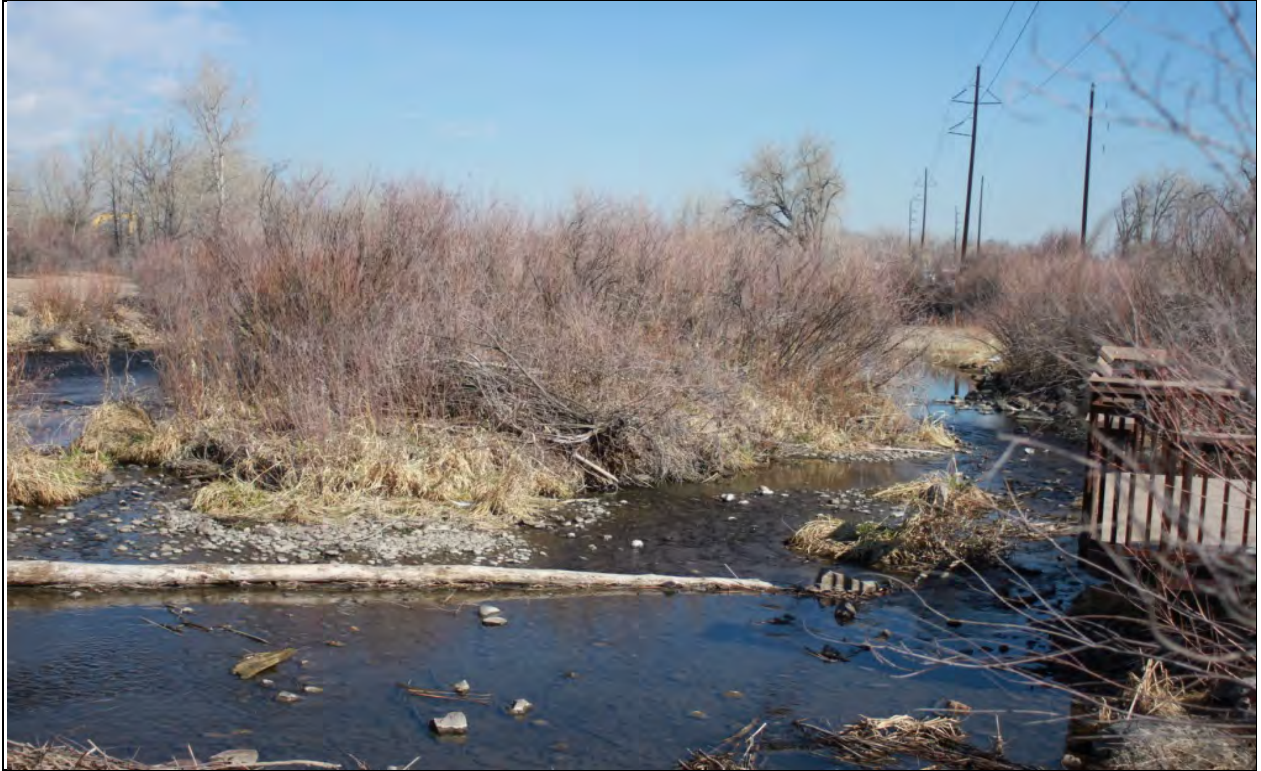
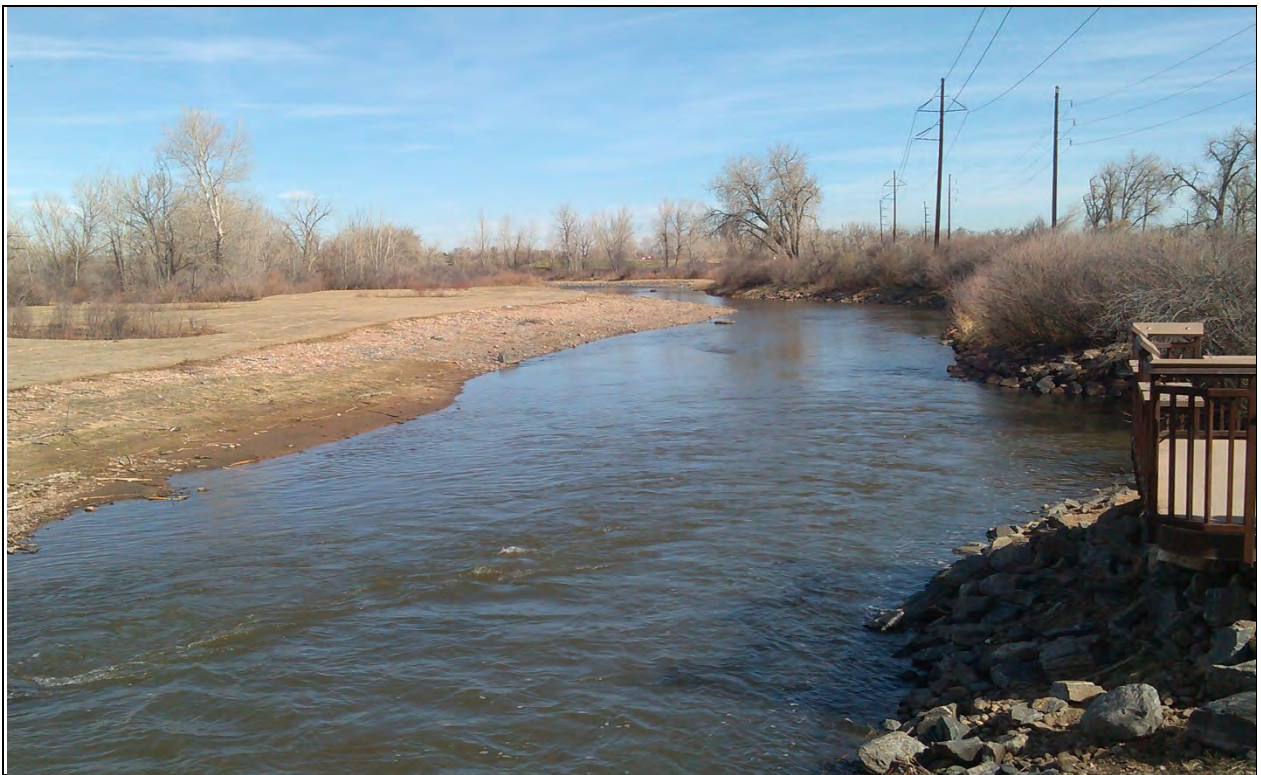
**Top:** Looking downstream from fishing pier at braided channel clogged with debris (before).

**Bottom:** Constructed low flow channel and vegetated point bar (after).

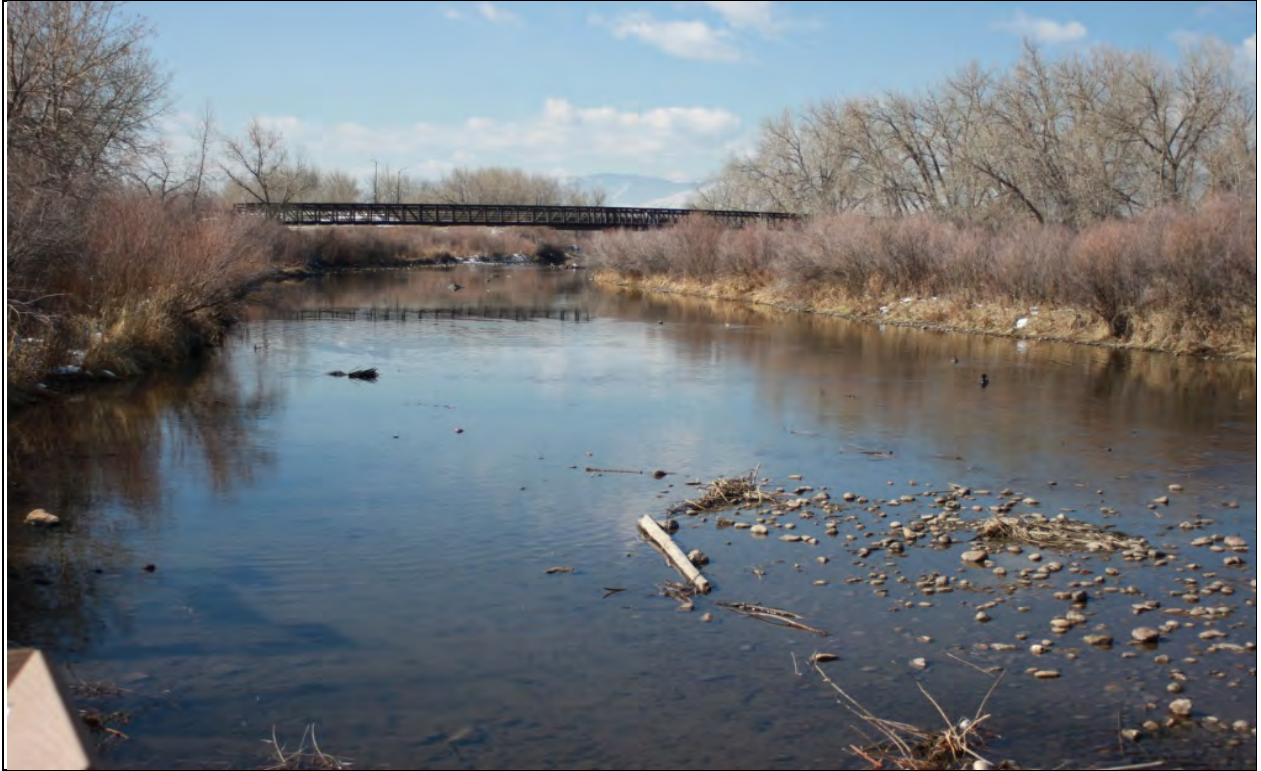
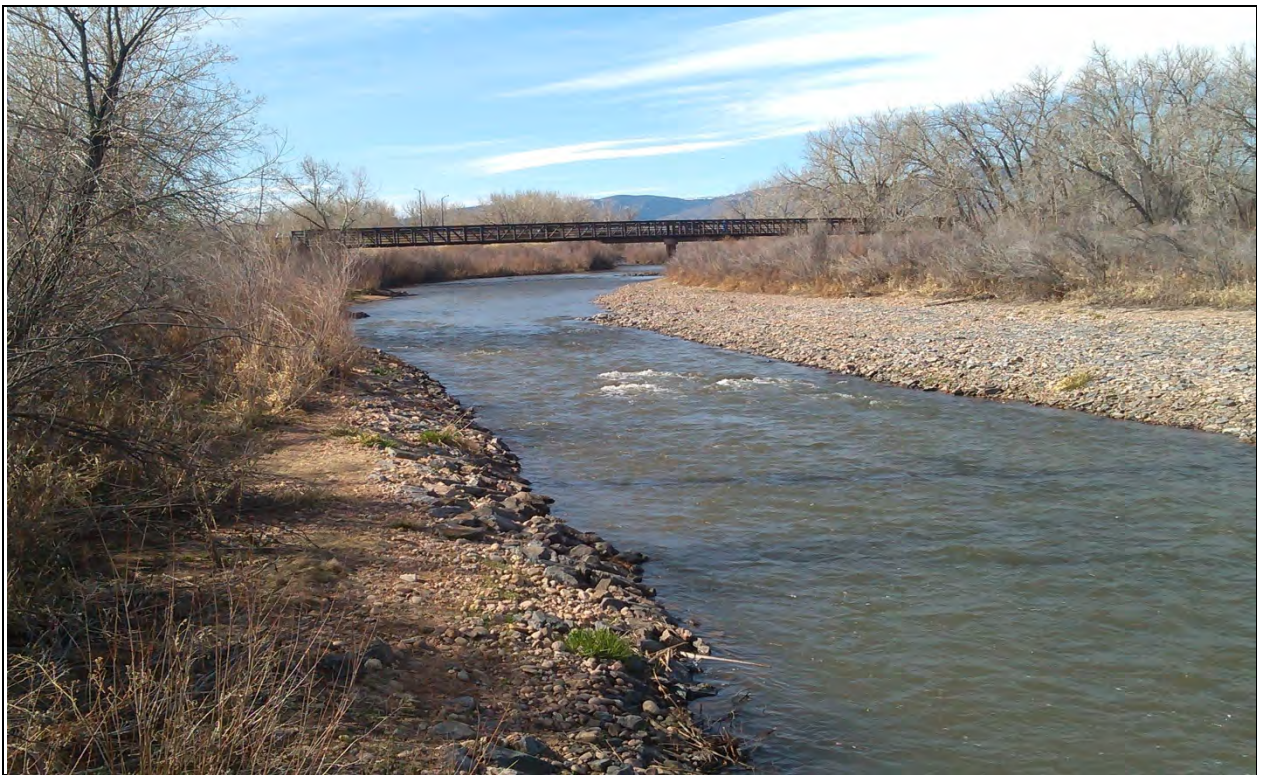
**Top:** Looking upstream from fishing pier at overly wide channel (before).

**Bottom:** Constructed low flow channel and vegetated point bar (after).

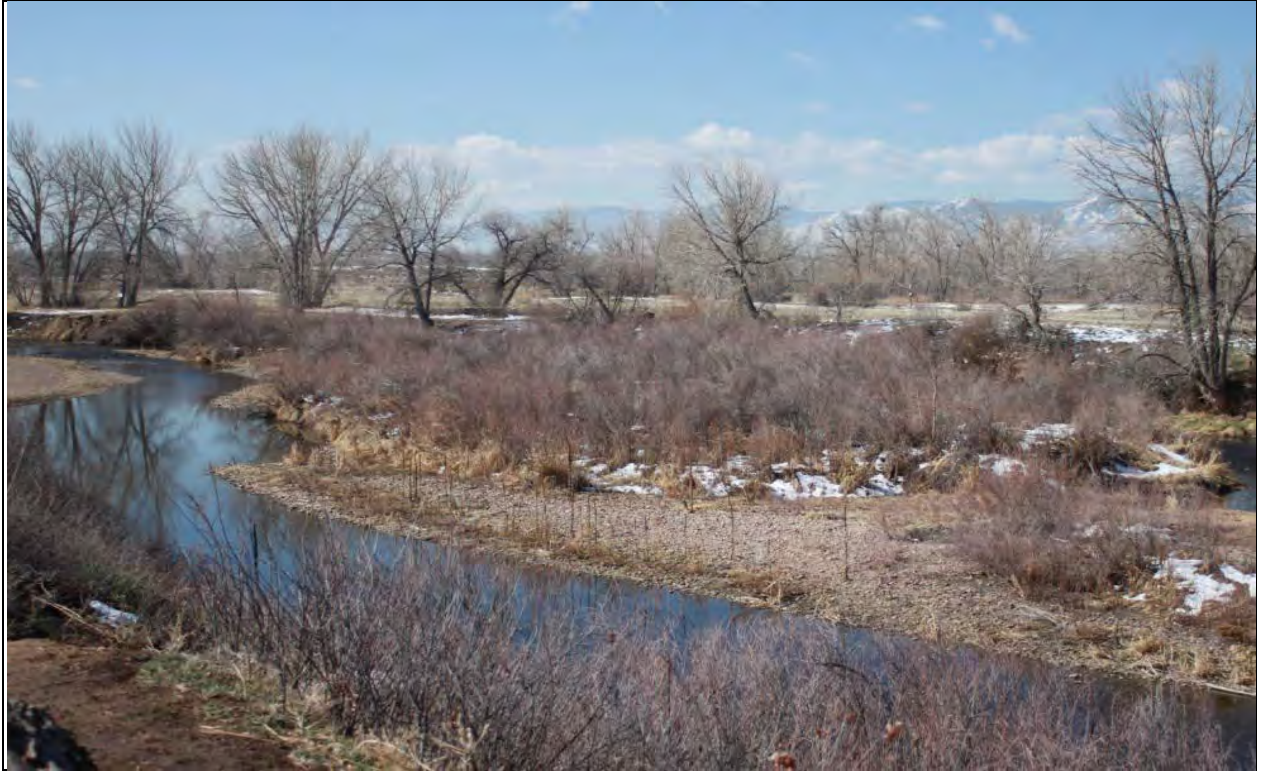
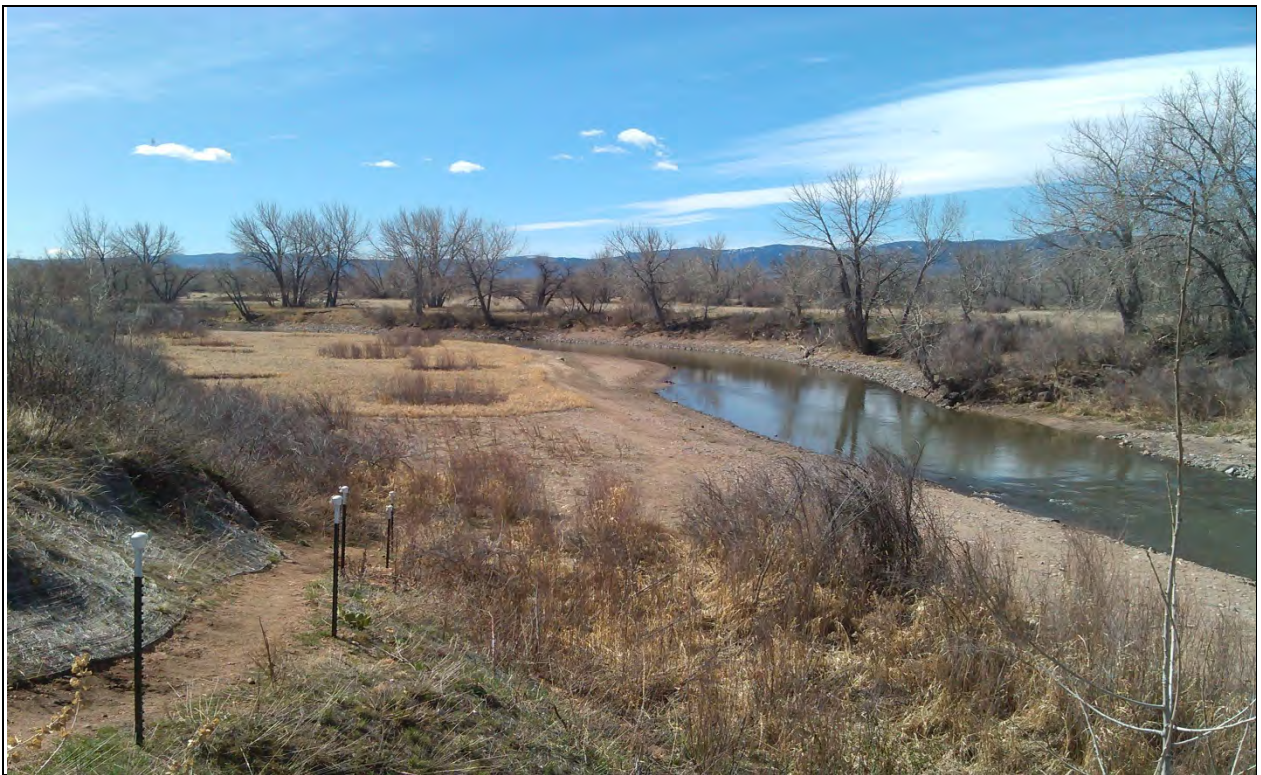
**Top:** Looking upstream at braided channel (before).

**Bottom:** Constructed low flow channel and vegetated point bar (after).

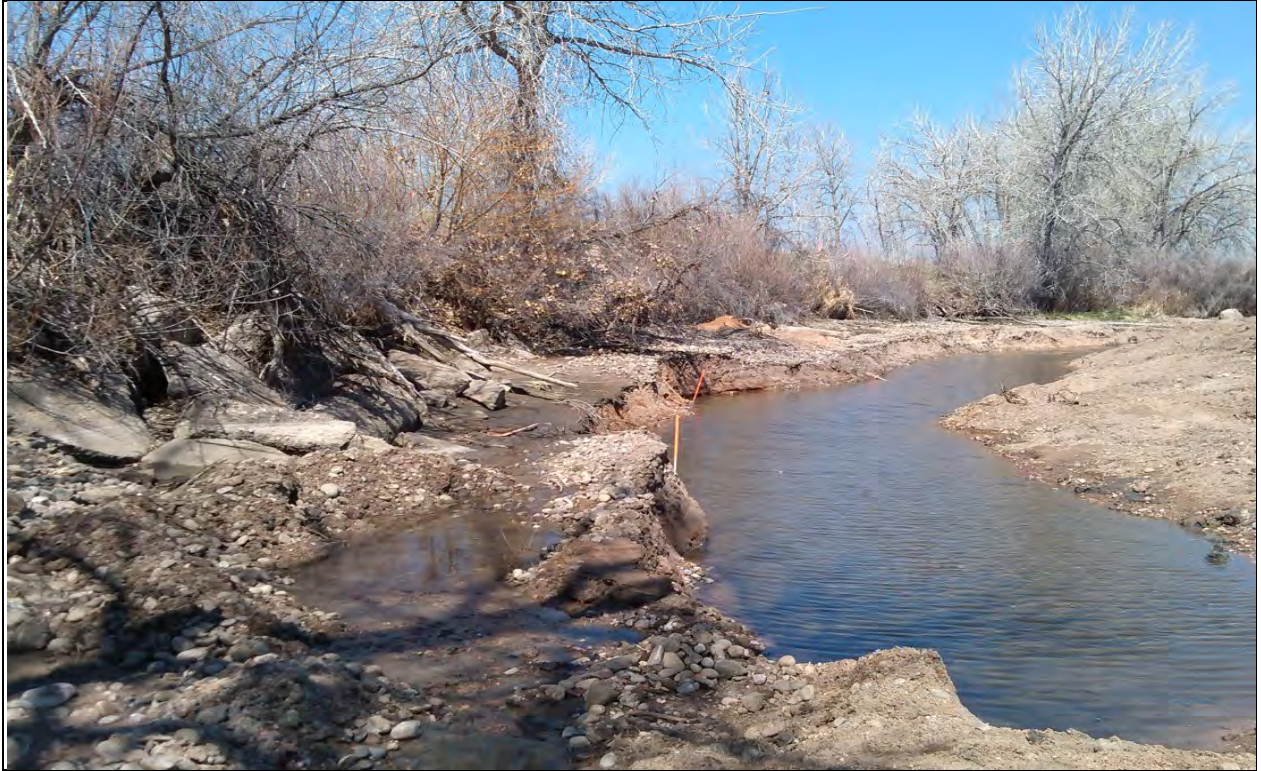
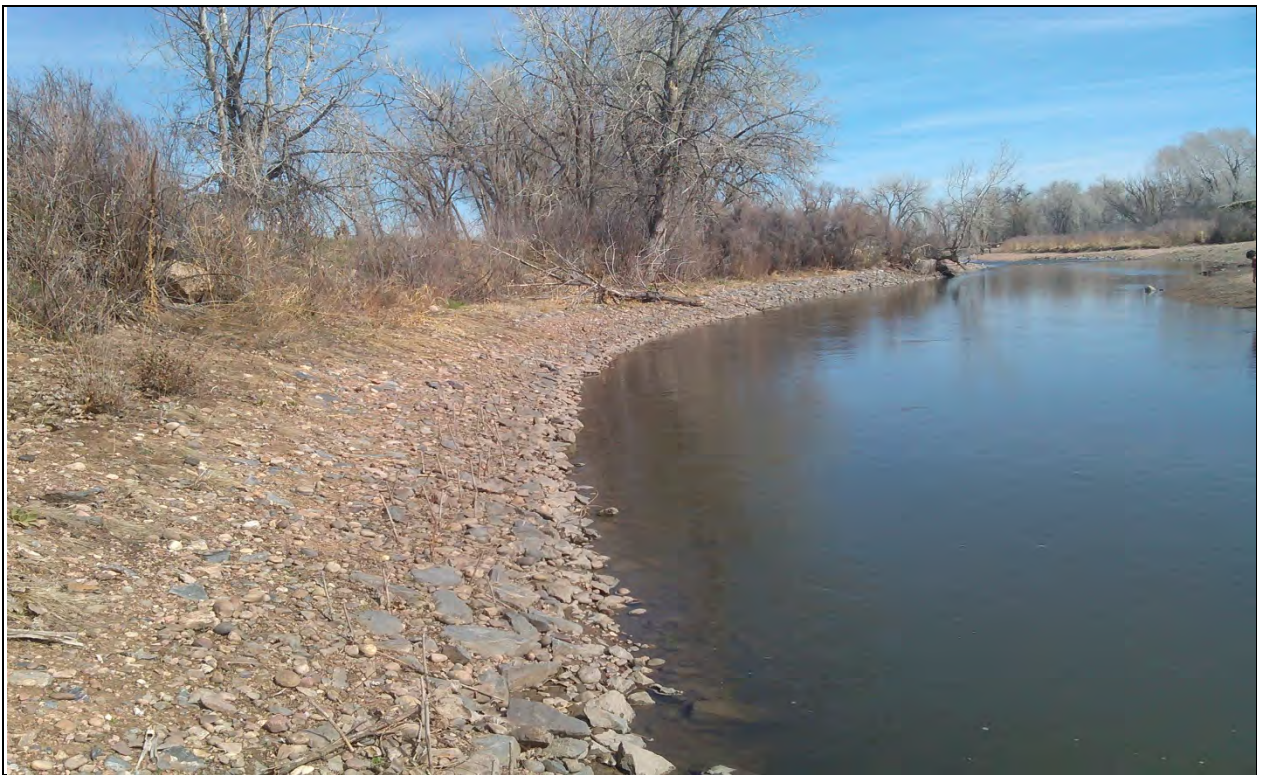
**Top:** Looking downstream towards at unstable bank littered with concrete rubble (before).

**Bottom:** Constructed low flow channel and bank stabilization (after).

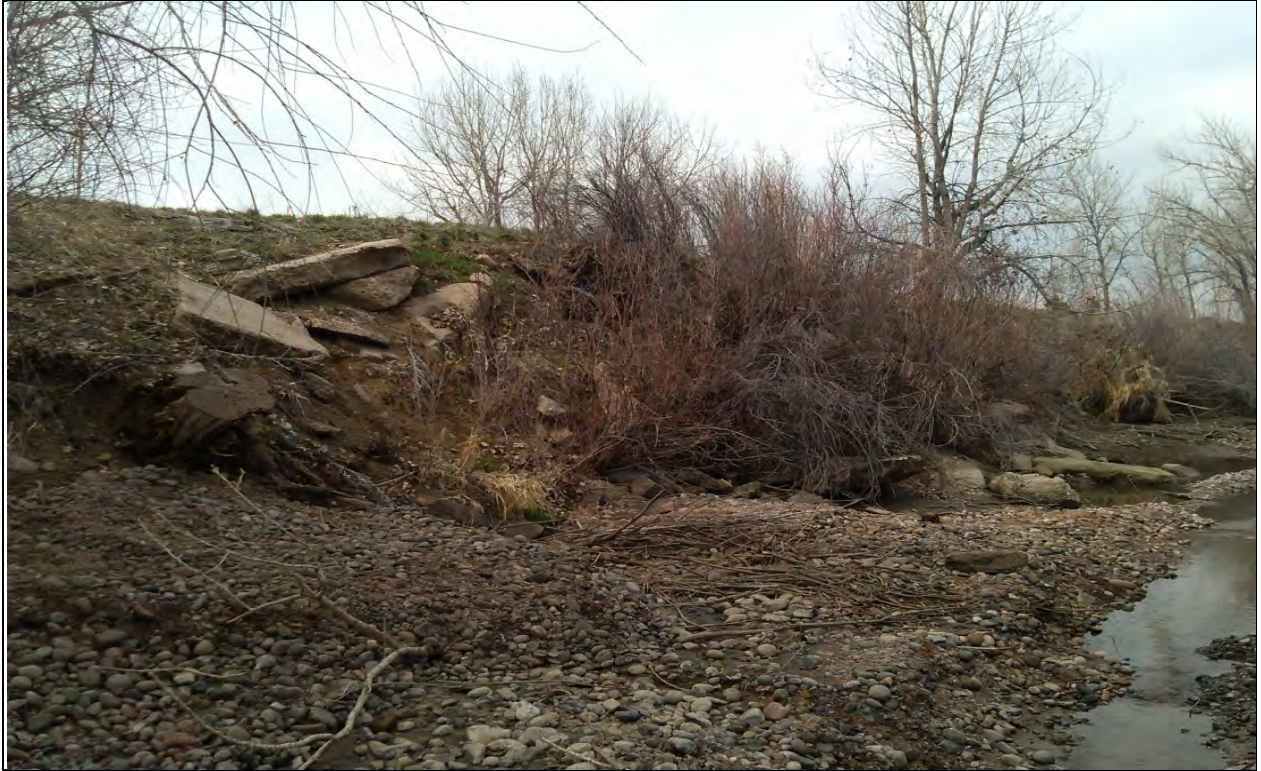
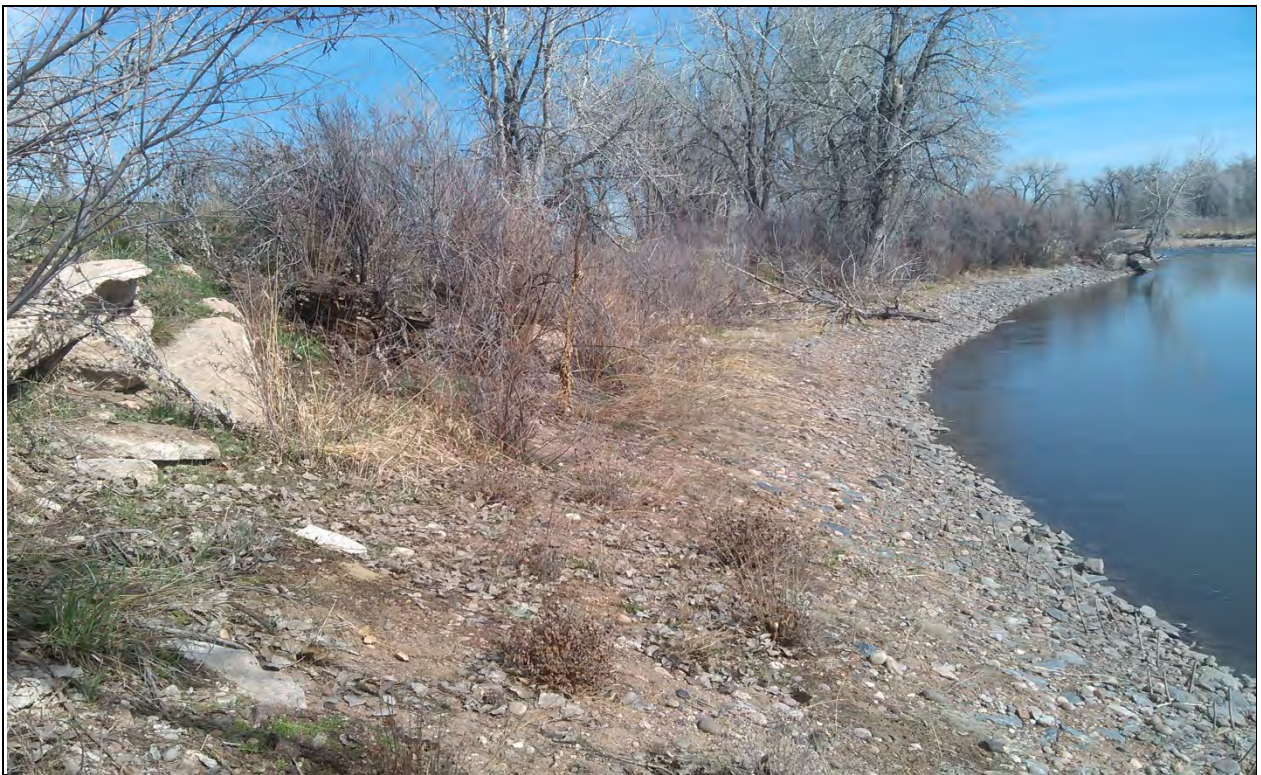
**Top:** Looking downstream towards at unstable bank littered with concrete rubble (before).

**Bottom:** Constructed low flow channel and bank stabilization (after).

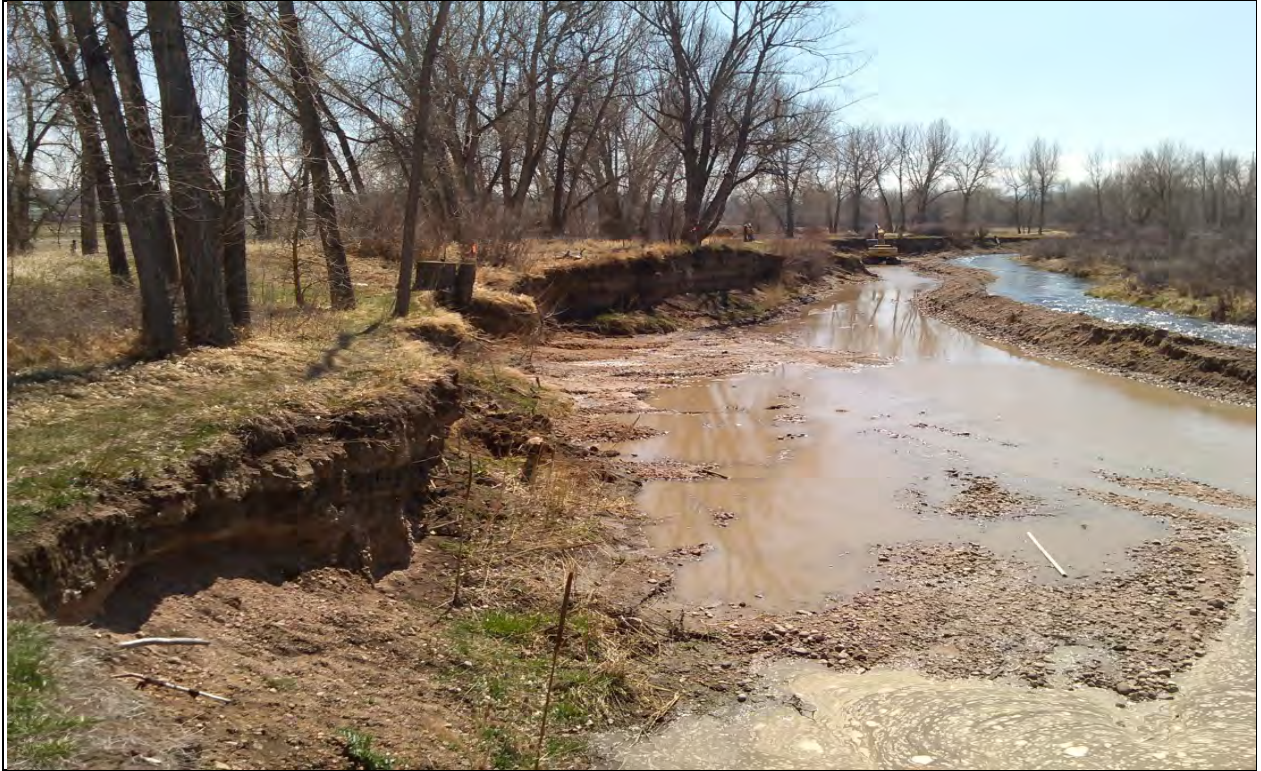
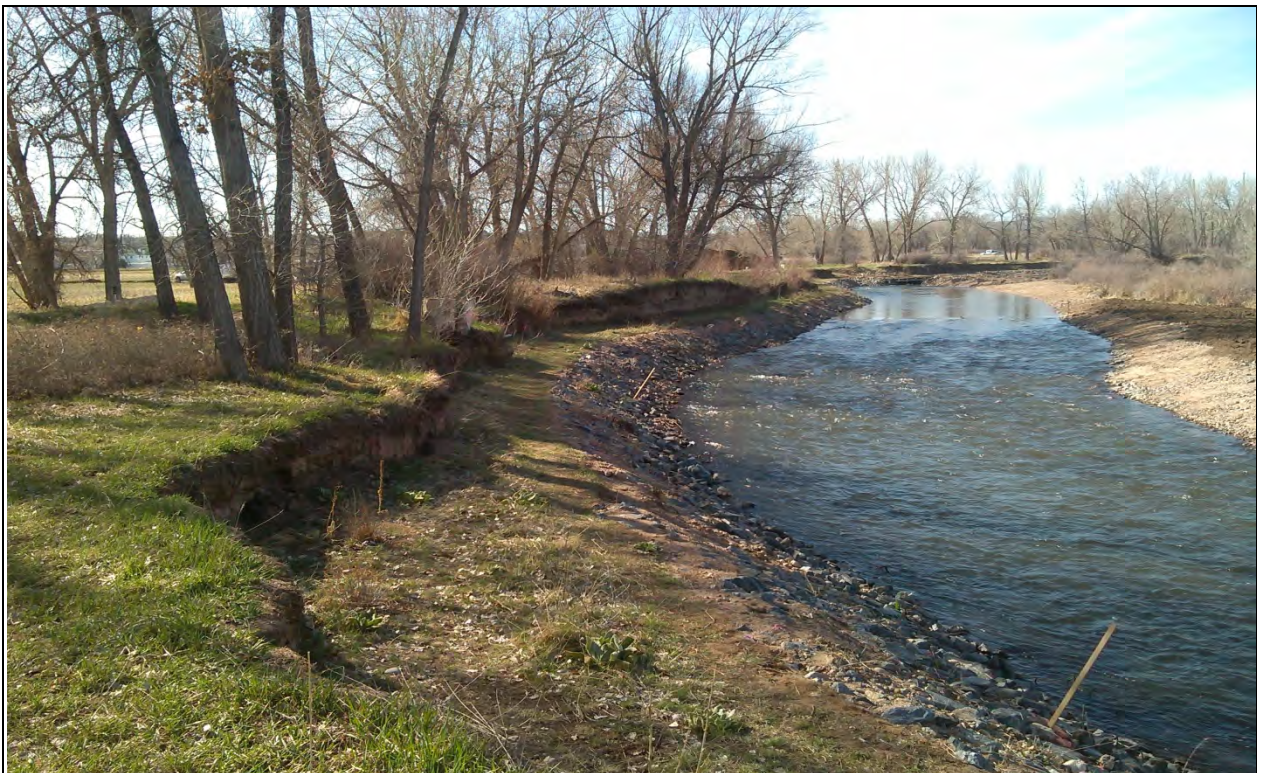
**Top:** Looking upstream at caving bank near Redtail Lake just after construction began (before).

**Bottom:** Type A bank stabilization installed to protect cut bank habitat (after).

Upstream, near Redtail Lake, 720 linear feet of Type A bank stabilization was constructed. Type A bank stabilization was constructed from 9-inch soil-filled riprap and included a reinforced toe and a 5-foot wide planting bench at bankfull elevation for native grass and shrubs. Type A bank stabilization was designed to maintain the upper portion of the eroding bank, at the Park's request, for wildlife habitat (cut banks are used as nesting areas by bird species such as the kingfisher).
