Kerber Creek Restoration Project Final Report

December 8, 2014

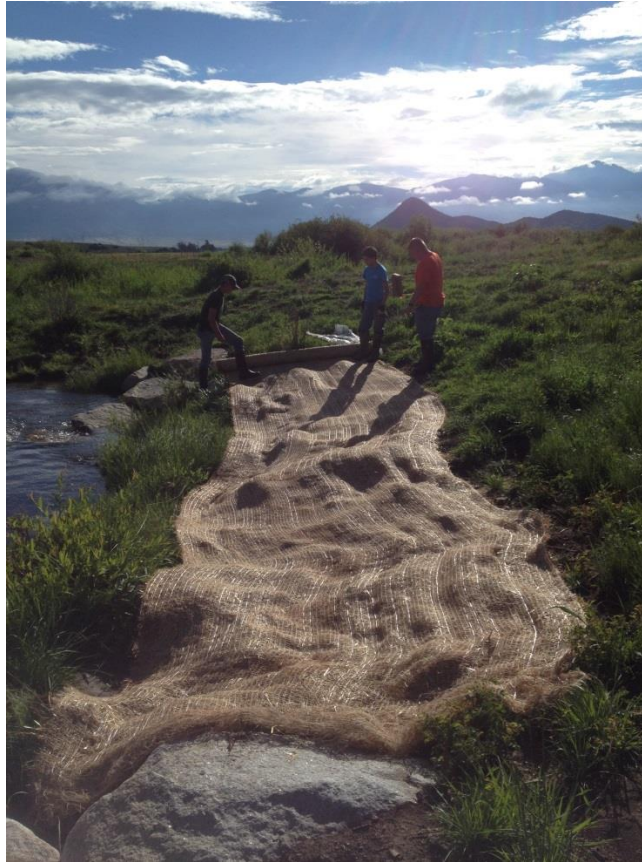
Figure 4.1: Boy Scouts installing erosion control mats on newly reshaped streambanks.

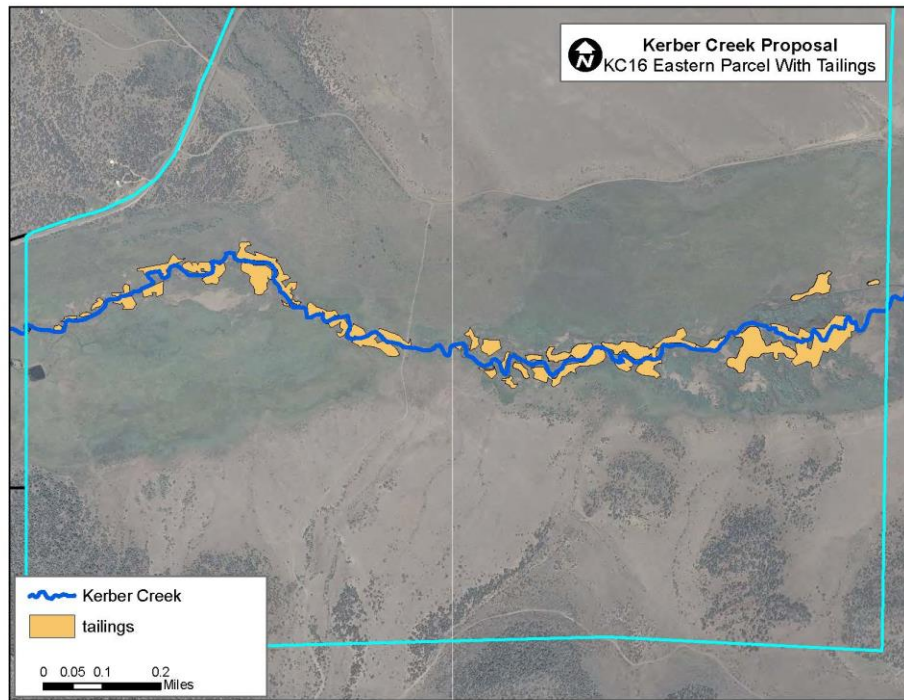
Figure 4.3: KC16-E Parcel map identifying mine waste piles that correspond to amendment quantities listed in Table 4.2.

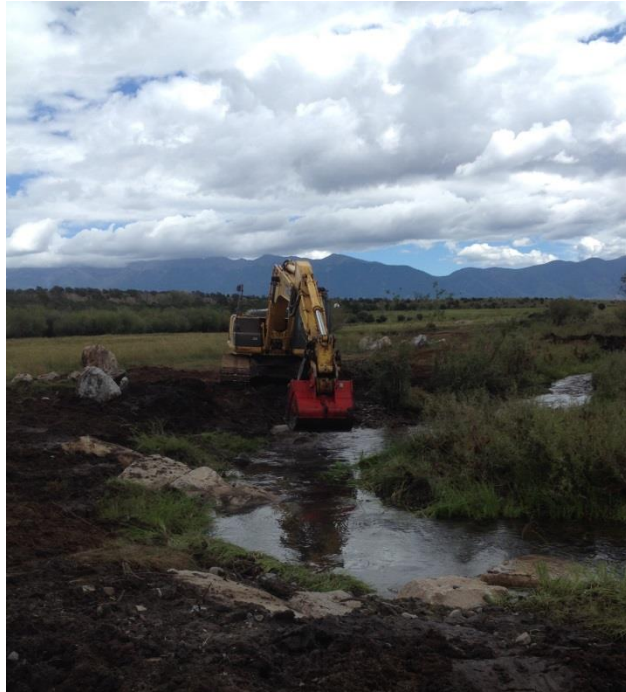
Most of the rock placement and in-stream work performed by RMC was with the use of an excavator and loader for rock transportation (Figure 4.5). Rocks were properly installed per NRCS design specs using footer rocks and keying the feature into the bank.

Figure 4.5: Excavator installing in-stream rock structures along Kerber Creek at KC16-E

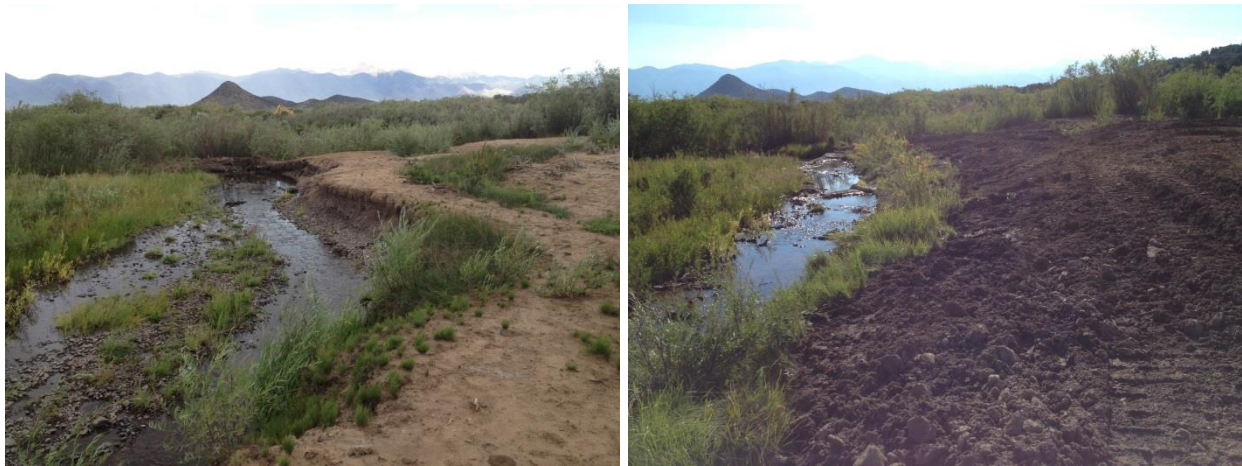
As mentioned earlier, fine grained mine wastes are a poor growing medium and provide poor bank stability. It is not uncommon to find four to six foot cut banks throughout the Kerber Creek watershed. These soils were treated, reshaped to a 3:1 slope, and further stabilized with rock barbs to protect against high flows.

Figure 5.1: KC16-E looking east at degraded steep banks before restoration (left) and after restoration and installation of 3 rock barbs (right)

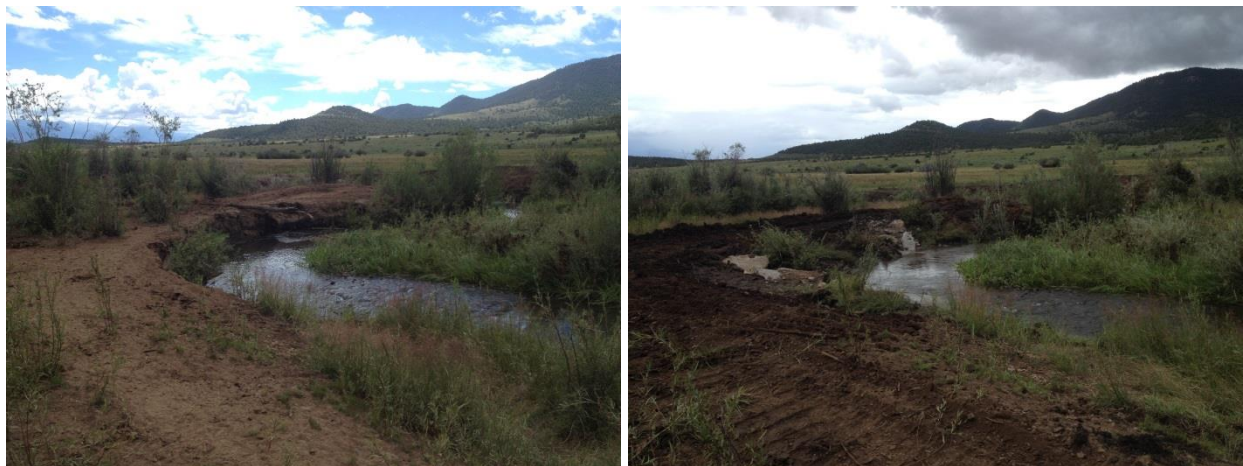
Another high cutbank area was reshaped and stabilized using rock structures and a combination of willow bulb and sedge mat transplants. The willows and sedges provide immediate vegetation giving the newly vegetated bank time to develop (Figure 5.2).

Figure 5.2: KC16-E meander bend before restoration (left) and after installation of two rock barbs and sedge/willow transplants (right)

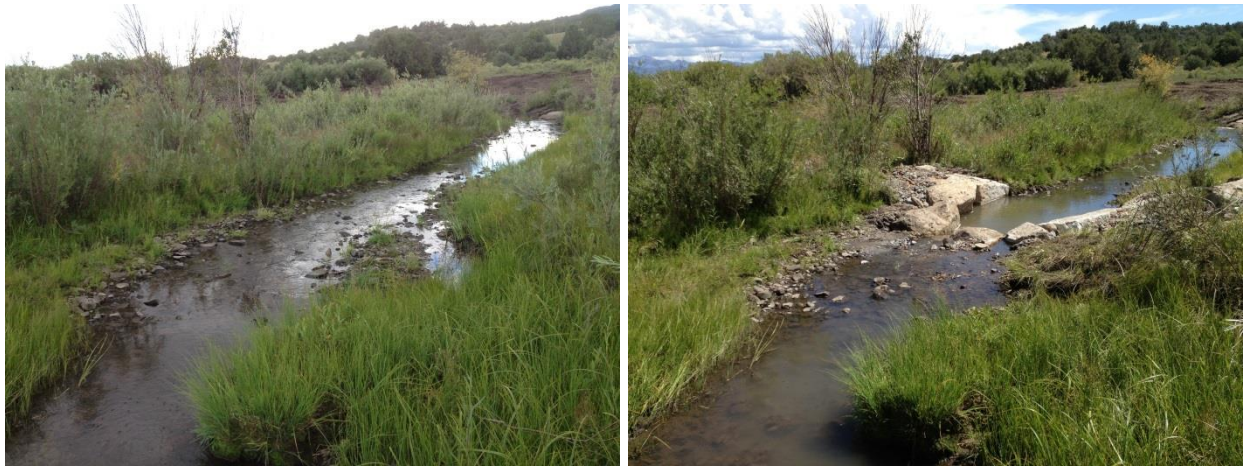
Rock structure installations were used throughout the project to create habitat and improve the width to depth ratio in previously featureless zones. Cross vanes were typically used in straight sections, while barbs and j-hooks were used on banks to redirect flow away from newly reshaped unstable banks (Figure 5.3)

Figure 5.3: KC16-E Featureless section with extended shallow riffle zone (left) and cross vane installation creating downstream pool habitat and grade control before 90 degree bend (right)
