Submitted to Bruchez and Sons, LLC P.O. Box 1359 Kremmling, CO 80459

Submitted by AECOM 804 Colorado Ave Suite 201 Glenwood Springs, CO 81601

ILVK Upper Colorado River Irrigation and Restoration Assessment Phase 1: K.B. Ditch to Blue River.

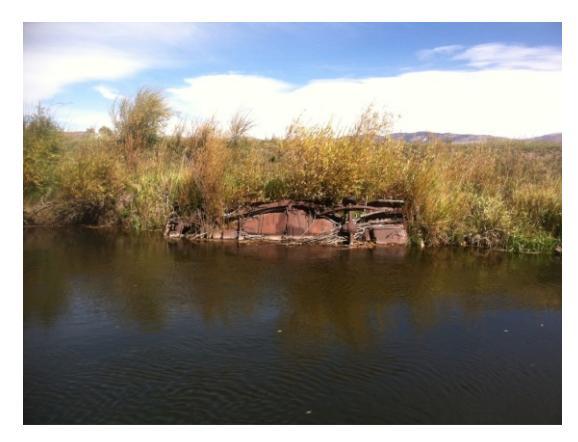
Figure 1-3. Diversion Drop Structure installed by Northern Colorado Water Conservancy District in 2004.

- Drop structures were improperly built in 2004 resulting in frequent maintenance and failure.
- Agricultural land use has degraded riparian vegetation resulting in increased rates of bank erosion.

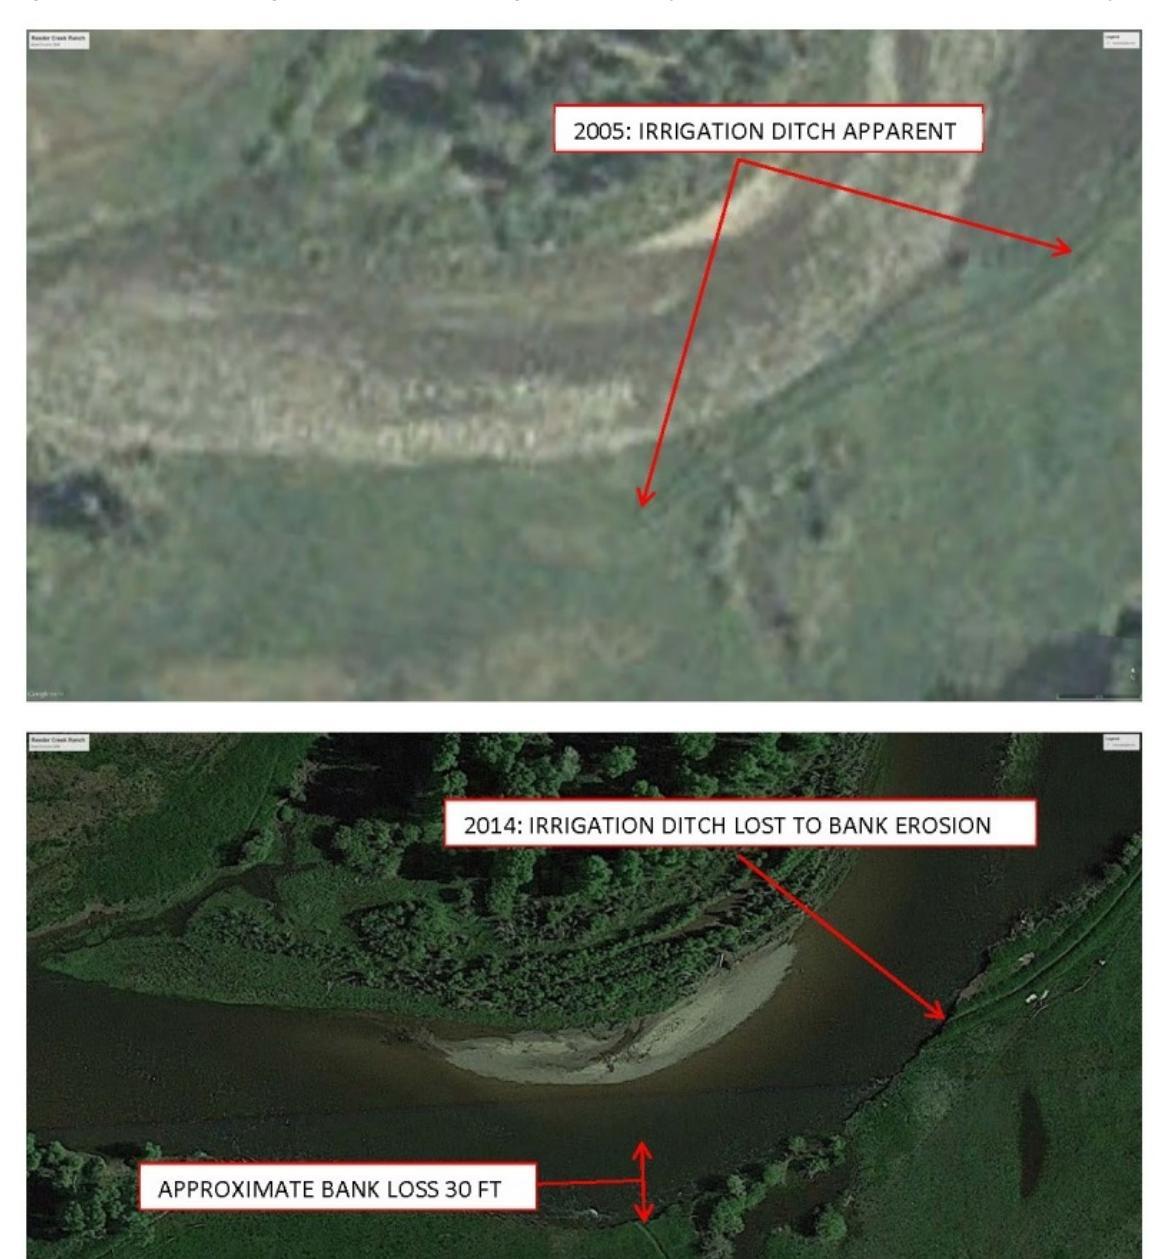
Figure 1-5. Sever Bank Erosion on Reeder Creek Ranch.

1900's, indicating that efforts to stabilize banks have been ongoing for decades. Throughout the study reach there are miles of eroded banks. Over the last few years the rate of loss has been as high as 30 ft per year at some locations, resulting in the loss of irrigation infrastructure and irrigated lands (Figure 1-5 and Figure 1-6).

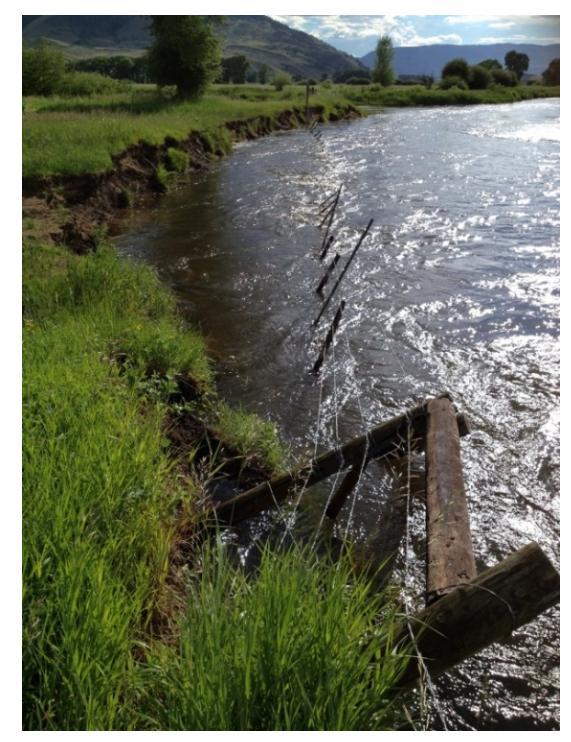
Figure 1-6. Severe Bank Erosion on Reeder Creek Ranch.

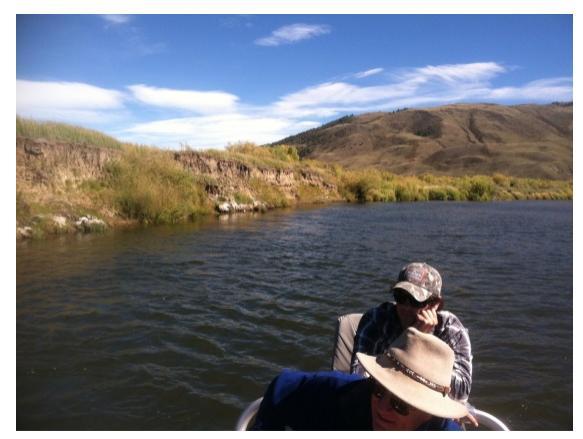
Figure 1-7. Evidence of Channel Incision on Riverside Ranch.

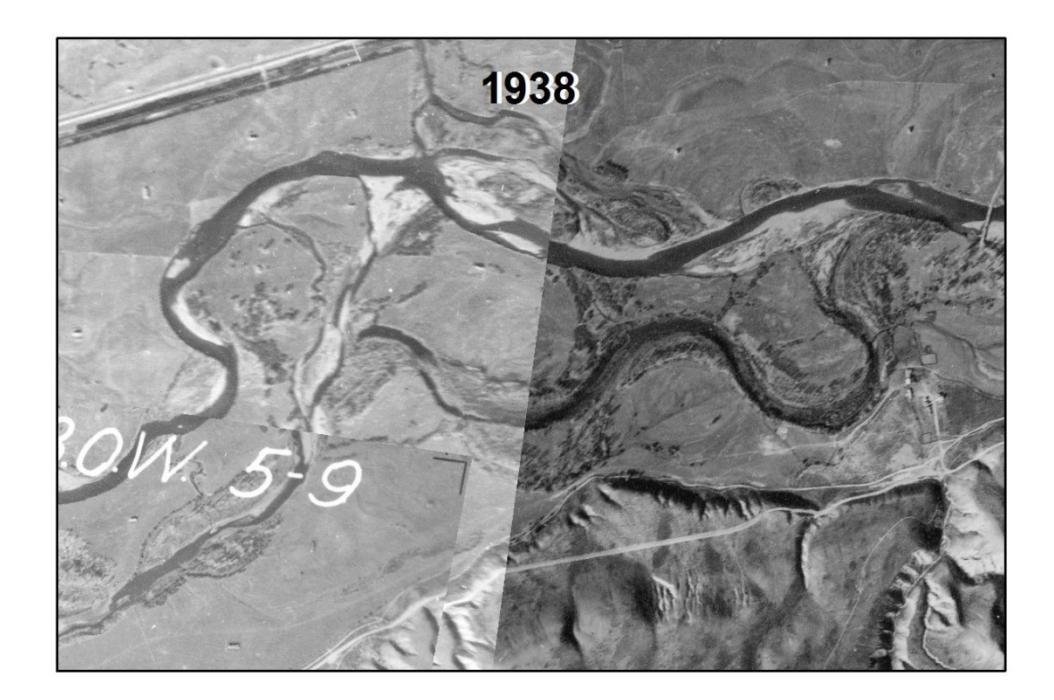
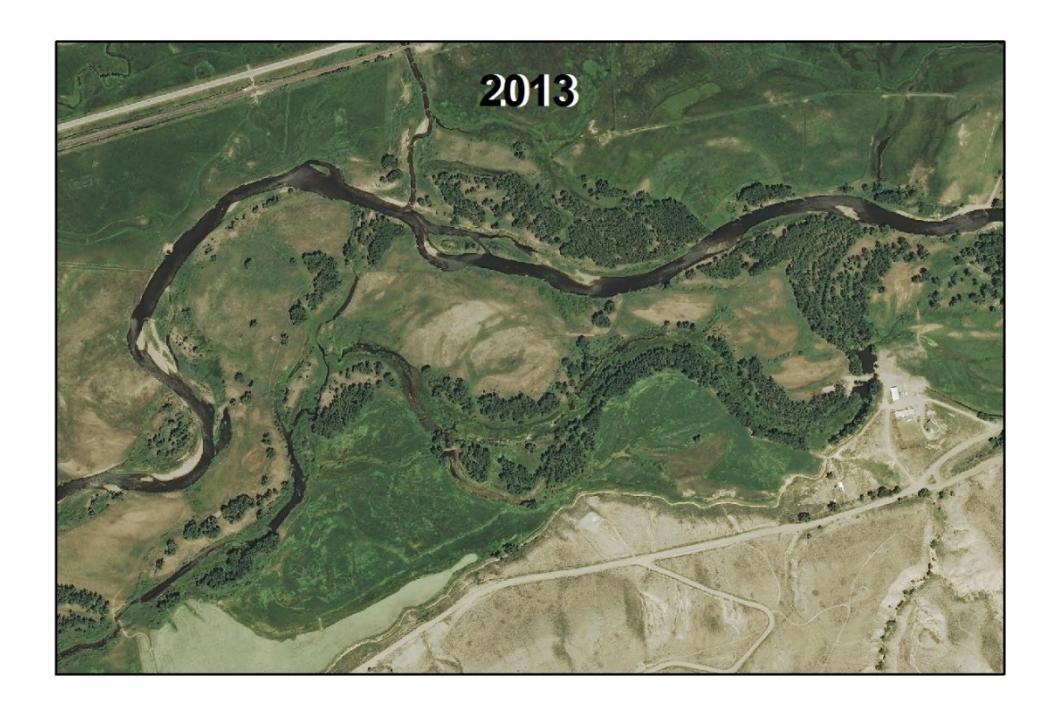
The analysis was performed for the upper most and lower most sections of the ILVK reach. Figure 3-6 presents the results of this analysis. Two points were plotted for each section: historic conditions and future conditions. It can be seen in Figure 3-6 that the upper section of the river, in the vicinity of Troublesome Creek, tends towards braiding under both the historic and future conditions. Conversely the lower section tends towards meandering. The results of this analysis indicate that the upper section of the ILVK reach tends towards a braided planform.

Figure 3-7. Evidence of multiple channels at Colorado River's confluence with Troublesome Creek.

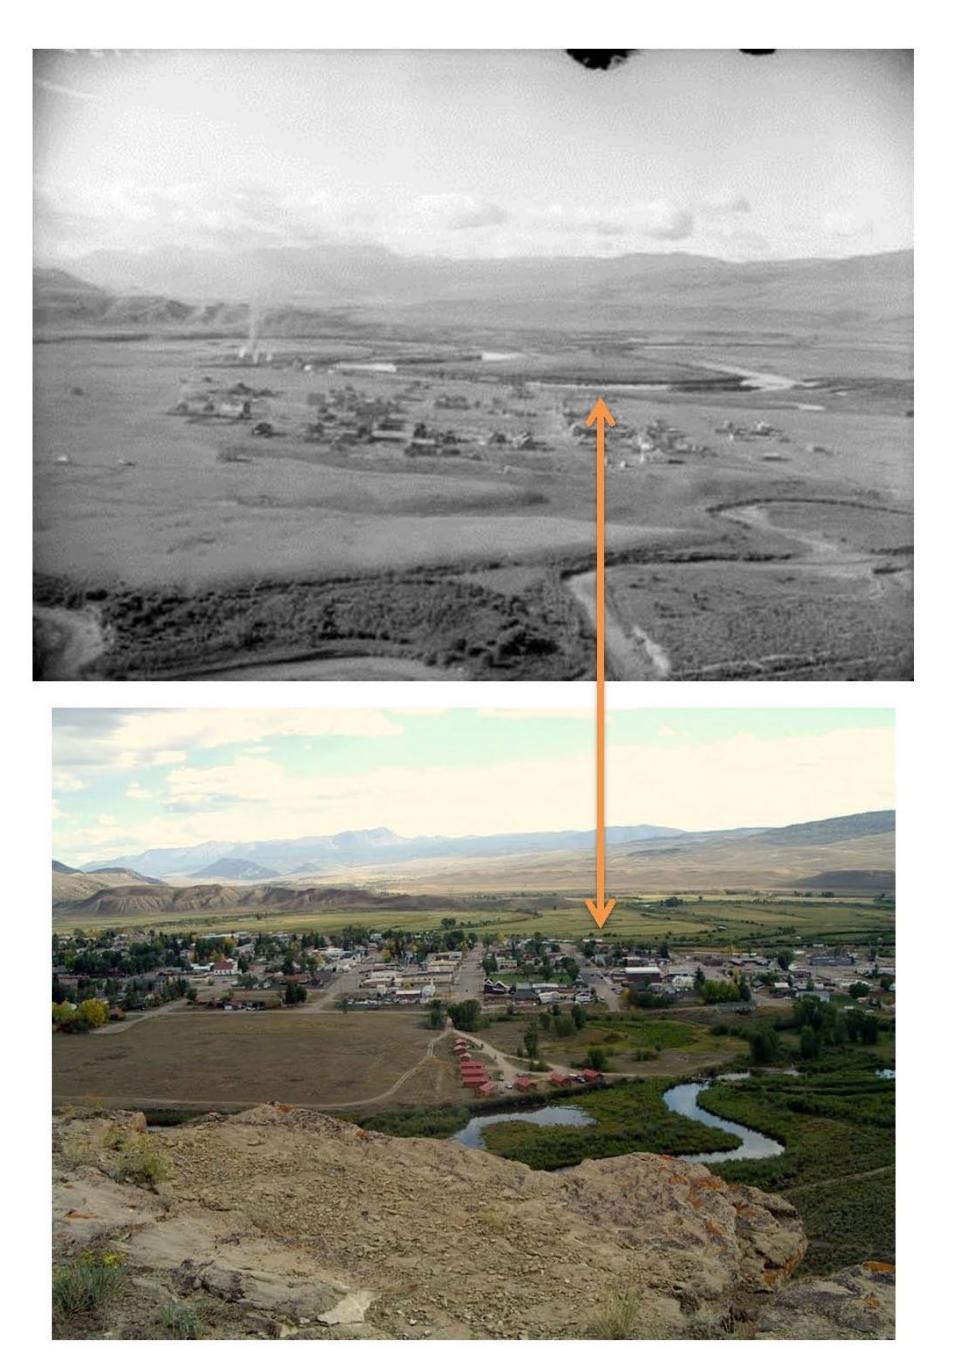
No information about the cutoff of the southwest meander was found, and it may be a historic Blue River channel. However, research discovered that early in the 20th century a channel was excavated that cutoff the northeast meander. Research of historic photographs indicates that this likely occurred between 1907 and 1914. The photos in Figure 3-14 show this meander on the McElroy Ranch. They were both taken from the ridgeline due north of the Town of Kremmling looking south towards the Eagle's Nest Range. The upper photo was taken between 1900 and 1907 and shows large meander close to Town. The scar of the historic meander is clearly evident in the lower photo, taken in 2010.

Figure 3-14. Photos of Historic Meander Location.

The reach from Highway 9 to the Blue River has a slope of approximately 0.0002 ft/ft. The meander that was cutoff was approximately 7250 ft long. It is assumed that the River has had adequate time to adjust to the meander cut off, and the existing channel slope is similar to the historic (pre-cutoff) channel slope. This would indicate that the channel degraded approximately 1.5 ft as a result of the meander cut (7250*0.0002=1.45).

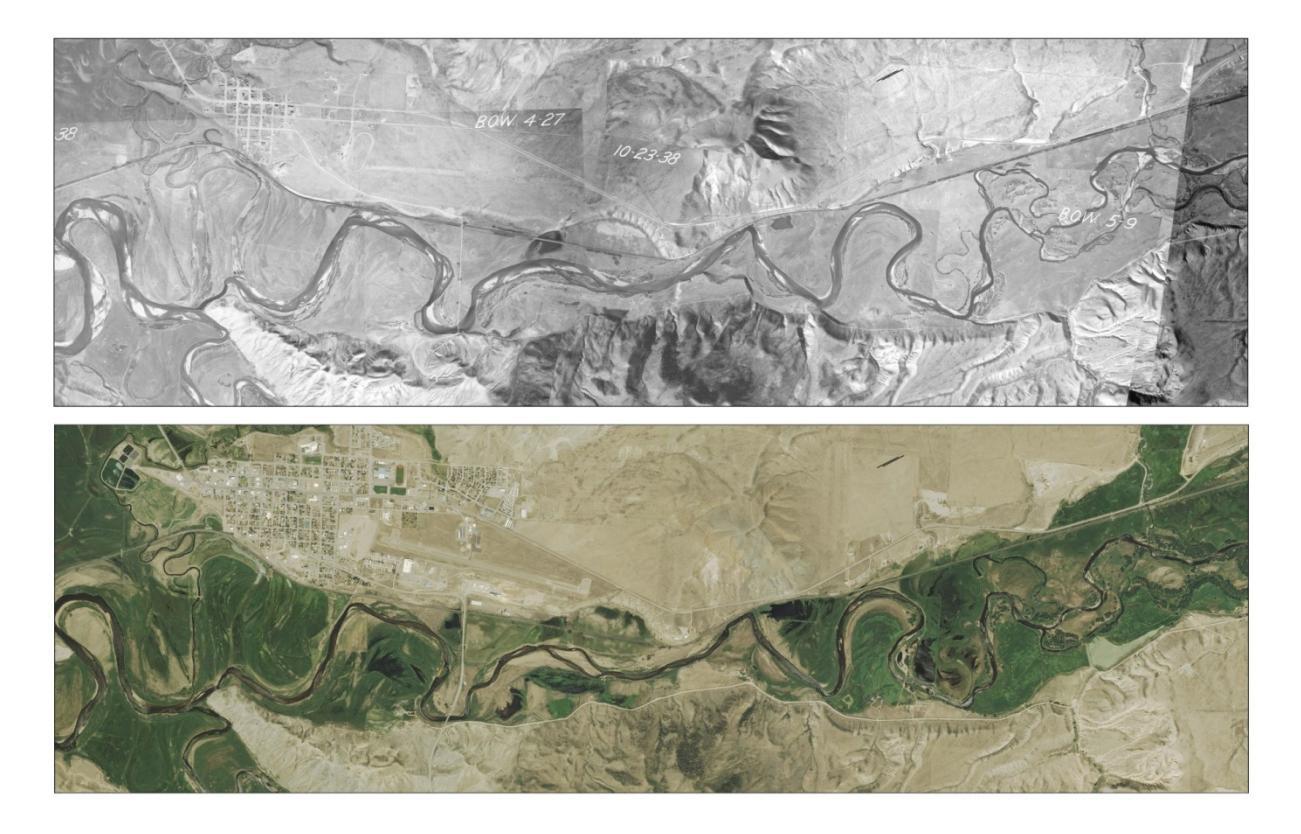
It is evident from this photo comparison that the Colorado River has maintained a relatively stable planform over the past 75 years. While the planform is similar, it is clear from the photos that the historic Colorado River had significantly more structure (point bars, mid-channel bars, and riffles). The channel has also narrowed significantly during this time period.

Figure 3-20. Aerial Photographs from 1938 and 2013.

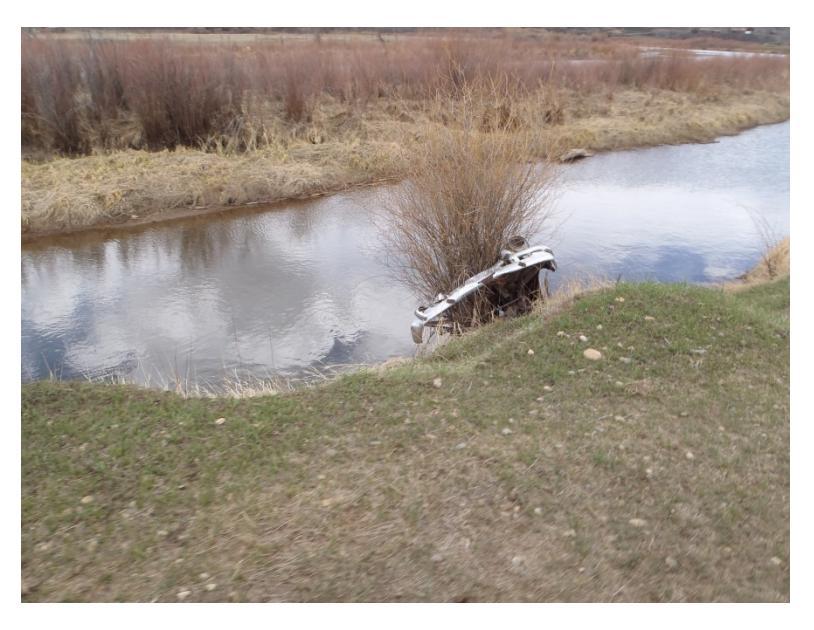
Throughout the ILVK reach there are numerous automobile bodies that have been placed for bank protection. Many of these are from the early 20th century. In many cases the riverbanks have revegetated around the car bodies (Figure 4-5). While removal of these cars would be an excellent project goal, the costs could be significant, and the disturbance could outweigh the benefit. Therefore, the restoration plan was developed assuming that these car bodies would be left in place and backfilled.

Figure 4-5 Example of revegetation through Automobile Body
