## **RGDSS Memorandum**

**To:** Mike Sullivan, P.E. Colorado Division of Water Resources  
Andy Moore, P.E. Colorado Water Conservation Board  
**From:** HRS Water Consultants, Inc.  
Eric J. Harmon, P.E., G. Eric Saenger, CPG, Steven K. Barrett  
**Subject:** Hydrogeologic Review and Data Collection, Rio Grande, Del Norte to Rio Grande – Alamosa County Line  
**Date:** July 17, 2012

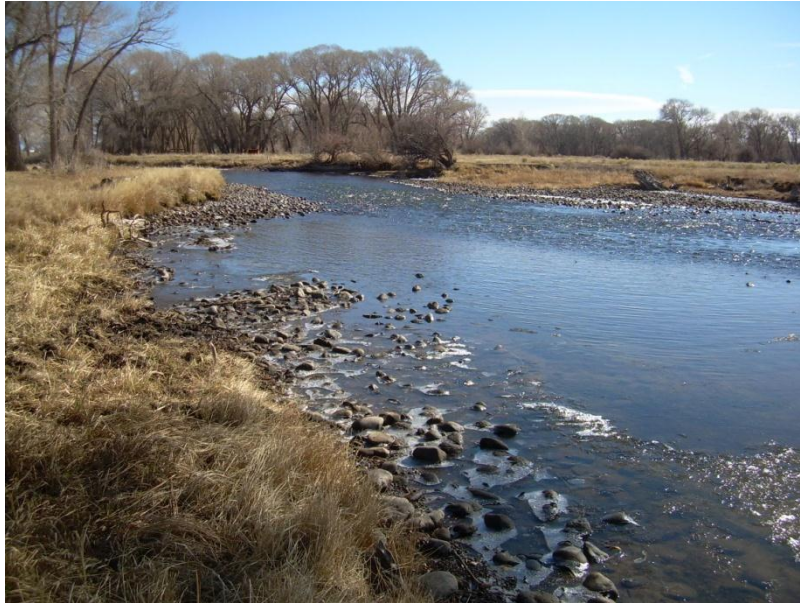
Figure 18 is a photo of the North Channel of the Rio Grande just below the Kane-Callan Ditch headgate, about one mile downstream of the “split”. Note cobbles up to ~16 inches on the right and left banks, and armoring the stream channel.

**Figure 18: North channel of Rio Grande, approximately 100 feet downstream of Kane-Callan Ditch headgate. Looking downstream (east.)**

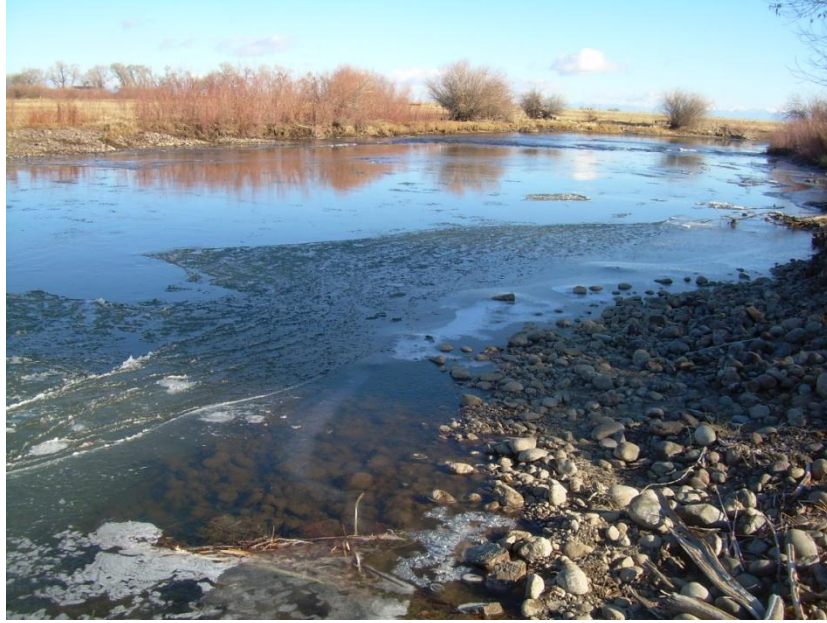
Figure 19 is a photo of the North Channel of the Rio Grande just below the Raber Ditch headgate, about three miles downstream of the “split”. Note cobbles up to ~10 inches on the right bank.

**Figure 19: North Channel of Rio Grande at the Raber Ditch headgate. Looking downstream (east).**

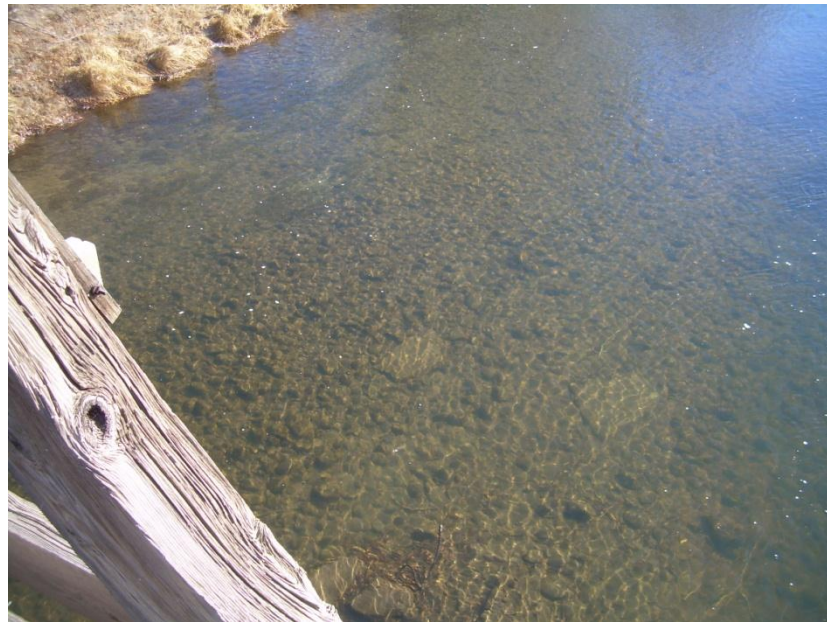
Figure 20 shows the South Channel at the Off Ranch Bridge located approximately three miles downstream of Del Norte. Note the cobbles up to ~10 inches armoring the streambed.

**Figure 20: Rio Grande South Channel at Off Ranch bridge about 3 miles downstream of Del Norte.**

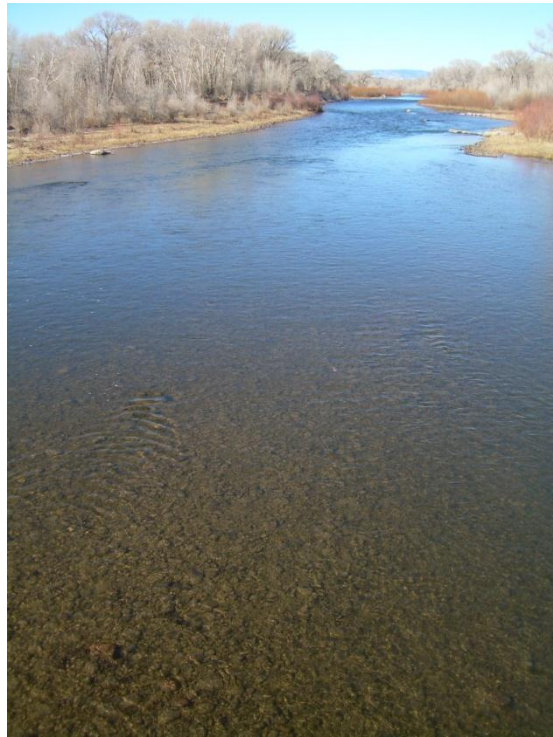
Figure 21 shows the streambed of the Rio Grande looking upstream from the County Road 3W Bridge approximately 3 miles below Sevenmile Plaza (~10 miles below Del Norte). At this location, there is only one main channel of the Rio Grande. Note the presence of cobbles up to ~6 inches in size in the streambed.

**Figure 21: Rio Grande channel at CR 3W bridge, looking upstream (west).**

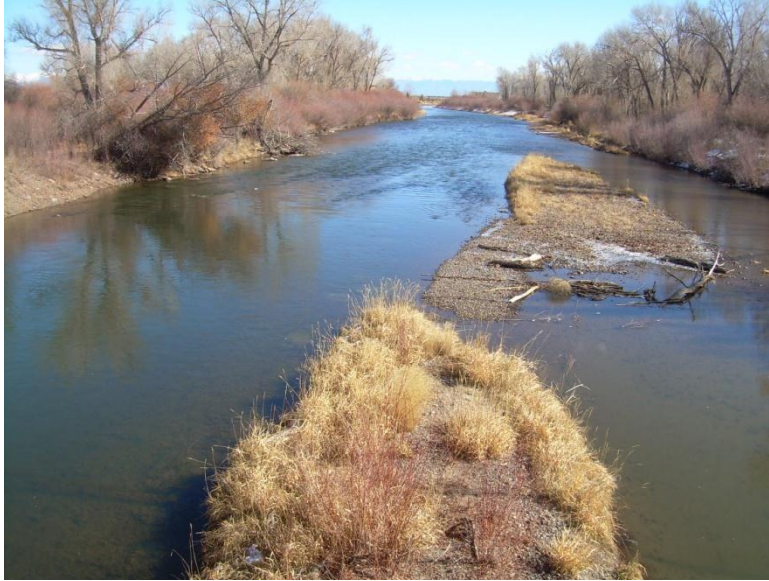
Figure 22 was taken looking downstream at the US 285 bridge just north of Monte Vista. The channel-centered bar is just downstream of a bridge pier. Note the cobbles are much smaller in size than they are further upstream. Largest cobbles are in the ~3 to 5 inch range. The stream channel is partially cobble-armored, with some deep channel scour evident.

**Figure 22: Rio Grande at US 285 bridge, looking downstream (east).**

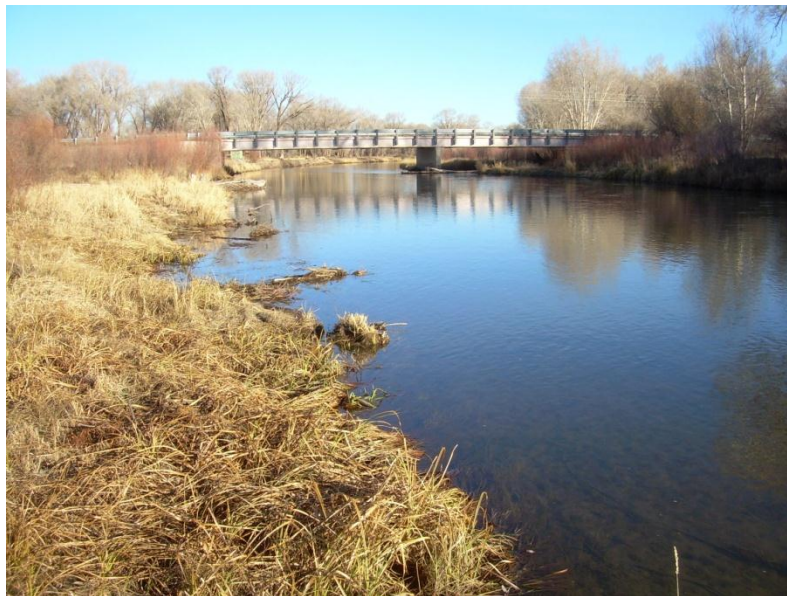
Figure 23 shows the Rio Grande channel looking downstream to the bridge at the Rio Grande – Alamosa County line. There is a small percentage of cobble-sized material in the streambed and banks at this location. The channel is composed predominantly of sand and silt-sized material.

**Figure 23: Rio Grande at Rio Grande – Alamosa County Line Bridge. Looking downstream (east).  
Note sand / silt channel at this location.**

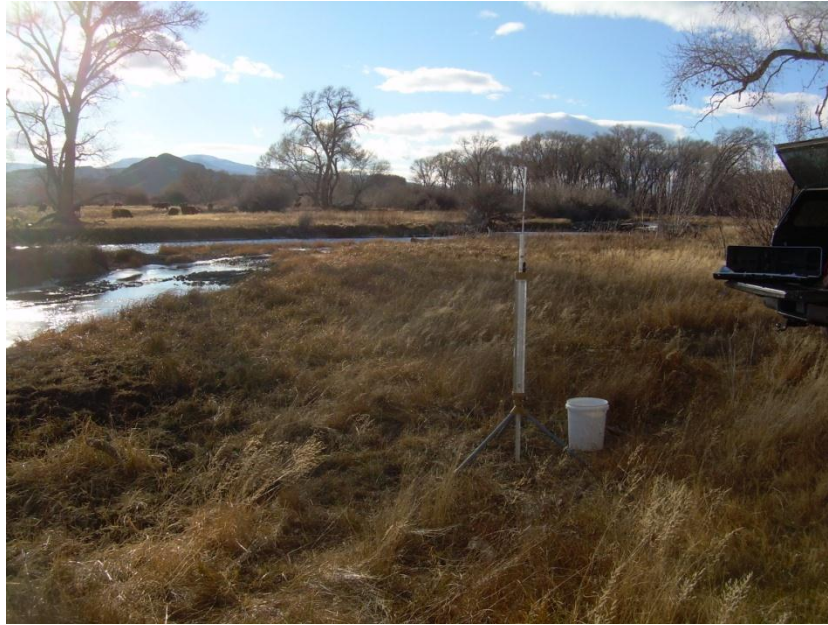
**Figure 24: Field setup of Guelph constant-head permeameter.  
Near Kane-Callan headgate, looking upstream (west).**

One test was in the upstream cobble-armored reach, near the Kane-Callan ditch headgate. The other was in the downstream, sand channel, near the Rio Grande – Alamosa County line. In both tests, we attempted to dig the shallow test hole and set up the test so that only the clayey / silty-sand layer was being tested. The manufacturer's recommended auger drilling, borehole cleaning, and testing procedures were followed at both tests.

Upstream test:	Observed material: organic-rich, black to gray clayey sand.
	$K = 1.5 \times 10^{-3}$ feet/day
	Results were rejected due to observed frost in this material in an adjacent test hole after test was completed.

Downstream test:      Observed material: gray silty to clayey sand  
                                 K = 0.93 feet/day

Due to the observed frost at the first test site, we do not believe the results are accurate. There was no frost in the ground at the second site, and the results, based on Mr. Harmon's experience, appear credible for the observed material.
