# RGDSS Memorandum

**Subject:** Hydrogeologic Investigation of Upper San Luis Creek, Saguache County CO

**Date:** November 18, 2014

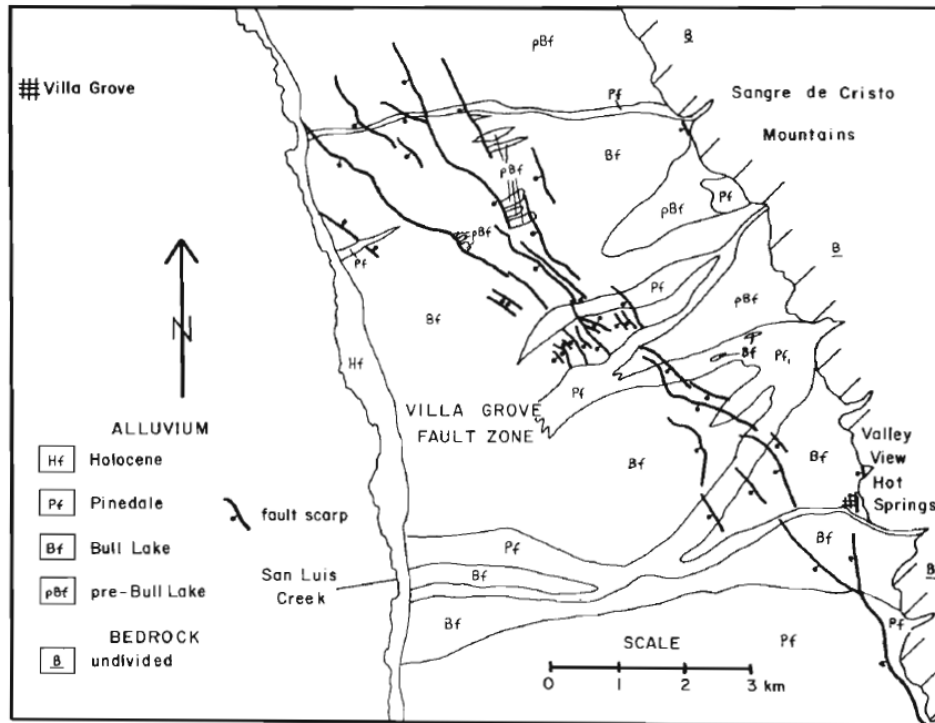
Figure 2: Generalized geologic map of the Villa Grove Fault Zone area (Figure 49 from McCalpin, 1982).

Figure 2 shows the Quaternary sediments of San Luis Creek (“Holocene alluvium”) and the fans deposits east of San Luis Creek up to the Sangre de Cristo Mountains, in terms of their glacial age. Pinedale age sediments reflect younger alluvial fan deposits sourced from glaciation (approximately 30,000 to 10,000 years before present<sup>13</sup>). Older Bull Lake age sediments reflect glaciation approximately 200,000 to 130,000 years before present.

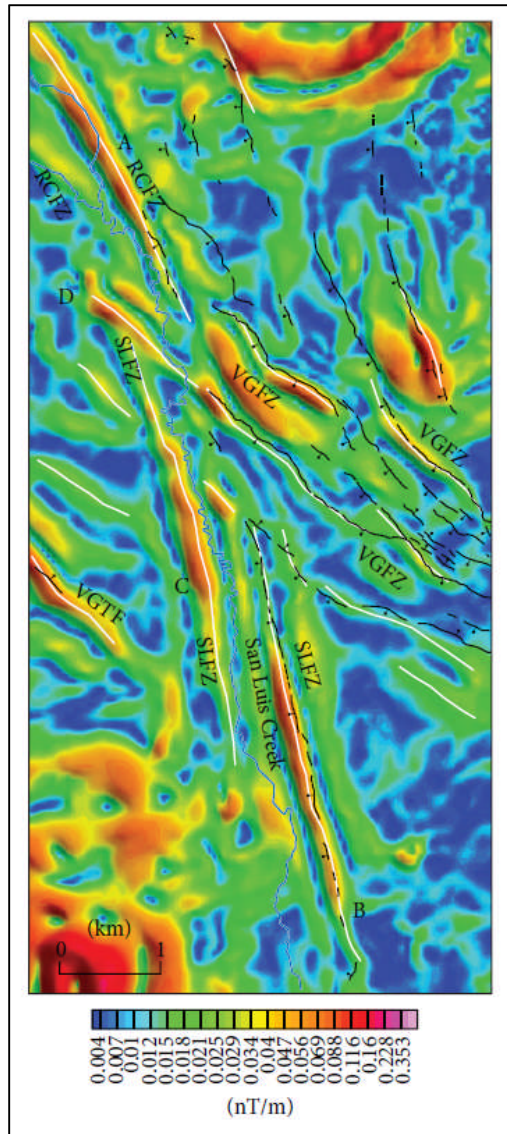
As the authors state, a topographic escarpment such as the erosional edge of a stream terrace may cause a magnetic anomaly, this does not appear to be the origin of the observed anomaly leading to the fault interpretation along San Luis Creek:

“...observed aeromagnetic anomalies generally have greater amplitude than reasonably produced by relief on the terrain alone. Furthermore, HGM ridges follow straighter lines than the stream bank scarps and are continuous across places where the bank has been eroded.”<sup>21</sup>

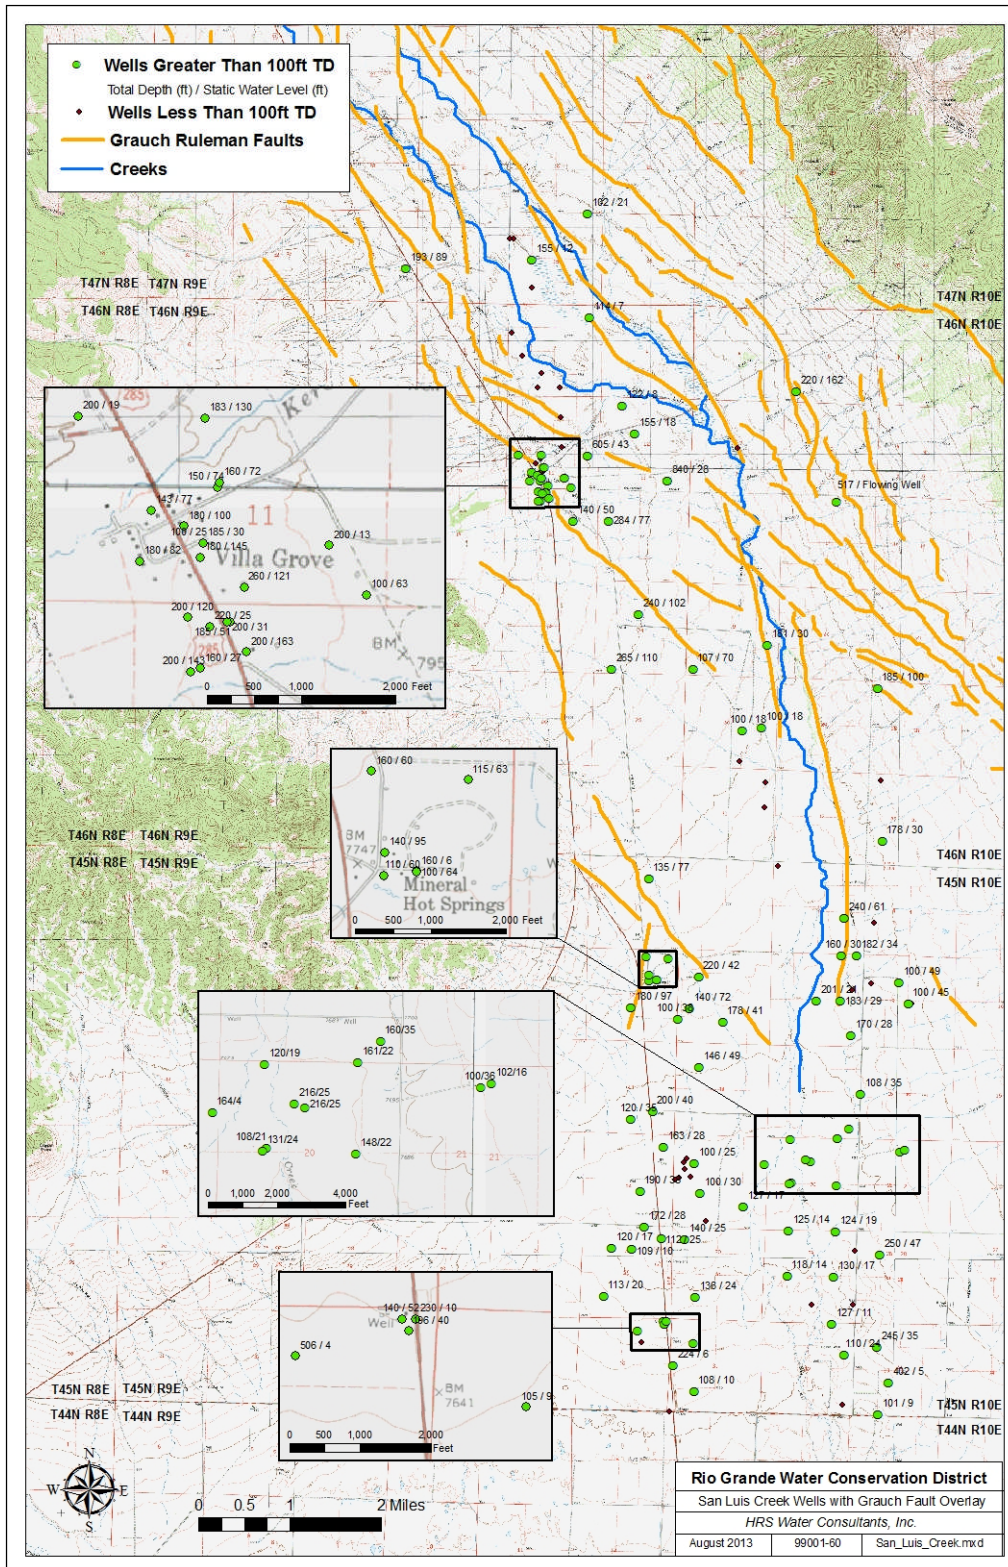
Figure 5: Wells from CDWR adjacent to San Luis Creek

One well of interest is the well listed as “517 / flowing” located in Section 17, T46N, R10 E, Permit No. 11808-F/284405 (that is, total depth 517 feet, and the well reportedly flowed at the ground surface). This well is located on an alluvial fan approximately one mile east of the San Luis Creek valley. An overlay of the mapped faults shown on Figure 5, (Grauch and Ruleman, 2013) plotted with the well locations, shows the well to be located on the upgradient side of a fault trace. This well is within a wet area, as seen on Google Earth images. HRS believes that this is an example of a normal fault acting to inhibit ground water flow within the fan material, possibly due to development of fine-grained gouge material within the fault, thus causing the upward discharge of ground water on the upgradient side of the fault.

The driller's logs were reviewed for lithology, as reported on the driller's well completion reports, to determine if there were any discernible trends or changes in lithology that could account for the observed changes in depth to water from north to south along San Luis Creek. The reported lithology generally consisted of sand, gravel, cobbles and clay lenses and layers as would be expected for deposition by alluvial fans and relatively high-energy fluvial environments. There were no discernible trends or changes in the reported lithology from the driller's reports that could be a contributing factor to the abrupt change in depth to water as discussed above. This may be due, at least in part, to oversimplification of the reported lithology by the drillers.

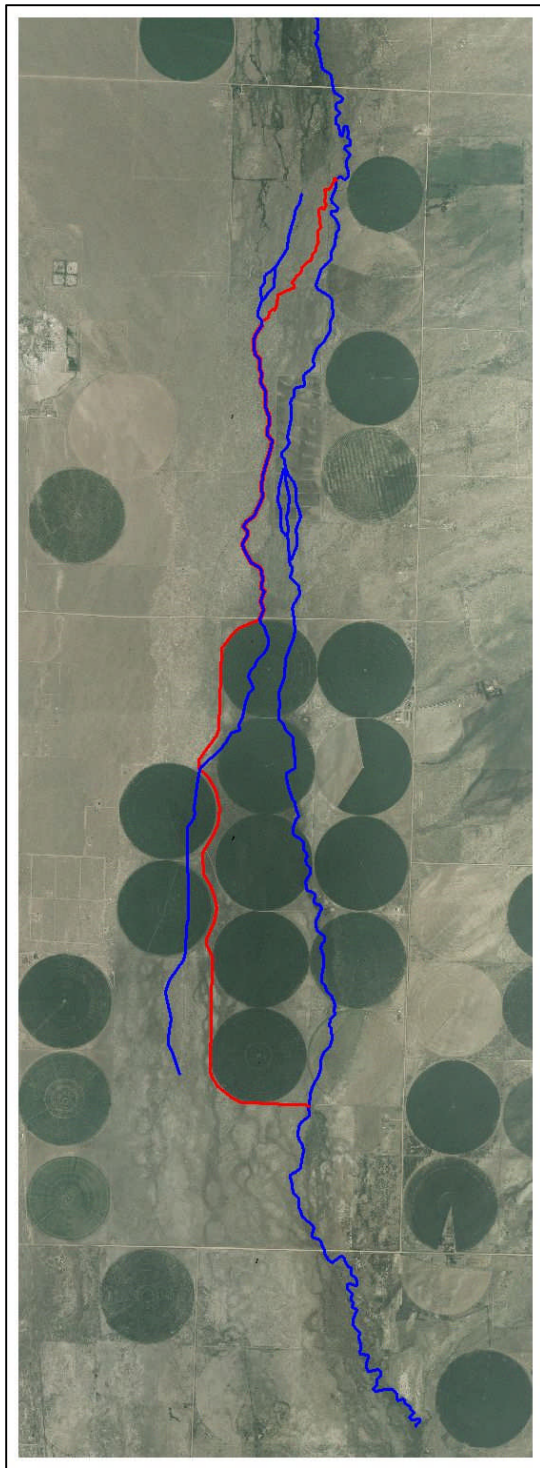
Figure 6: "Historic" (blue) and "relocated" (red) channels of San Luis Creek between Saguache County Road GG (north) and AA (south). Photo interpretation by Kelley Thompson, Colorado DWR, July, 2013.

- Overall, we have found no hydrogeologic rationale to relocate the channel of San Luis Creek from the “natural” channel to the “relocated” channel.
