# **Kerber Creek Restoration-Middle Parcel Project Final Report**

Mine Restoration Project Manager - Trout Unlimited

July 13, 2016

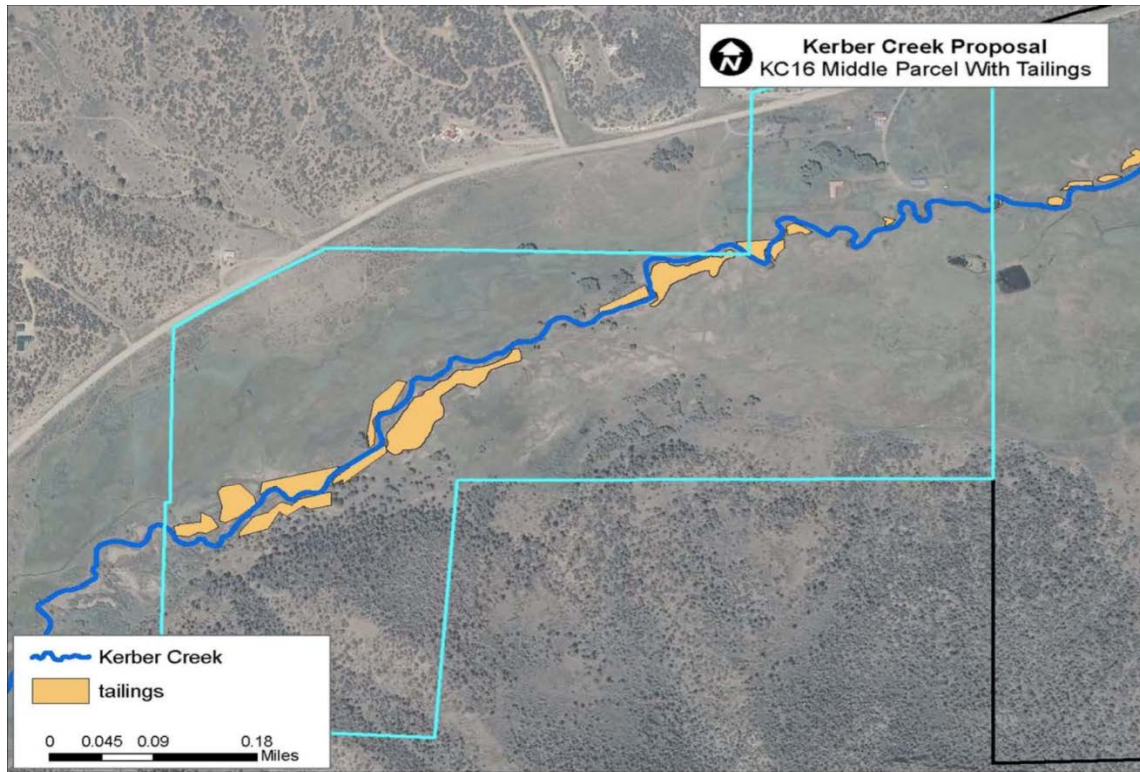
In 2015, TU originally received \$30,000 from WSRA to restore six acres of mine tailings contained within the floodplain of site KC16-M (Figure 1.2). However, due to increased material costs, the budget only allowed for the reclamation of five acres of prioritized mine tailings that coincided with 5,900 feet of in-stream improvements accomplished by the National Resource Conservation Service (NRCS). It was important to perform these two activities together to minimize metals loading due to construction, as well as future erosional events.

**Figure 1.2:** KC 16 M Plan View of Site map showing placement of mine waste areas and property boundaries. WSRA funds went towards restoring the stream and floodplain within the Middle Parcel in 2015.

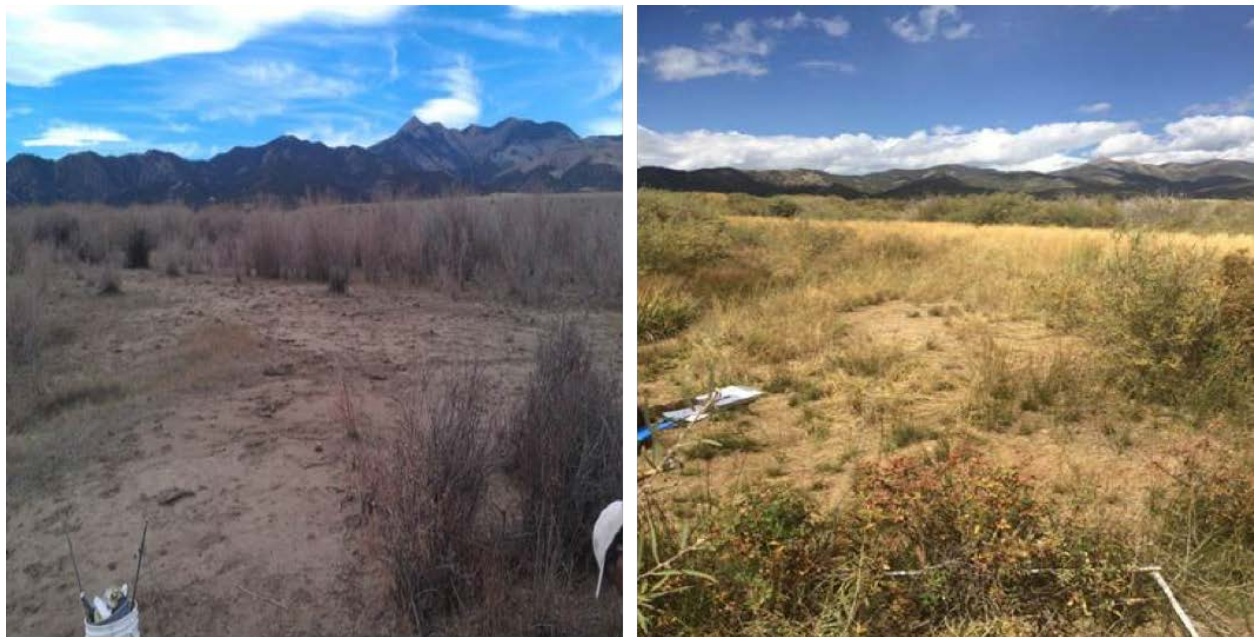
The photo set shown below represents a brief snippet of the work that was over the course of 2015 at KC16-M to improve mine waste areas with no vegetation (Figure 5.1).

**Figure 5.1:** KC16-M looking at mine waste areas with little vegetation (left) and after restoration involving phytostablization. (right)

Phytostabilization was the method of choice to treat the mine tailings. It is an *in-situ* (in-place) treatment of mine wastes consisting of the introduction of lime, limestone and organic compost as amendments to affected soil, usually followed by a site's revegetation. The result provides a good growing medium for riparian vegetation that has long term stability while reducing bioavailability for entry into the food chain through aquatic life. Amounts of limestone, lime, and compost were calculated based upon initial soil chemistry data for KC16-M (Figure 4.2). For neutralization purposes, 101 tons of Lime ( $\text{Ca}(\text{OH})_2$ ) and 220 tons of limestone ( $\text{CaCO}_3$ ) were used. The Limestone was donated by the Bureau of Land Management saving the project \$16,548. The purpose of these components is to bind to metals, demobilizing them and raising the pH of the soil. This process reduces the mobility of metals by altering them into less soluble, or toxic forms, thus preventing migration to surface or ground

water. These amendments were ripped into the soil at depths between 18". Next 353 tons of organic compost were mixed to a depth ranging from 8-12". In addition to the 106 pounds of Kerber Creek Seed mix that was distributed, 11 tons weed-free mulch/straw was crimped in on top of 787 pounds of mono-ammonium phosphate (MAP) fertilizer.
