Gunnison River and Riparian Habitat Restoration Project Final Report

January 18, 2019

City of Gunnison and Colorado Department of Parks and Wildlife Grant Amount: \$440,589 Prepared by: Andie Ruggera

Gunnison River and Riparian Rehabilitation Project: Floodplain Analysis and Preliminary Design Report

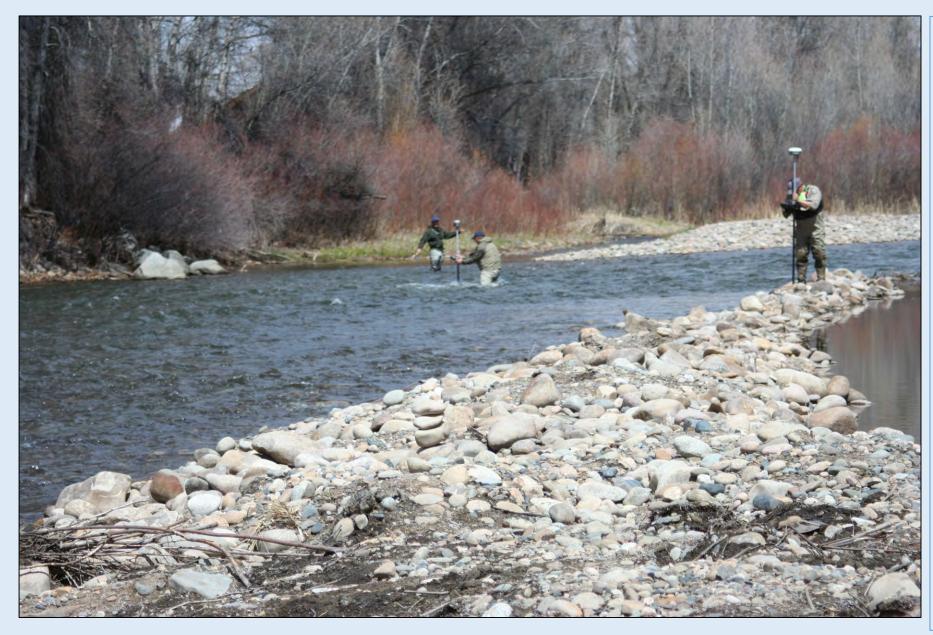
Pre-Construction Conditions – Hydraulic Modelling

Hydraulic modeling indicated that the initial designs of one channel feature would cause flood elevation rise & final design alterations were made to ensure norise would occur.

Elevation grade change between the head gates and diversion points were critical functions of the final design to ensure adequate water delivery and sediment control.

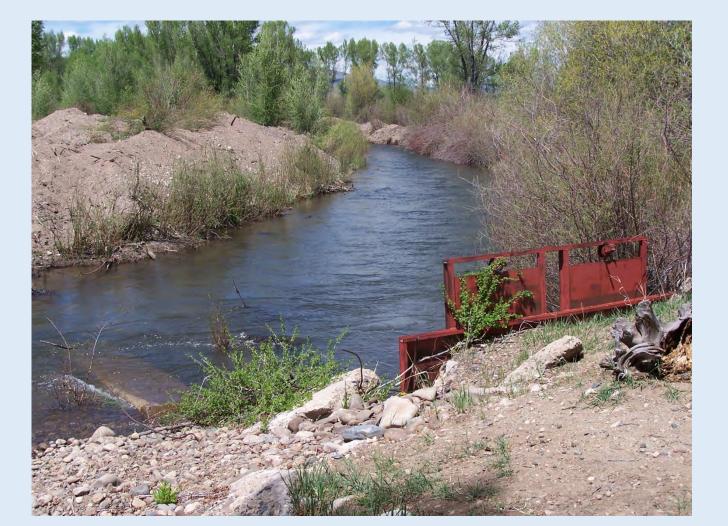
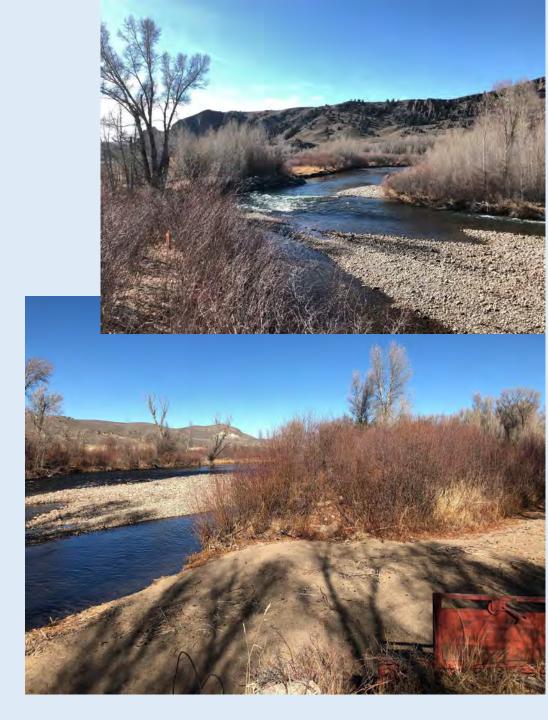
Wilson Diversion Pre-Construction Conditions Significant design & construction challenges

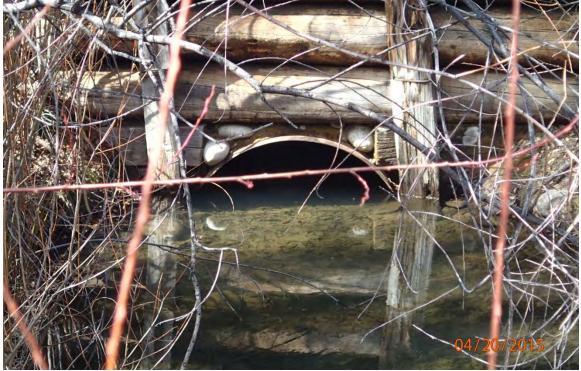
Figure 2. Outlet of the head gate culvert showing accumulation of sediment with adverse impacts on flows into the Piloni Ditch.

Piloni Ditch Design — The proposed design for the Piloni diversion replaces the existing pushup dam with a boulder vane arm (Appendix A-2). To minimize floodplain impacts, the vane arm was set at the same elevations as the existing pushup dam. Based on historical photos and survey data, the vane arm was extended an additional 60 ft upstream to replicate the extent of the existing pushup dam prior to runoff. To provide additional stability at the terminus of the boulder vane arm, an optional boulder sill is shown on the proposed design layout. This sill would be set at the elevation of the existing stream bed and extend across the channel. The proposed structure may require maintenance following ice flows or floods, but can be repaired in the wet when flows are sufficiently low to accommodate equipment access.

Sediment issues at head gates and within irrigation ditches can increase maintenance needs for water users. Sediment sluice or bypass structures can be used to improve water and sediment management near head works. The head gate for the Piloni Ditch is constructed of landscape timbers that could be damaged during installation of a sediment sluice. Installing a new head gate and sediment sluice at the ditch inlet would improve water delivery and reduce sedimentation. Increasing culvert capacity within the irrigation ditch system would also improve water delivery. These design options should be evaluated by project stakeholders prior to developing the final design package.

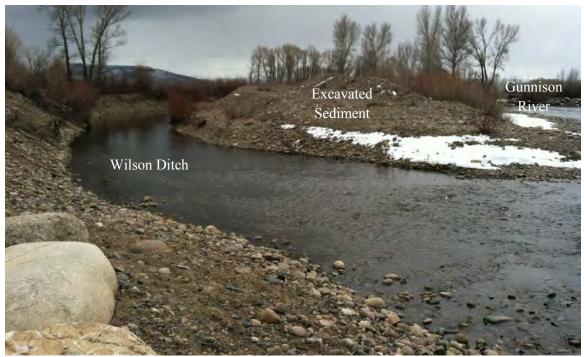
Figure 3. Inlet to the Wilson Ditch showing large pile of sediment that has been removed from the ditch and placed between the ditch and the Gunnison River.

Wilson Ditch Design — The objectives of the proposed design are to improve aquatic and riparian habitat by providing a stable water diversion structure that can deliver 15 cfs to the Wilson Ditch. Currently, there is not a water diversion structure at the inlet to the Wilson Ditch. The proposed design will use a boulder, cross-vane diversion structure (Figure 5; Rosgen, 2006) that will tied directly into the head works to divert flows into the Wilson Ditch. The elevation of two culvert inverts at the Wilson head gate structure were used inform design elevations for the cross-vane diversion structure was set 0.78 ft higher at 7724.50 ft. This design elevation should provide sufficient hydraulic head to deliver water to the Wilson head gate. Two steps were incorporated into the diversion structure design to provide additional grade control and to protect the upstream crest from scour. The vertical drop between each step was set to 1.0 ft. Proposed conditions for the Wilson Ditch are presented in Appendix B-2.

Sedimentation at the ditch inlet, within the ditch itself, and at the head gate is a major issue at the Wilson Ditch under existing conditions. Relocating the ditch inlet to an area that is not prone to sedimentation should reduce issues with sediment aggradation. Furthermore, incorporating a sediment sluice into the head works should reduce maintenance needs and improve operations. Sediment that was previously excavated from the ditch will be graded into a multi-stage channel design that includes a low-flow channel, bankfull riparian bench, and terrace features. New streambanks will be stabilized with a boulder and cobble matrix and backfilled with native material. Willows, trees, and sod mats will be transplanted to riparian benches and terrace features to initiate revegetation, followed by seeding and planting with native riparian and upland species as specified on final construction documents. Concrete rubble previously used for bank stabilization will be removed from the left streambank downstream of the diversion structure. The new streambank will be stabilized with a combination of boulders and large wood that will also enhance aquatic habitat. The opposite point bar will be shaped to increase the radius of curvature around bend and reduce shear stress on the outside bank.

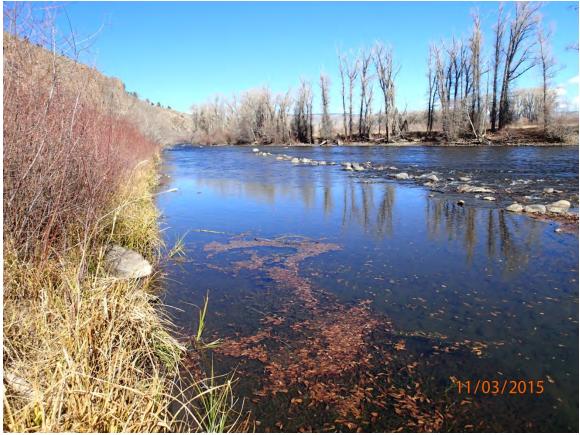
Figure 4. Looking upstream at the Palisade #2 pushup dam, note the vegetated bank on river right and the exposed cottonwood roots on river left.

Palisade #2 Ditch Design — The existing pushup dam at the Palisade #2 diversion will be removed and replaced with a cross-vane diversion structure with a single step (Appendix C-2). The proposed design should reduce the need for maintenance, including re-construction of the pushup dam and removal of sediment from the ditch inlet. The crest of the cross-vane diversion structure was set at an elevation of 7696.90 ft, which is 0.5 ft higher than the invert of the culvert at the head gate (i.e., 7696.40 ft). The proposed structure should provide sufficient hydraulic head to deliver water the Palisade #2 Ditch. Bank erosion near the terminus of the existing pushup dam has undermined a number of cottonwood trees by exposing their root systems. Stabilizing the bank on river left would protect the cottonwoods from further erosion while improving channel morphology, sediment transport, and aquatic habitat. Bank stabilization around these cottonwood trees was not included in the preliminary design due to uncertainty regarding constructability and cost. The need for bank stabilization should be discussed with project stakeholders prior to developing the final design package.
