Lake Fork of the Gunnison River and Henson Creek Monitoring Data In-Stream Structures and Comparative Cross Sections

Camille Richard
Lake Fork Valley Conservancy (LFVC)

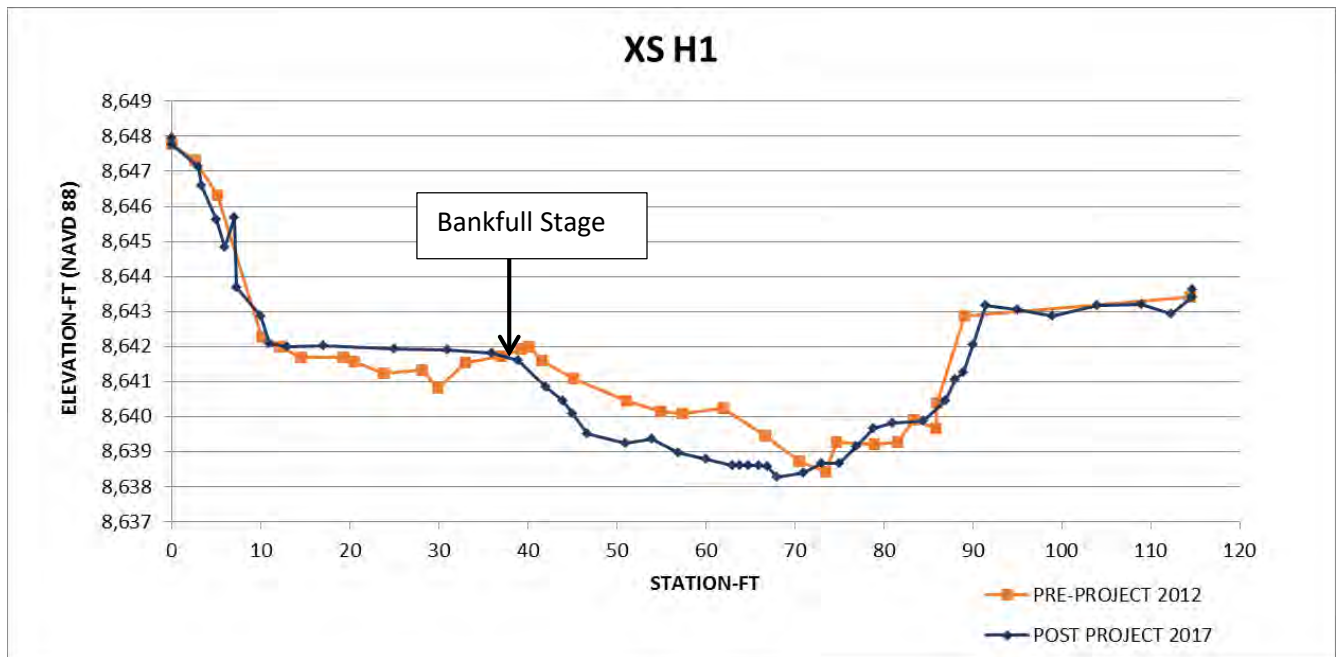
Henson Creek Section H1

Reach average representative channel cross sections were surveyed for pre-project and post-project conditions. The locations of these sections are shown in **Appendix C**. Four HC/LFG confluence reach sections were surveyed in 2012 and then again in 2017. These are shown in **Figures 1-4**. Results demonstrate that the channel as designed and built has maintained an average bankfull depth of 4 feet and a bankfull width ranging from 50-65 feet with some natural variability. The project has successfully transport the high upstream bedload sediment loads through the reach and maintained excellent depth for fisheries habitat.

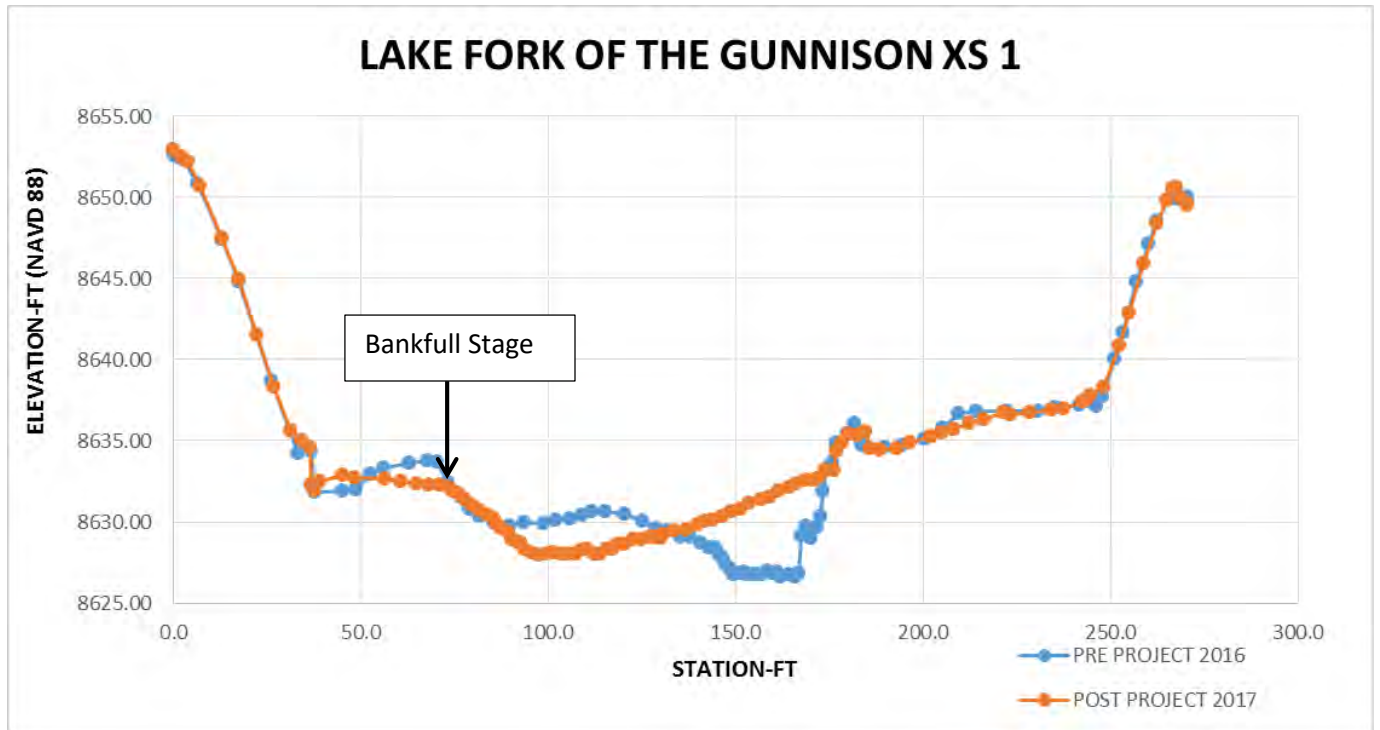
Figure 5 LFG Section 1

Three representative channel sections for the project reach on the LFG downstream of the 8 ½ bridge were surveyed pre-project in the fall of 2016 and post-project in the fall of 2017. These sections are very wide and spanned the entire valley bottom up to the adjacent hillslopes they are shown in **Figures 5-7**. Through the high water runoff season the section surveys have demonstrated that the project reach has maintained its project designed single thread meandering planform and maintained sediment transport and stability in a reach previously subject to channel braiding aggradation and channel instability. The average bankfull width post runoff ranged from 80-100 feet and the bankfull depth post runoff ranged from 4-5.5 feet.

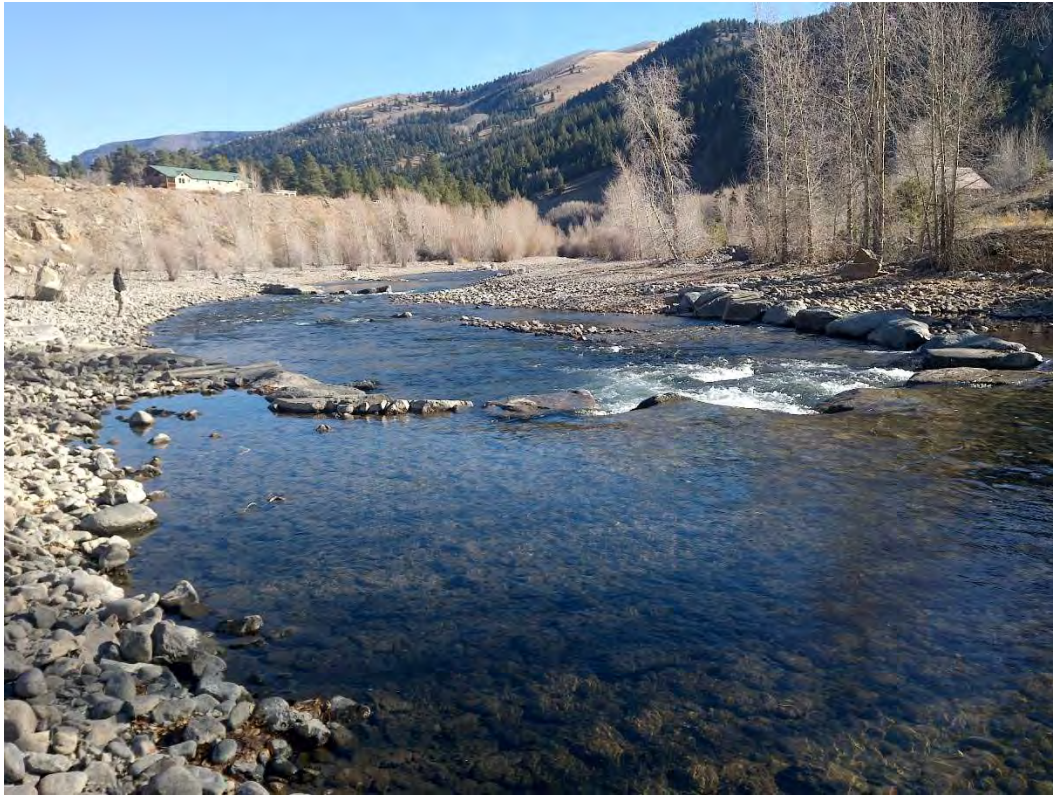
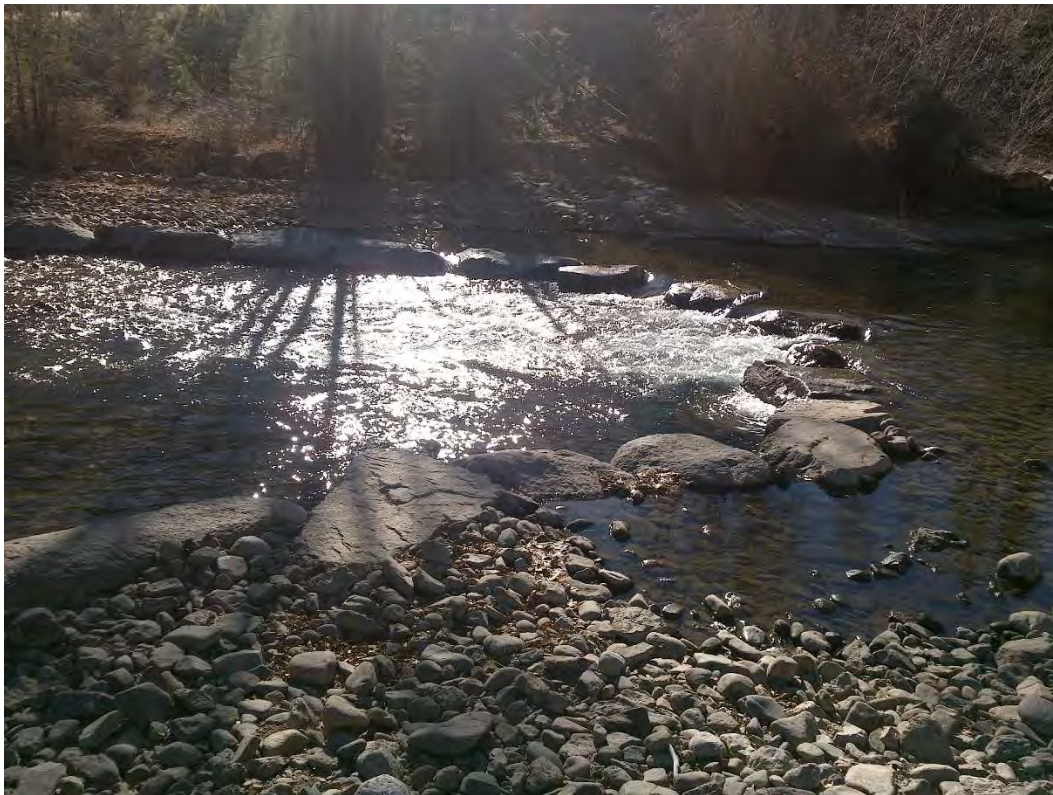
Lake Fork Gunnison – Cross Vane #1 DS/ 8 ½ St. Bridge.

Stream: LAKE FORK GUNNISON Date: 10/17/17
Site ID: SH# DS 8 1/2 ST. BRIDGE
Assessed by: JORDAN / BRUNDAK
Location Coordinates: WPT #002 38.035507°N
-107.309278°W

- 1__ Severe (Numerous failure points along structure)
- 2__ Moderate (Some movement of rocks noticeable, some evidence of undermining or out-flanking)
- ~~3__ Minor (Minor movement of stones, structure appears to be stable and functional, sediment may not be in ideal location in relation to structure)~~
- 4 ☒ Stable (Structure appears with no evident migration, looks to be trapping and/or moving sediment as intended)

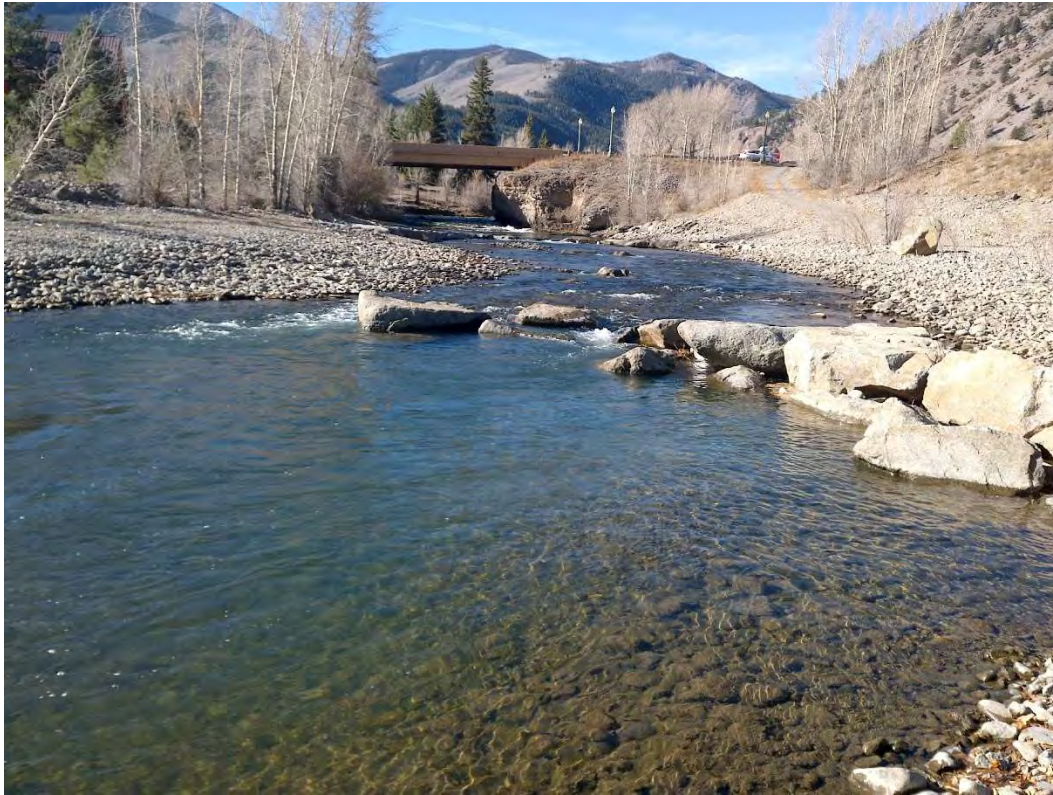
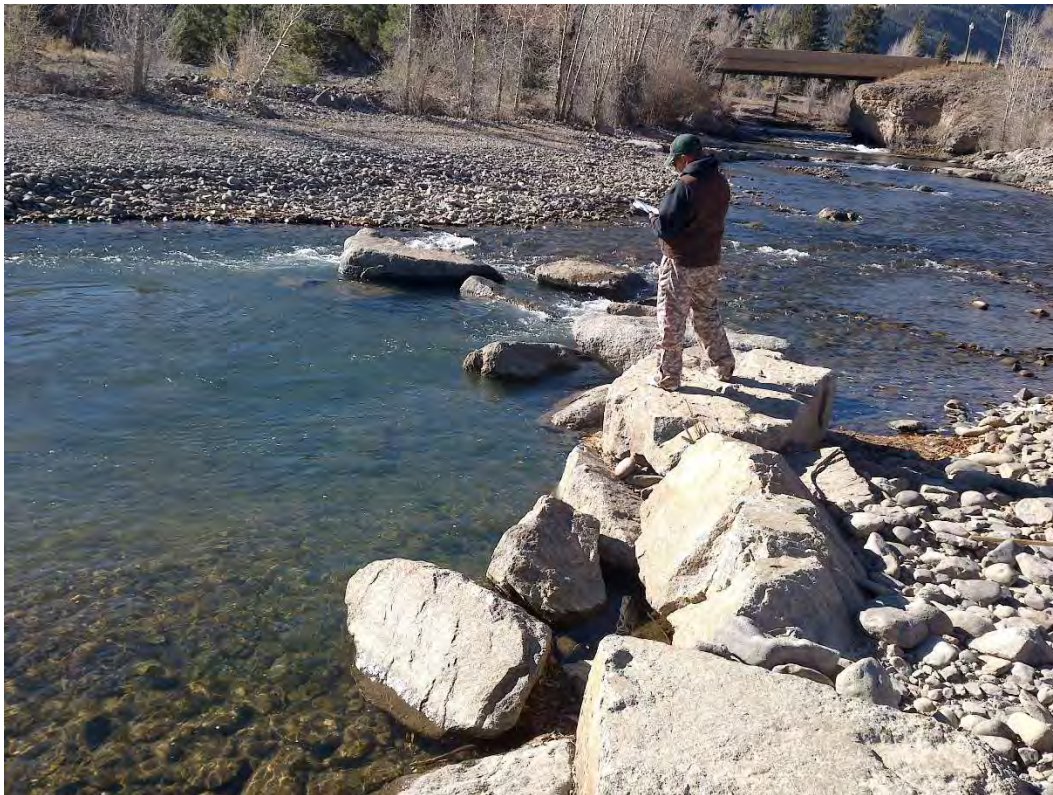
Lake Fork Gunnison – J-Hook #1 DS 8 ½ St. Bridge

COMMENTS EXCELLENT POOL DEPTH, BN TROUT COVER
PHOTOS GPS 9-12

Stream: LAKE FORK GUNNISON Date: 10/17/17
Site ID: JH #2 DS 8 1/2 ST. BRIDGE
Assessed by: JORDAN BRUNSTAK
Location Coordinates: WPT # 003 38.035656°N
-107.308919°W

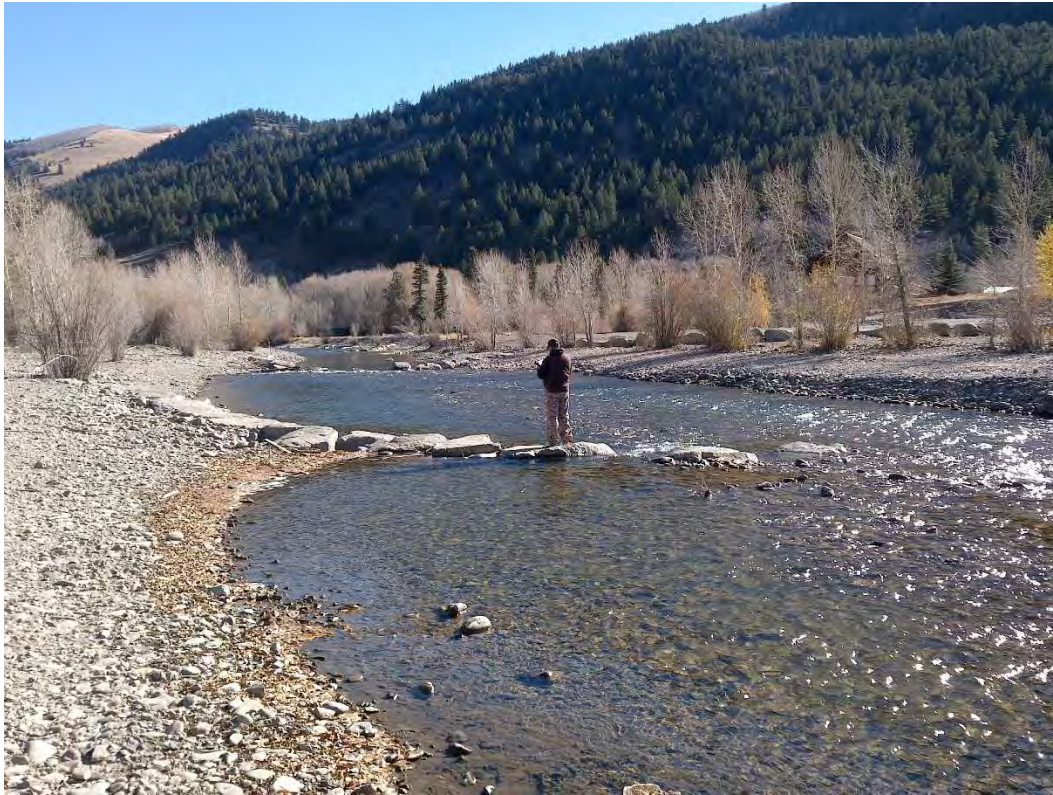
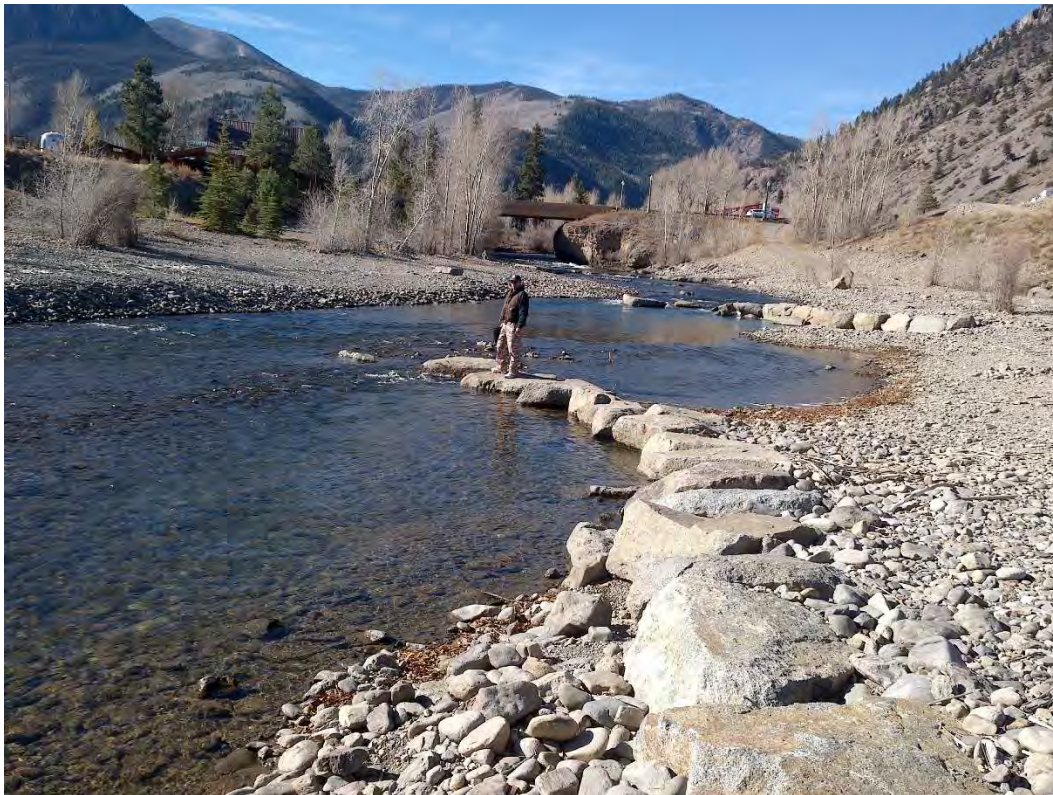
Lake Fork Gunnison – J-Hook #2 DS 8 ½ St. Bridge.

COMMENTS - NO POOL, POOR NAVIGAT

- NOTE DOWNSTREAM MID CHANNEL BAR

Stream: LAKE FORK GUNNISON Date: 10/17/17
Site ID: CV #2 DS 8 1/2 ST. BRIDGE
Assessed by: Jordan / Benjmin
Location Coordinates: WPT 004 38.035819° N
-107.3083580 W

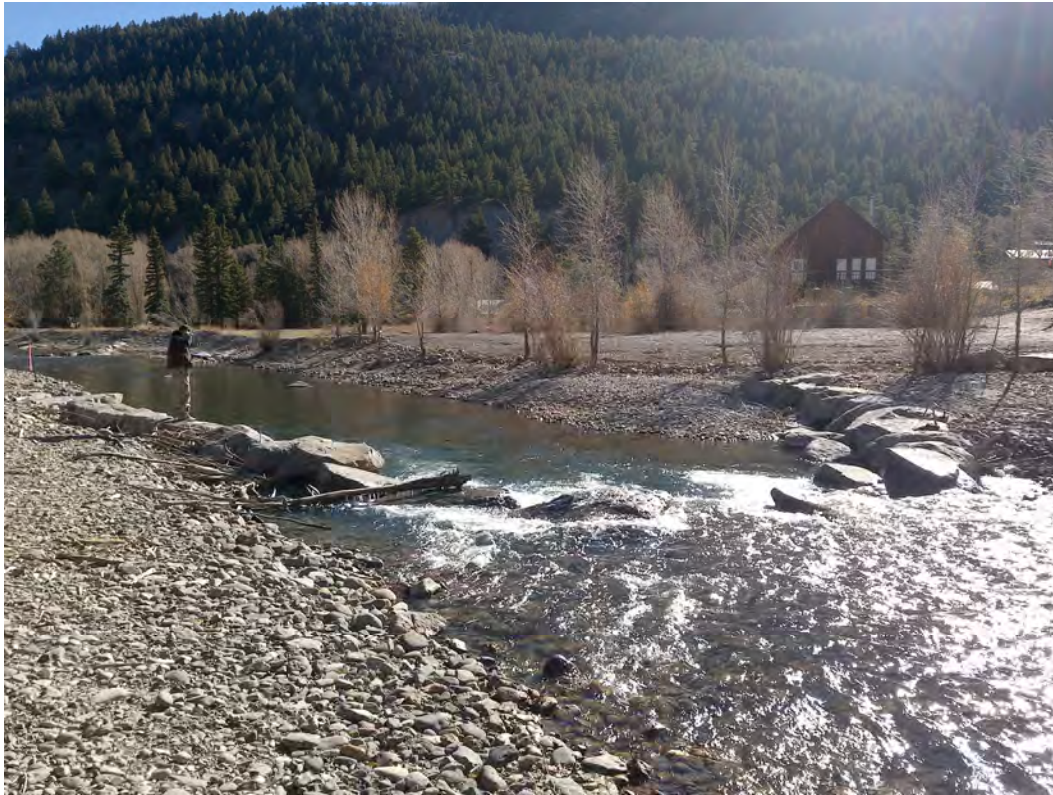
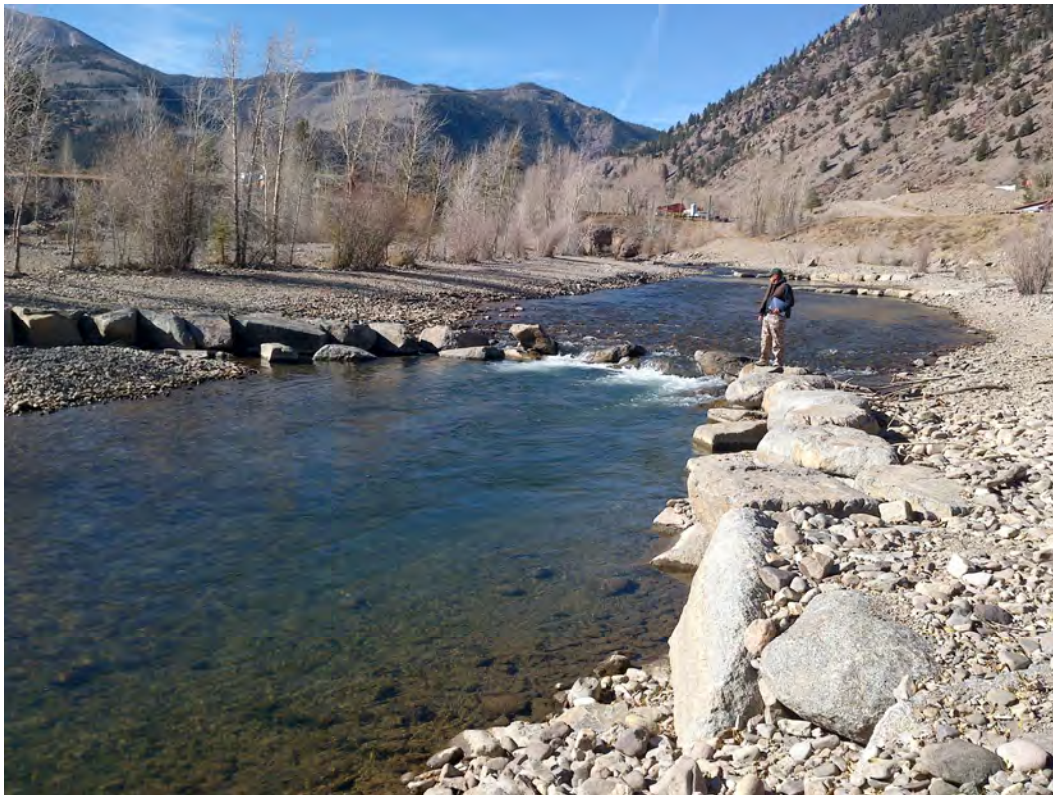
Lake Fork Gunnison – Cross Vane #2 DS 8 ½ St. Bridge.

- 1__ Severe (Numerous failure points along structure)
2__ Moderate (Some movement of rocks noticeable, some evidence of undermining or out-flanking)
3 ☒ Minor (Minor movement of stones, structure appears to be stable and functional, sediment may not be in ideal location in relation to structure)
4__ Stable (Structure appears with no evident migration, looks to be trapping and/or moving sediment as intended)

Good pool depth

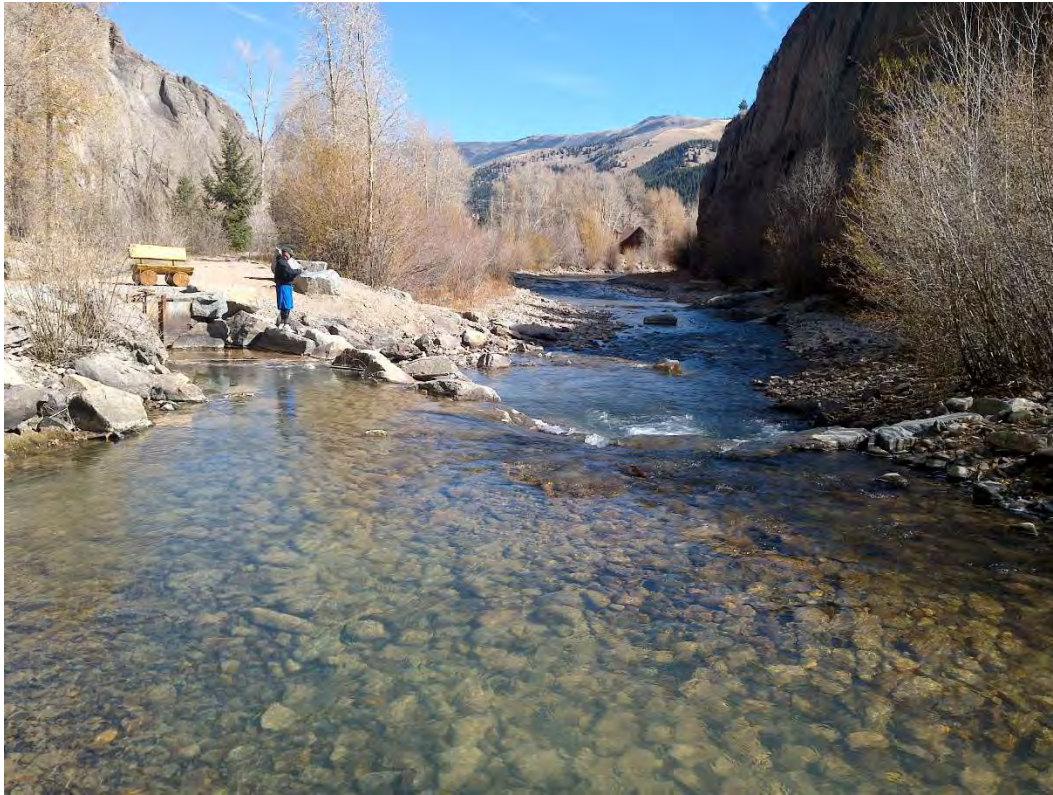
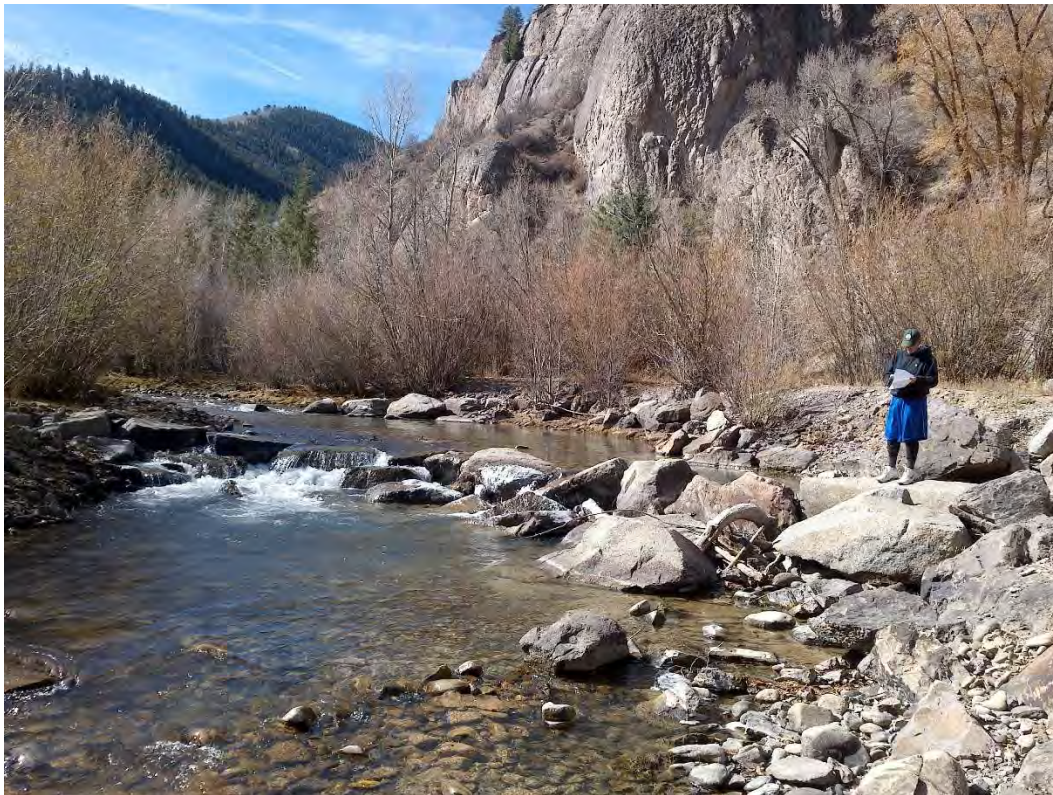
Henson Creek – Cross Vane HC-CV1 Diversion

— GOOD POOL DEPTH
