Rio Grande Stream Management Plan

Rio Grande Basin Roundtable and the
Stream Management Plan Technical Advisory Team

Executive Summary

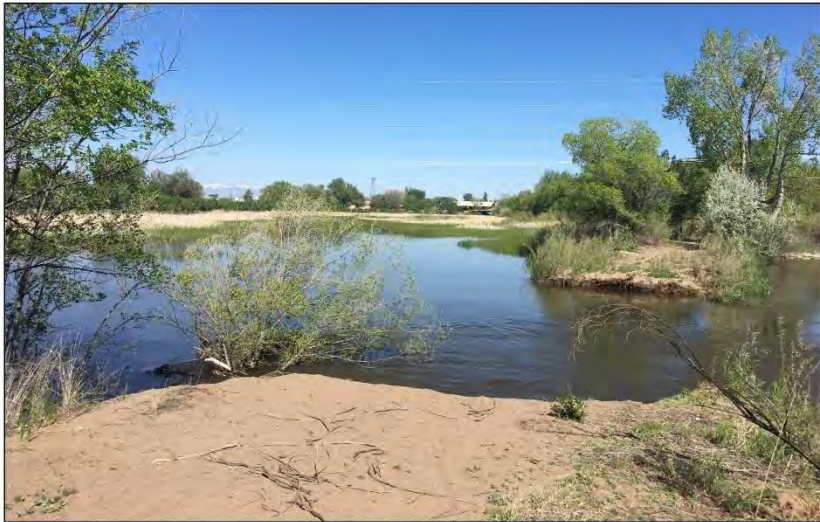
Failed levee north of diversion dam during Spring 2019 runoff.

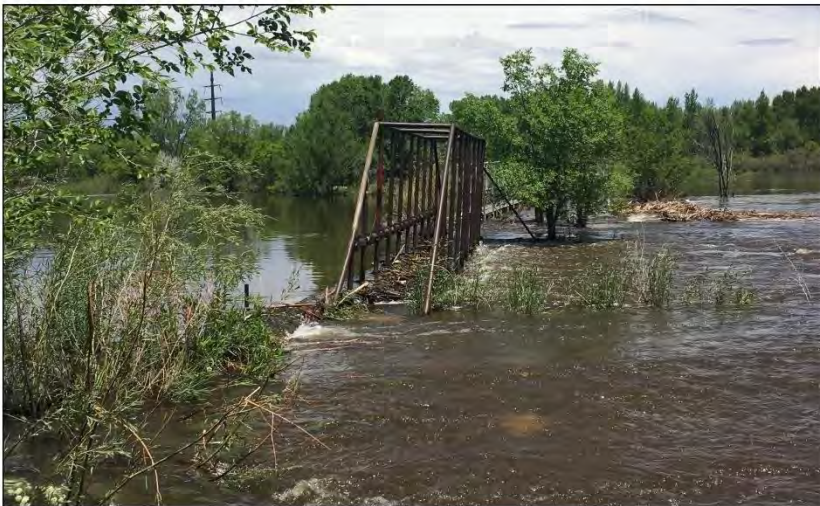
Flooded diversion dam during Spring 2019 runoff.

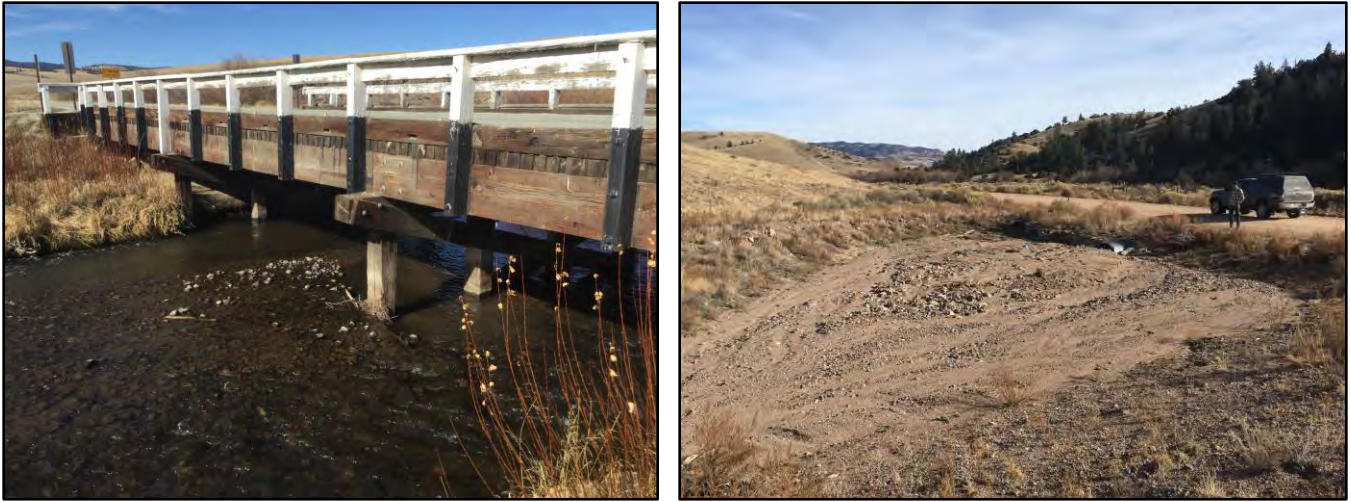
Figure 2.12: (Left) Bridge over Saguache Creek with a pier in the middle of the bridge that may collect debris during a flood. (Right) Undersized culverts failing to transport sediment in a dry wash in Saguache County.

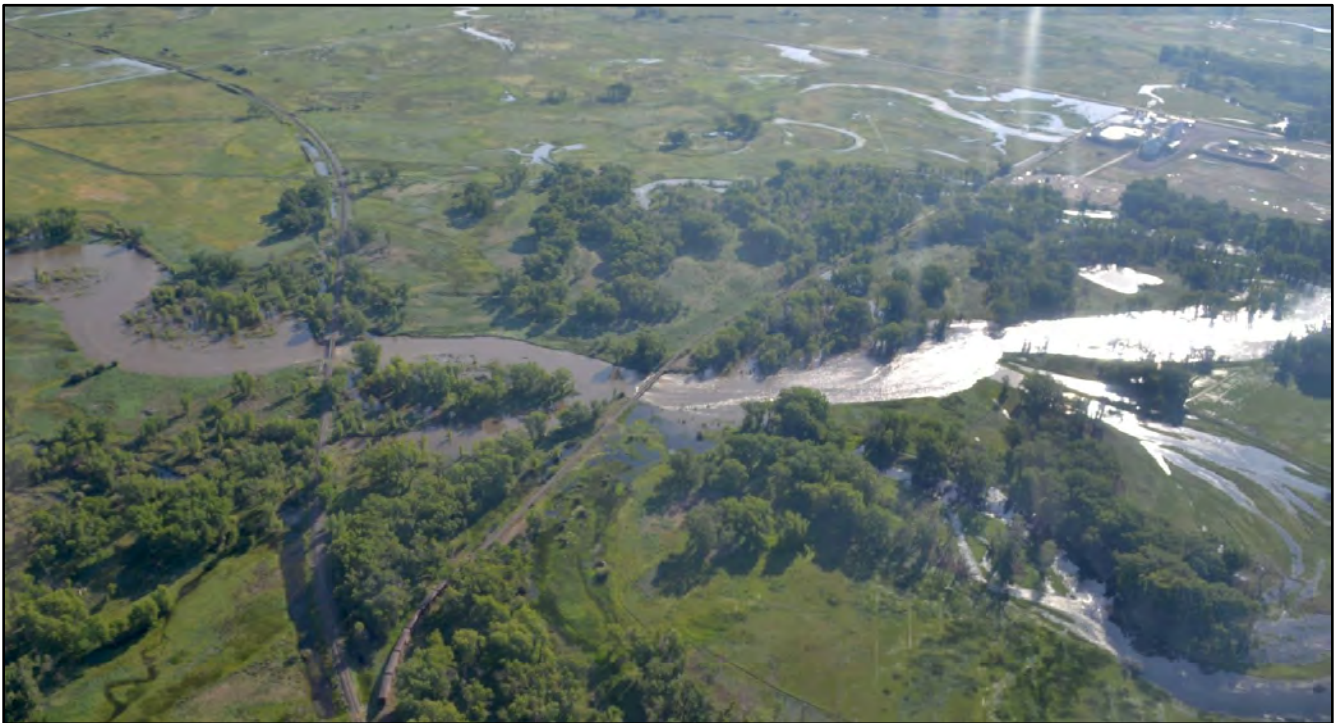
Roads oriented so they constrict the active river corridor can increase flow depths, shear stresses, and sediment transport capacities of streams. These constrictions can affect reaches upstream and downstream. Road and railroad bed encroachment does not appear to be significantly affecting the geomorphic stability of any of the streams in the SMP study area (Figure 2.13).

Figure 2.13: Railroad lines and bridges crossing the Rio Grande near flood stage, June 2019.

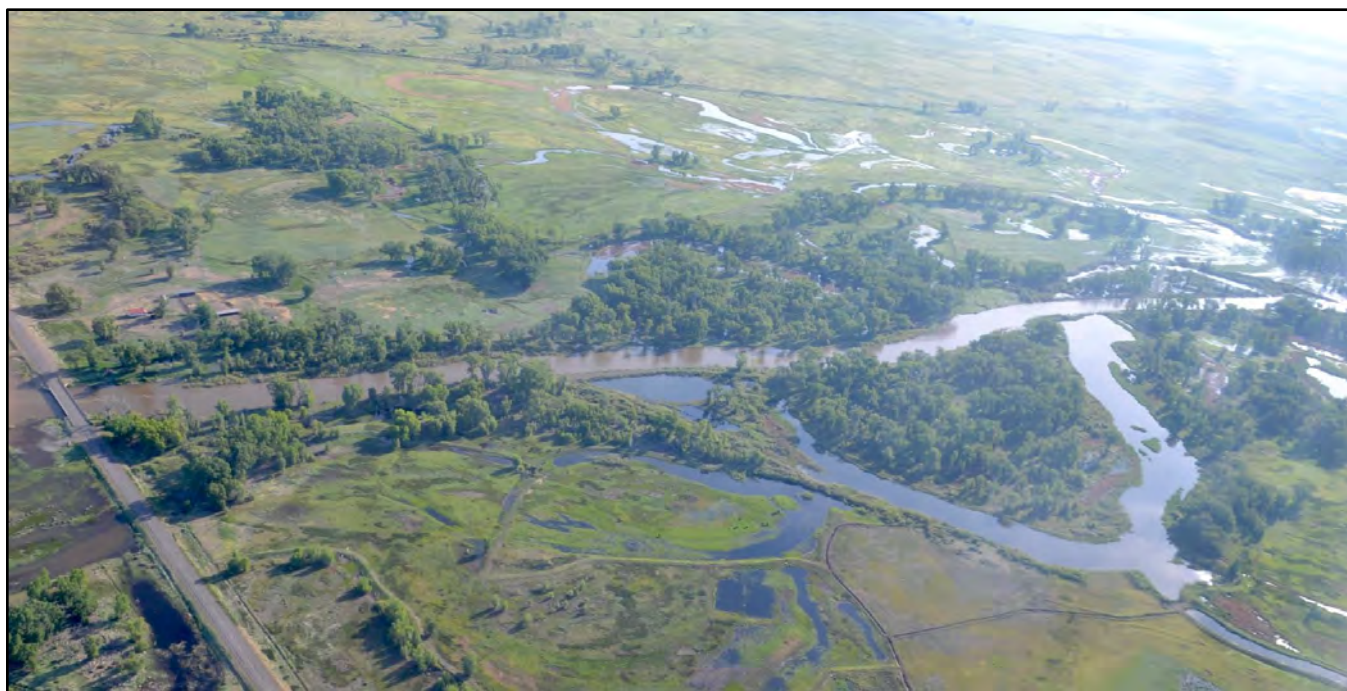
Channelization (i.e., straightening of channel meanders; removal of large wood and/or beavers; filling of side channels to force a stream into a single-thread) and stream bank armoring (i.e., placement of rock riprap, concrete barriers, or other materials to prevent channel migration or widening) has occurred on the SMP study streams and adversely affects natural channel processes and stream health. Figure 2.14 shows a channelized portion of the Rio Grande.

Figure 2.14: Channelization of the Rio Grande at the Soldiers Home Road (County Road 3E).

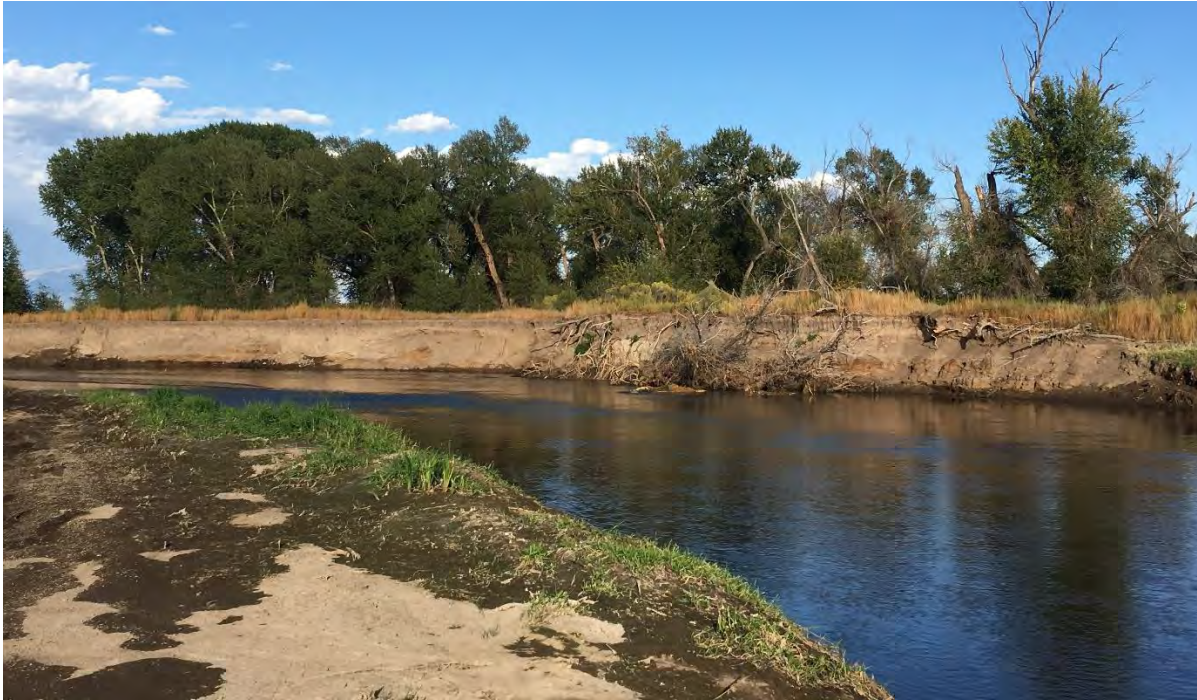
These features can cause river-floodplain disconnection (i.e., the river is unable to access its floodplain at high flows where it otherwise would have). Stream response to floodplain disconnection and/or bank armoring typically results in the transfer of erosive energy to the opposite bank, a downstream reach, or toward the channel bed.

Figure 2.15: River-floodplain disconnection on the Rio Grande upstream of Alamosa.

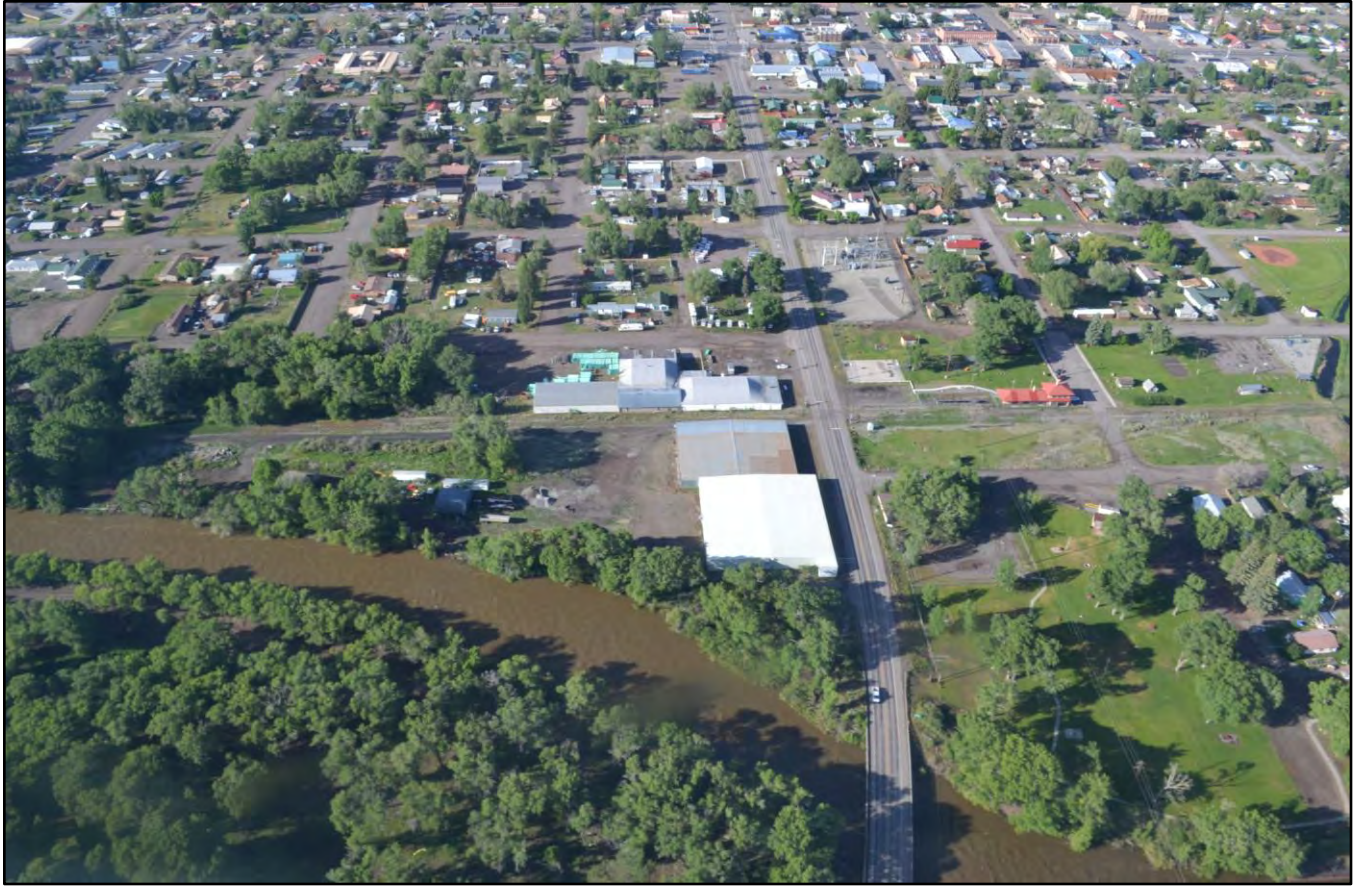
Land conversion can alter or eliminate floodplain complexity, side channels, wetlands, riparian vegetation, overflow relief channels, and other important geomorphic and ecological components of streams. Riparian vegetation and wetlands along some SMP reaches are impacted by fill and/or floodplain/riparian area conversion resulting from development, overgrazing, and nonnative species dominance. Riparian vegetation throughout the floodplain and river corridor, not just along the main channel, is critical to energy dissipation, stream shading, bank stability, wildlife habitat, and many other natural stream processes. Overgrazing and/or development fill brought into the corridor erases the evidence of past channel migration, possibly creating a false sense of protection from fluvial erosion to those that occupy the land. Furthermore, development creates the expectation (e.g., stable banks) that these rivers will remain in their current location indefinitely and therefore current and future generations will be willing and able to invest in the costs (both monetary and ecological) that will be required to resist natural channel processes (e.g., bank erosion and channel migration) (Figure 2.16).

Figure 2.16: Development in the active river corridor of the Rio Grande in the Town of Del Norte.

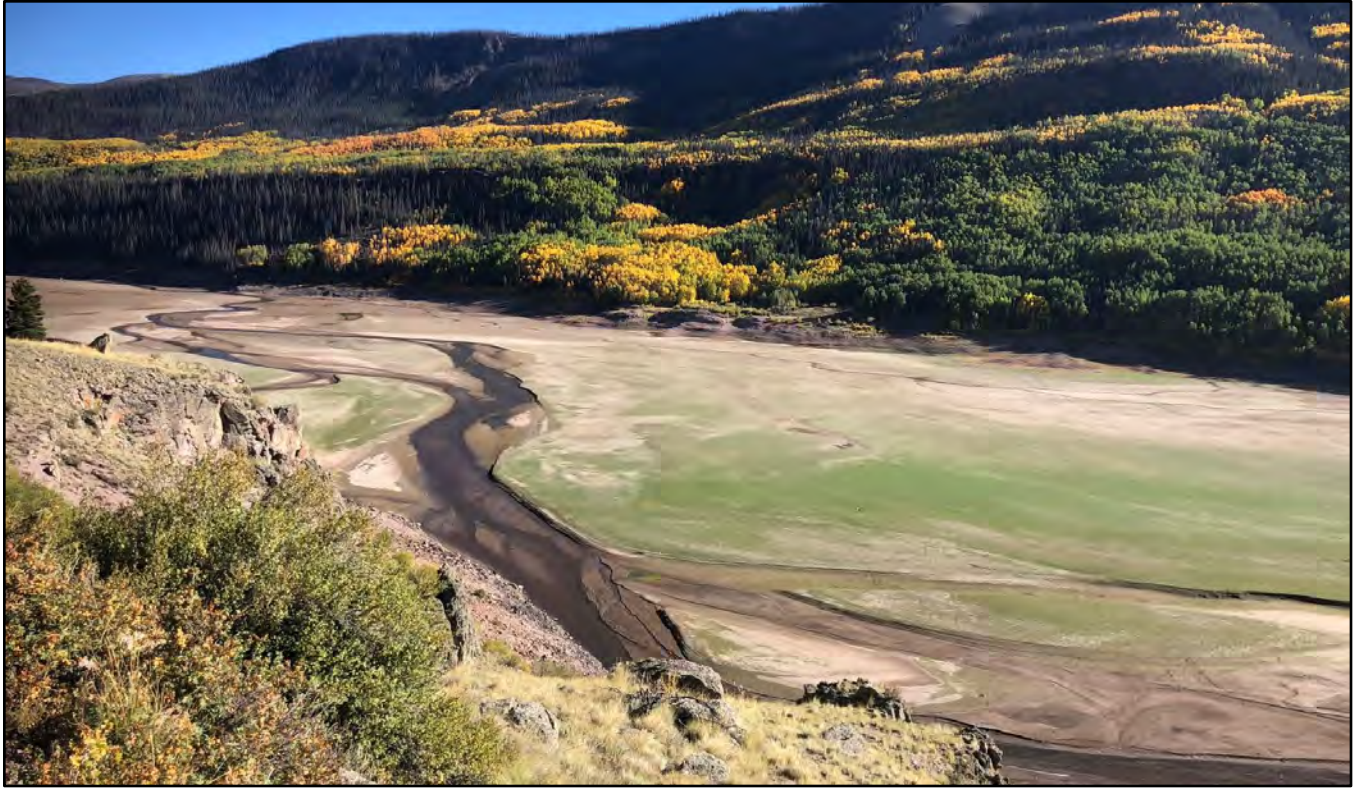
While Saguache Creek is a free-flowing stream, large dams affect both the Rio Grande and Conejos River. Dams affect these rivers both by reducing sediment transport, by trapping sediment behind them (Figure 2.17), as well as by reducing the peak flows that might otherwise provide channel-forming flows to flush fines, mobilize sediments, and do other geomorphic work. The Rio Grande is controlled by the earthen dam of the Rio Grande Reservoir which sits approximately 20 miles west of Creede. To a lesser degree, flows are also affected by Continental and Santa Maria reservoirs, which flow into Clear Creek. The Platoro dam on Conejos River is located roughly 1 mile above the town of Platoro, Colorado. Because these reservoirs are required to pass inflows during spring runoff, peak runoff is only altered when reservoir inflows surpass reservoir outlet capacity.

Figure 2.17: Sediment trapped behind the Rio Grande Reservoir (seen during dam repairs which had the reservoir drained during the fall of 2018).
