## **Rocky Mountain Field Institute**

### ***Pilot Willow Propagation Program to Facilitate Resiliency in Critical Riparian Areas – Final Report***

**Number: POGG1 PDAA 2016 00628**

**June 20, 2017**

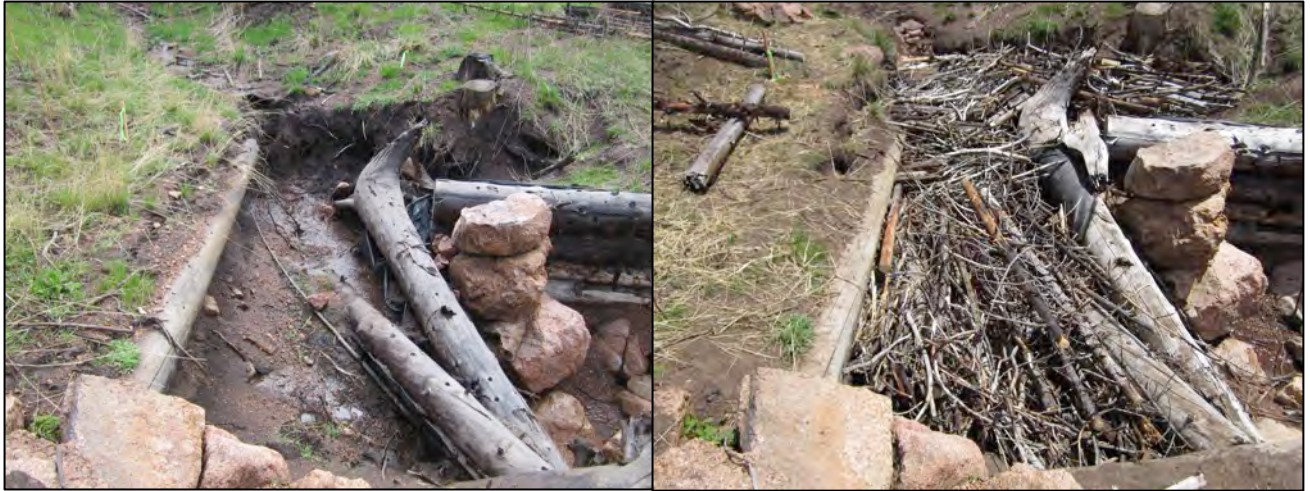
Figure 9. Before (left) and after (right) photos of headcut stabilization treatments completed by RMFI and MHYC.

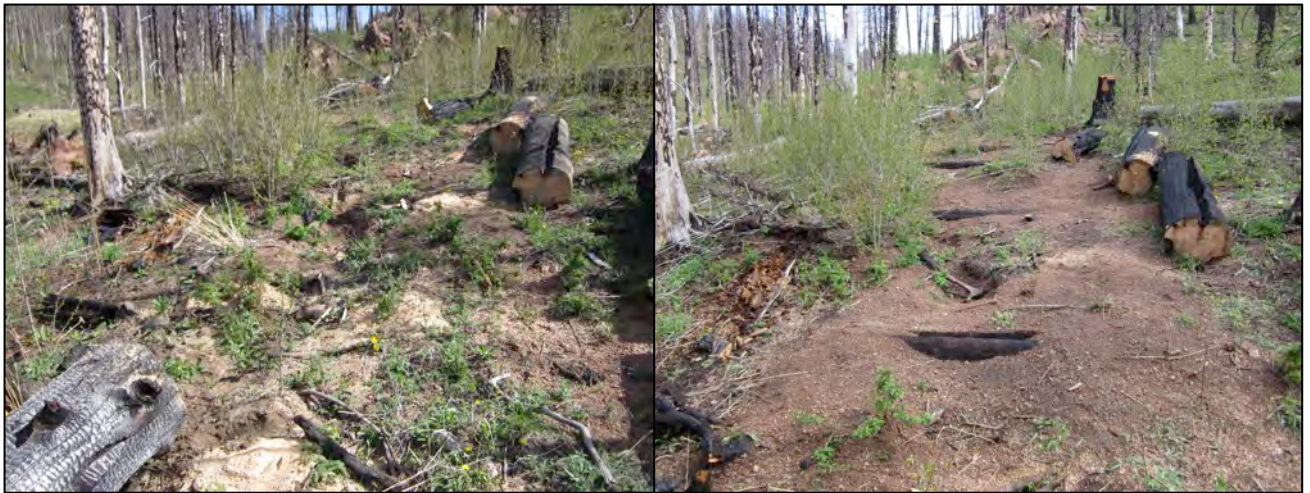
Figure 10. Before (left) and after (right) photos showing sills emplaced in a side drainage to stabilize the slope.

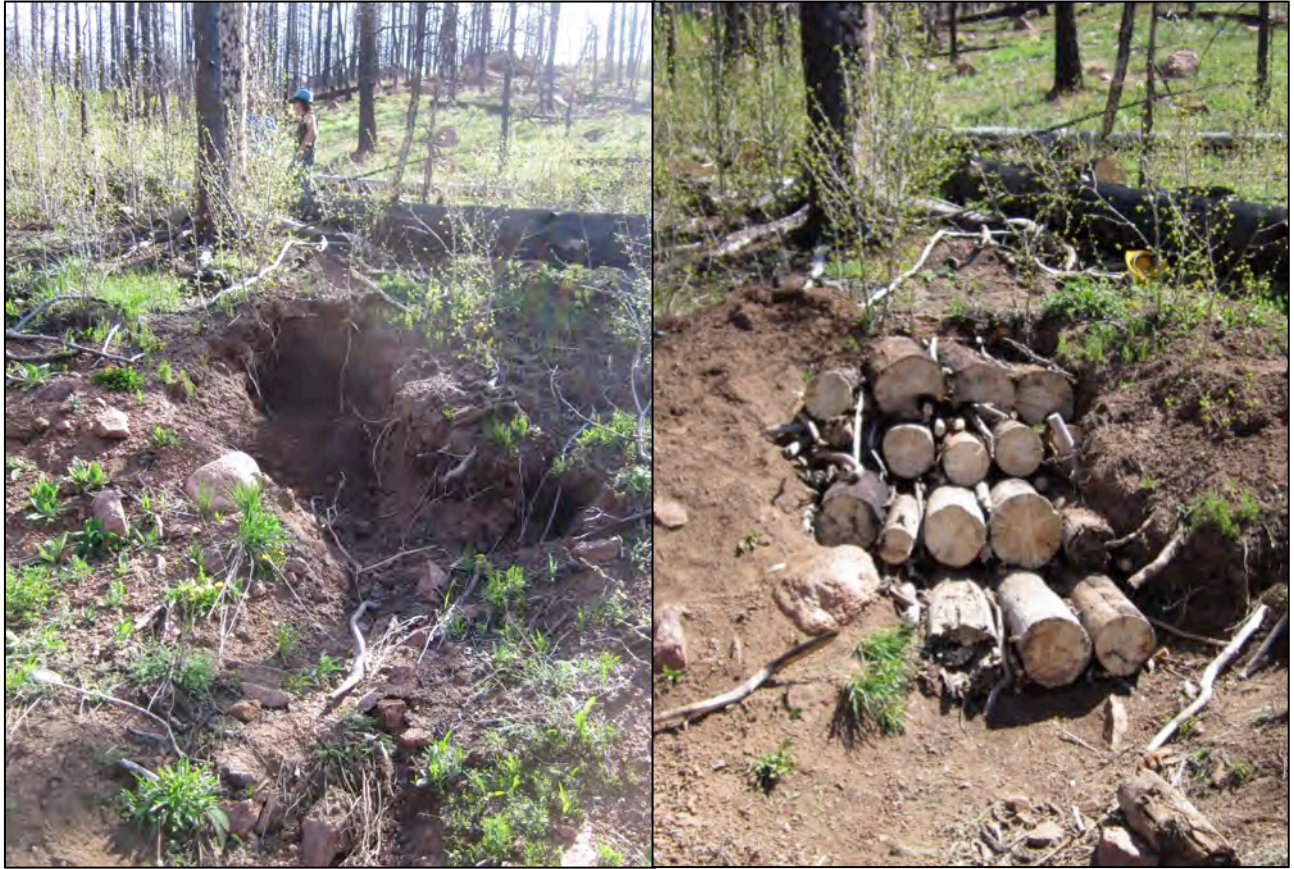
Figure 11. Before (left) and after (right) showing headcut stabilization treatment.

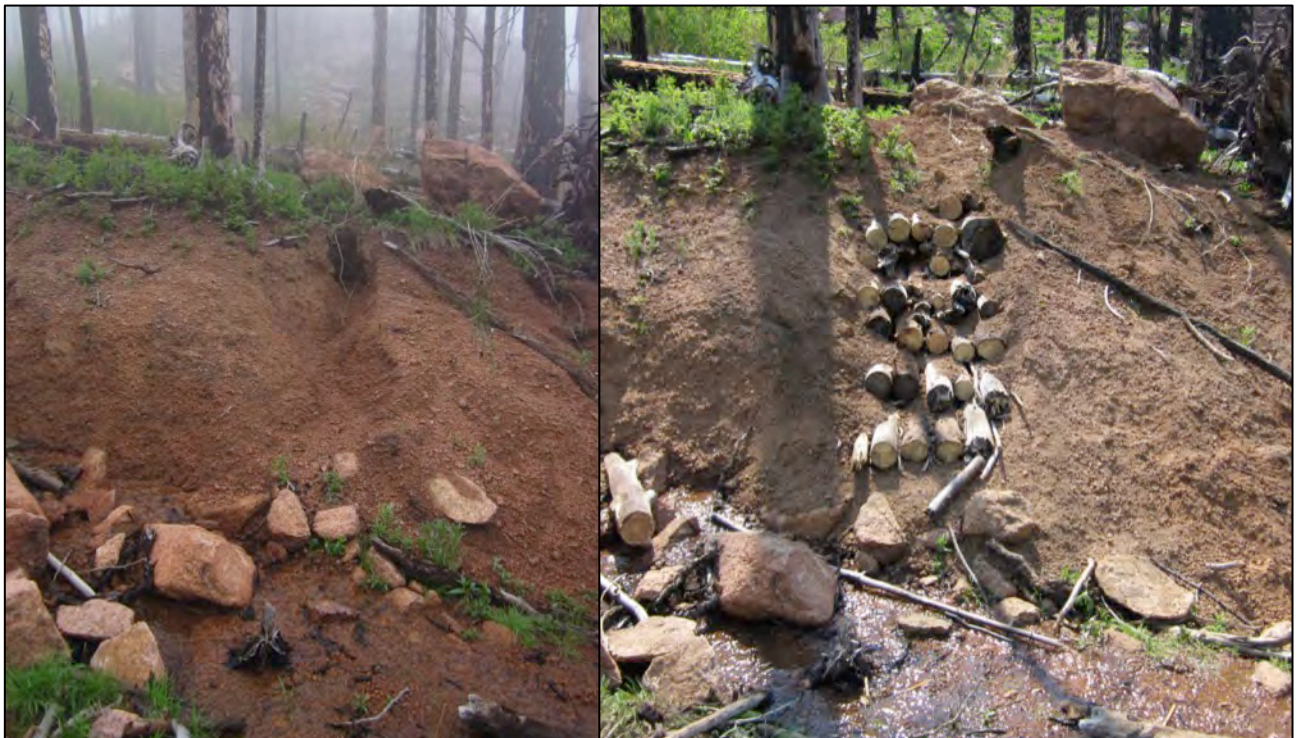
Figure 12. Before (left) and after (right) of a stepfall construction technique to stabilize the stream channel.

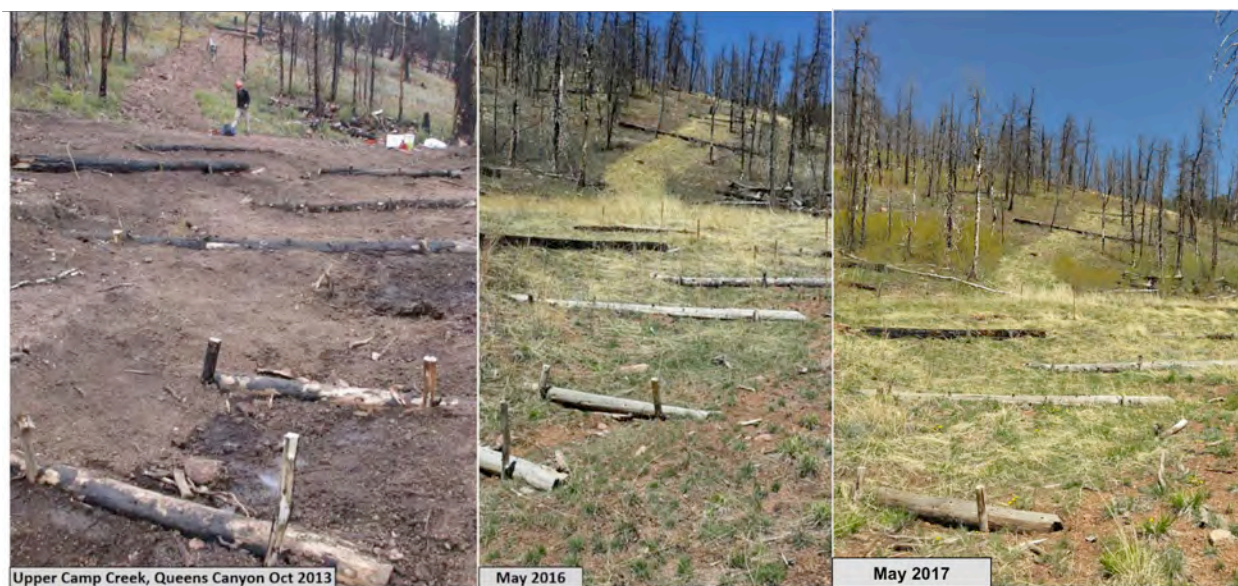
The erosion control and stabilization treatments that were constructed within the Upper Camp Creek drainage were all functioning properly. There were no failures observed in the structures

and a 4-year photo series (see Figure 13) visually demonstrates the successful stabilization of slopes, increase in native vegetation, and natural regeneration of aspen trees within the watershed.

Figure 13. A 4-year photo series showing the impact of RMFI's restoration work in the Upper Camp Creek drainage of the Waldo Canyon burn scar.

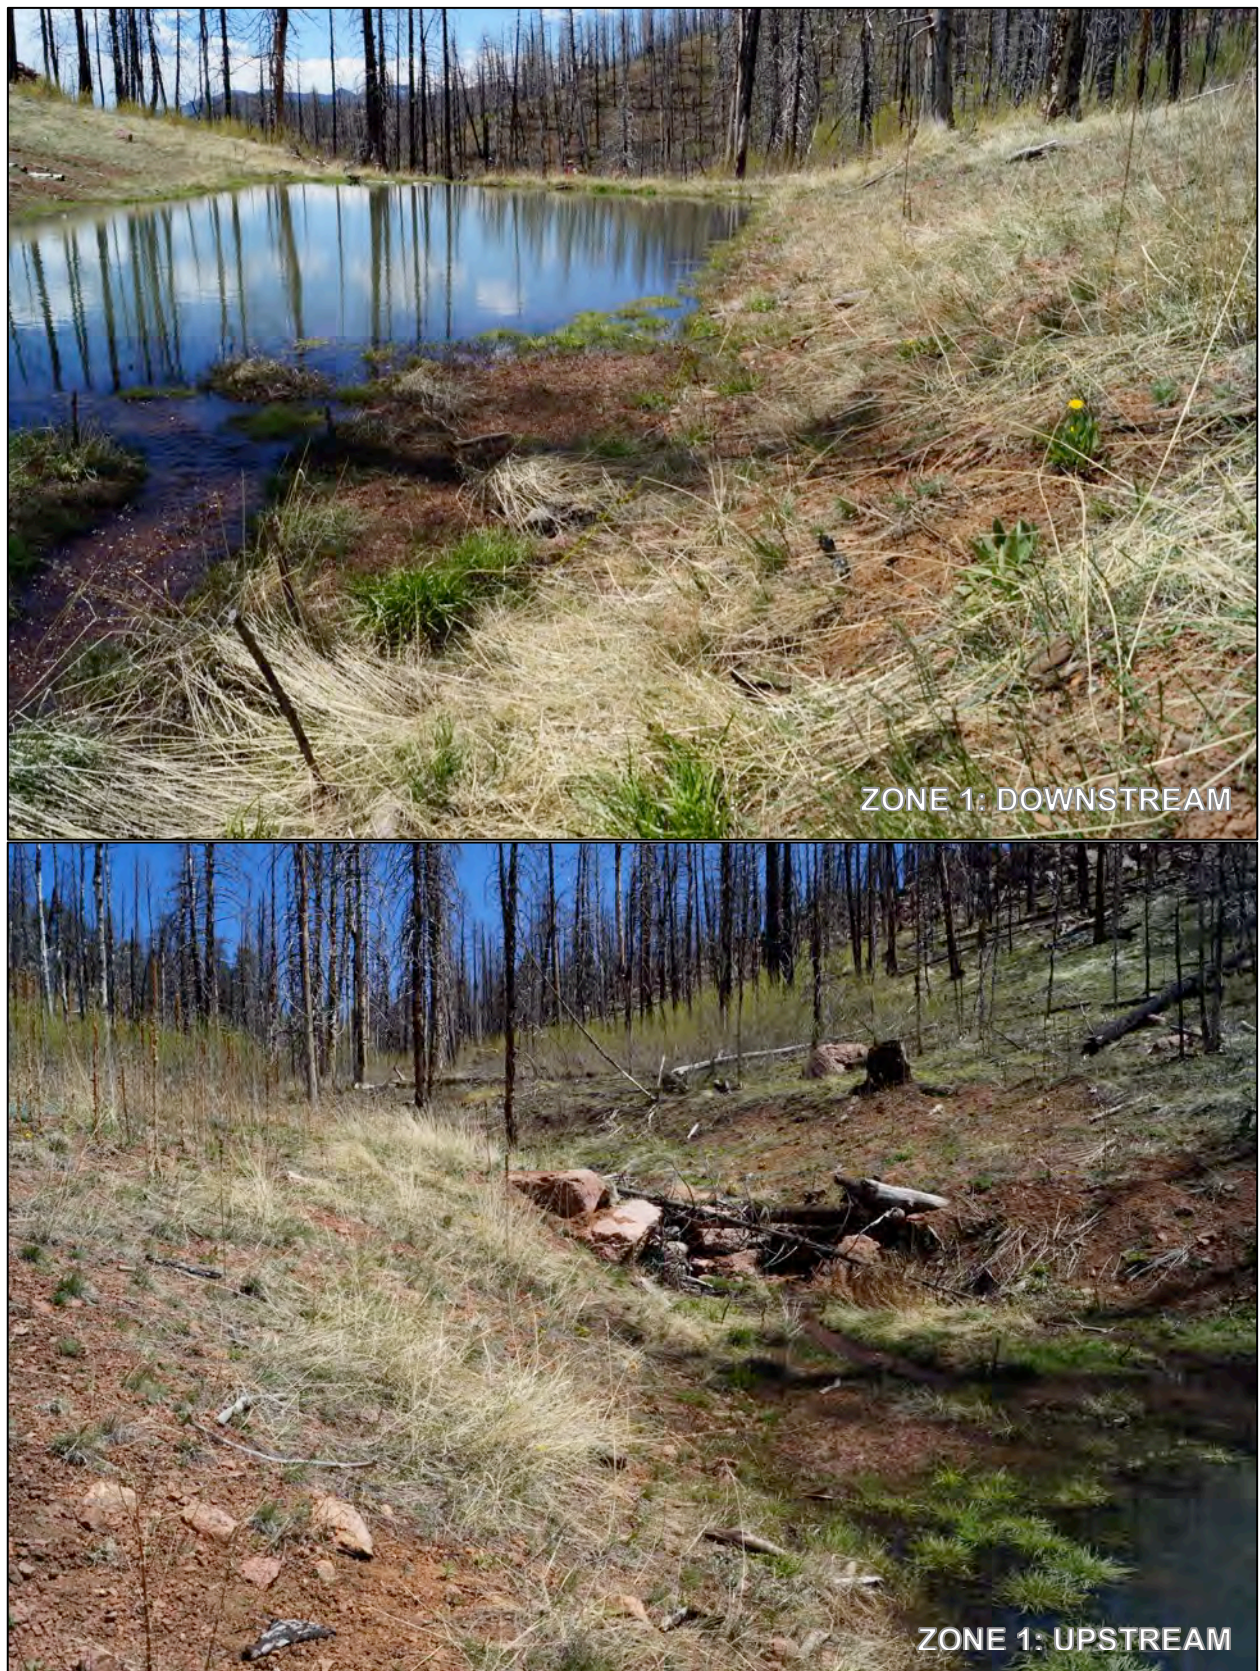
Figure 14. Photos of Zone 1 looking downstream and upstream. Photos taken on May 25, 2017.

| A<br>Reach/Zone # | B<br># Willows Planted | C<br># Surviving<br>Willows Counted<br># counted | D<br>% Estimated<br>Survival Rate<br>(B/C) | E<br>Willow Species Observed | F<br>Observations/Notes |
|---|---|---|---|---|---|
| 1 | 25 | ~19 | 0 mortality | Exidua Coyote | evidence of elk/deer |

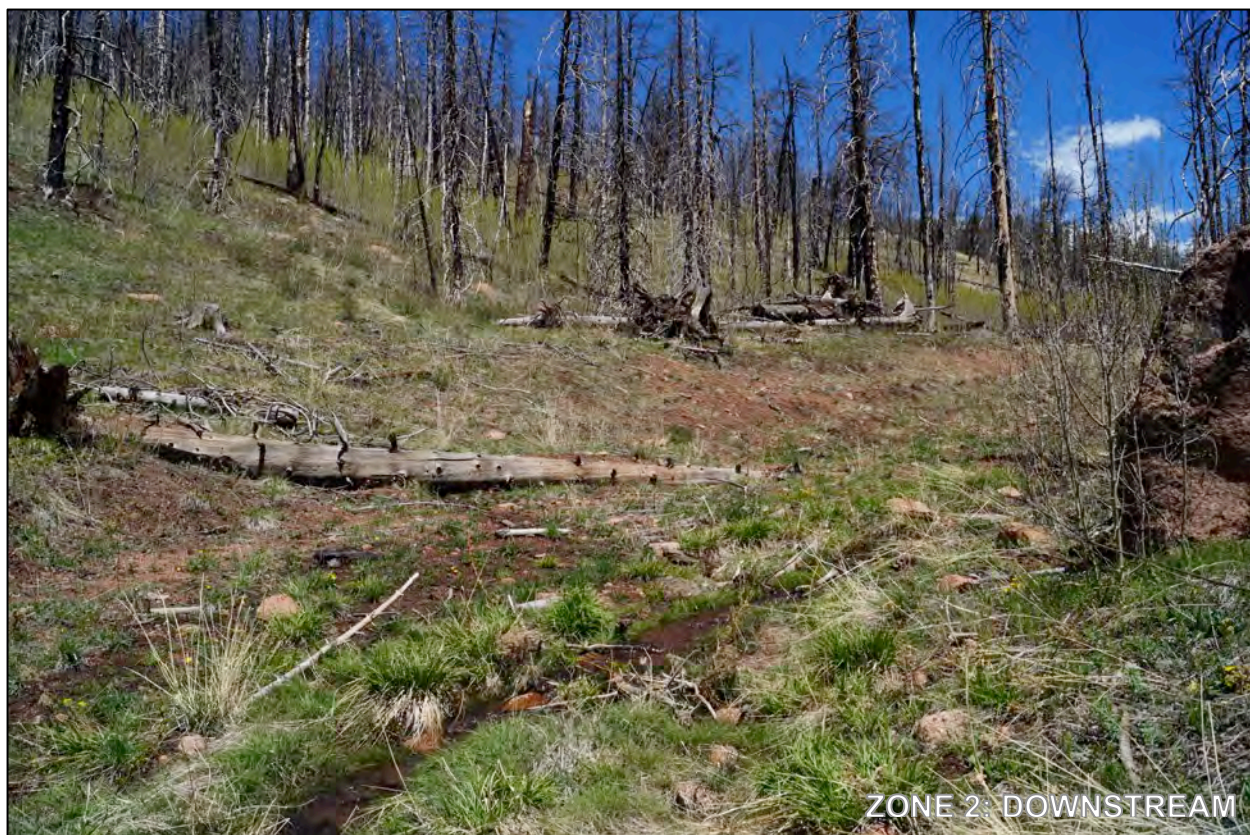
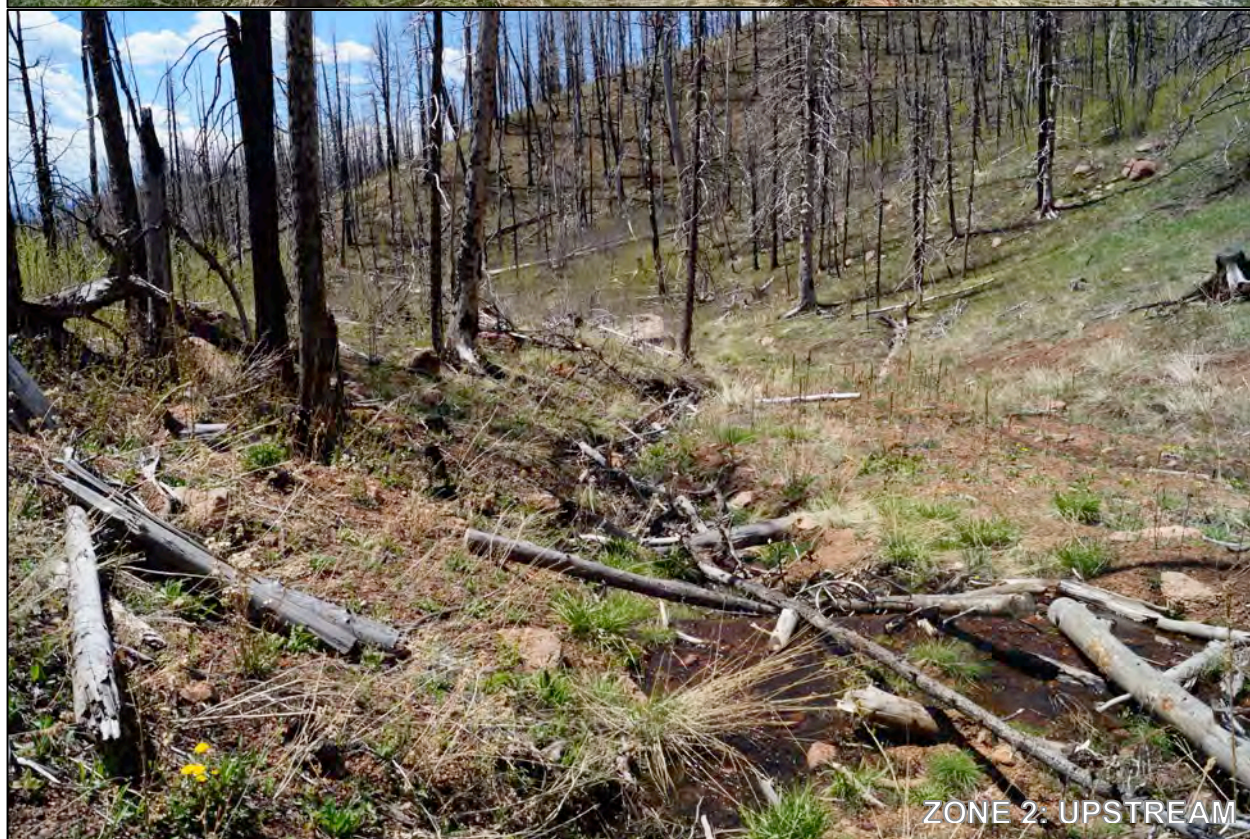
Figure 15. Photos of Zone 2 looking downstream and upstream. Photos taken on May 25, 2017.

| A<br>Reach/Zone # | B<br># Willows Planted | C<br># Surviving<br>Willows Counted<br># counted | D<br>% Estimated<br>Survival Rate<br>(B/C) | E<br>Willow Species Observed | F<br>Observations/Notes |
|---|---|---|---|---|---|
| 2 | 125 | counted 55 | observed | Exidua | mummt of debris |

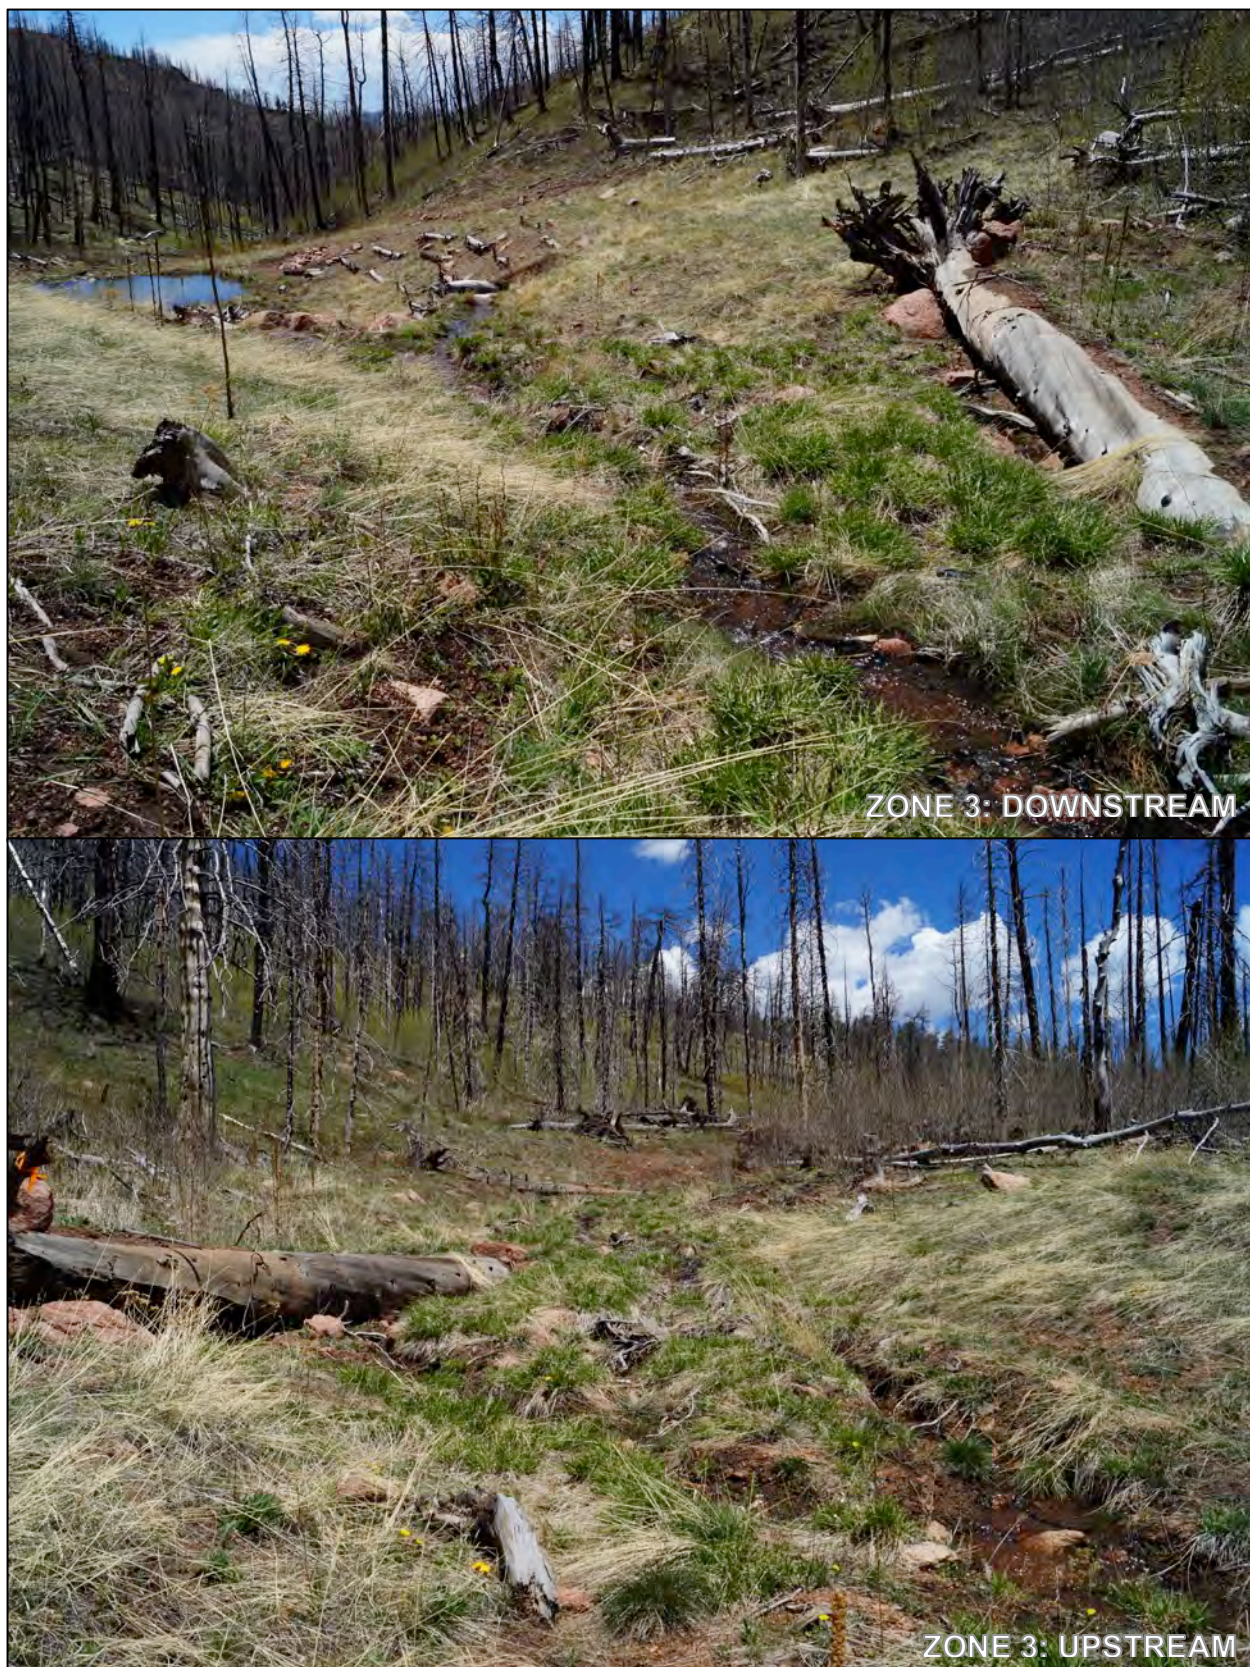
Figure 16. Photos of Zone 3 looking downstream and upstream. Photos taken on May 25, 2017.

| A<br>Reach/Zone # | B<br># Willows Planted | C<br># Surviving<br>Willows Counted<br># counted | D<br>% Estimated<br>Survival Rate<br>(B/C) | E<br>Willow Species Observed | F<br>Observations/Notes |
|---|---|---|---|---|---|
| 3 | 100 | 40 | | Exidua | Hard to see/count |

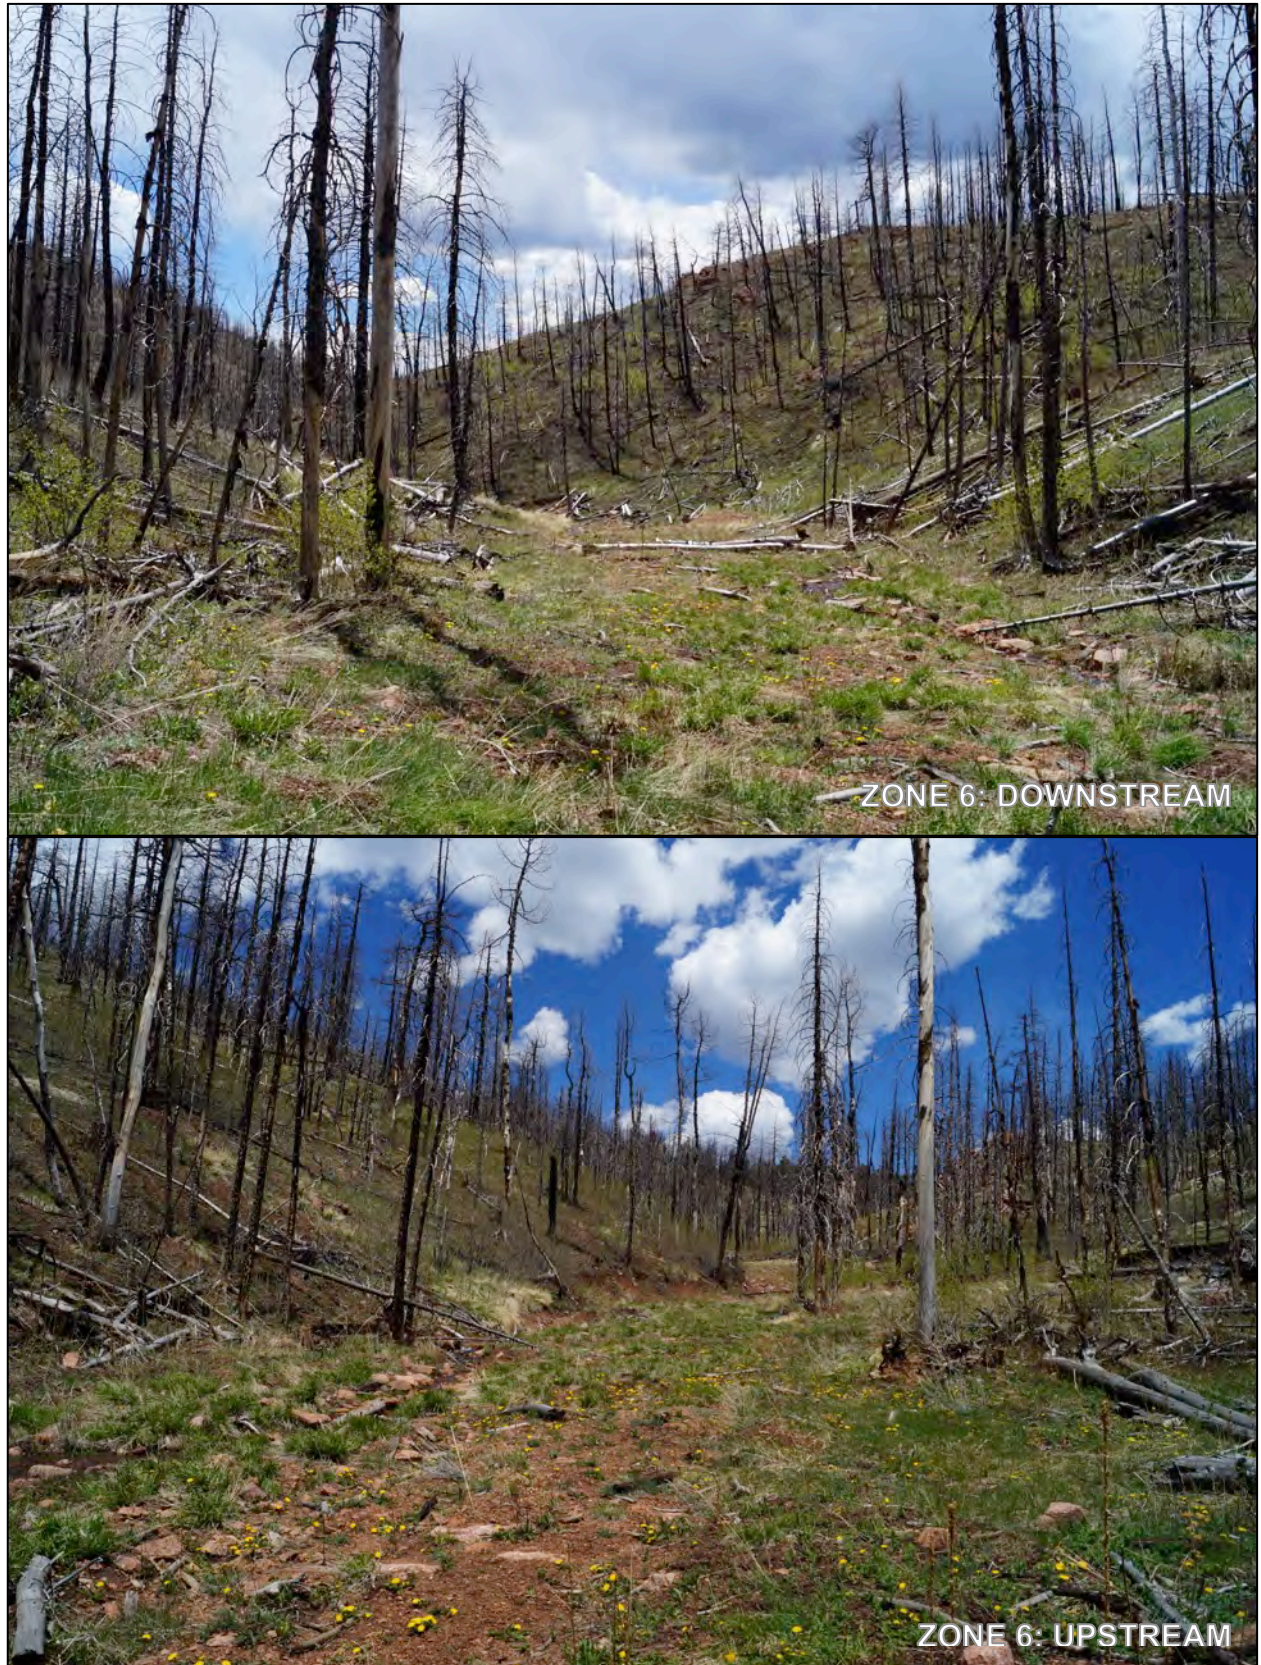
Figure 19. Photos of Zone 6 looking downstream and upstream. Photos taken on May 25, 2017.

| A<br>Reach/Zone # | B<br># Willows Planted | C<br># Surviving<br>Willows Counted<br># counted | D<br>% Estimated<br>Survival Rate<br>(B/C) | E<br>Willow Species Observed | F<br>Observations/Notes |
|---|---|---|---|---|---|
| 6 | 100 | 40 | | bebbiana | braided channel becomes<br>more substantial |

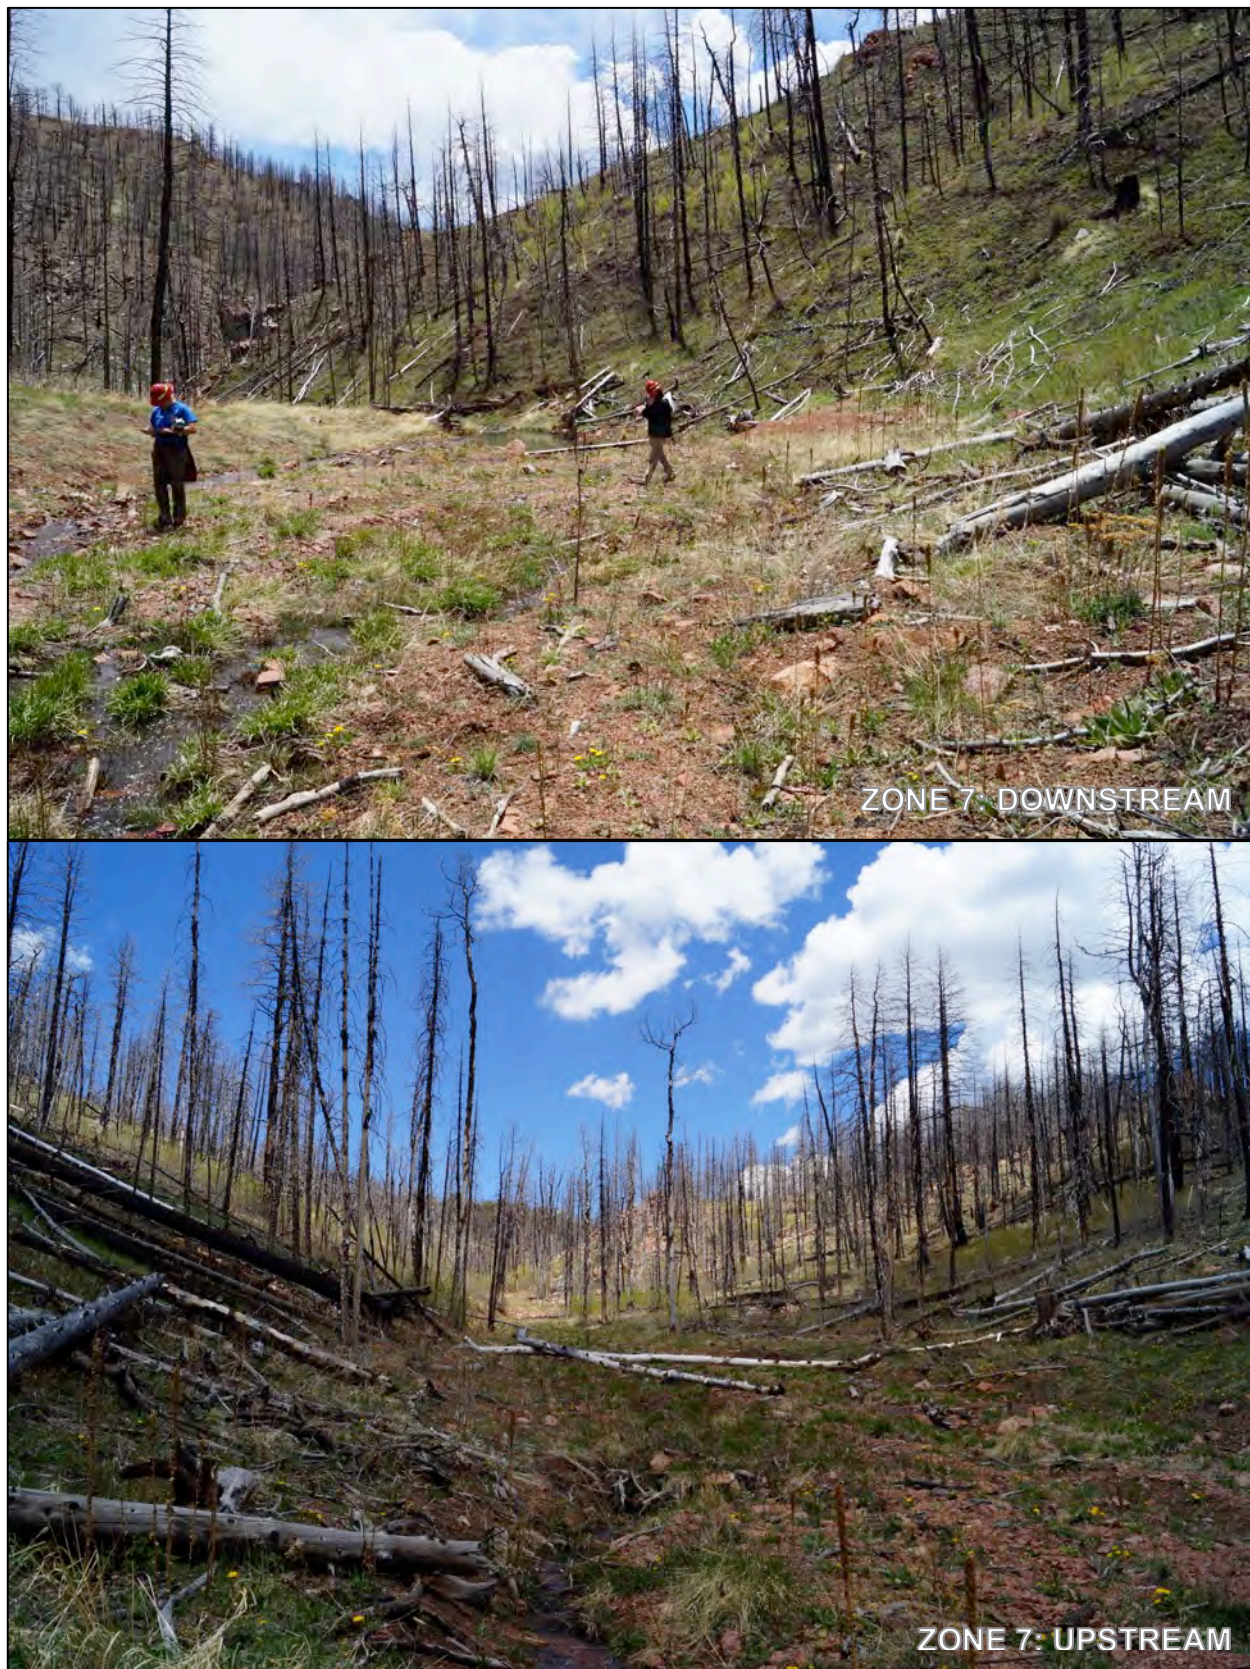
Figure 20. Photos of Zone 7 looking downstream and upstream. Photos taken on May 25, 2017.

| A<br>Reach/Zone # | B<br># Willows Planted | C<br># Surviving<br>Willows Counted<br># counted | D<br>% Estimated<br>Survival Rate<br>(B/C) | E<br>Willow Species Observed | F<br>Observations/Notes |
|---|---|---|---|---|---|
| 7 | 75 | 30 | | Exidua | around 6 & 7 → more water |

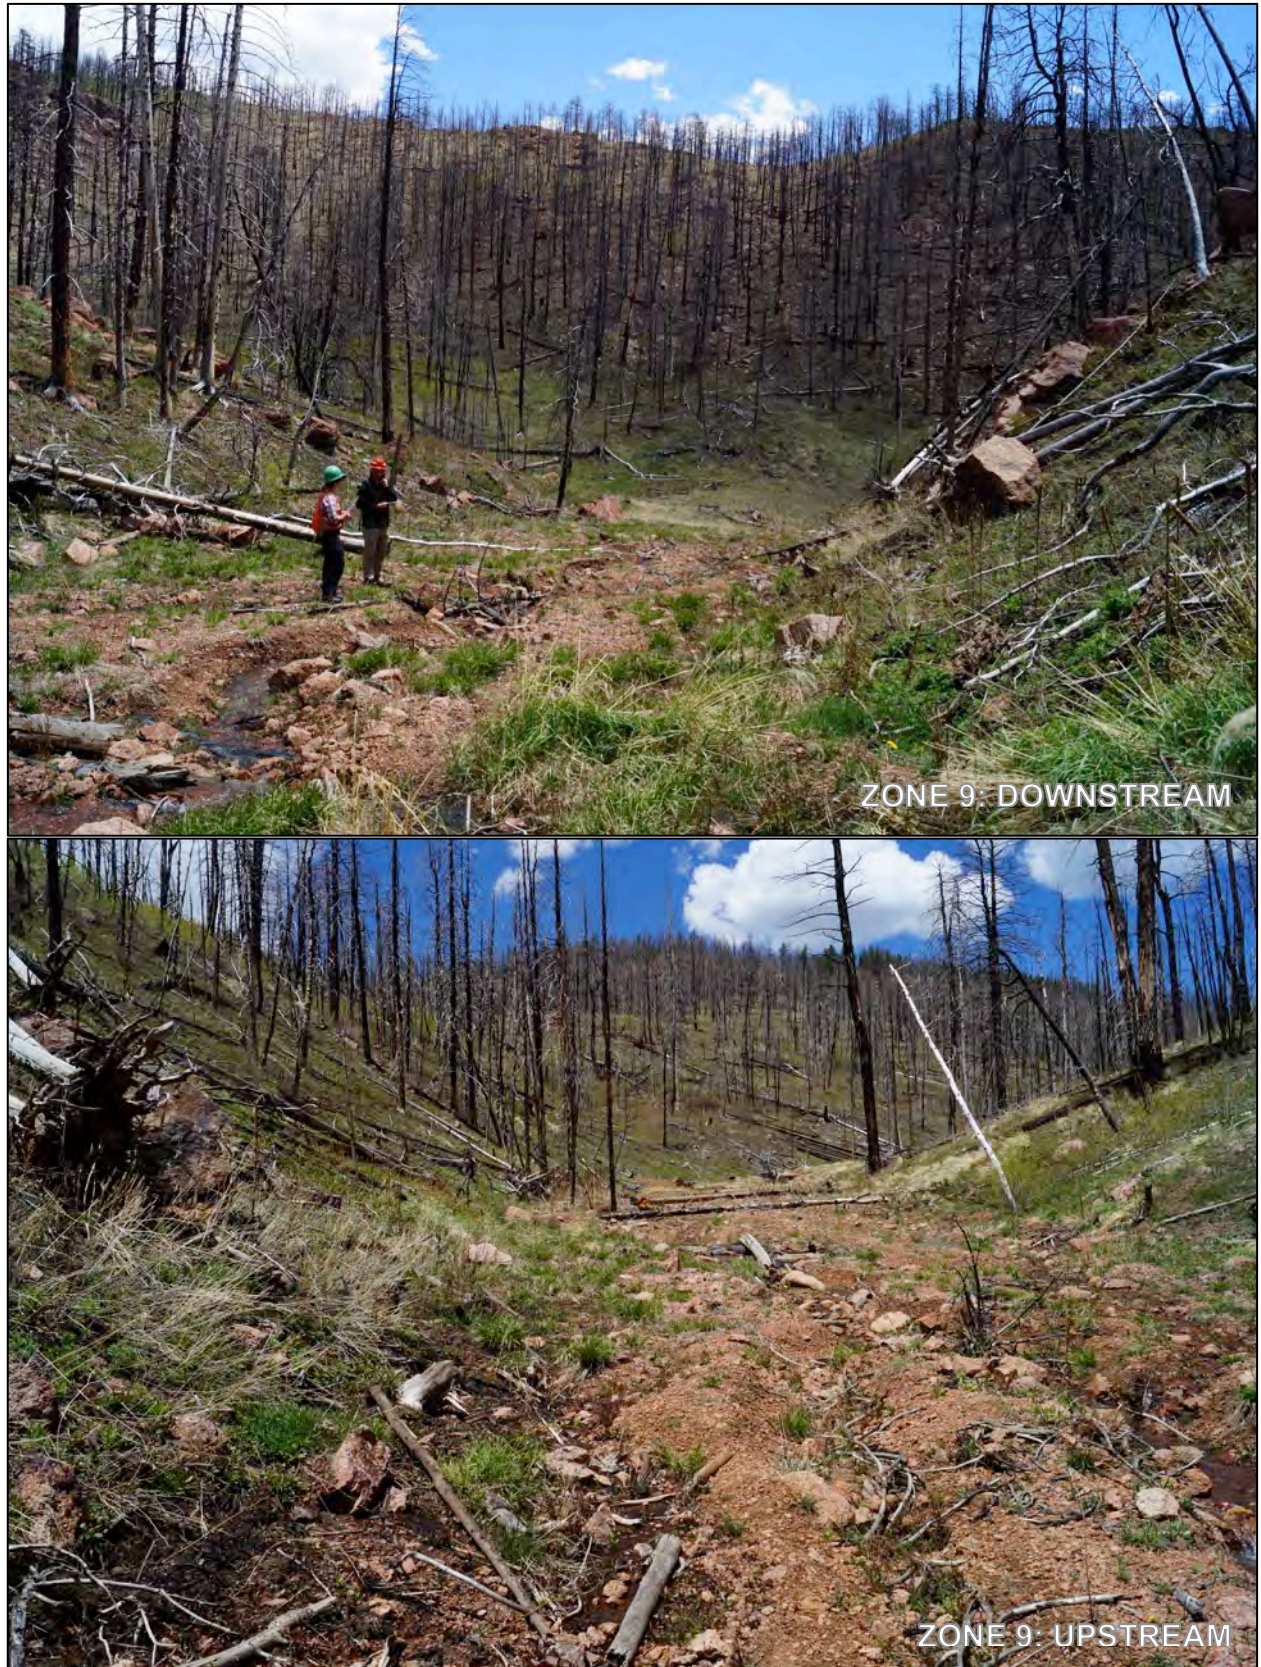
Figure 22. Photos of Zone 9 looking downstream and upstream. Photos taken on May 25, 2017.

| A<br>Reach/Zone # | B<br># Willows Planted | C<br># Surviving<br>Willows Counted<br># counted | D<br>% Estimated<br>Survival Rate<br>(B/C) | E<br>Willow Species Observed | F<br>Observations/Notes |
|---|---|---|---|---|---|
| 9 | 150 | 45 | | Exidua | Strong growth |
