Rocky Mountain Field Institute

Enhancing Resiliency in Critical Riparian Areas through Continuation of Willow Propagation Program – Final Report

Grant Number: POGG1 PDAA 201800000718

September 6, 2019

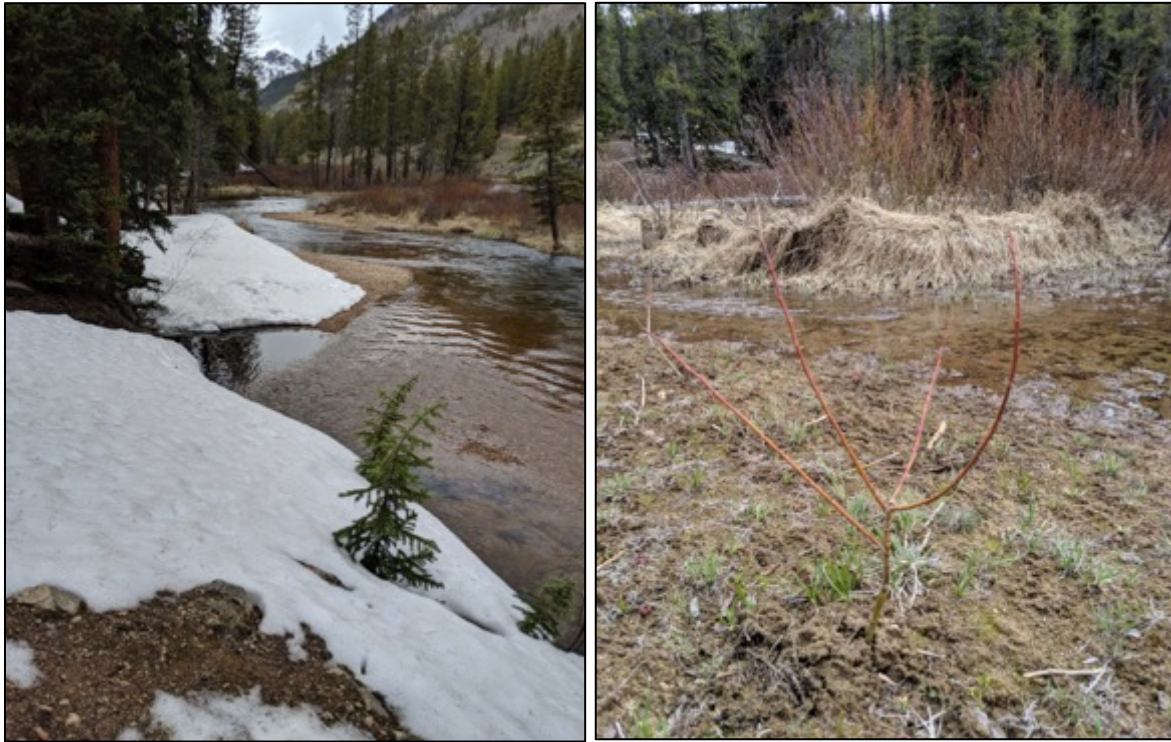
The estimated survival rate at Halfmoon Creek is 70% (Figure 3, page 8). The 600 willows were planted along Halfmoon Creek where recreation sites had encroached stream banks and badly impaired existing vegetation. These sites were first decommissioned by the Leadville Ranger District staff before planting willows. Decommissioning techniques included de-compacting soil, fencing, boulder placement, and signing.

The willows were not expanding and producing additional limbs and leaves at the time of the monitoring visit, likely due to the late and heavy snowpack, however ample buds were observed. Roots appeared to

be anchored and expanding and surface water was observed at each site. There was no evidence of grazing. There were six planting sites within this one location, and one of the sites was believed to have been disturbed. This site had an estimated mortality rate of close to 50% and is believed to be due to human activity. The planting area is good habitat for willows, but the proximity to a high use camping area is believed to be the reason for high mortality. USFS personnel believe campers pulled the willows.

Figure 3: Halfmoon Creek. Estimated 70% survival rate. Late snowpack affected new growth.

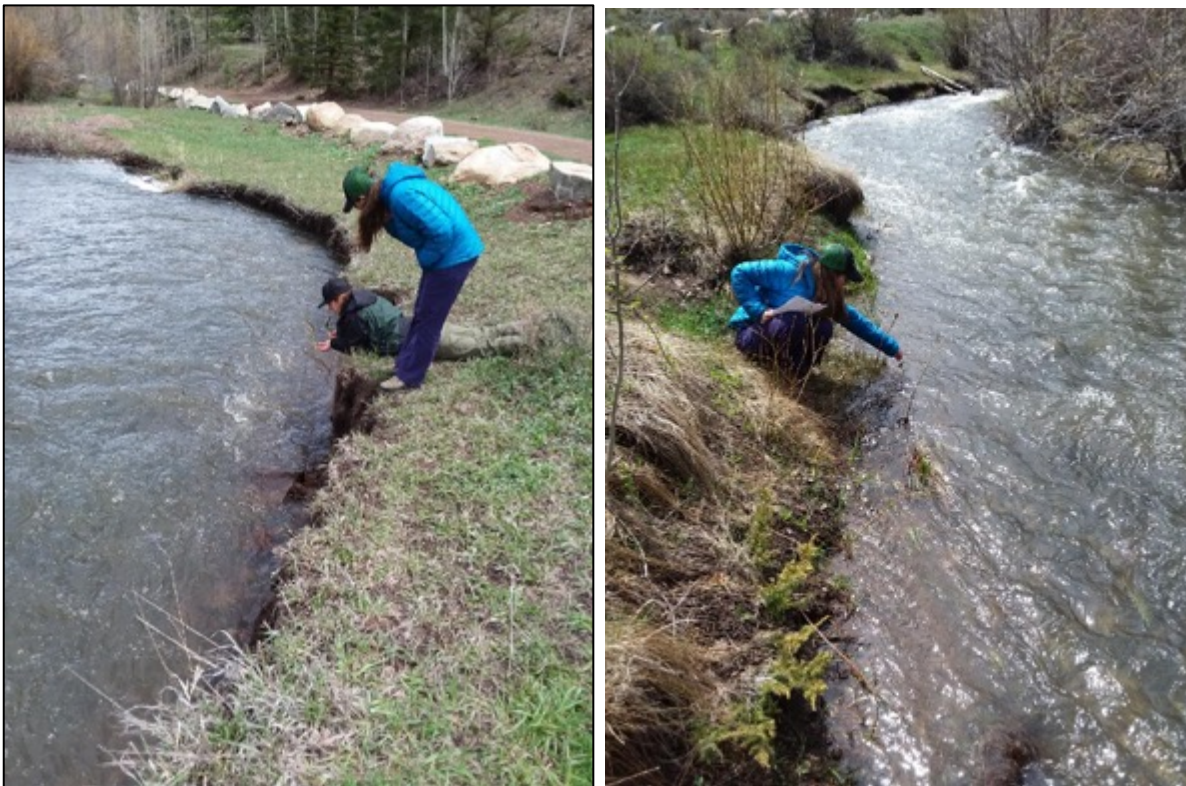
The estimated survival rate at Poncha Creek is 70% (Figure 4, page 8). The 1,015 willows were planted in several locations along Poncha Creek. These sites were similarly disturbed to those of Halfmoon. Forest Service engineers and Salida Ranger District staff decommissioned the sites before planting willows.

The willows were observed to be expanding and producing additional limbs and leaves. The roots were anchored and expanding, though a few did not take hold likely due to the deviating level of the water table. There was no evidence of grazing and surface water was observed at each site. A dispersed campsite may be causing streambank instability. Some willows may have washed away during large storm events, and boulders that were emplaced to protect the willows had been displaced.

Figure 4: Poncha Creek. Estimated 30% mortality from eroded streambanks due to recreational impacts.

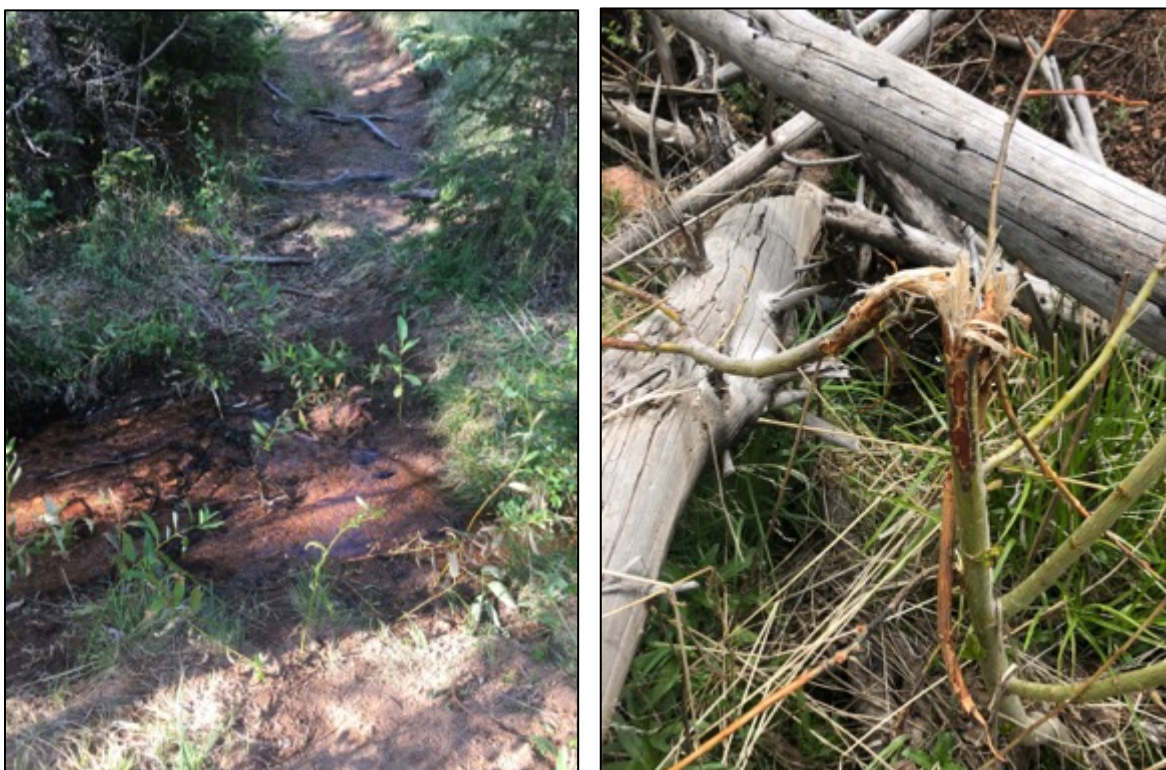
The estimated survival rate at Bear Creek is 90% (Figure 5, page 9). The 1,040 willows were planted at 7 sites within a 4-mile stretch of Bear Creek. The stream is habitat to the Bear Creek greenback cutthroat trout, Colorado's state fish. RMFI has worked with the USFS and other land management partners to improve the Bear Creek Watershed.

The willows were expanding and producing additional limbs and leaves, however due to the late winter the foliage was limited. The observed mortality is believed to have occurred during a late-season snowstorm that produced heavy snow. A small percentage of willows had broken stems where the plant

grows from the ground. In addition, some willows appeared to have been trampled by illegal hikers (the decommissioned trail is closed to recreation) and/or restoration crews.

Figure 5: Bear Creek. Estimated 90% survival rate. Evidence of new growth and browsing.

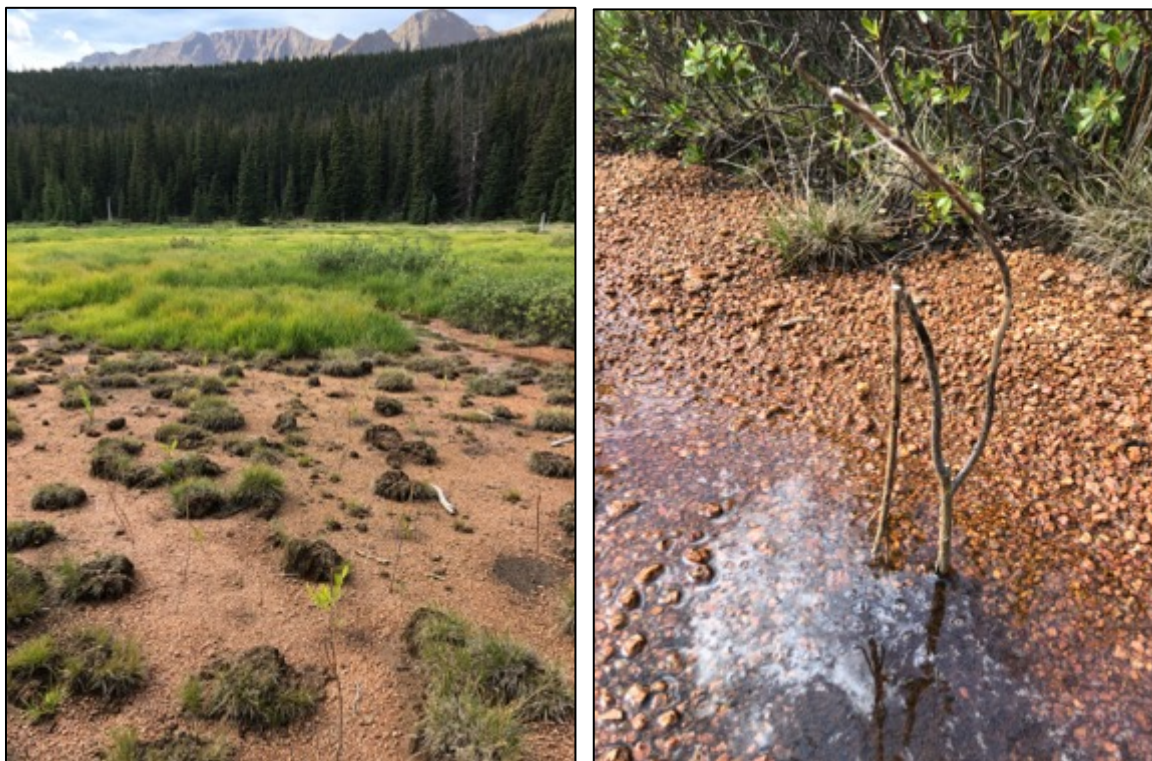
It is too soon to estimate the survival rate of the willows planted in Severy Creek Wetland (Figure 6, page 9). The 1,135 willows were planted in 2018 at an elevation of 10,970 feet. Severy is the location of 15 years of restoration completed by RMFI. The alpine fen was heavily impacted from sedimentation originating from the Pikes Peak Highway.

The willows were observed to have little new growth at the August monitoring visit. There appeared to be evidence of grazing, and the area is known habitat for elk and bighorn sheep. Approximately 50% of the willows had no additional limbs and leaves. The plants will likely produce new growth next season, however there is a high probability of browsing. There is great natural regeneration of willows in the area, however RMFI wanted to plant willows at this site to gauge their success as compared to willow stakes planted in 2015. Those stakes do not show signs of new growth but it is not believed to be due to browsing. RMFI will continue to monitor this location.

Figure 6: Severy Creek. Survival rate not available. Slow regrowth and evidence of browsing.

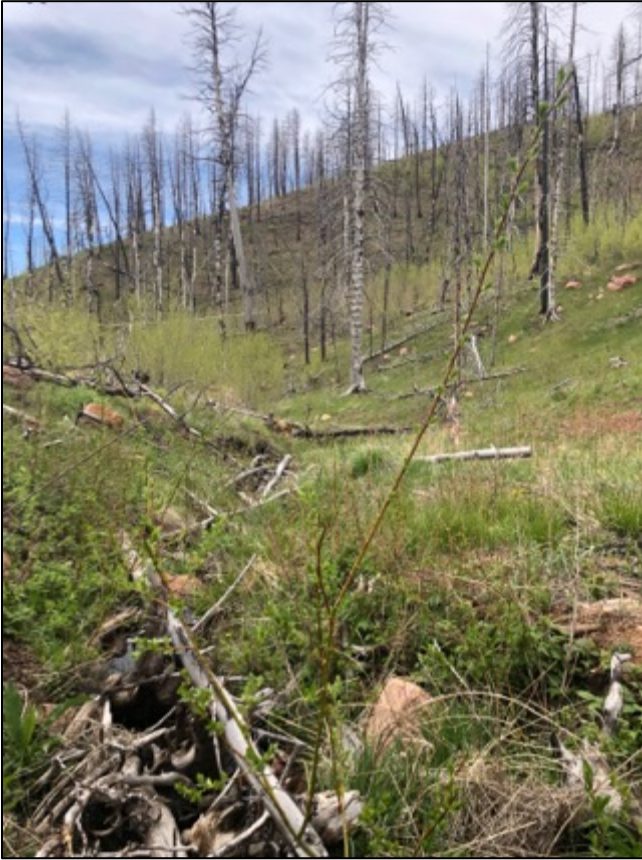
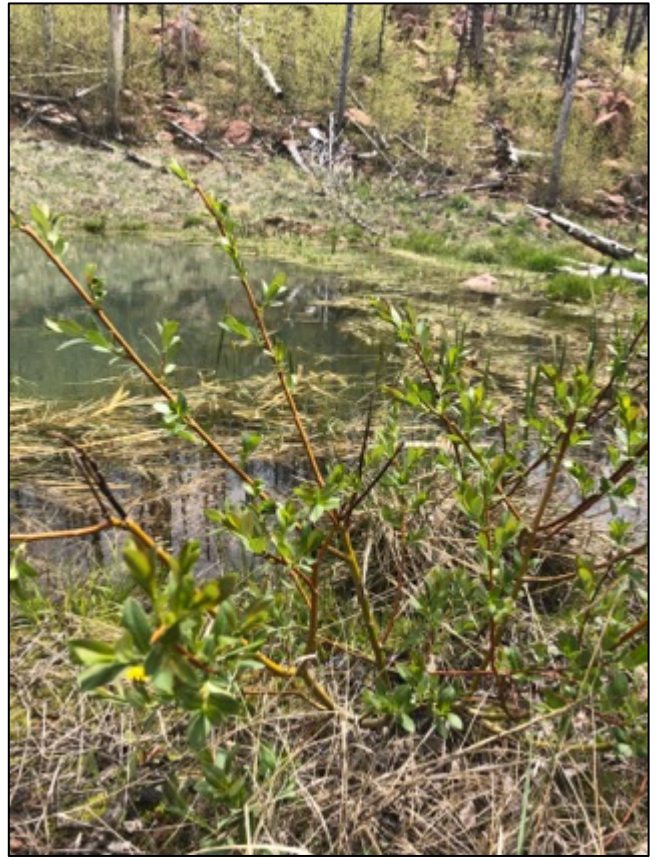
This is the location of the pilot willow planting in 2016, when 1,000 willows were planted. RMFI planted an additional 850 willows at this location in 2017. The survival rate is estimated to be 75%. There was evidence of browsing, particularly at the planting sites located around the detention ponds that hold water. There was evidence of new growth, however it was limited due to the late winter. The willows have aided in stabilizing this drainage which was severely burned during the Waldo Canyon Fire in 2012. The success of this site and Lower Waldo Canyon has led to the expansion of the program to other disturbed riparian areas.

Figure 7: Camp Creek. Estimated 75% survival rate 3 years after planting.

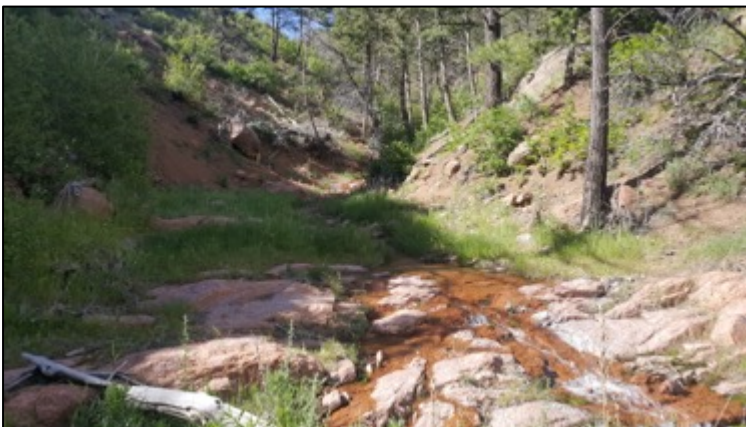
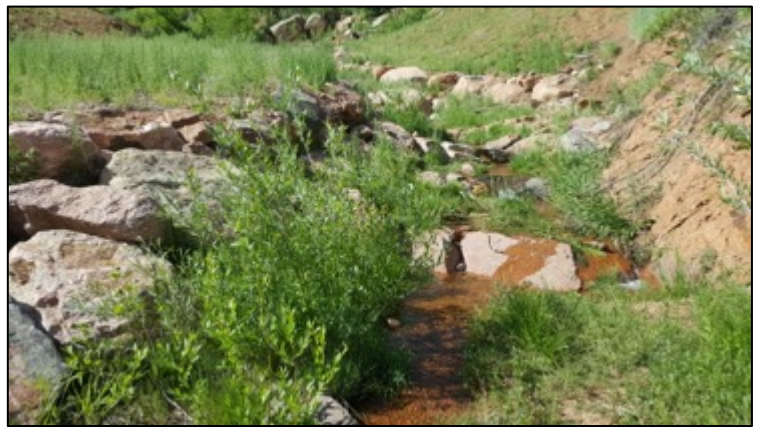
This Waldo Canyon site was visited more than two years after planting. At the time of planting, the drainage was divided into 11 sections over approximately 1,321 ft. to facilitate future monitoring efforts measuring willow survivability. During the June site visit, approximately 1,458 willows were counted, a survival rate of approximately 73%. Storm events in 2017 are believed to have uprooted many willows, and a drought in 2018 caused additional mortality. There was no new mortality observed in the 2019 monitoring visit. Natural recruitment was observed at many of the sites.

Figure 8: Waldo Canyon. Estimated 73% survival rate 2 years after planting.
