Upper Culebra Watershed Assessment Report

In Progress Draft

Prepared for Costilla County Conservancy District

Tailwater Limited

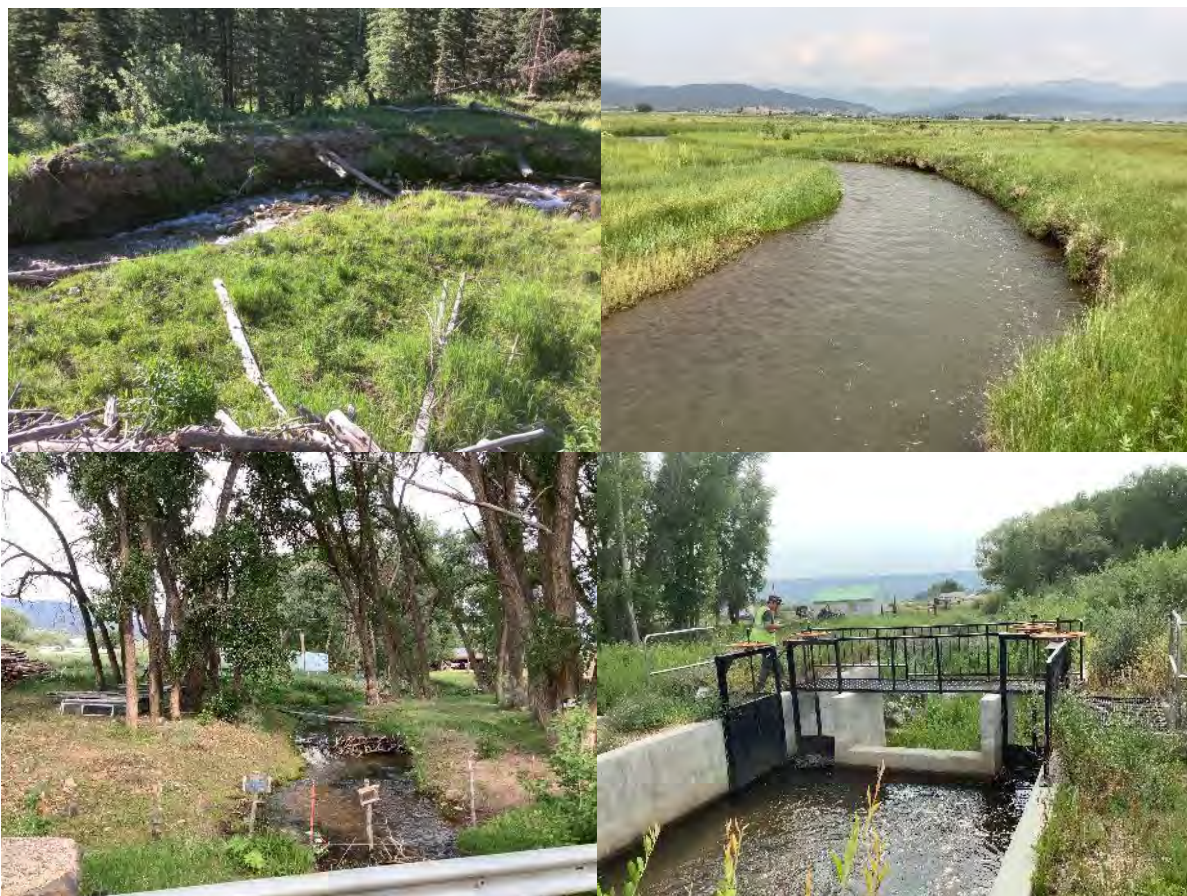
Figure 2-16. Examples of degraded riparian areas throughout UCWA. Clockwise starting at top left: heavily incised banks, no structural diversity and incised banks, headgate at the confluence of Vallejos and Culebra Creeks, and floodplain intrusions in the form of homes and roadways.

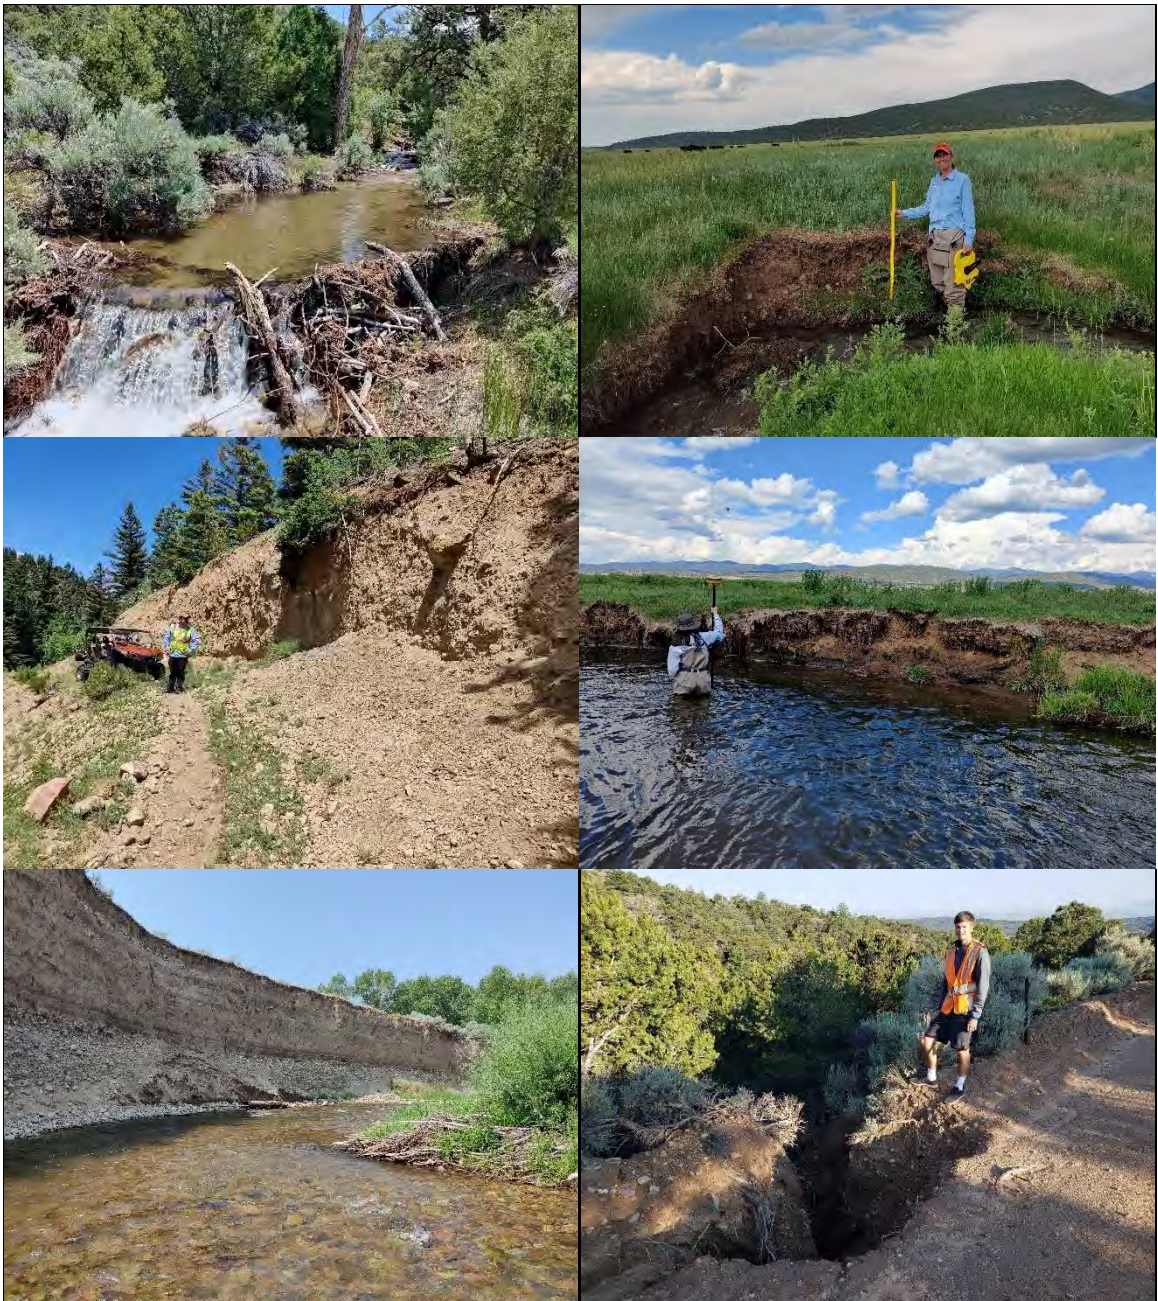
Figure 4-9 Top left sediment filling in behind obstruction on Willow Creek. Top right cutbank erosion from banks entering Jaroso Creek. Middle left erosion along roadside going up San Francisco Creek drainage contributing excess sediment to the stream. Middle right bank erosion on Culebra Creek in La Vega. Bottom left cutbank eating into terrace on Culebra Creek above Sanchez Diversion. Bottom right gully/headcut forming in Sangre de Cristo Ranches.

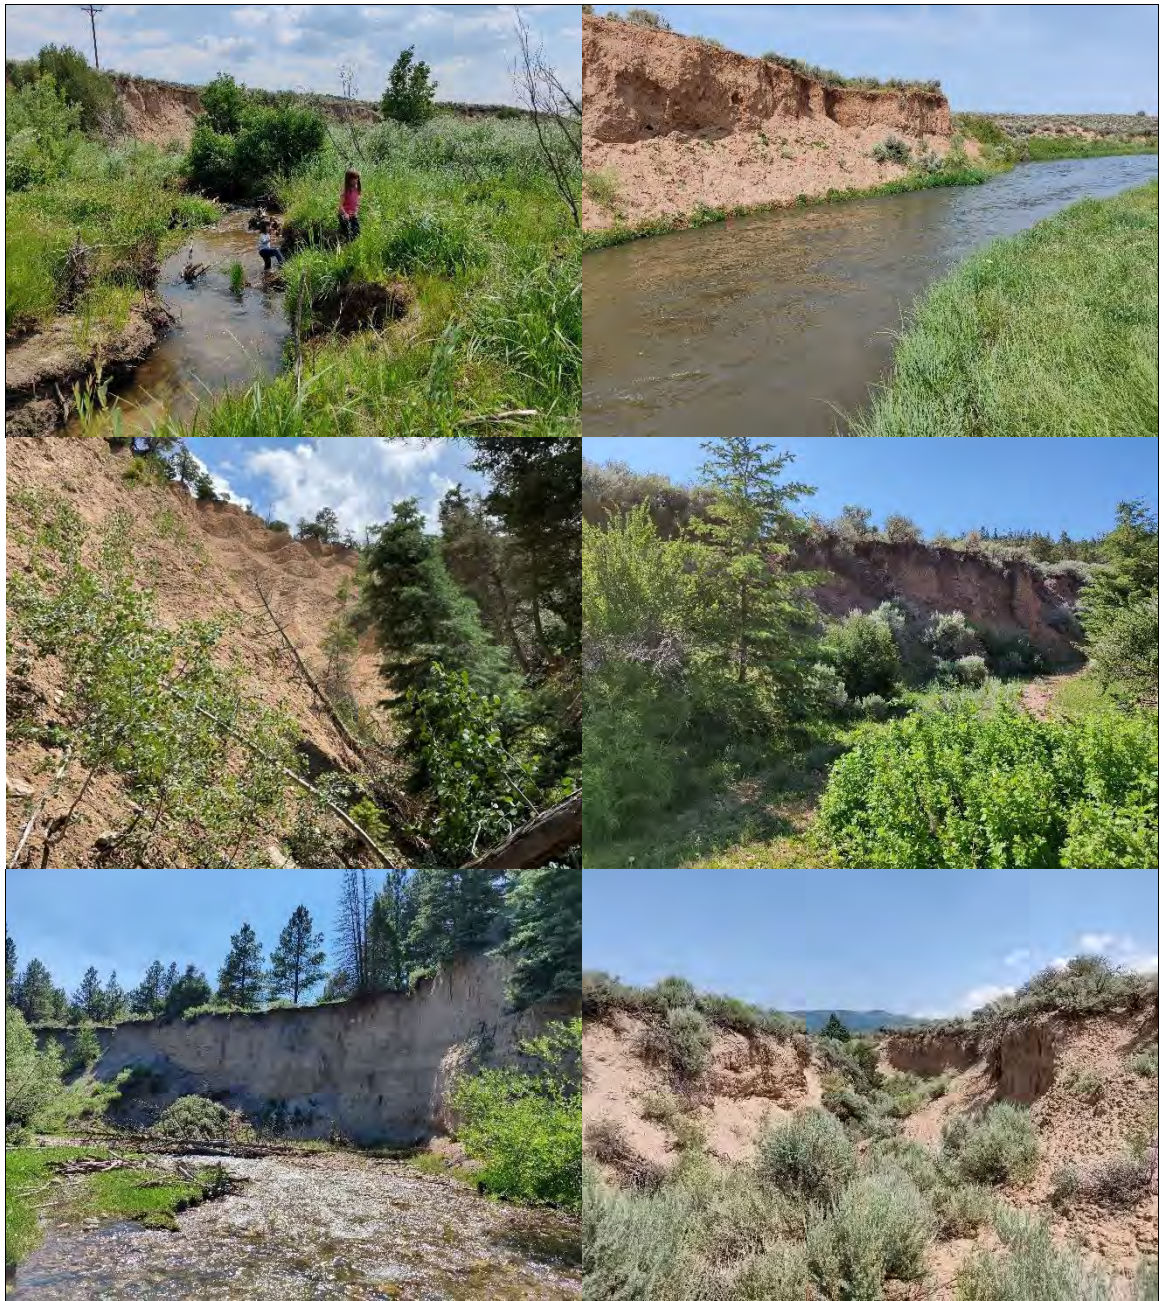
Figure 4-10 Top left Rito Seco incision. Top right channel cutting into a high terrace on Lower Culebra Creek. Middle Left mass wasting up the Vallejos drainage. Middle right El Poso is cutting into a high terrace. Bottom left El Poso cutting into a high terrace. Bottom right gully in the Vallejos drainage.

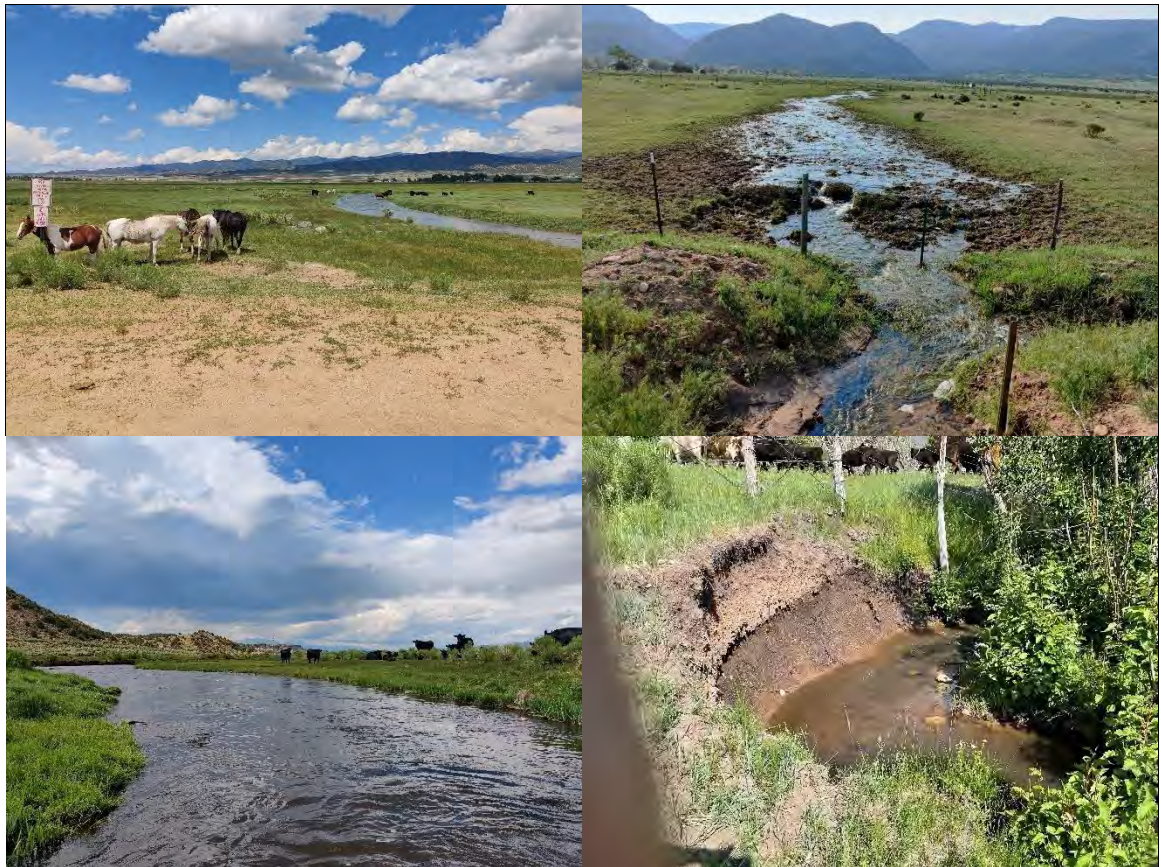
Figure 4-11 Top left horses in the foreground, cattle in the background Culebra Creek on La Vega note stream banks without woody riparian cover. Top right hoof shear along the stream channel. Bottom left cattle grazing next to Culebra Creek on La Vega. Bottom right cutbank on Jaroso Creek, notice fence and cattle in the background.

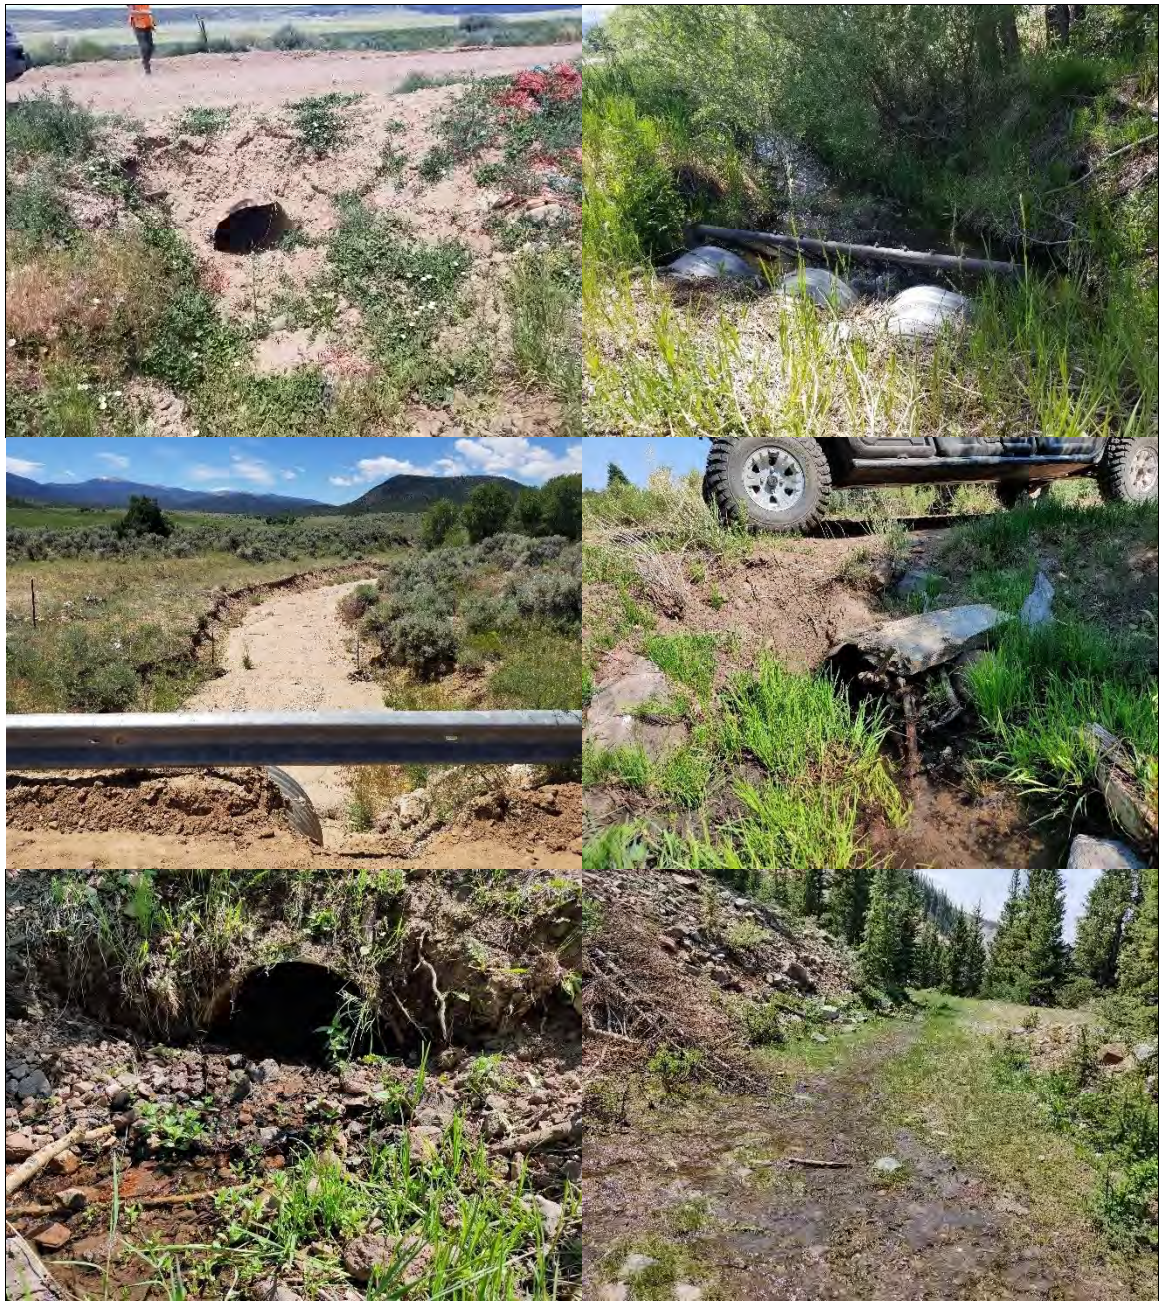
Figure 4-12 Top left: culvert filling with sediment below the road. Top right: three culverts convey water at the road crossing. Middle left: culvert at a road crossing, notice channel incision and cutbanks. Middle right: culvert at road crossing filling with sediment. Bottom left: culvert filling with sediment. Bottom right: water running off down the road.

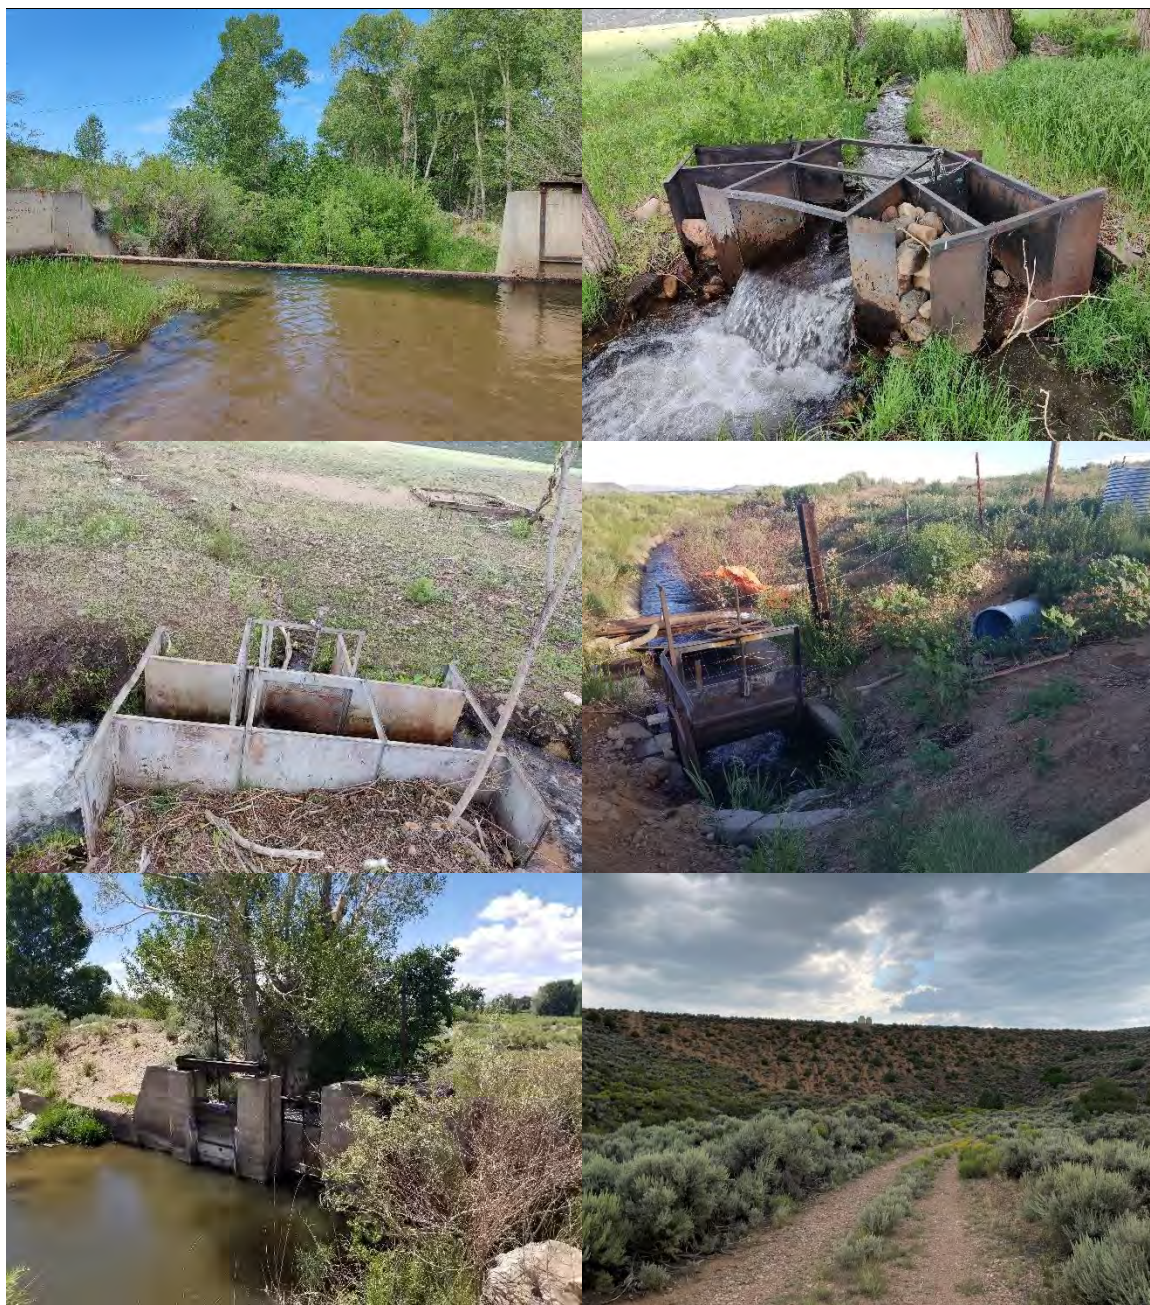
Figure 4-13 Top left: sediment filling in behind check structure at San Francisco Ditch headgate, notice elevation difference between top of the structure and downstream of it. Top right: splitter box to split flows. Middle left: splitter box. Middle right: culvert and headgate. Bottom left: headgate for Culebra Cerritos, Island Ditch, and Francisco Sanchez. Bottom right: the Sanchez Dam.

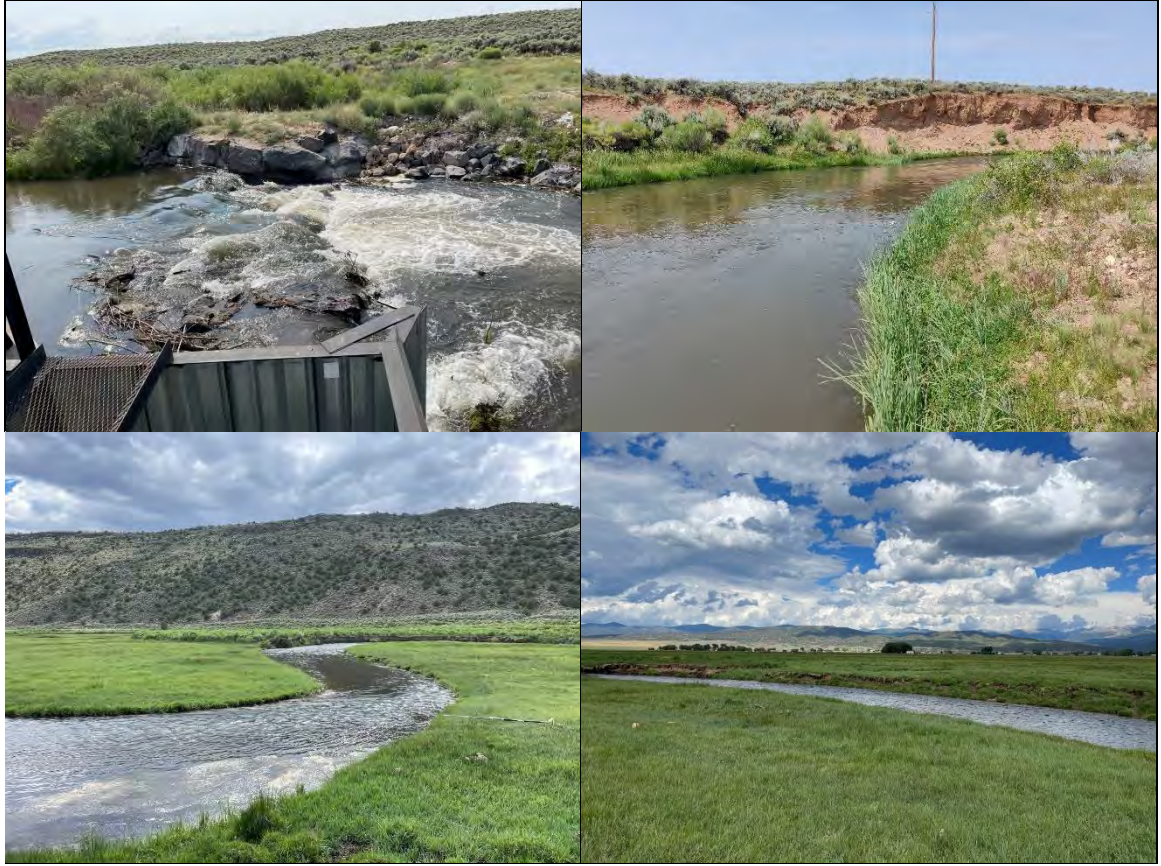
4.3.1.1 Lower Culebra Creek (Reaches 25, 27, 28, 29, and 30)

Figure 4-16 Top Left Culebra Creek (30) notice use of riprap for bank stabilization. Top Right Culebra Creek (29) notice bank erosion in background. Bottom Left Culebra Creek (27) notice vertical bank in the background. Bottom Right Culebra Creek (27) notice channel is slightly entrenched with bank erosion.

Overall review of Culebra Creek in the lower basin found potential issues with the channels pattern. The stream is channelized (Figure 4-18) and slightly entrenched in sections. Inspection of radius of curvature in aerial photographs throughout the stream was found to be both too small and too large to be sustainable throughout the reach. The meander bends with tighter radii are more likely to avulse over time. Meander bends that are too large are an indication of straightening which can result in accelerated bed and bank erosion, increased stream velocities, and decreased aquatic habitat.

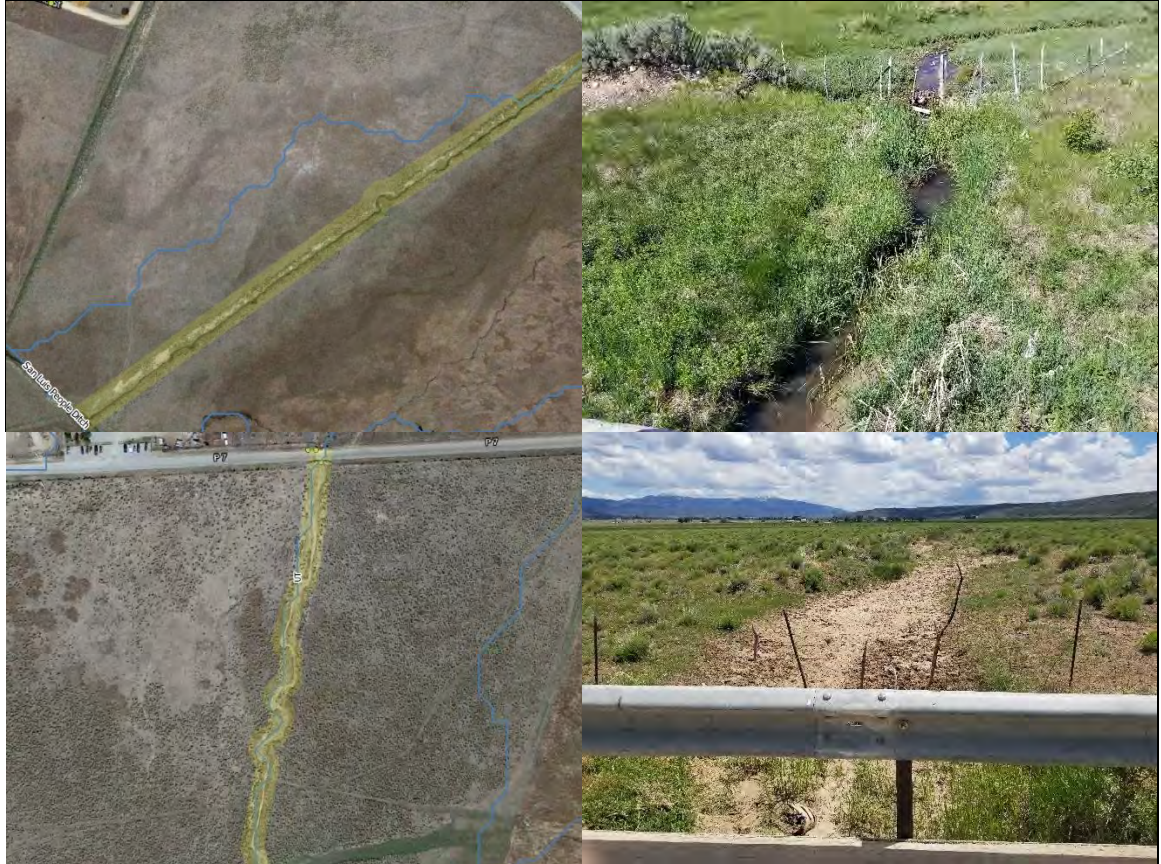
Figure 4-55 Top Left aerial view Return flow channel, Cerro Ditch and Rito Seco historic alluvial channel (26), notice channel pattern and signs of deposition on floodplain. Top right Unknown (26) view from the road, notice channel incision. Bottom Left aerial view of Rito Seco historic alluvial channel (24) notice channel pattern and aggradation. Bottom Right (reach 24) aggradation in channel apparent from the road.

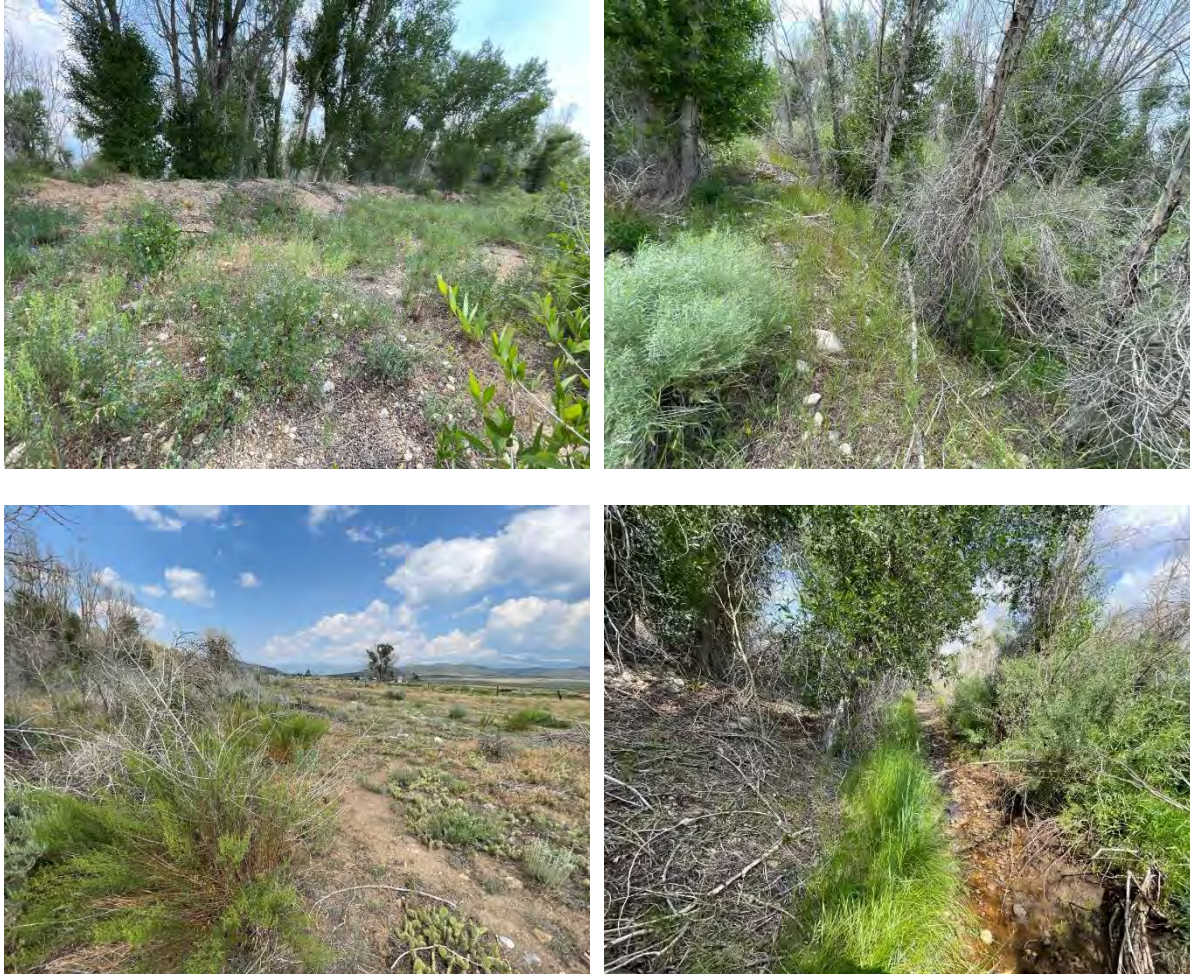
Figure 6-194 Levees block view of Culebra Creek channel (upper left) vegetation growth reduces conveyance within levees (upper right), floodplain converted to upland vegetation communities (lower left), and small Culebra Creek channel (lower right).

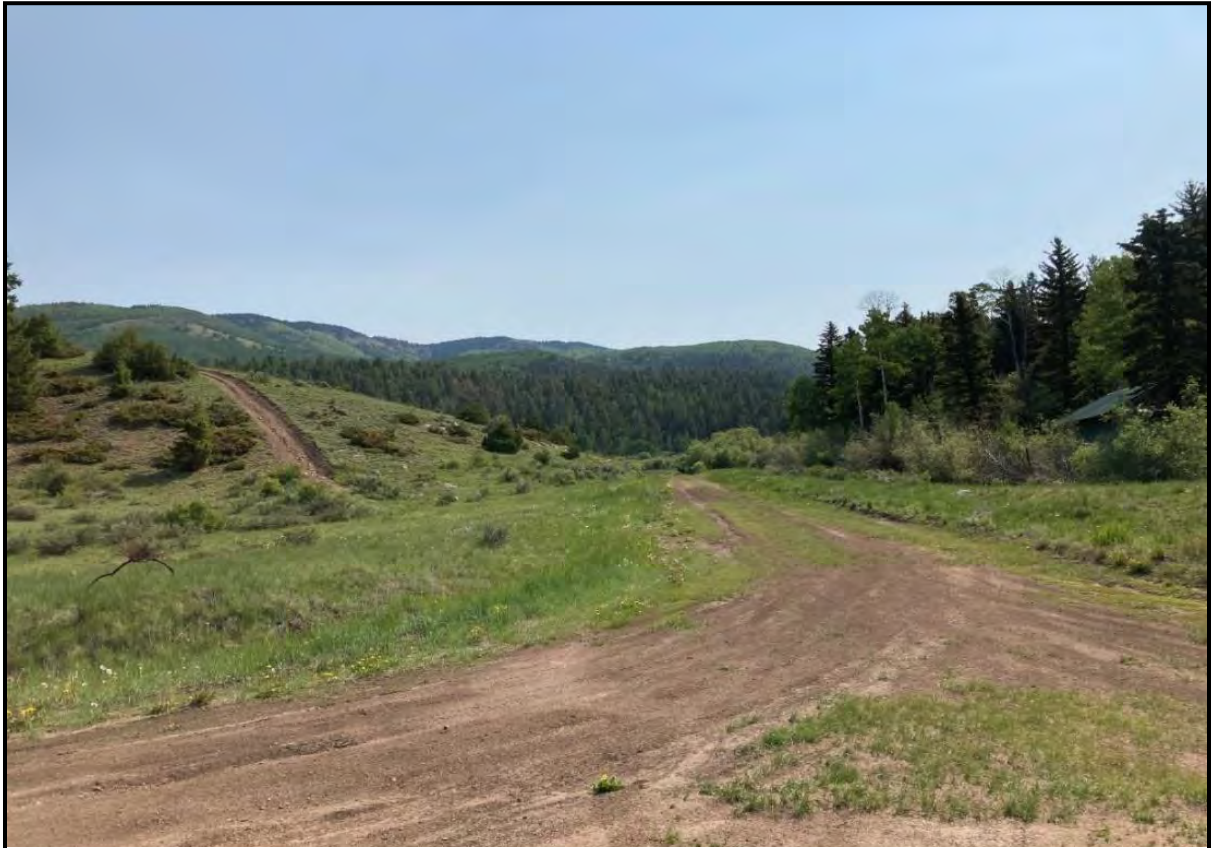
Figure 11-21 Example of poor road grade and surface conditions that would slow evacuation and ingress by emergency vehicles.
