COLORADO DIVISION OF RECLAMATION, MINING AND SAFETY MINERALS PROGRAM INSPECTION REPORT PHONE: (303) 866-3567

MINE NAME:	MINE/PROSPECTING ID#:	MINERAL:	COUNTY:	
Bachelor Syracuse Mine (Khedive Portal)	M-1980-171	Silver and gold	Ouray	
INSPECTION TYPE:	INSPECTOR(S):	INSP. DATE:	INSP. TIME:	
Monitoring	Wallace H. Erickson	September 20, 2013	15:00	
OPERATOR:	OPERATOR REPRESENTATIVE:	TYPE OF OPERATION:		
Bachelor Silver Mines Company	None present	110(2) - Hard Rock Limited Impact		
REASON FOR INSPECTION:	BOND CALCULATION TYPE:	BOND AMOUNT:		
Normal I&E Program	Partial Bond	\$6,536.00		
DATE OF COMPLAINT:	POST INSP. CONTACTS:	JOINT INSP. AGENCY	:	
NA	None	None		
WEATHER:	INSPECTOR'S SIGNATURE:	SIGNATURE DATE:		
Cloudy	Welland J. El	September 23, 2013

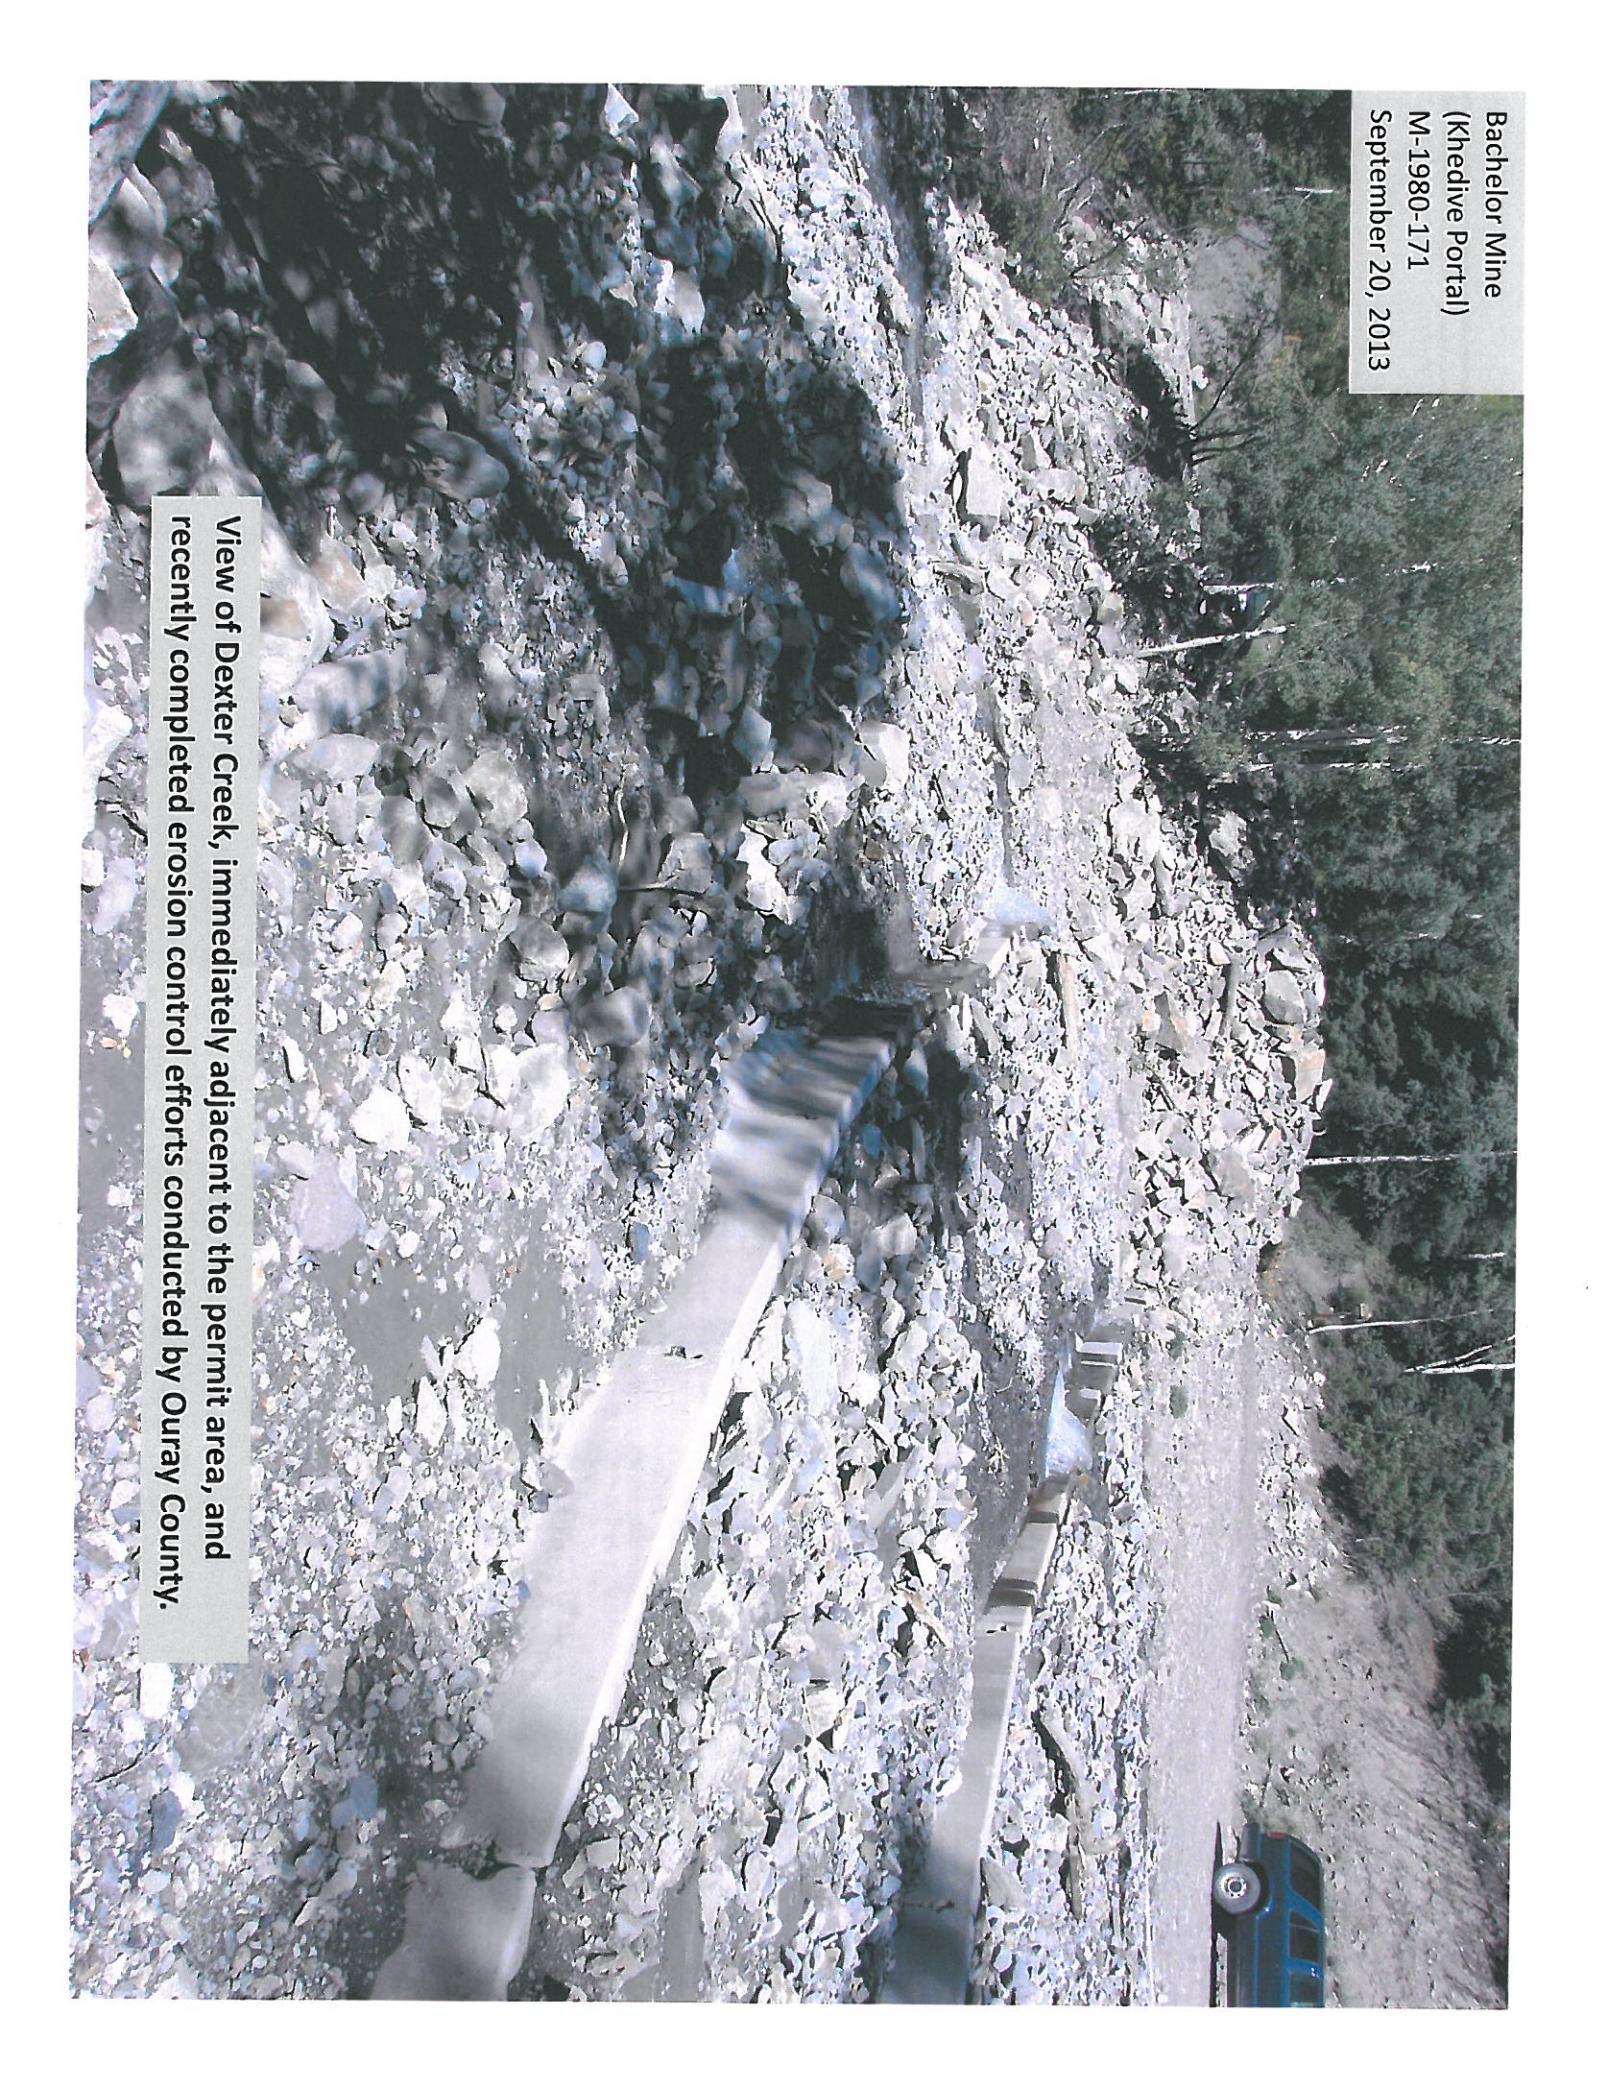
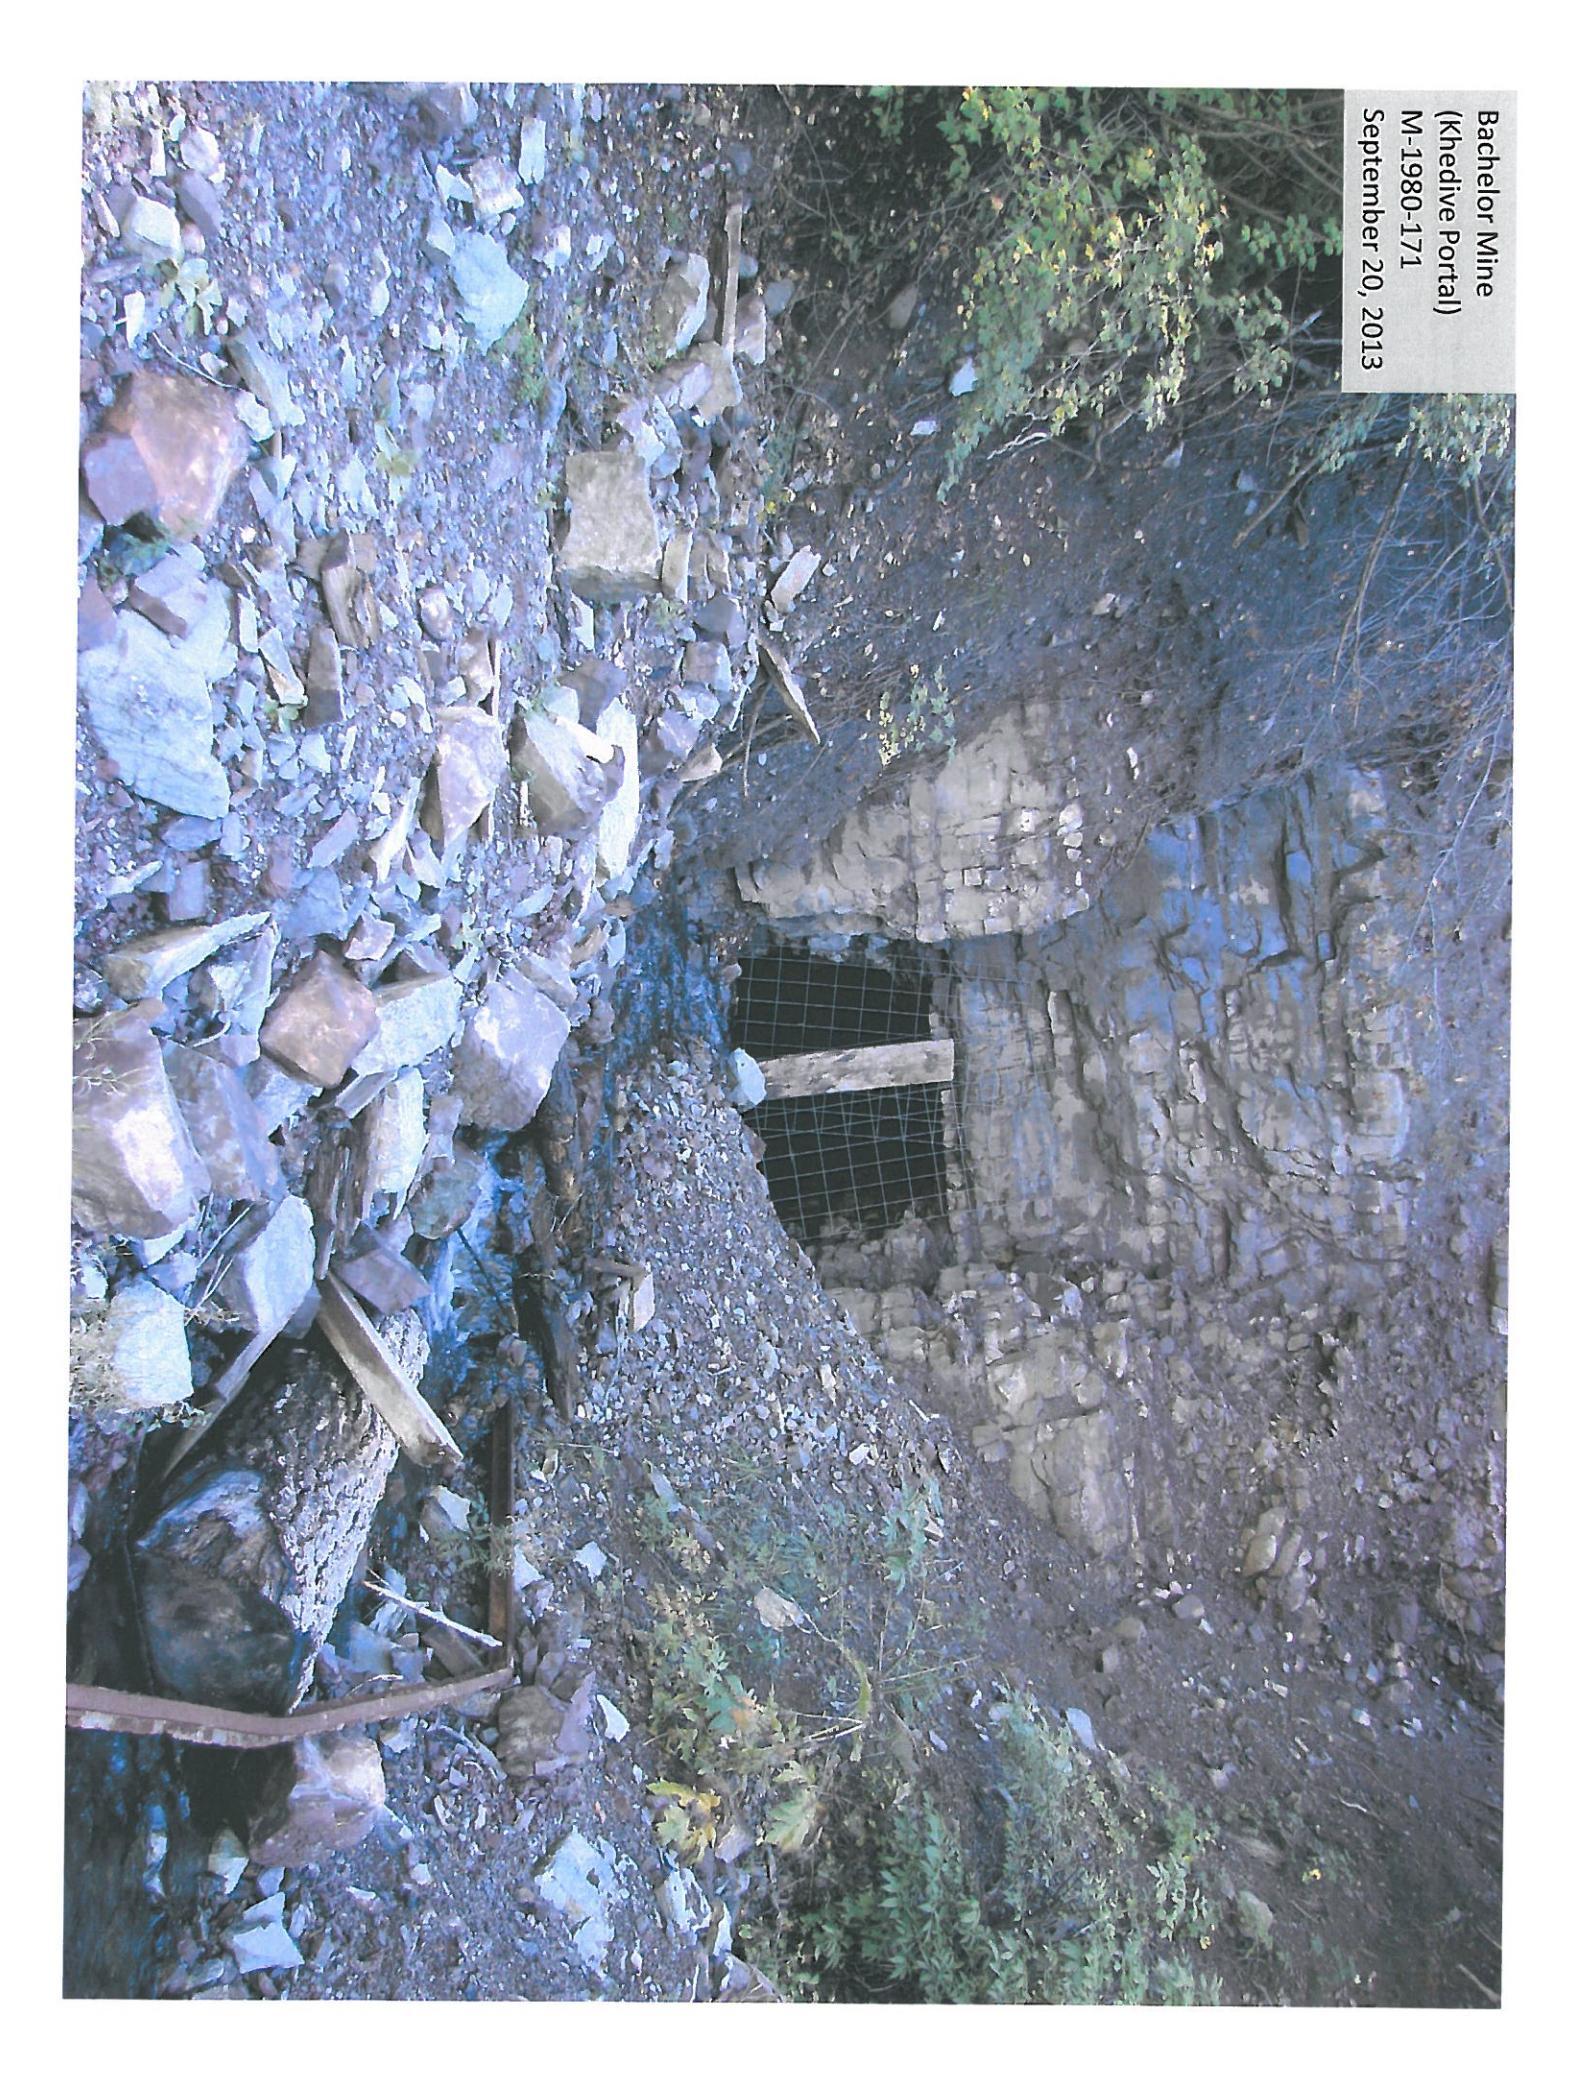
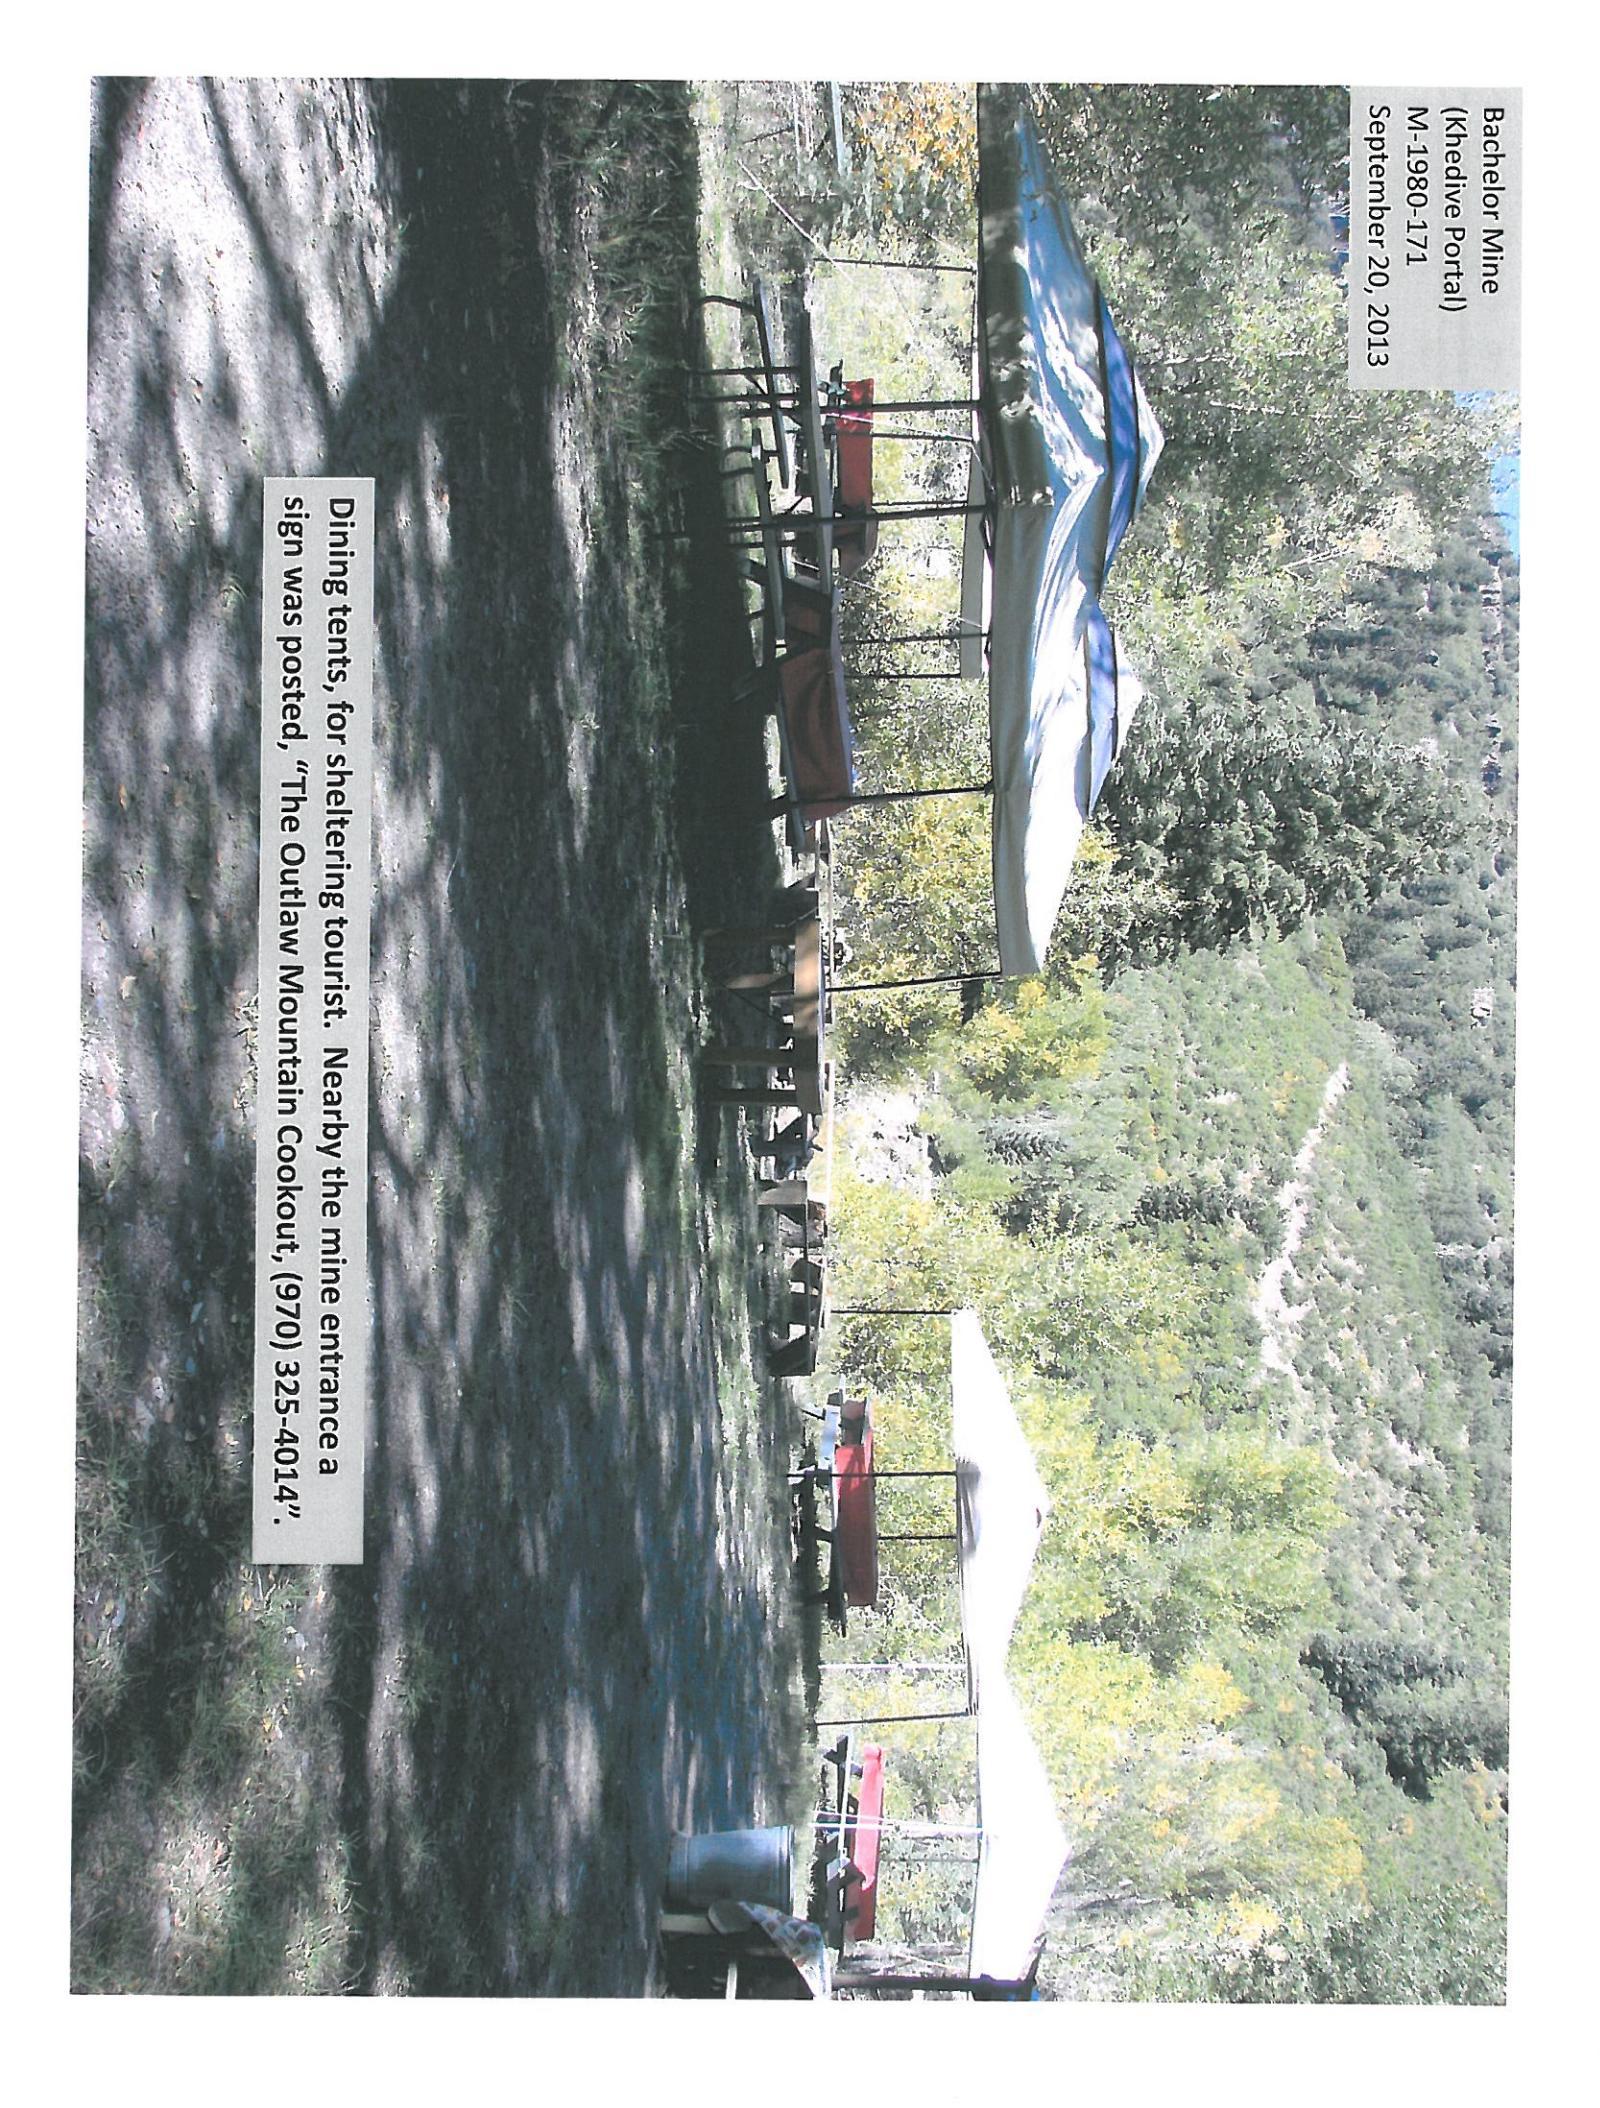
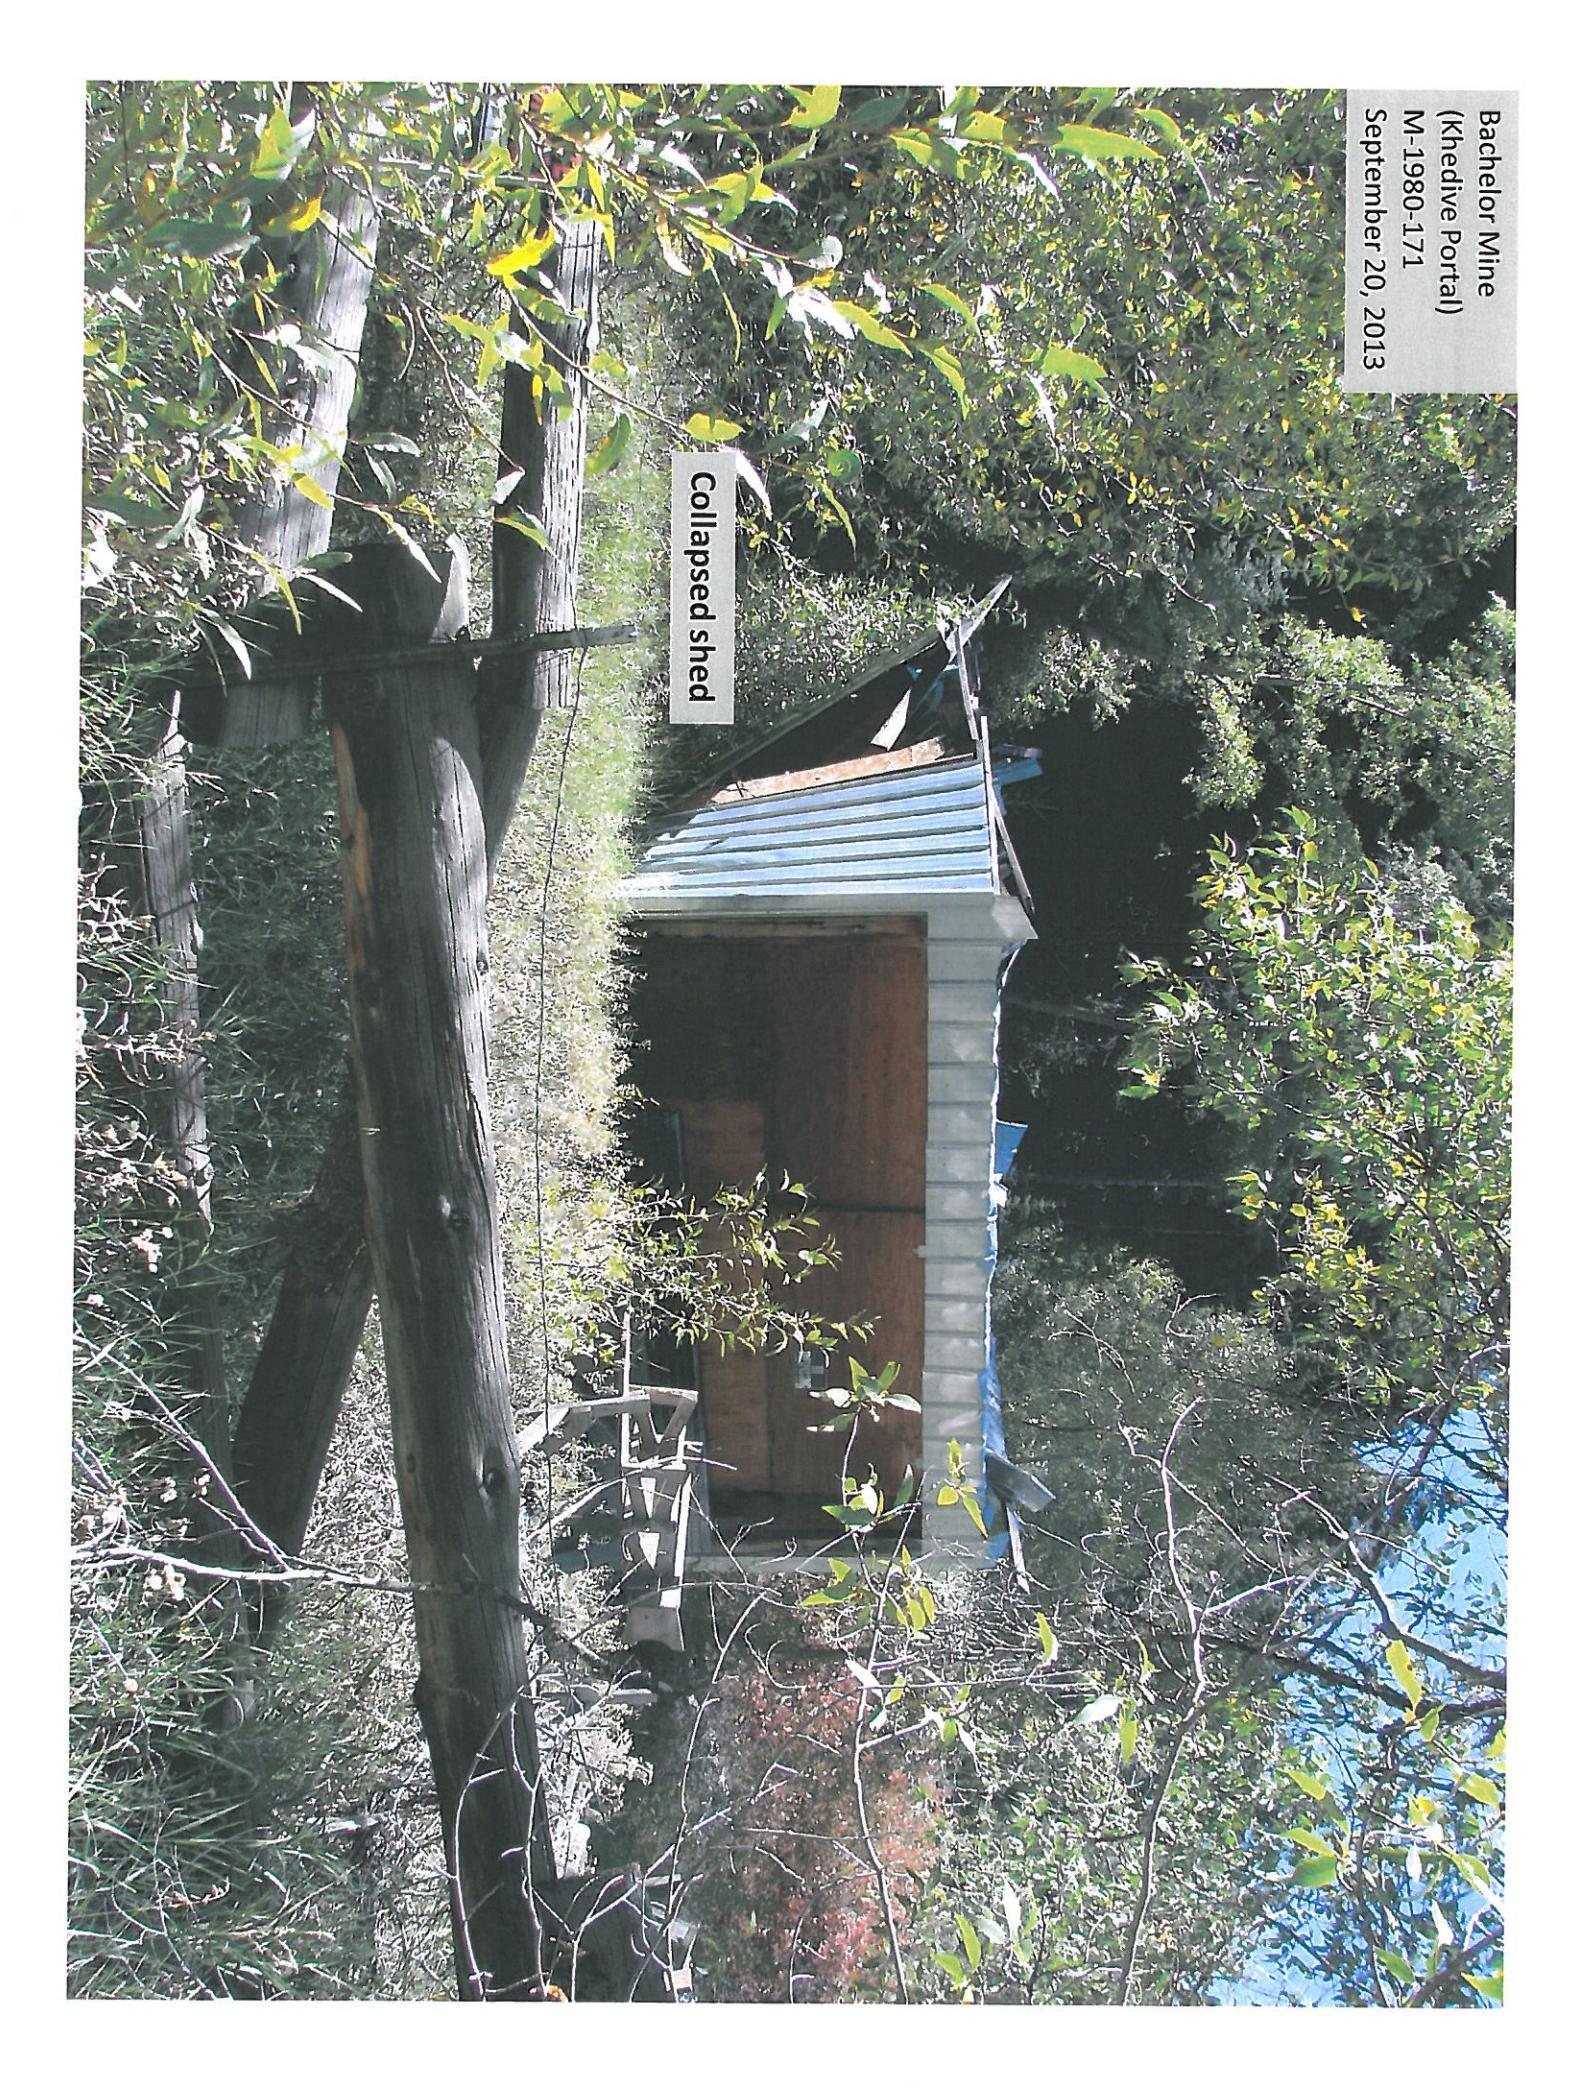
As shown in the enclosed photos, significant erosion control efforts have recently occurred within the channel of Dexter Creek, located immediately upstream of the permit boundary and extending through the southwest corner of the permit area. The erosion control efforts included the installation of concrete drop structures within the Dexter Creek channel and immediately downstream of the low water crossing of County Road 14.

Vegetative cover ranged from dense and diverse, for areas of the mine dump not recently disturbed, to sparse and emerging for areas of the mine dump graded in accordance with the plans approved through TR-01. For areas characterized as exhibiting sparse vegetative cover, there were numerous volunteer conifer and cottonwood seedlings emerging. The stockpiled materials may be too rocky to support grasses but will support trees and shrubs. The west-central portion of the affected lands contained dining tents, picnic tables and an outdoor cooking station for chuck wagon type dinners. A shed, located nearby the portal and shown on the recent annual report maps, was collapsed. The portal was marginally safeguarded by an improvised gate constructed of wire fencing materials. Portal discharge was estimated at 150 gallons per minute and appeared clear; no evidence of iron staining or metals precipitation was observed.
