COLORADO DIVISION OF RECLAMATION, MINING AND SAFETY COAL PROGRAM INSPECTION REPORT

Permit Number: C-1996-083 Mine Name: Bowie No. 2 Mine Operator: Bowie Resources, LLC Operator Address: Mr William A Bear P.O. Box 483 Paonia, CO 81428 County: Delta Operation Type: Underground Permit Status: Active Ownership: Federal and Forest

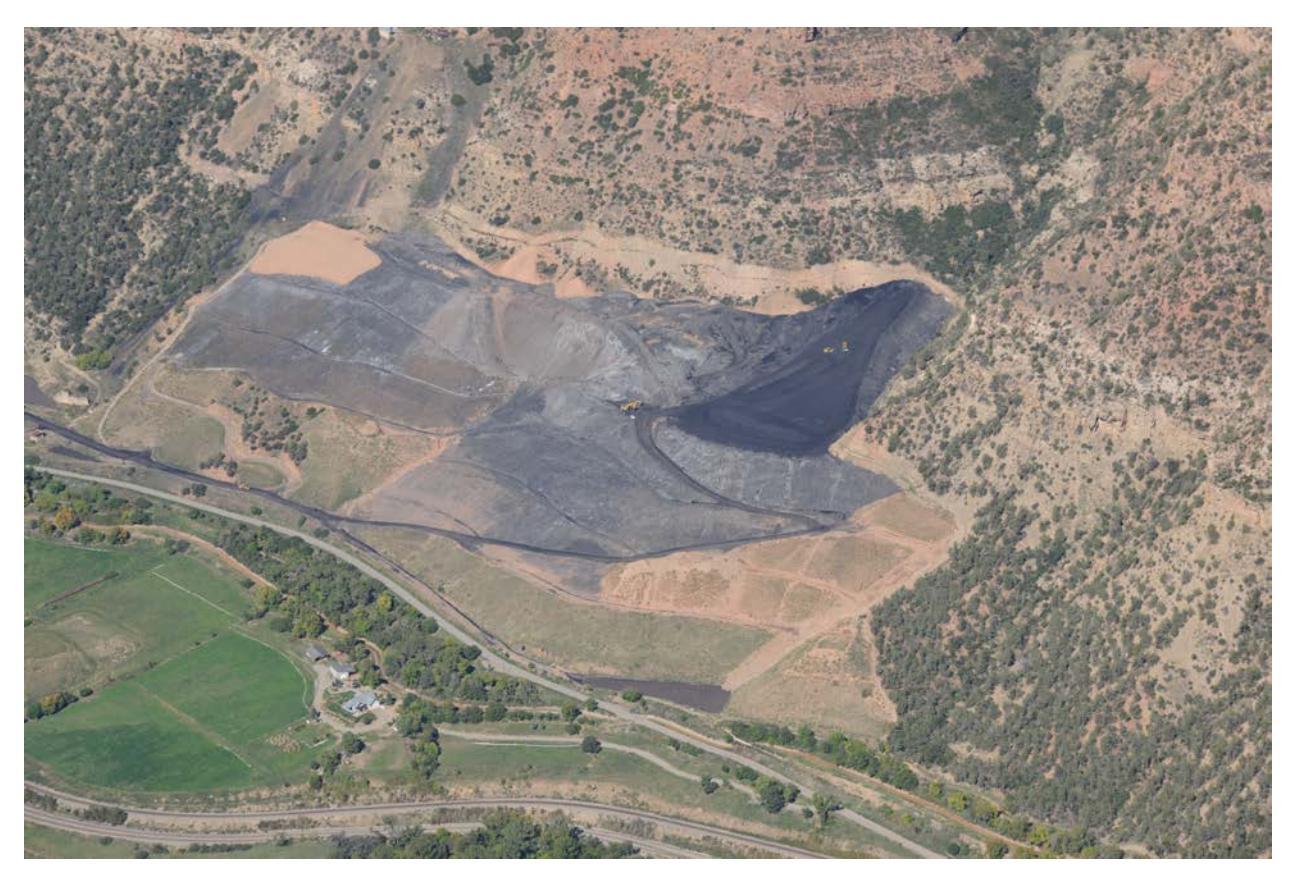
Gob Pile #4 and #2

The Gob Pile #2/#4 haul road was being graded at the time of the flight.

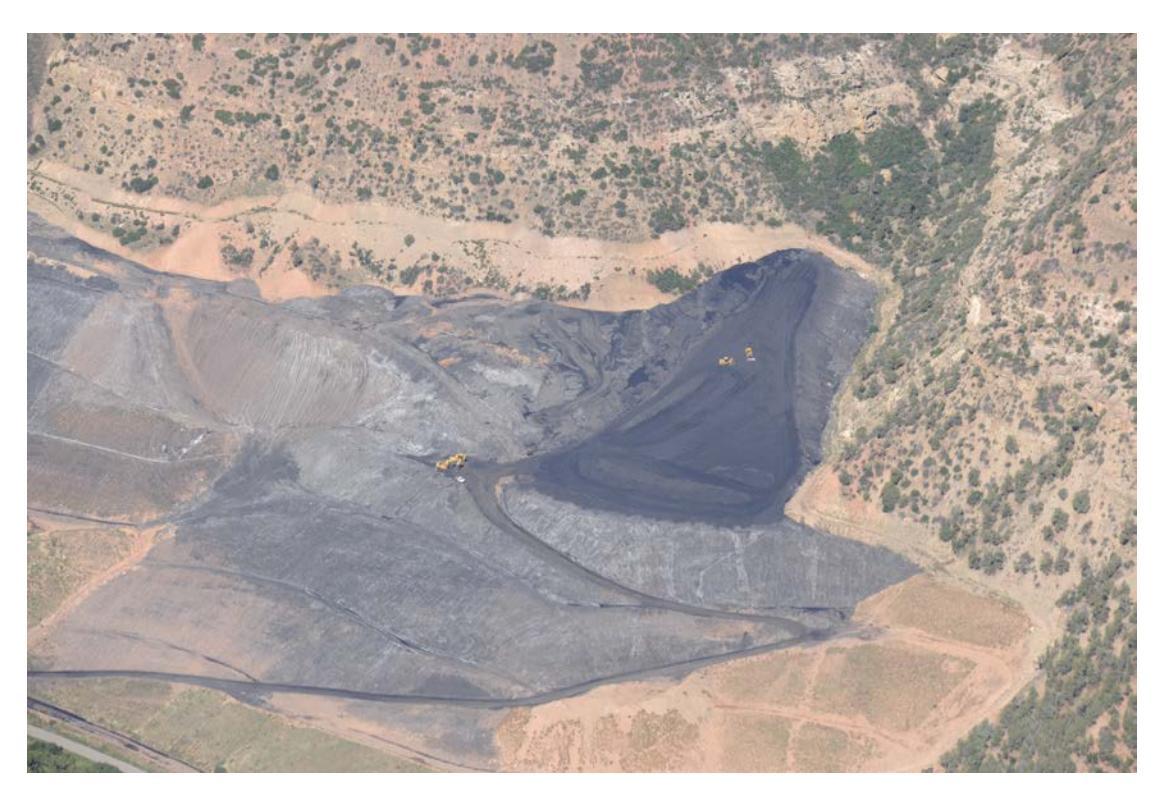
Gob Pile #2

Two excavators, a compactor, and a bulldozer were working on the upper bench of Gob Pile #2, working the material that was cited in NOV CV-2013-004. Gob material had been end dumped on the west end of the upper bench of Gob Pile #2, presumably for drying prior to grading and compaction.

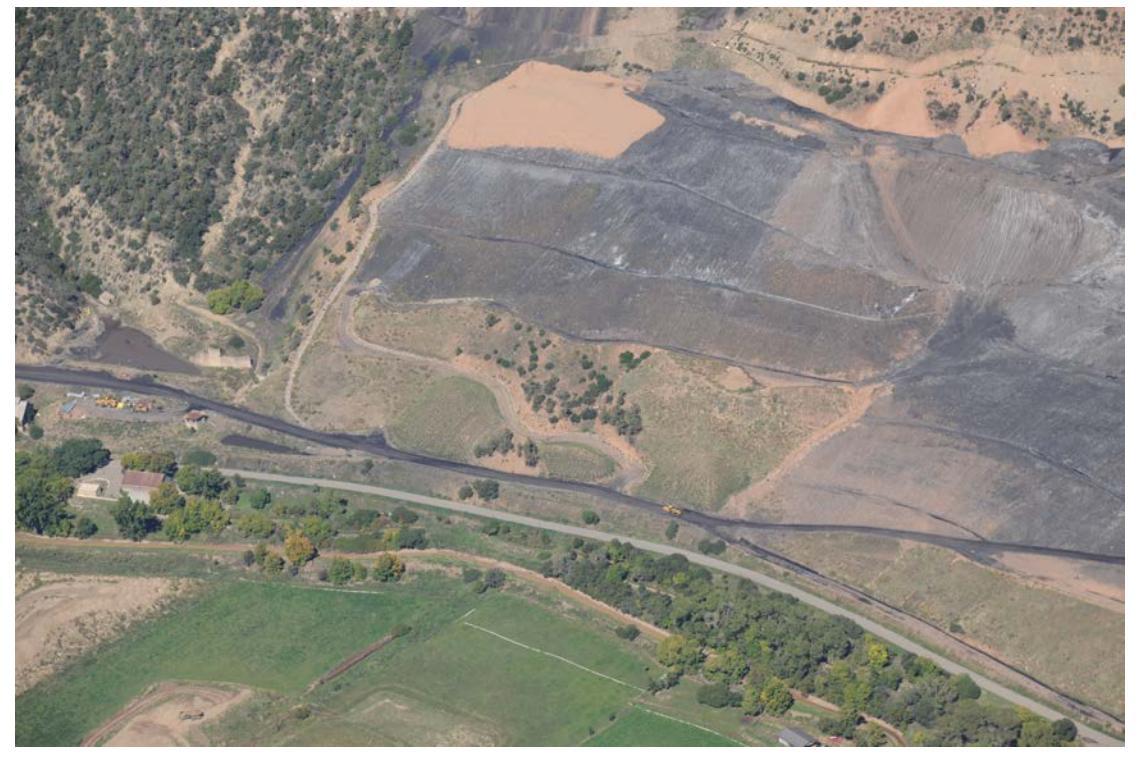
Gob Pile #4

Cover material had been placed on the fifth bench (second from top) of Gob Pile #4. It appeared that some of the cover material may have extended into ditch D-F19, on the far western end. BRL should check this ditch and verify that it is clear or remove any cover material that may be blocking the ditch.

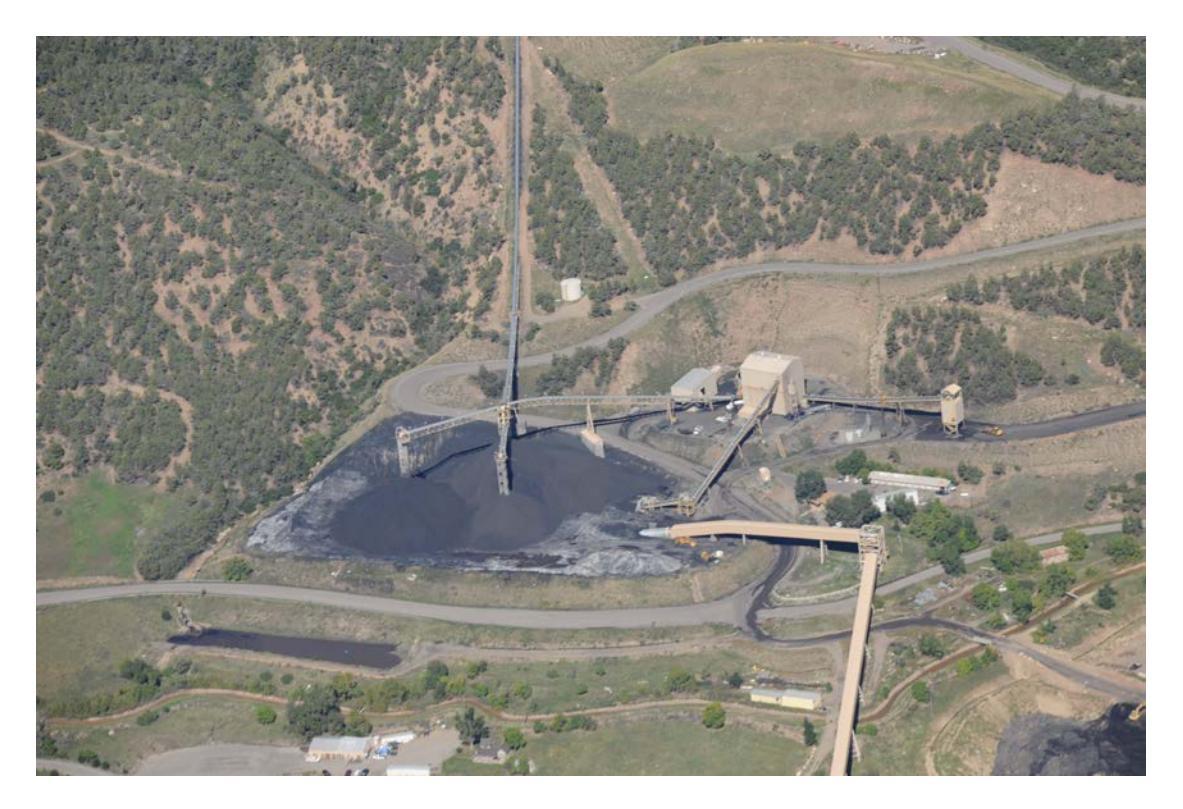
Coal Stockpile Bench and Pond B

Ponds B, C, D, F, and J were holding water. Ponds B, C, and F are in need of cleaning.
