DIVISION OF RECLAMATION, MINING AND SAFETY

**Re: JD-9 Mine Drainage Design Plan – Second General Stormwater Comments,
Permit No. M-1977-306 / AM-01**

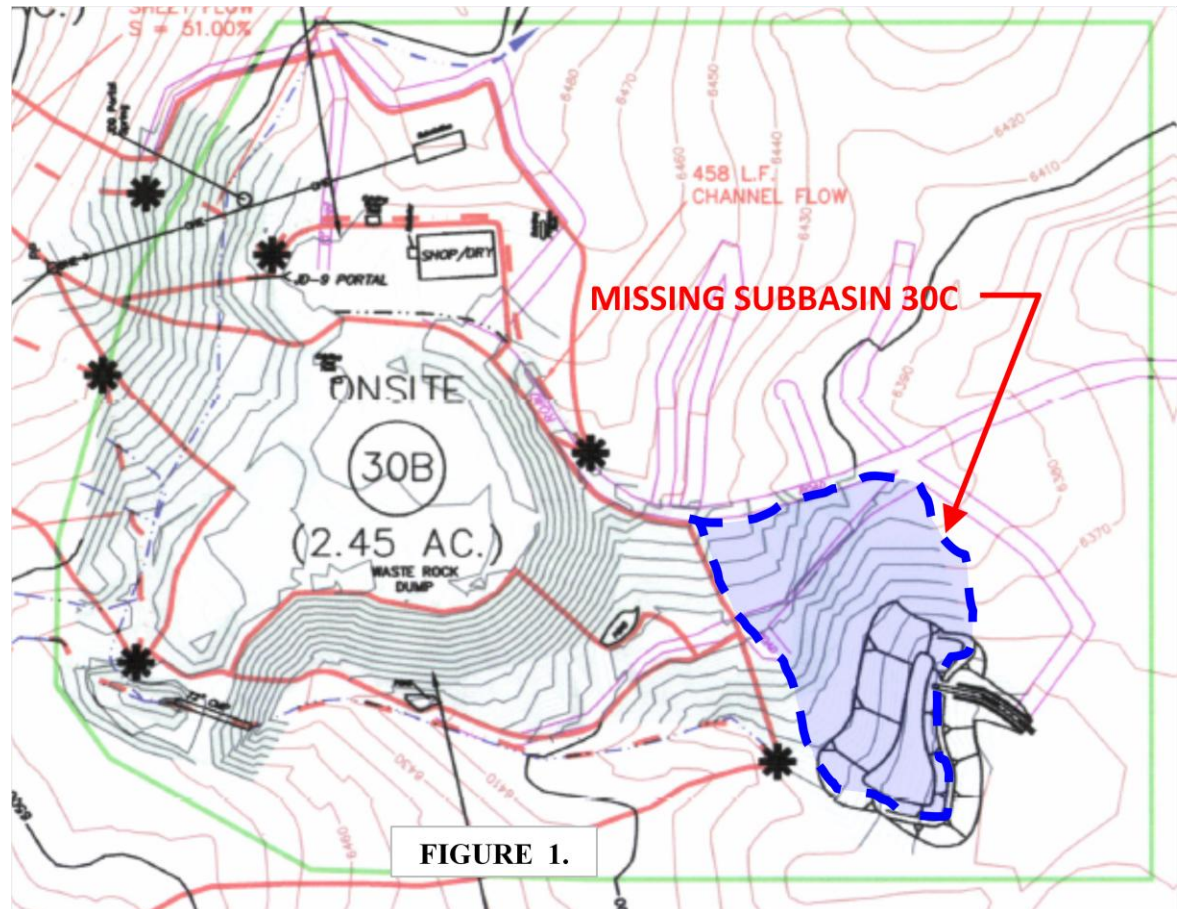
- a. The missing subbasin (labeled 30C) contributing to the proposed retention pond 30, see Figure 1 below must be added to account for runoff from this area to the pond. Adjustments will need to be made to spillway and chute design analyses.

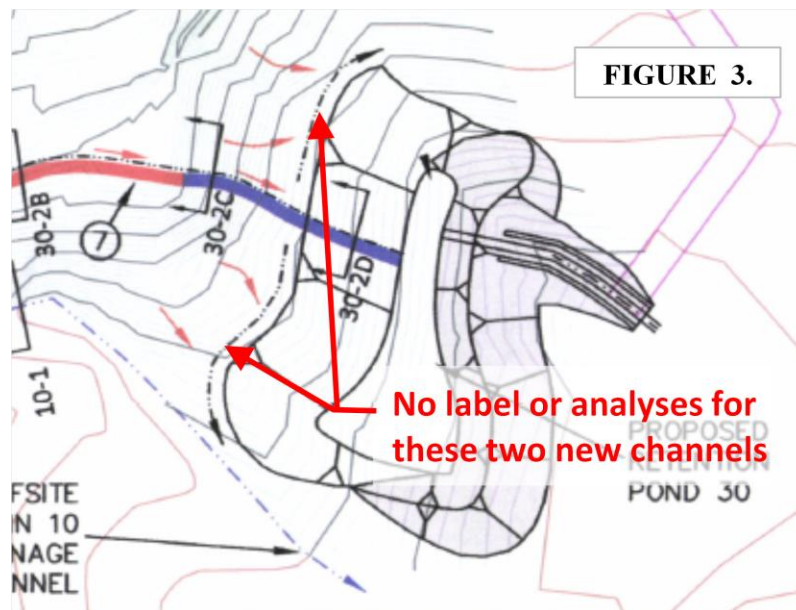
- a. There are two diversion channels upgradient of proposed retention pond that have not labeled or analyzed. Please see Figure 3 below and either provide the requisite analyses or remove them from Sheet 3 of 10.

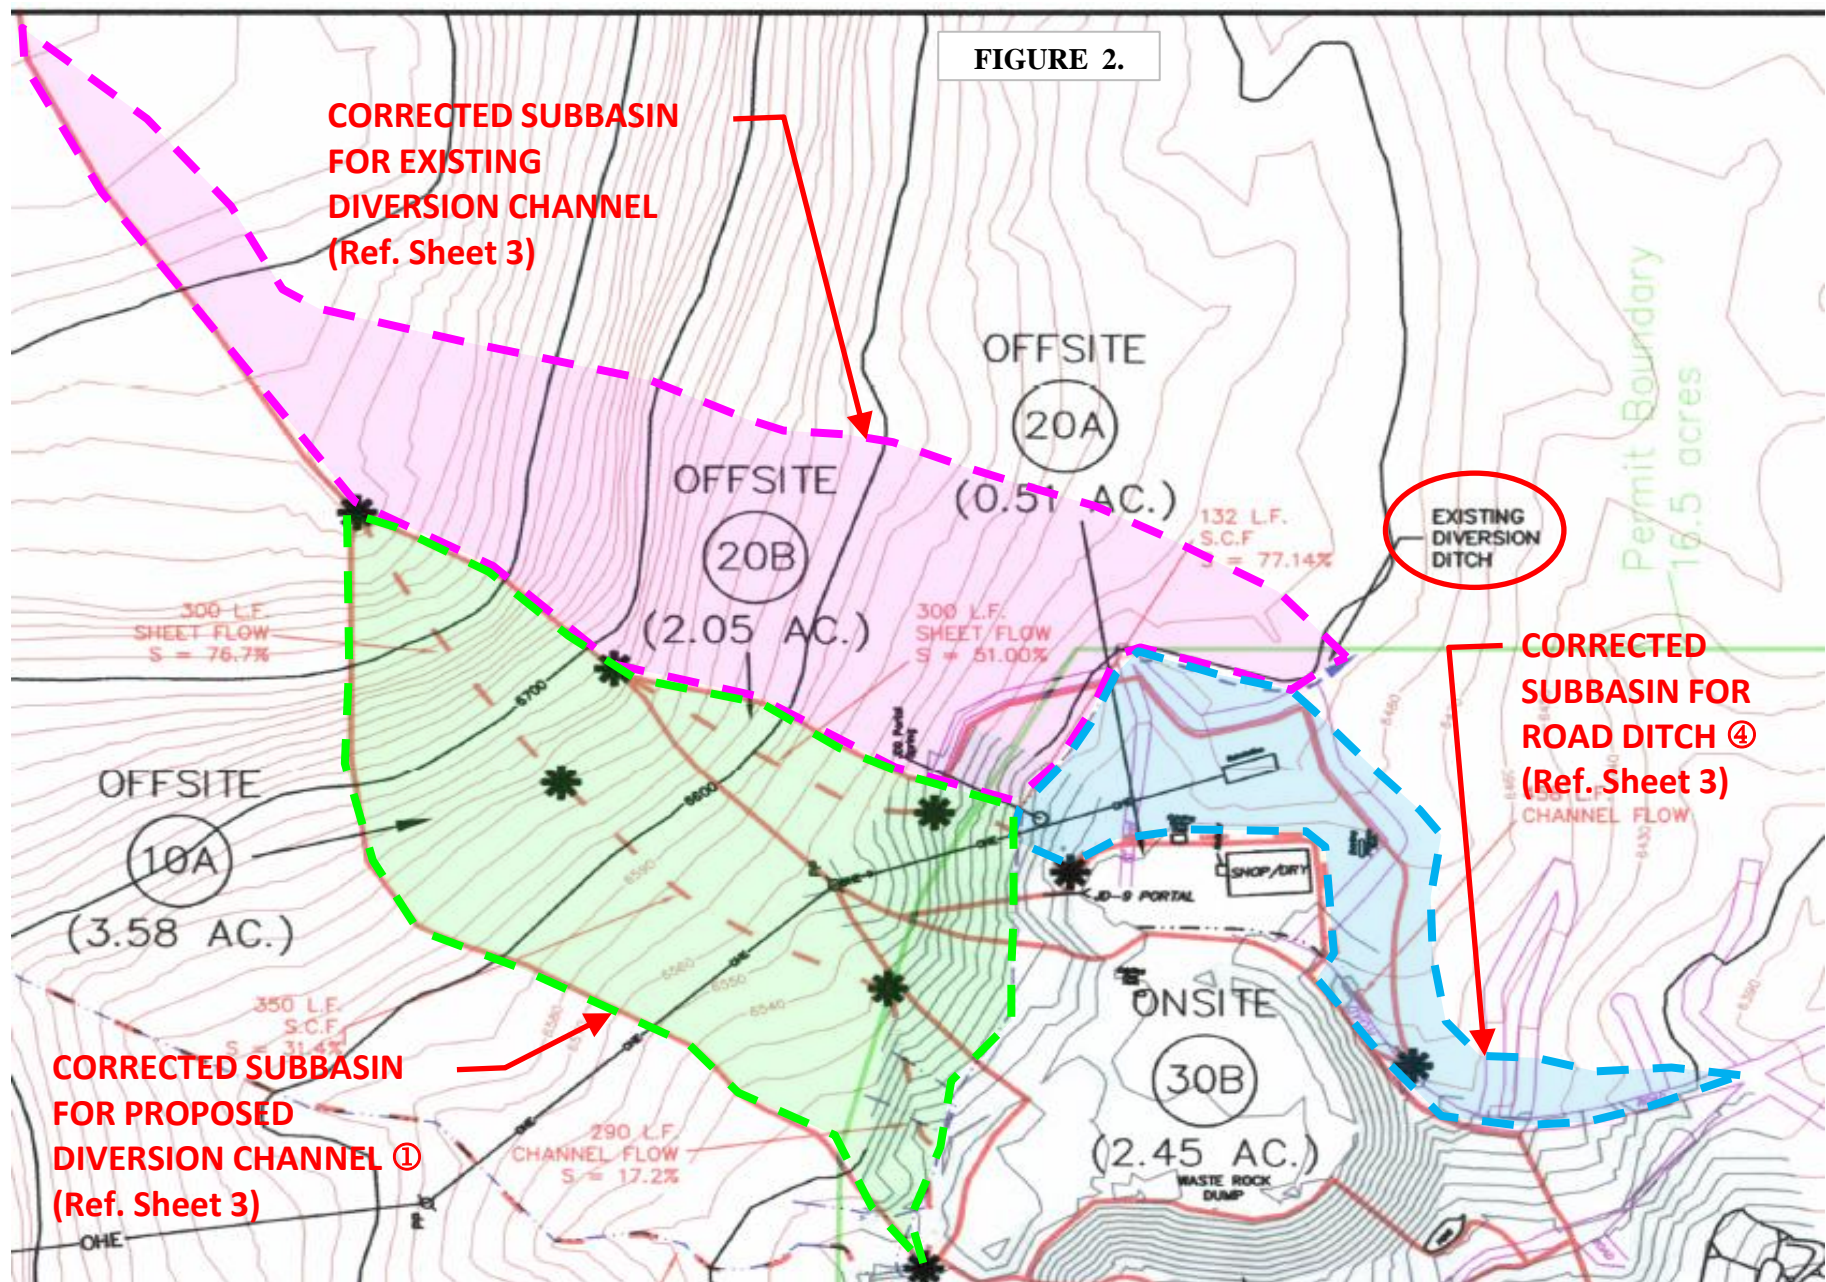
- b. The subbasin area contributing to the existing road ditch ④ (ref. Sheet 3 label) has been reduced. Please reference Figure 2 (attached) to see the area (highlighted in light blue) DRMS deems necessary to address contributing runoff to existing road ditch ④ and ensure adequate design capacity and stability. Please revise the hydrology estimates and make the necessary adjustments to the channel analyses for capacity and stability. Section 20-1 may need a flatter slope to be considered for the capacity analysis. (Note this area was included in the 9/12/2012 submittal).

- c. The new “existing” diversion ditch east of Offsite 20B is not analyzed for stability or capacity nor is the contributing subbasin drawn to consider it. Please reference Figure 2 (attached) to see the area (highlighted in magenta) DRMS deems necessary to address contributing runoff to this existing diversion ditch and ensure adequate design capacity and stability. Please revise the hydrology estimates and make the necessary adjustments to the channel analyses for capacity and stability.

- d. Subbasin 10A is not drawn to consider the proposed diversion channel ① (ref. Sheet 3 label). Please reference Figure 2 (attached) to see the area (highlighted in

green) DRMS deems necessary to address contributing runoff to this existing diversion ditch and ensure adequate design capacity and stability.

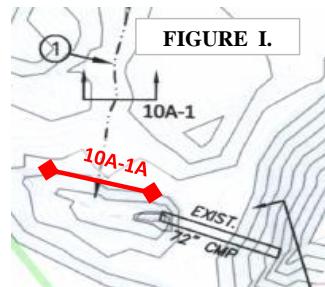
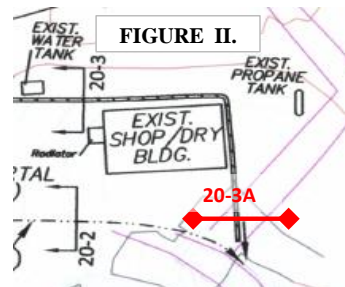
8. *Sheet ~~3 of 7~~, now 3 of 10.* The August 1, 2013 response is partially adequate. The proposed sections 20.-A and 10A-1A are not where the DRMS intended analyses to be performed. Please see Figures I and II on page 3 of **Attachment A** for clarification and revise Sheet 3 accordingly.
