## U.S. DEPARTMENT OF INTERIOR BUREAU OF LAND MANAGEMENT ROYAL GORGE FIELD OFFICE <u>3600 INSPECTION REPORT</u>

MINE NAME:	Red Canyon Quarry
OPERATOR:	RMMA- Tom Smith/Seth Meeks
MAIN COMMODITY:	Aggregate
TYPE OF OPERATION:	112c
COUNTY:	Fremont
LOCATION:	3131 Barrett Road, Colorado Springs, CO 80926
INSPECTOR(S)/ OP. REP PRESENT:	Carissa Snyder – BLM, Seth Meeks – Operator,
INSPECTION DATE:	1/2/2014
DATE OF COMPLAINT, if applicable:	N/A

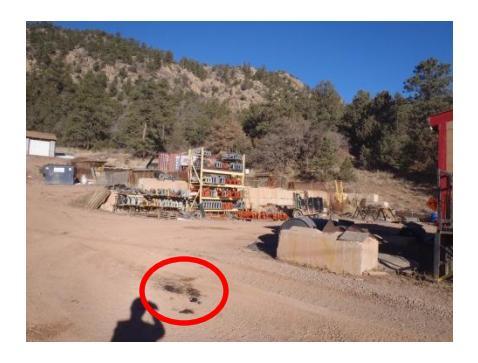
Oil spill near office

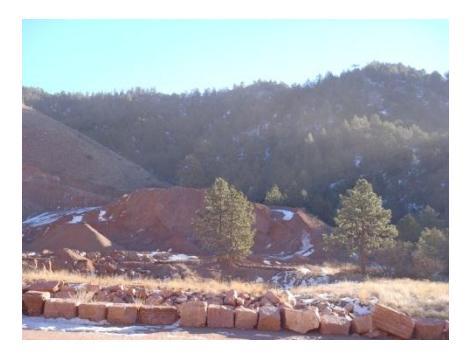
**Reduced Structure Stockpile**

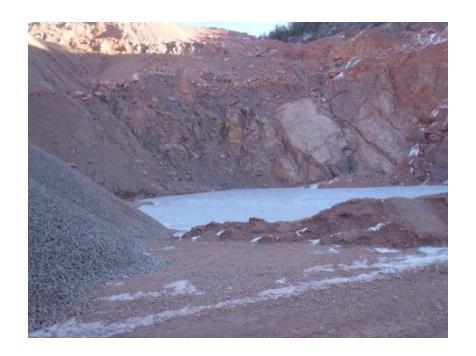
EROSION/ SEDIMENTATION	There is water holding in the pond on the 4 <sup>th</sup> floor (developed during heavy rains) and on the bottom floor. The west-facing benches on the BLM are fairly eroded in sections after the heavy rains this fall. Additional reclamation may be needed during final reclamation of the site. Phone calls, email discussions, and meetings have determined further coordination between Kelly Stack, RMMA, CDRMS, and BLM is going to be needed to ensure everyone is on the same page and interim management of this area (not being actively mined) upholds public safety.
	EXPLOSIVES	Blasting occurred on the 3 <sup>rd</sup> or 4 <sup>th</sup> floor the week or 2 before Christmas. The blast site has not been completely bermed off but according to Seth Meeks, will be as soon as possible. Per discussions with RMMA after the inspection, they do not always berm off blasted areas and this practice has been reviewed and allowed by MSHA during past inspections. Seth Meeks alerted Carissa to the hazard as they approached during the inspection. RMMA assures any person permitted to work in this area of the quarry is trained and aware of the blast zone. RMMA stated tailgate meetings are held every Monday to go over site conditions and hazards, Seth inspects the site every day before work commences, and additional meetings during the week occur as site conditions and hazards change.

Stormwater pond on bottom floor

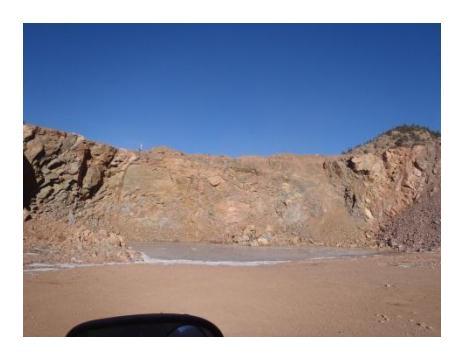
Stormwater pond on 4<sup>th</sup> floor

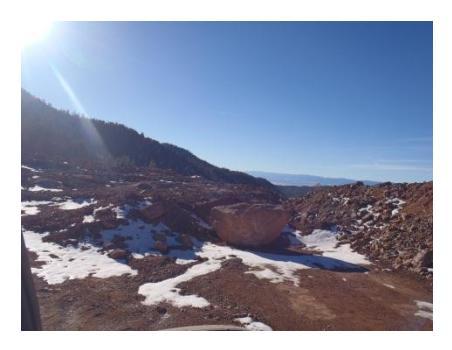
SAFETY	The only safety issue arises from the blast area not having been completely bermed off or signed. RMMA assures BLM that this issue is addressed through safety meetings, training, and has been reviewed and ok'd by MSHA inspectors. RMMA noted there have been no problems with safety on site.

Blasted area not fully bermed off

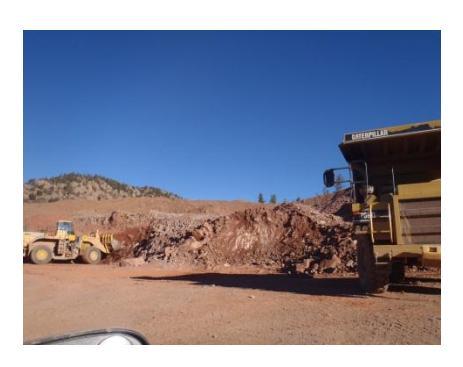
Top floor being mined

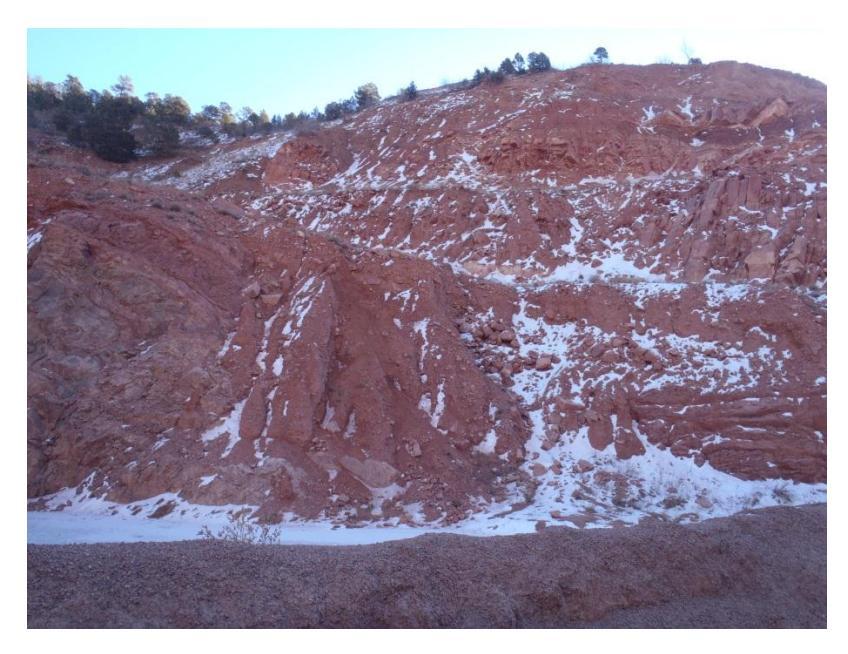
Reclaimed benches on the BLM are fairly eroded in spots after the last heavy rains and may need fixed during final reclamation of the site.
