MINE NAME:	MINE/PROSPECTING ID#:	MINERAL:	COUNTY:
Ward Pit	M-2003-024	Sand and gravel	Phillips
INSPECTION TYPE:	INSPECTOR(S):	INSP. DATE:	INSP. TIME:
Monitoring	Elliott R. Russell	April 28, 2014	11:45
OPERATOR:	OPERATOR REPRESENTATIVE:	TYPE OF OPERATION:	
Phillips County	Randy Schafer	112c - Construction Regular Operation

PHOTOGRAPHS

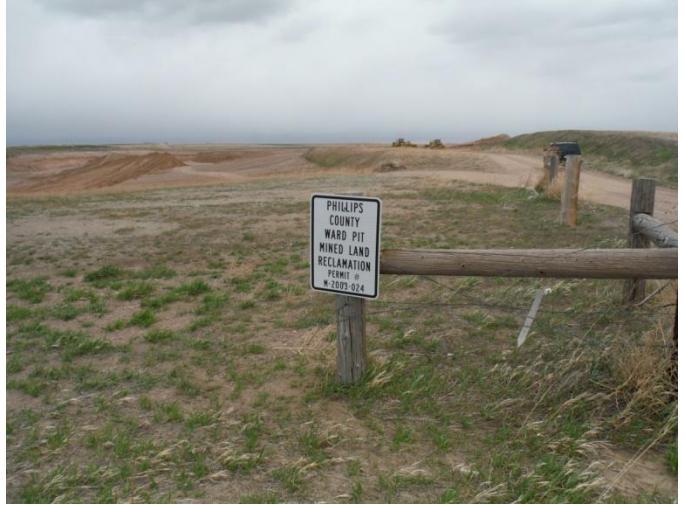
Permit identification sign along CR49; looking east.

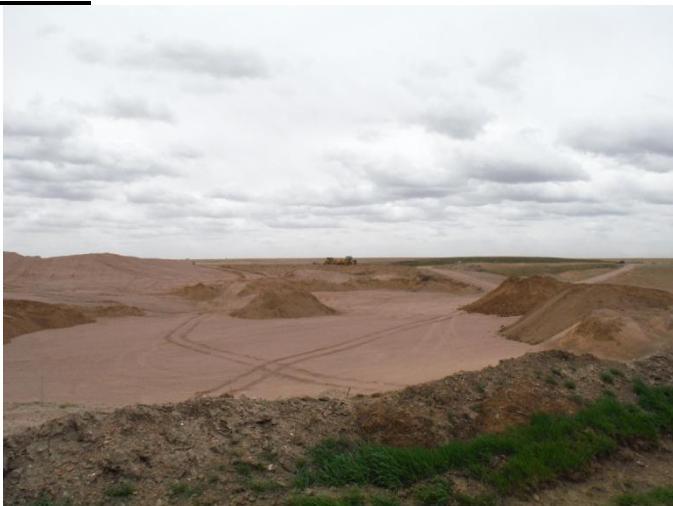
Active pit area; looking southwest.

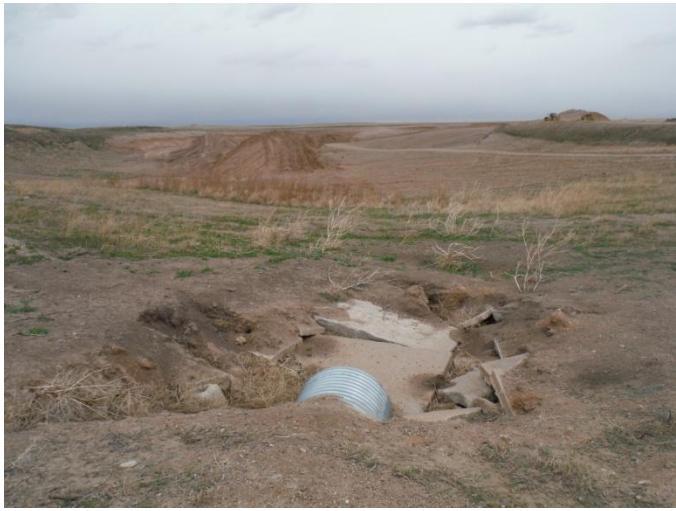
Concrete fill and culvert along west boundary; looking east.

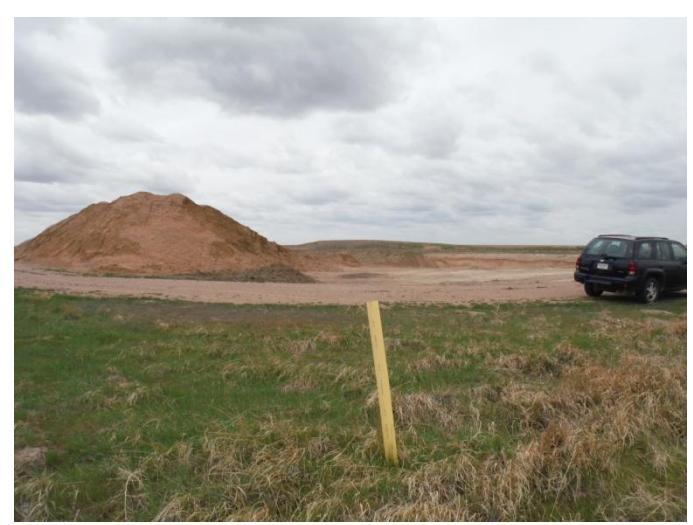
Southeast carsonite boundary post; looking northwest.

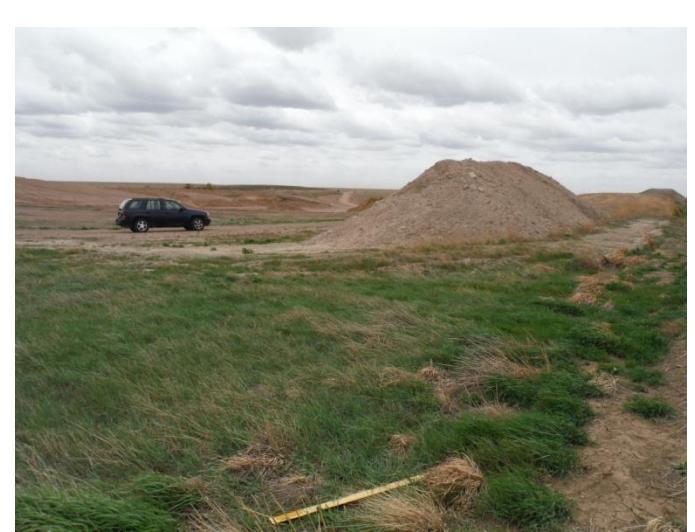
PROBLEM/POSSIBLE VIOLATION: Problem: The affected area boundary markers are missing or incorrectly placed. This is a problem for failure to maintain boundary markers around the affected area as required by Section 3.1.12(2) of the Rule.

The Ward Pit is a sand and gravel operation and Mr. Schafer stated it is the most active pit of Phillips County. In late 2009 the pit underwent a conversion and added 9.9 acres to the pit on the east side of the old 110c permit. An inert backfill notice was also received in the conversion process to allow Phillips County to use recycled concrete to reduce erosion from a culvert entering the site from the western boundary. The current pit's boundaries are marked with a fence on the north, west, and south boundaries of the original (western half) pit and by flexible yellow posts on the northeast and southeast corners. Of which, the northeast post has been knocked down and needs to be replaced. Please see the corrective action section of this report for further information.

Damaged northeast carsonite boundary post; looking southwest.

CORRECTIVE ACTIONS: The operator shall conduct a survey and replace the boundary markers in the correct location(s). The operator shall provide photographic proof to the Division that this has been done by the corrective action date.

CORRECTIVE ACTION DUE DATE: 5/28/14

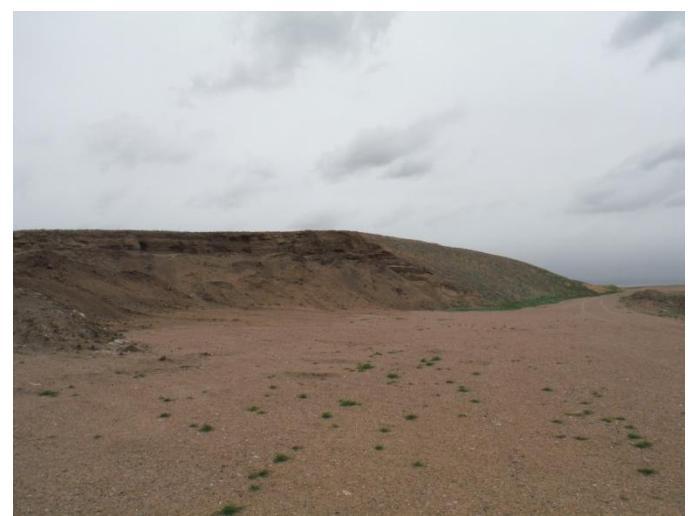
A topsoil pile was located along the north boundary of the site. On the western edge of this pile it appears that topsoil had been excavated and a small highwall remains in the pile. The Division recommends resloping this area to protect the topsoil resource from erosion. In addition, per Rule 3.1.9, when topsoil piles will not be used to replace the topsoil on a backfilled area in a short time period, the pile shall be protected from erosion by having a vegetative cover.

Excavated topsoil pile in the northwest portion of the site; looking northeast.
