**COLORADO DIVISION OF RECLAMATION, MINING AND SAFETY**  
**MINERALS PROGRAM INSPECTION REPORT**  
**PHONE: (303) 866-3567**

<b>MINE NAME:</b> Cross Creek Ranch	<b>MINE/PROSPECTING ID#:</b> M-2013-036	<b>MINERAL:</b> Sand & Gravel	<b>COUNTY:</b> La Plata
<b>INSPECTION TYPE:</b> Illegal(Unpermitted Operation)	<b>INSPECTOR(S):</b> Kate A. Pickford	<b>INSP. DATE:</b> June 6, 2014	<b>INSP. TIME:</b> 10:00
<b>OPERATOR:</b> John Avery – LUKE THE DUKE, LLC	<b>OPERATOR REPRESENTATIVE:</b> John Avery	<b>TYPE OF OPERATION:</b> IM - Is it Mining

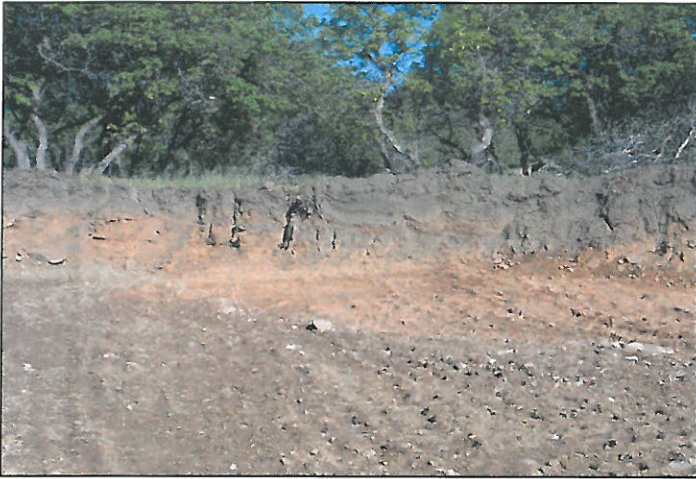
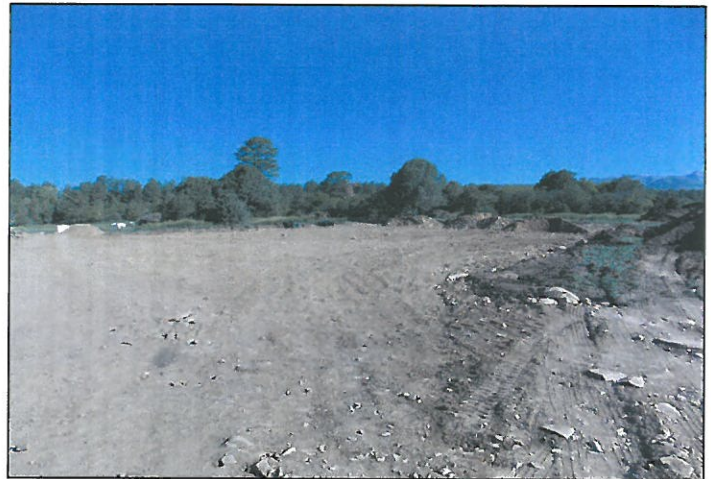
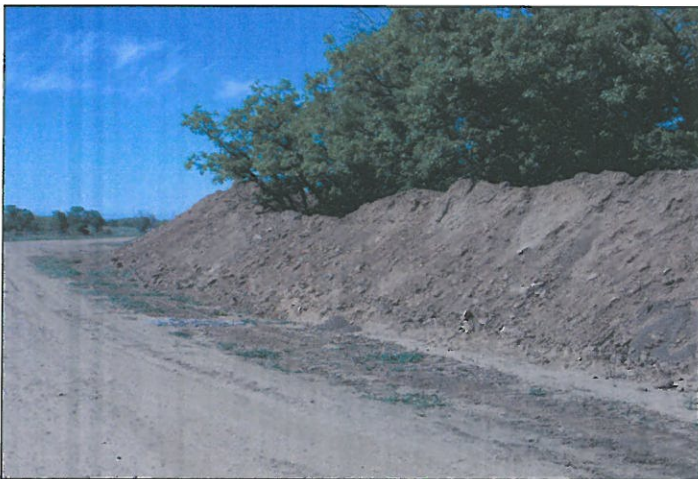
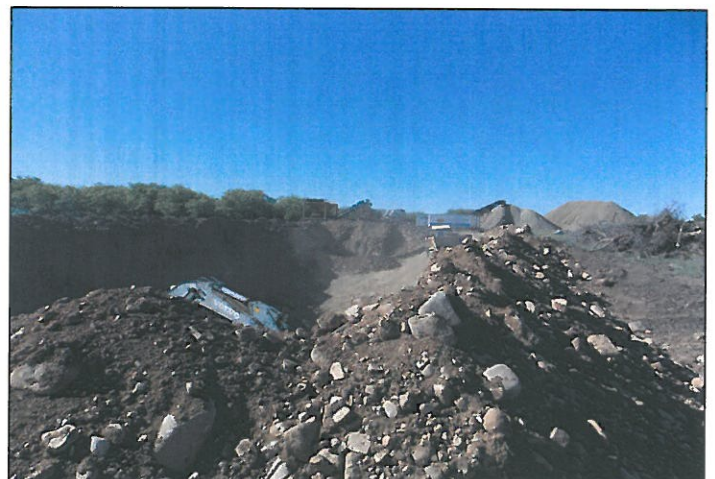
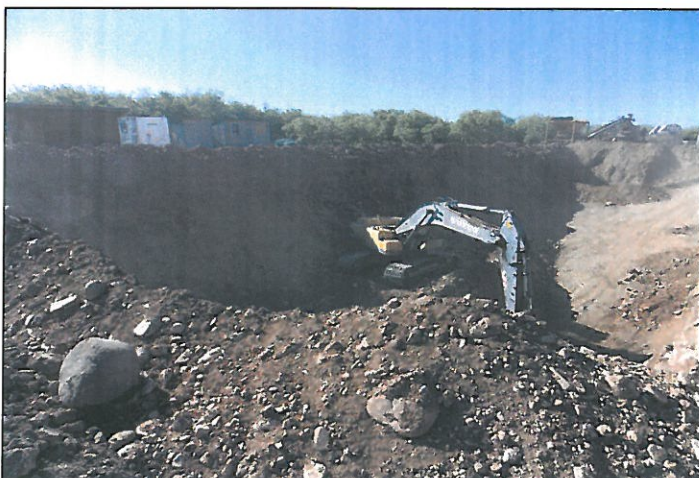
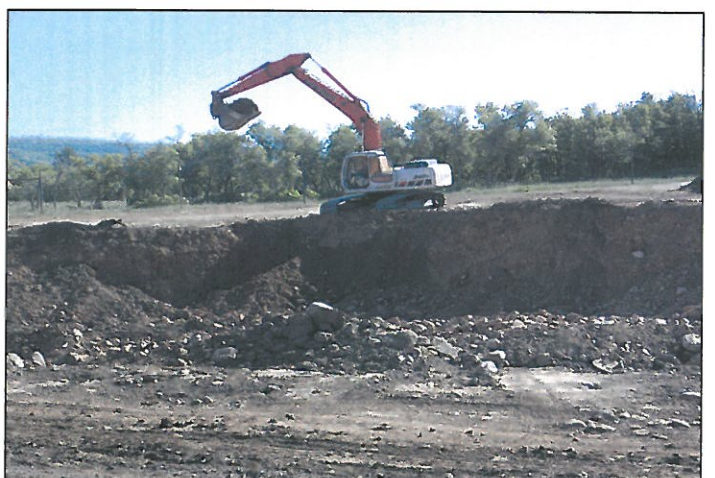
PHOTOGRAPHS

Over where the excavation and crushing had been observed during the previous inspection, there was now a very large pit, in addition to the original one. The new pit was approximately 30 feet deep and between 150 and 200 feet long. There were excavators working in the pit. Next to the pit, where the crushing was observed previously, there were two very large stockpiles of gravel, approximately 30 feet high. Crushing was still being conducted. The original hole that was present the previous year had been expanded and trucks were being loaded with an excavator taking material from that pit.
