The Division of Reclamation, Mining and Safety has conducted an inspection of the mining operation noted below. This report documents observations concerning compliance with the terms of the permit and applicable rules and regulations of the Mined Land Reclamation Board.

MINE NAME:	MINE/PROSPECTING ID#:	MINERAL:	COUNTY:
Robins Rock Pit	M-2009-053	Basalt	Conejos
INSPECTION TYPE:	INSPECTOR(S):	INSP. DATE:	INSP. TIME:
Preoperation Inspection	Wallace H. Erickson	October 3, 2014	12:00
OPERATOR:	OPERATOR REPRESENTATIVE:	TYPE OF OPERATION:	
Robins Construction, LLLP	Randy Robins, Scott Johnson	110c - Construction Limited Impact	
REASON FOR INSPECTION:	BOND CALCULATION TYPE:	BOND AMOUNT:	
Normal I&E Program	Partial Bond	\$33,192.09	
DATE OF COMPLAINT:	POST INSP. CONTACTS:	JOINT INSP. AGEN	CY:
NA	None	None	
WEATHER:	INSPECTOR'S SIGNATURE:	SIGNATURE DATE:	
Clear	Wallact. Sh	October 16, 2014

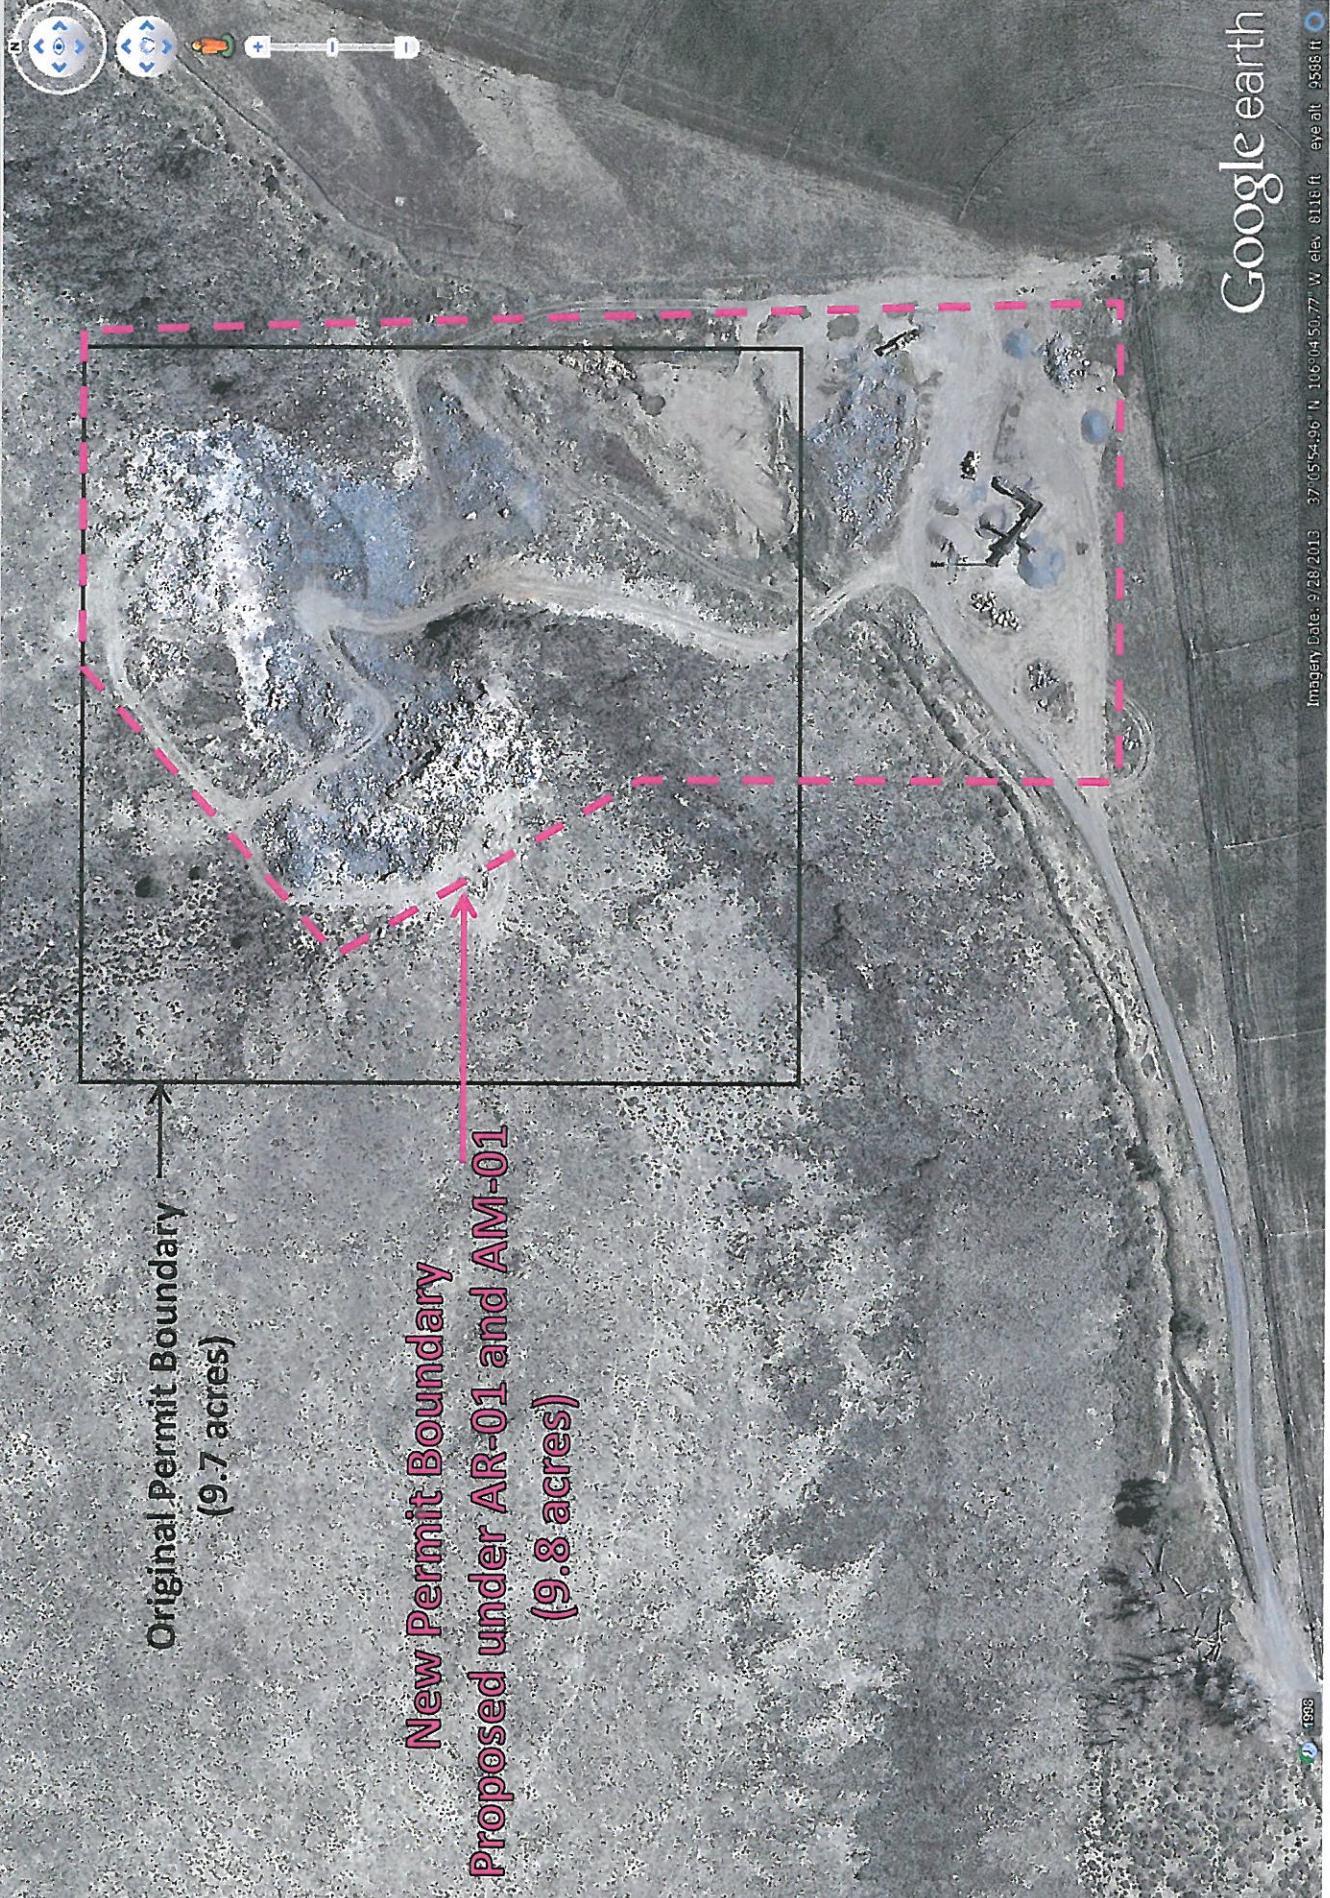
As shown on the Google Earth image, the Operator proposes to incorporate the off-site affected lands, subject of Violation MV-2014-053, into the permit area through AM-01, and maintain the 110c status of the permit by releasing an equal area of previously permitted but unaffected lands through AR-01. As shown on the photographs the new permit boundary was clearly delineated by survey lath and pins.

existing permit boundary, and the approximate location of the new permit boundary proposed under AR-01 and AM-01. Robins Rock Pit, M-2009-053, Google Earth image date September 28, 2013, showing the approximate location of the
