COLORADO DIVISION OF RECLAMATION, MINING AND SAFETY MINERALS PROGRAM INSPECTION REPORT PHONE: (303) 866-3567

MINE NAME:	MINE/PROSPECTING ID#:	MINERAL:	COUNTY:
CR #3 Pit	M-2009-064	Gravel and sand	Grand
INSPECTION TYPE:	INSPECTOR(S):	INSP. DATE:	INSP. TIME:
Monitoring	Peter S. Hays	November 5, 2014	13:00
OPERATOR:	OPERATOR REPRESENTATIVE:	TYPE OF OPERATION:	
Grand County	Bill Clark	112c - Construction Regular Operation	
REASON FOR INSPECTION:	BOND CALCULATION TYPE:	BOND AMOUNT:	
Normal I&E Program	None	\$0.00	
DATE OF COMPLAINT:	POST INSP. CONTACTS	JOINT INSP. AGENCY:	
NA	None	None	
WEATHER:	INSPECTOR'S SIGNATURE:	SIGNATURE DATE:	
Clear		November 7, 2014

PERMIT #: M-2009-064 INSPECTOR'S INITIALS: PSH INSPECTION DATE: November 5, 2014

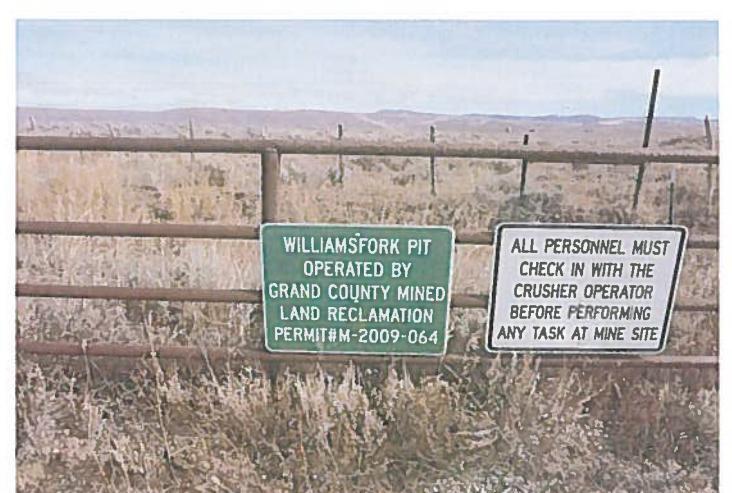
An entrance sign was posted and permit boundary markers were observed as required by Rule 3.1.12.

CR#3 mine sign

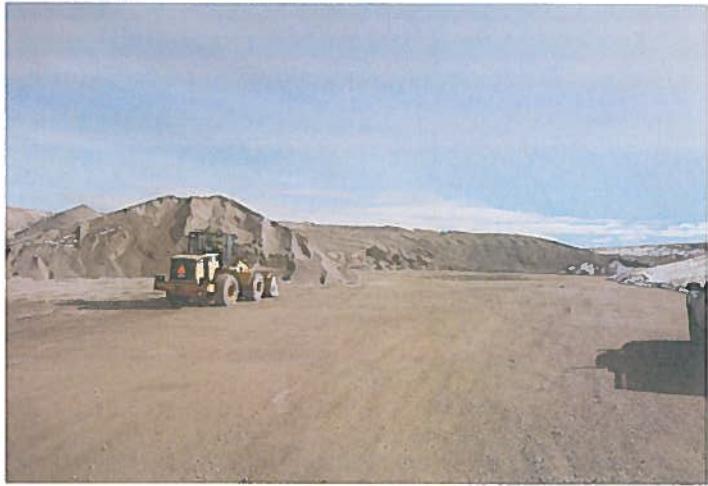
Looking south from north end of pit floor

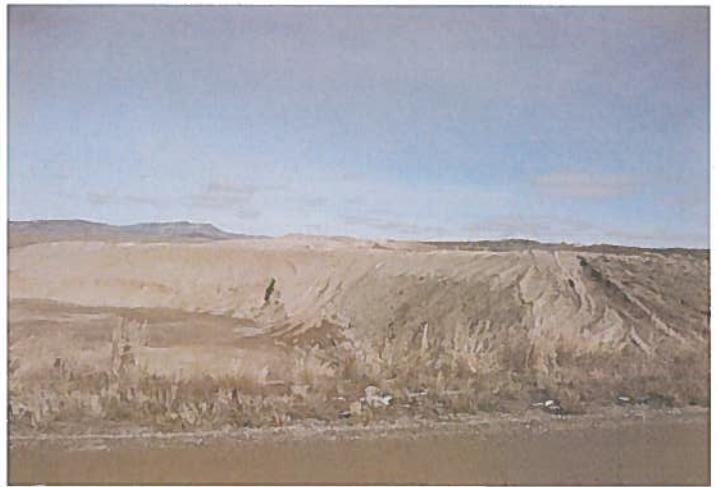
Looking west at highwall

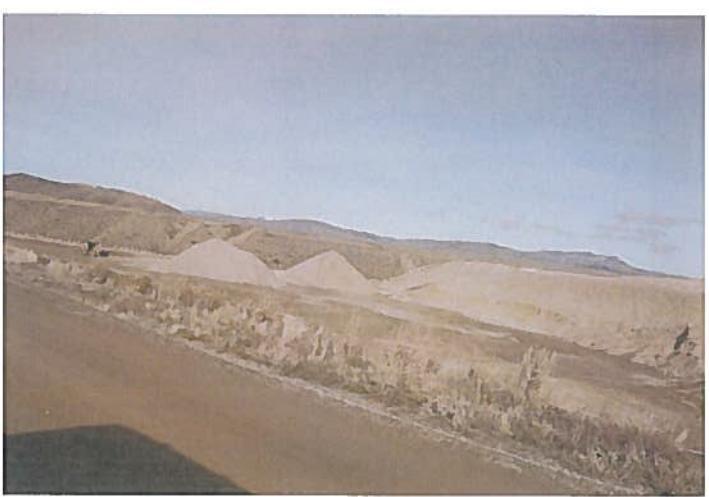
Looking NE at pit floor and highwall

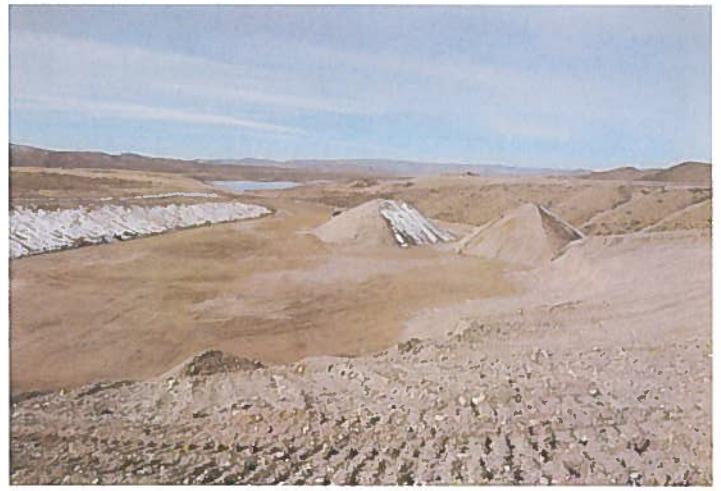
Looking north from highwall at pit floor

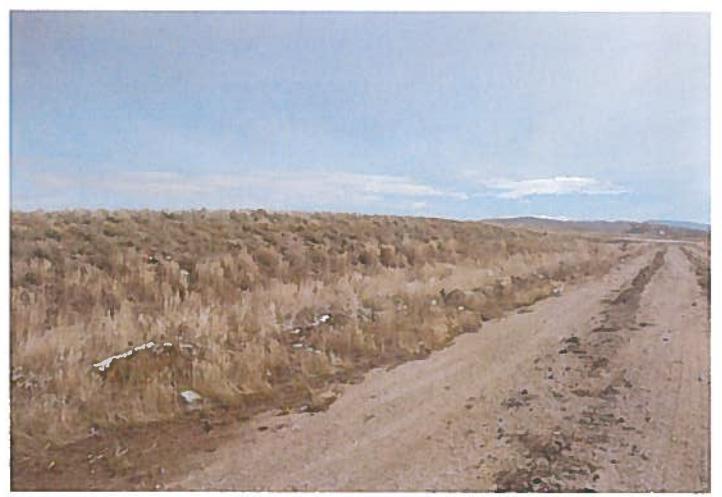
The site was actively hauling stockpiled material during the inspection. The material was being placed on County Road #3 south of the site. Two stockpiles of material were observed on the pit floor, Class 6 roadbase and minus 3 inch. The highwall has progressed to the north since the last inspection. Topsoil and overburden were stripped ahead of mining. The pit floor was dry and no erosion was noted during the inspection. The topsoil and overburden stockpiles located southwest and southeast of the pit were well vegetated and stable.

Looking at vegetated topsoil stockpile
