Appendix D Weekly Reports

CRIPPLE CREEK & VICTOR GOLD MINING Co. ANGLOGOLD ASHANTI (Colorado)

Squaw Gulch (VLF), HWY 67 Realignment Field Monitoring Summary Weekly Report

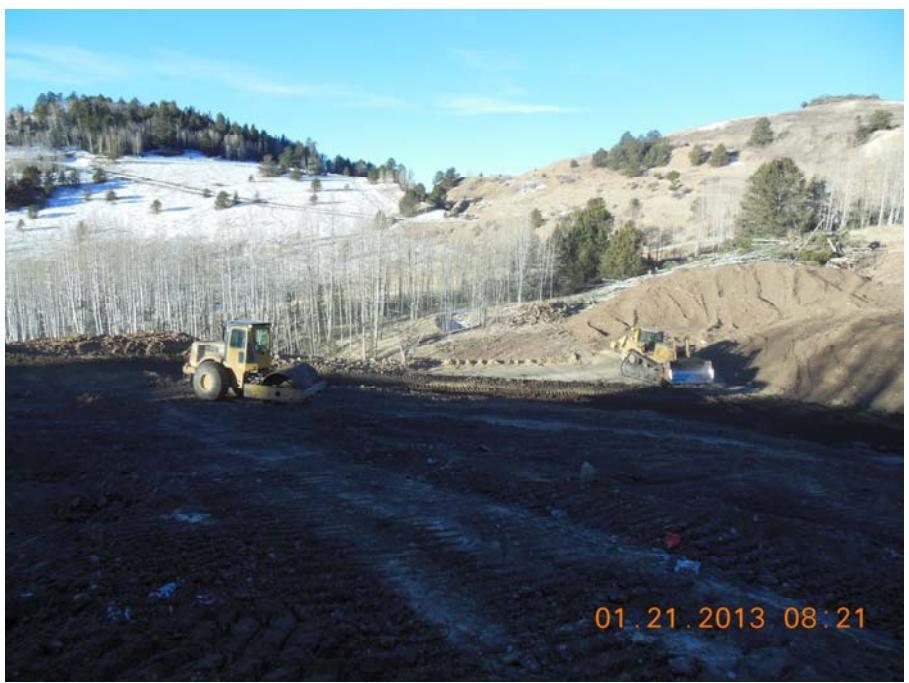
Photo No.1; Fill and Compaction efforts - Planned 740 haul route

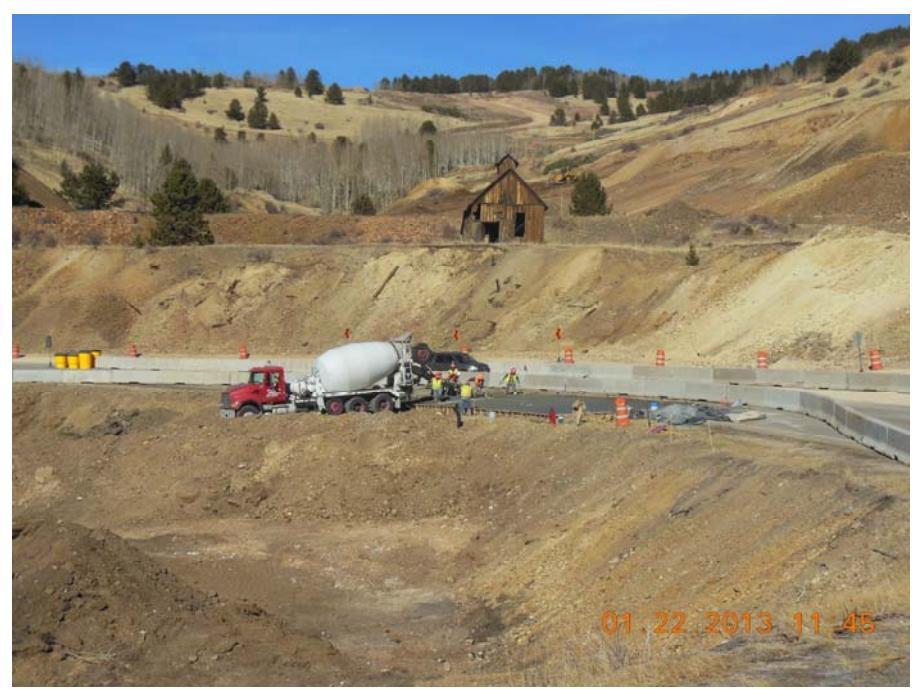
Photo No.2; Concrete placement West portion of crossing HWY 67

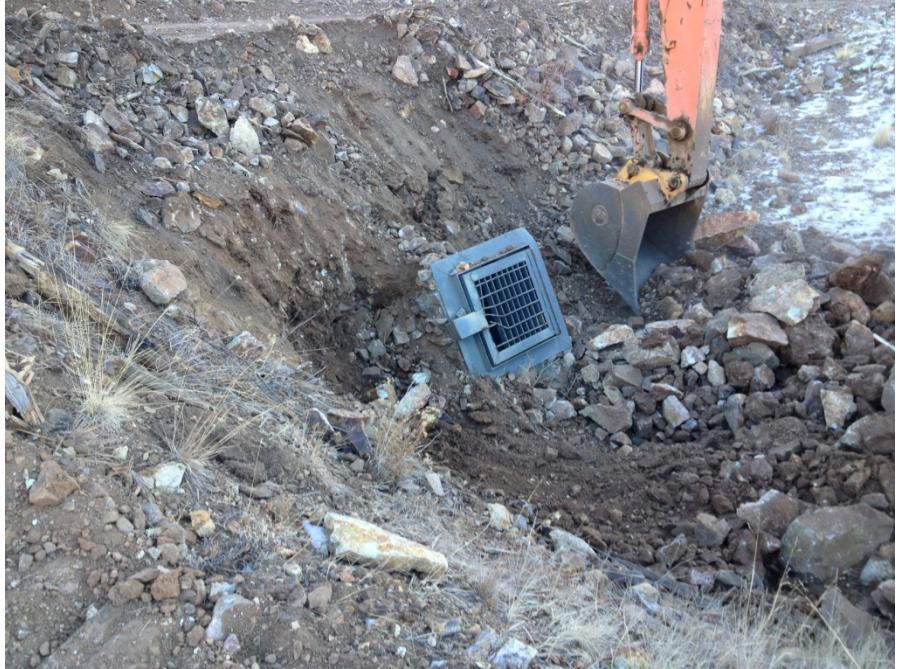
Photo No.1; UG # 5260 Exposing 36" CMP and grate

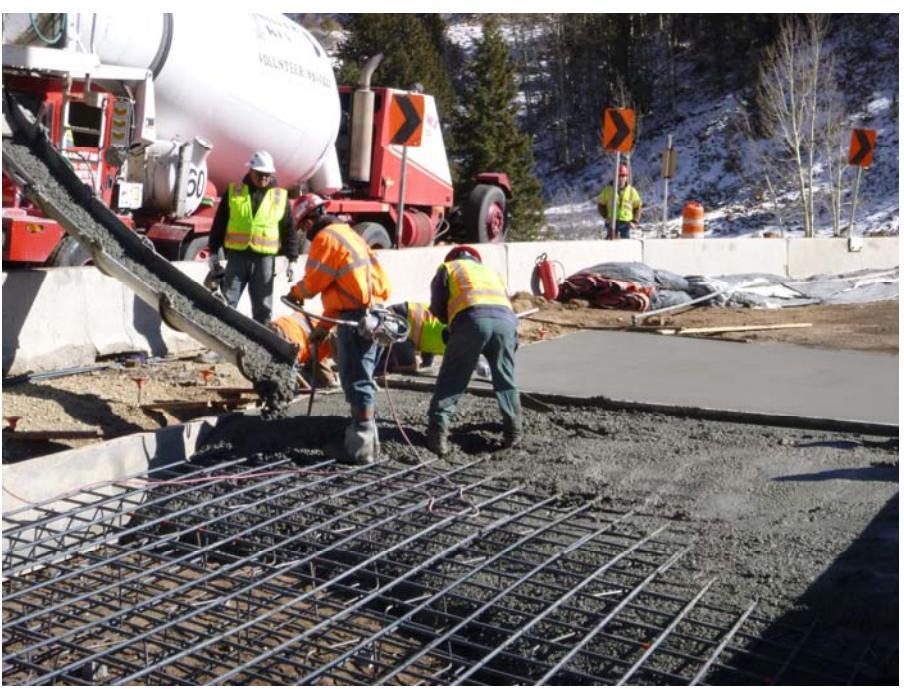
Photo No.2; Concrete placement East portion of crossing HWY 67

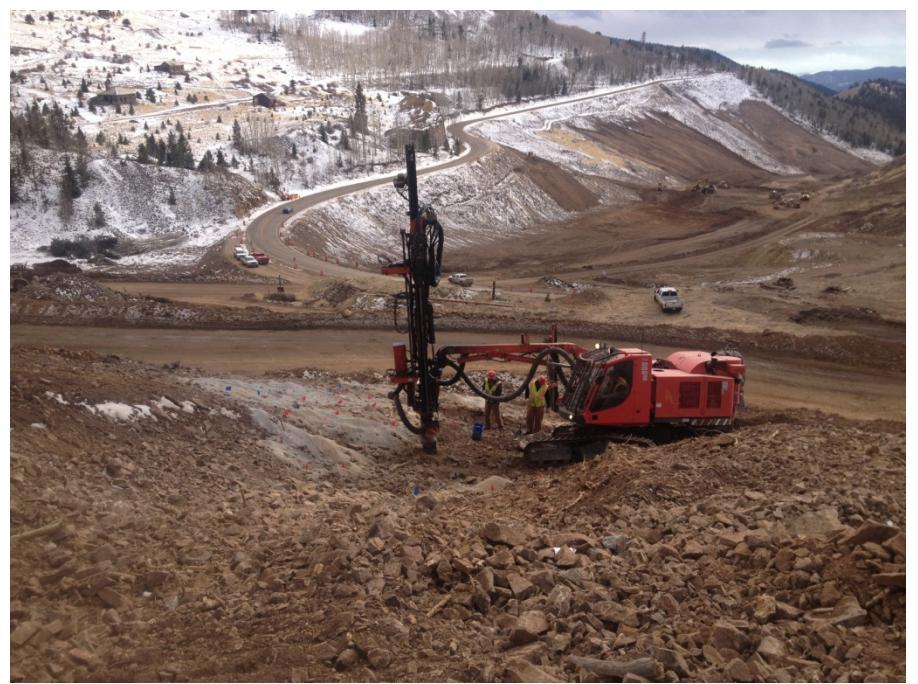
Photo No.2; Continue drilling the "upper drill line" at Historical UG #372

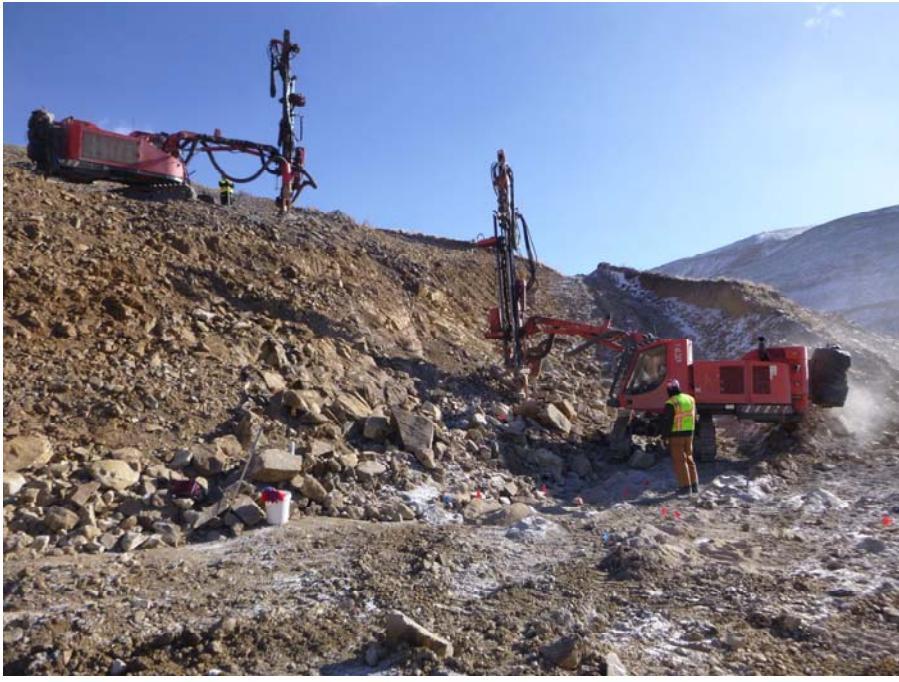
Photo No.3; Continue drilling the "upper/lower drill line" at UG #5126

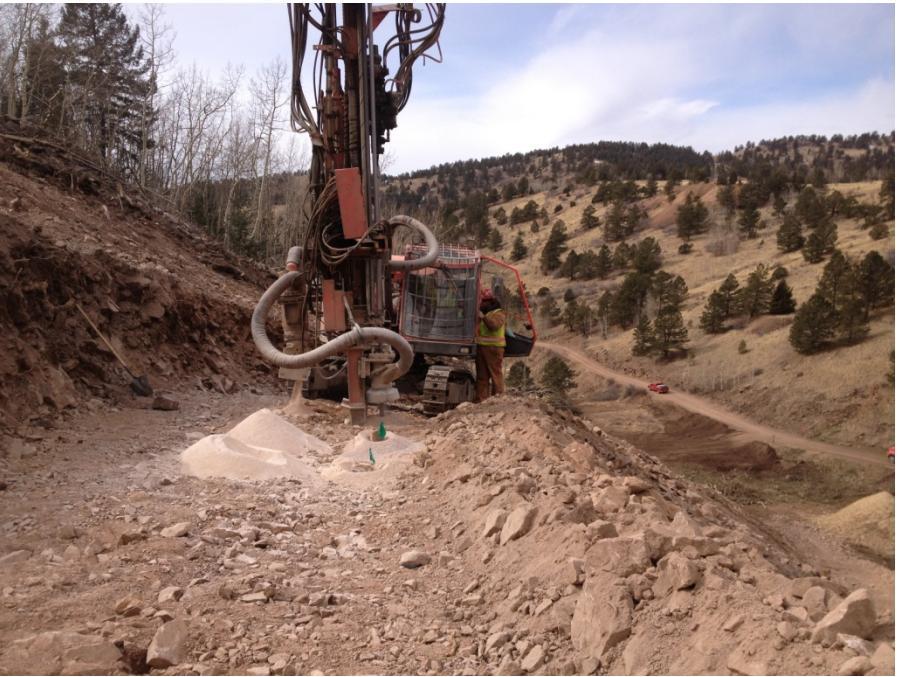
Photo No.1; Upper bench conformation drilling UG #6017

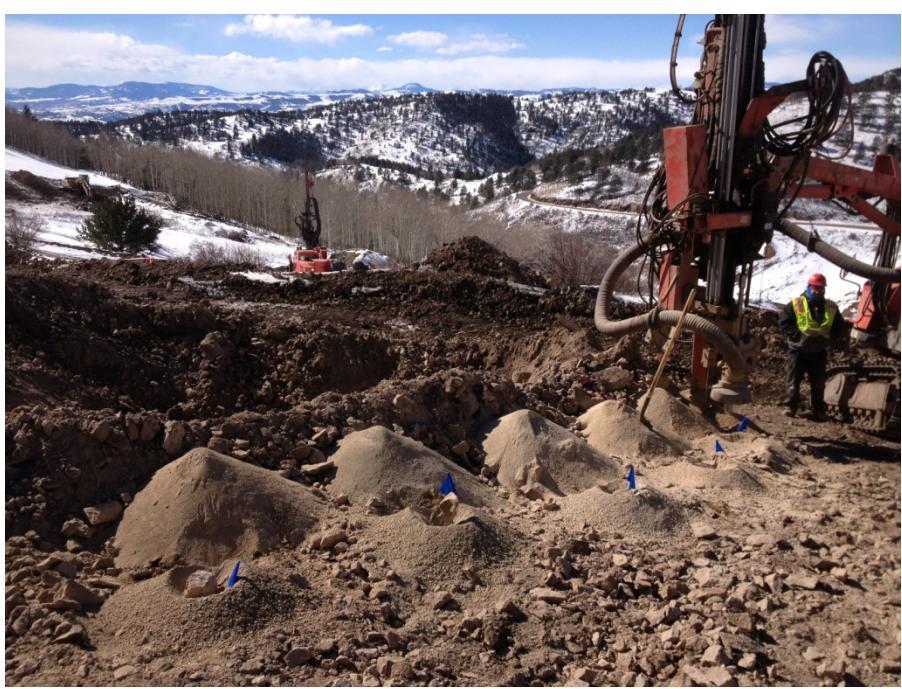
UG #6037: Exploratory findings indicate this is a collapsed shaft. Timbers were observed and removed from 12 feet to 22+/- feet. Confirmatory drilling was performed. 31 drilling locations were established encompassing UG #6037. All locations were placed on 4 foot centers. Confirmatory drilling commenced using one Sandvek 800 track drill rig and one Sandvek 700 track drill rig. Work will continue to encompass the working and to locate and isolate the void found.

Photo No.2; Confirmatory drilling UG #6037, background: drilling at UG #6036

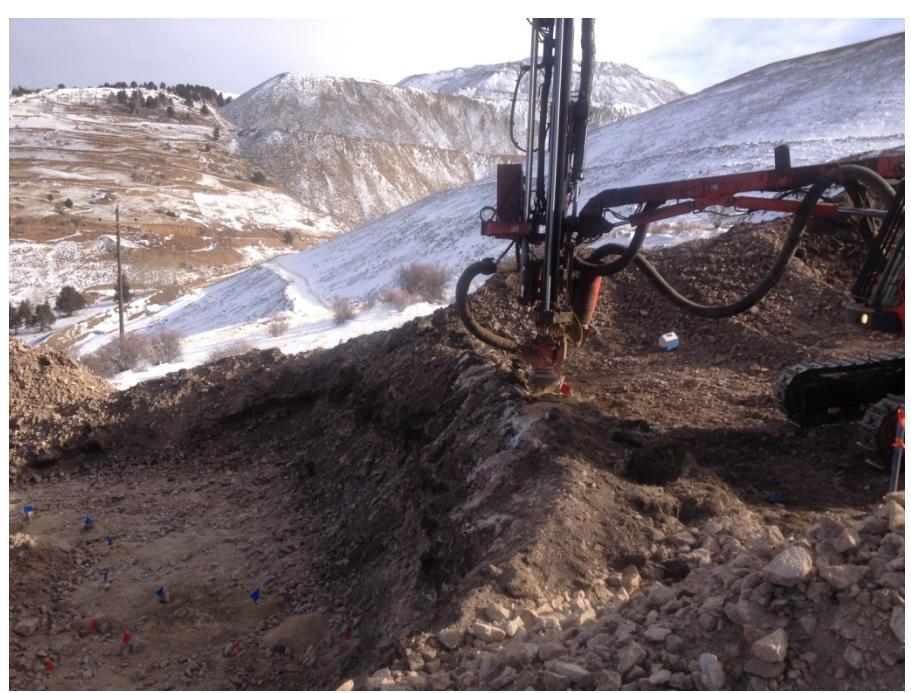
Photo No.4; UG #6037, drilling upper access provided

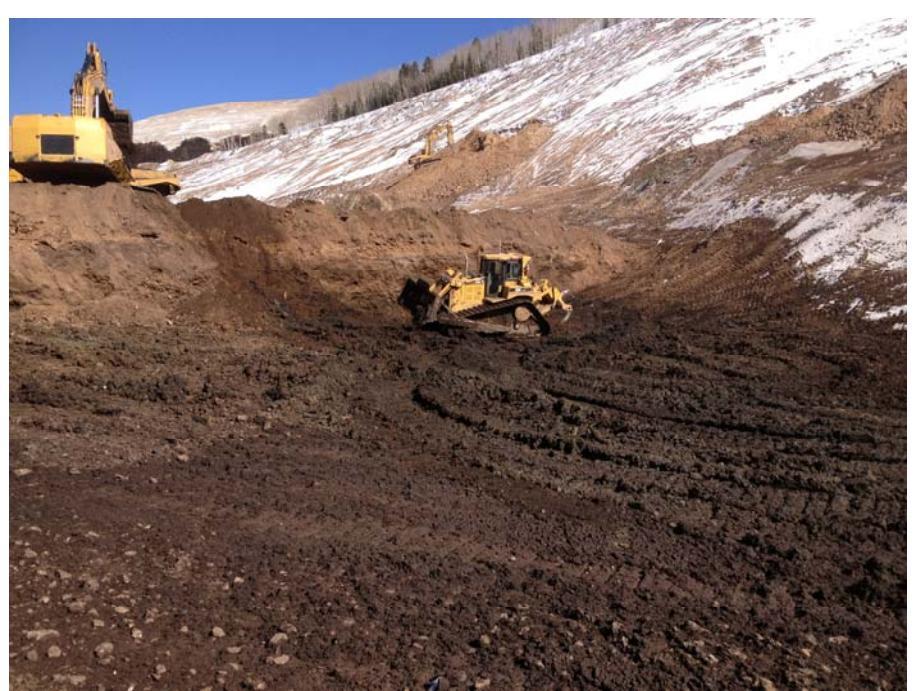
Photo No. 2; Unsuitable material, removal 200 feet east of Proposed Underdrain Pond location

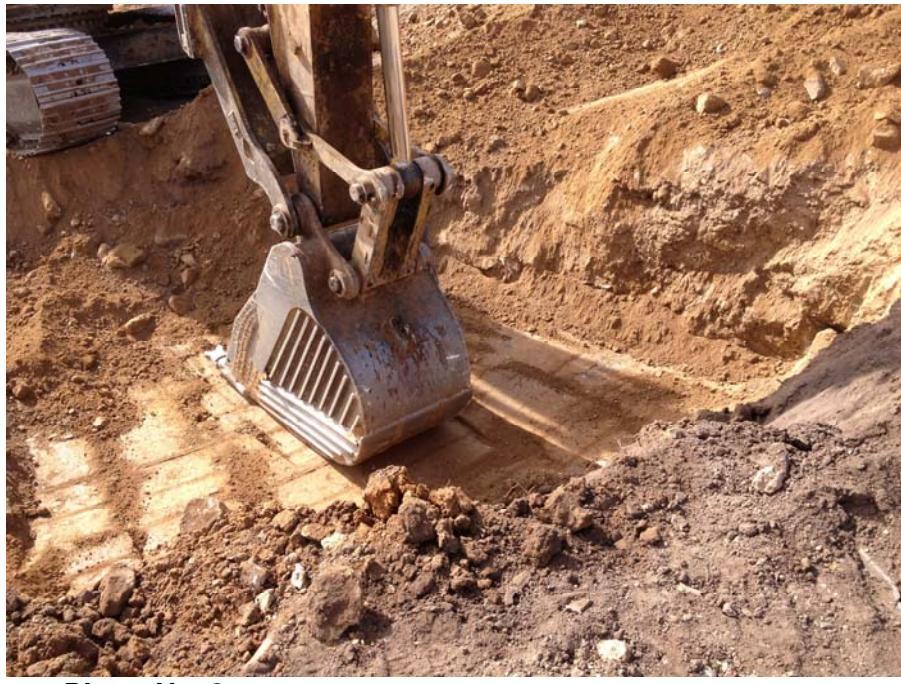
Photo No. 3; UG #6058, UG #6059, backfilling surface workings

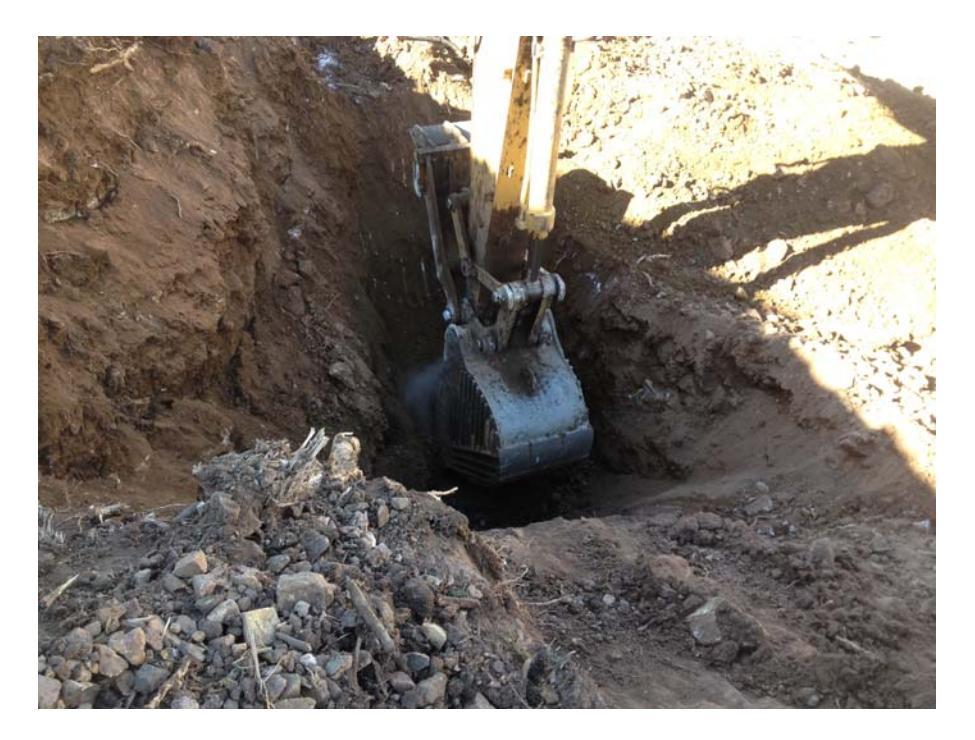
Photo No. 1; UG #6077 known as a collapsed shaft, excavated to about 12 feet into competent rock

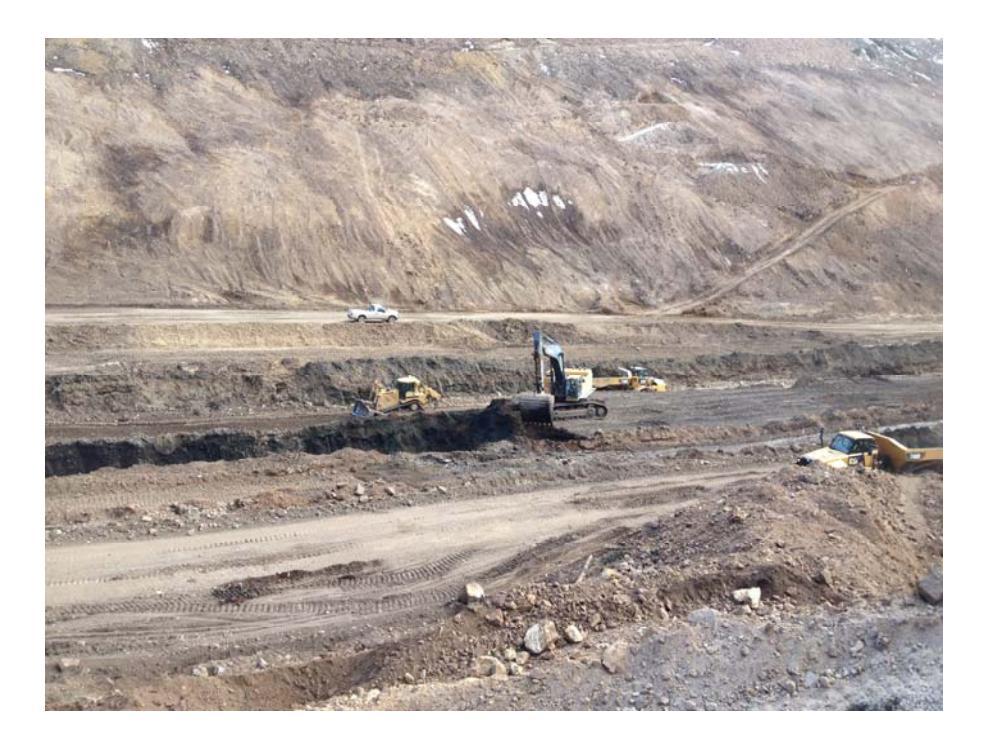
Photo No. 2 removing unsuitable material from within the planned footprint of the Hwy 67 embankment

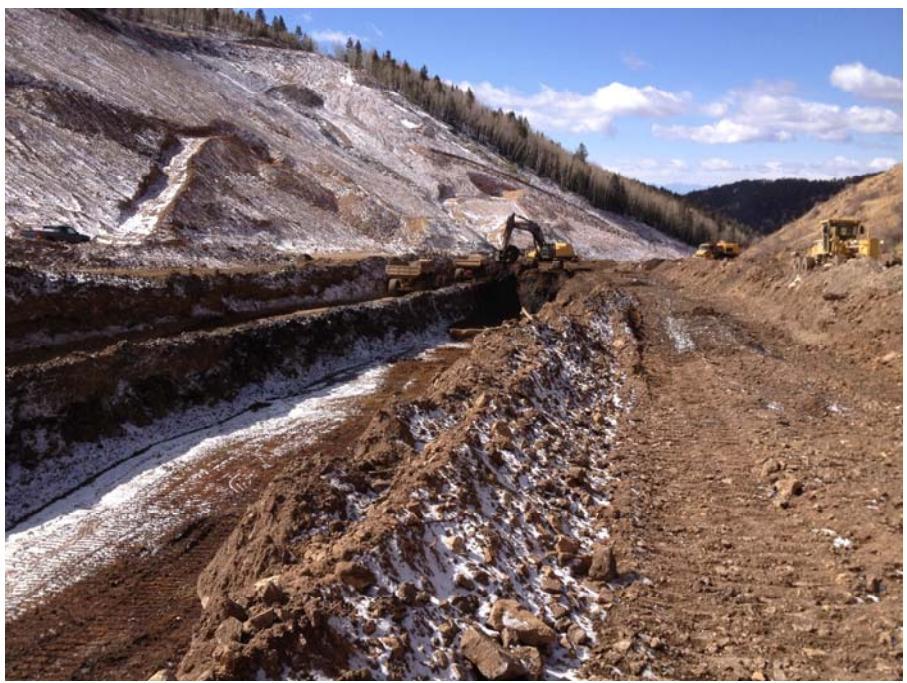
Photo No. 1; Removal of unsuitable material from the embankment footprint

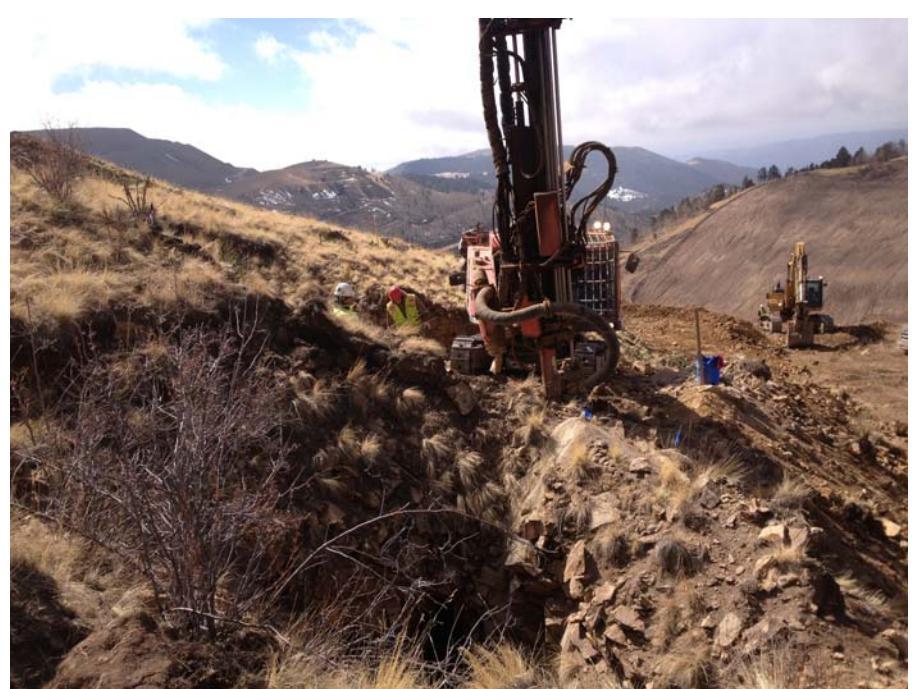
Photo No. 4; Start of Confirmatory drilling at UG #6112

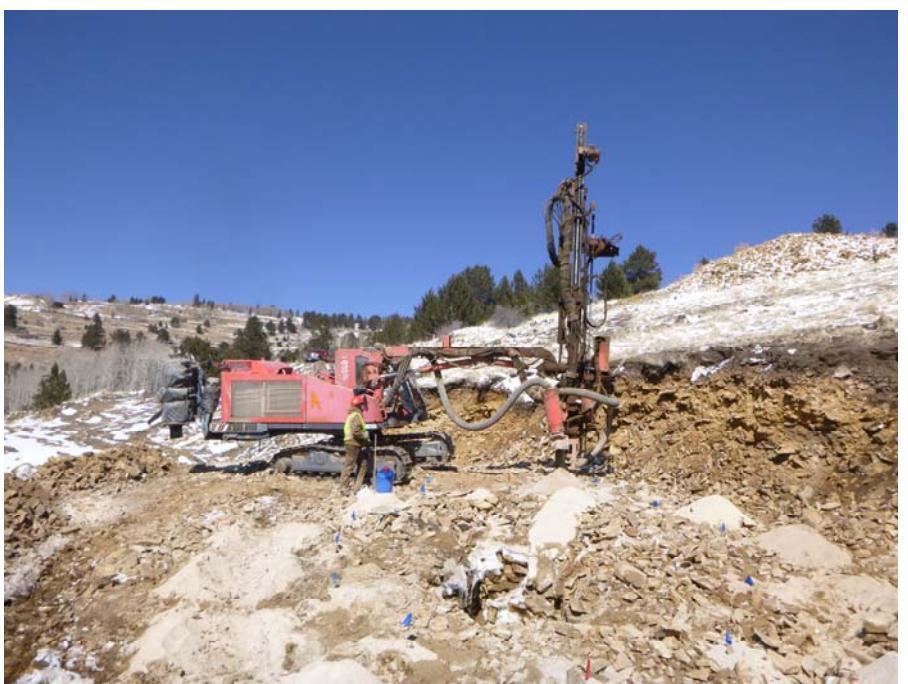
Photo No. 2; Confirmatory drilling at UG #U6113

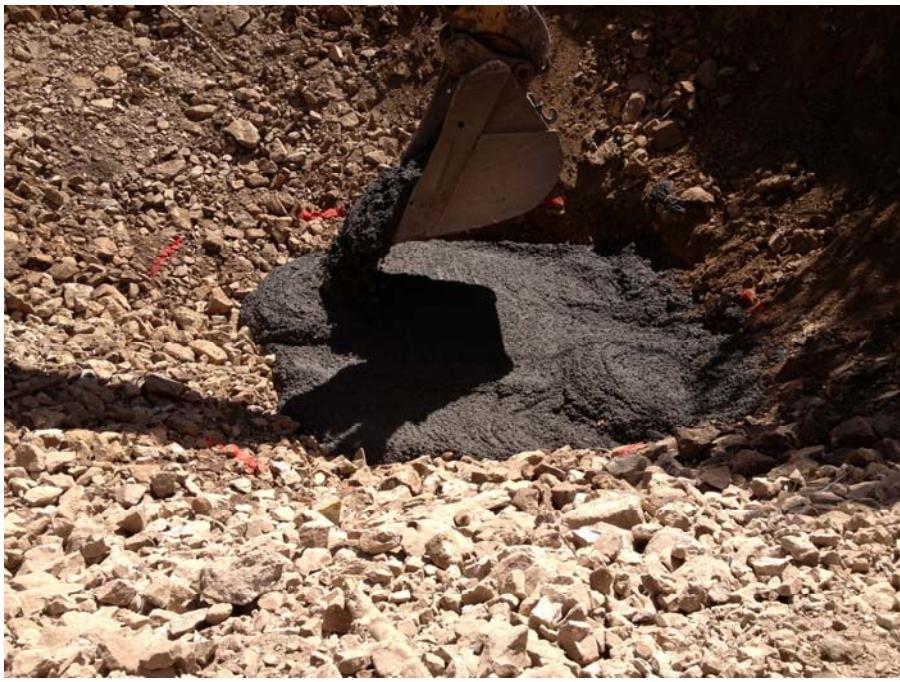
Photo No. 3; UG #6061 (Historical # 338) known as a shaft: placing the concrete "plug".

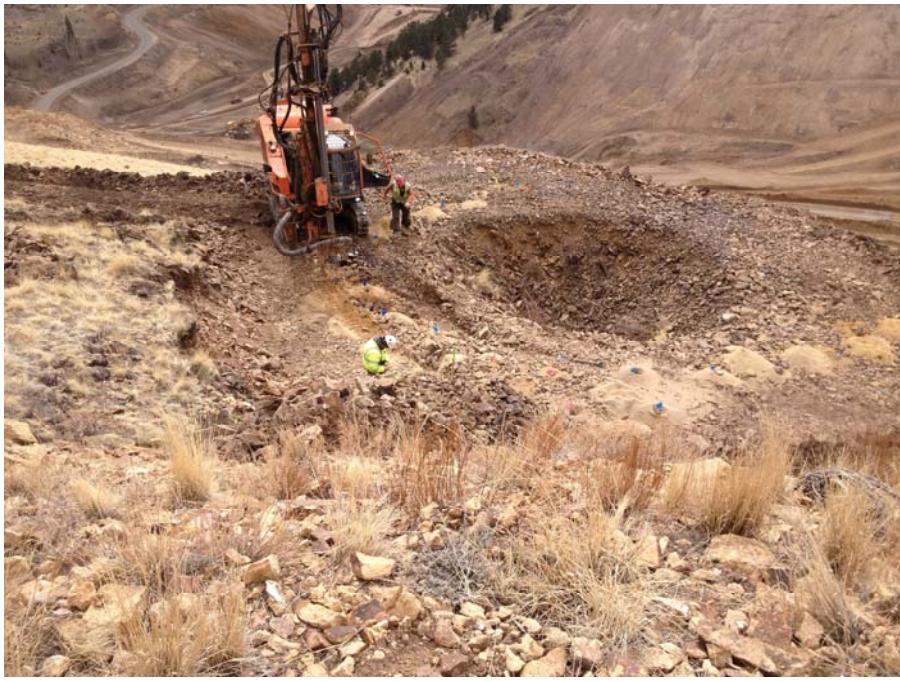
Photo No. 3; Drilling UG #6120, collapsed adit.

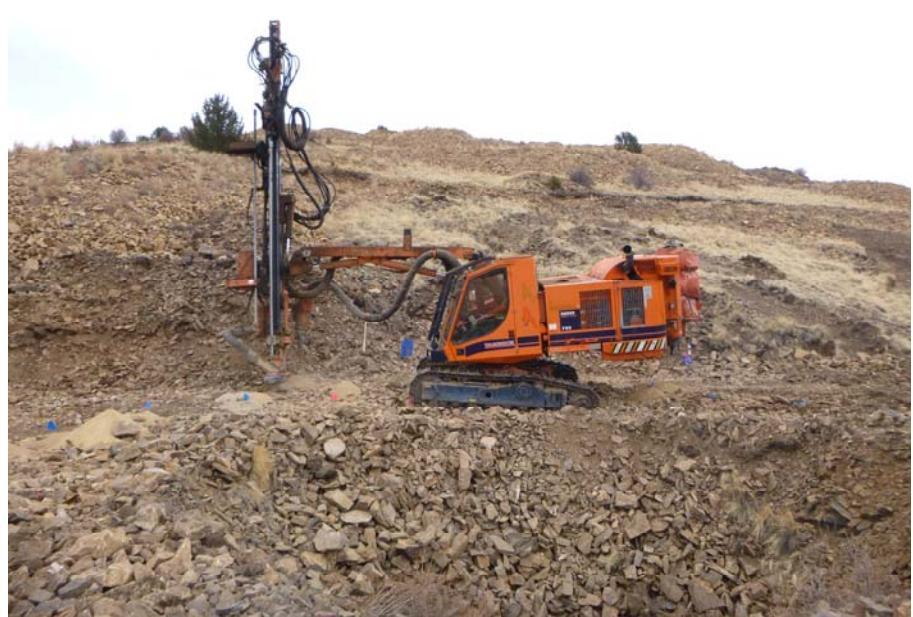
Photo No. 1; Drilling UG #6120, collapsed adit.

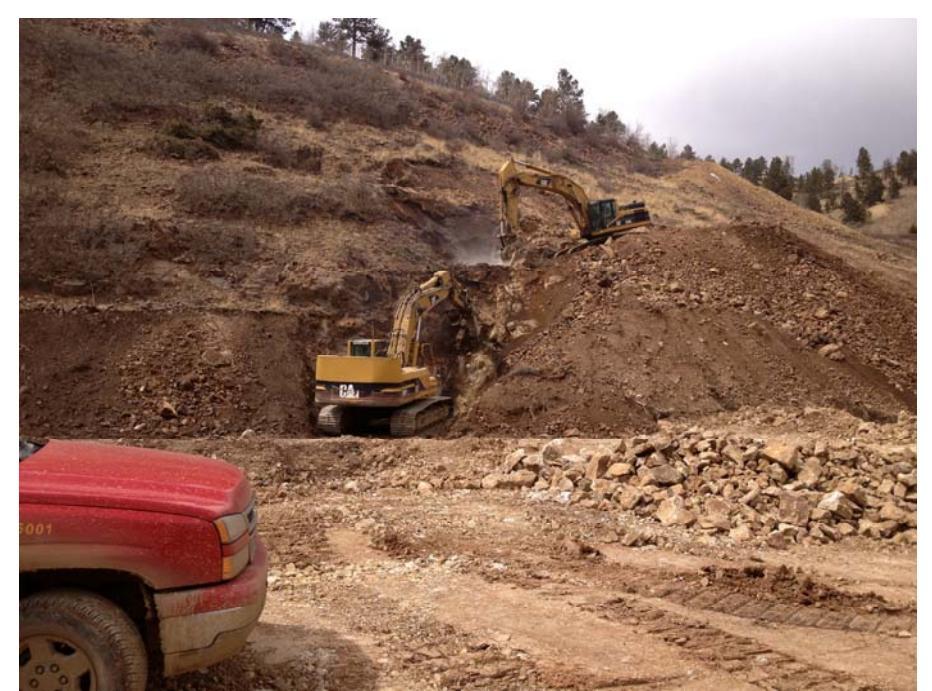
Photo No.4; UG #6030: Removing shot rock and breaking out the remaining crown pillar
